National Transportation Safety Board Hazardous Materials
Special Investigation Report: Cargo Tank Rollover Protection

PB92 917002
NHSB/SIR-92/01

CARGO TANK ROLLOVER PROTECTION

Abstract: Between January and May 1991, the National Transportation Safety Board investigated seven highway accidents in which bulk liquid cargo tanks, Department of Transportation (DOT) specification MC 306 or MC 312, overturned and released hazardous materials through damaged closures or fittings on top of the tanks. In three of the accidents, structural failure of the rollover protection devices for the top fittings resulted in impact damage to the fittings and the release of the cargo; in four of the accidents, the design and configuration of the devices were not adequate to protect and shield the top fittings from external objects or from plowing into the ground. As a result of these accidents, the Safety Board conducted a special investigation on cargo tank rollover protection. The safety issues discussed in this report are the adequacy of DOT regulations regarding the design and performance of rollover protection devices installed on bulk liquid cargo tanks; the effectiveness of oversight pertaining

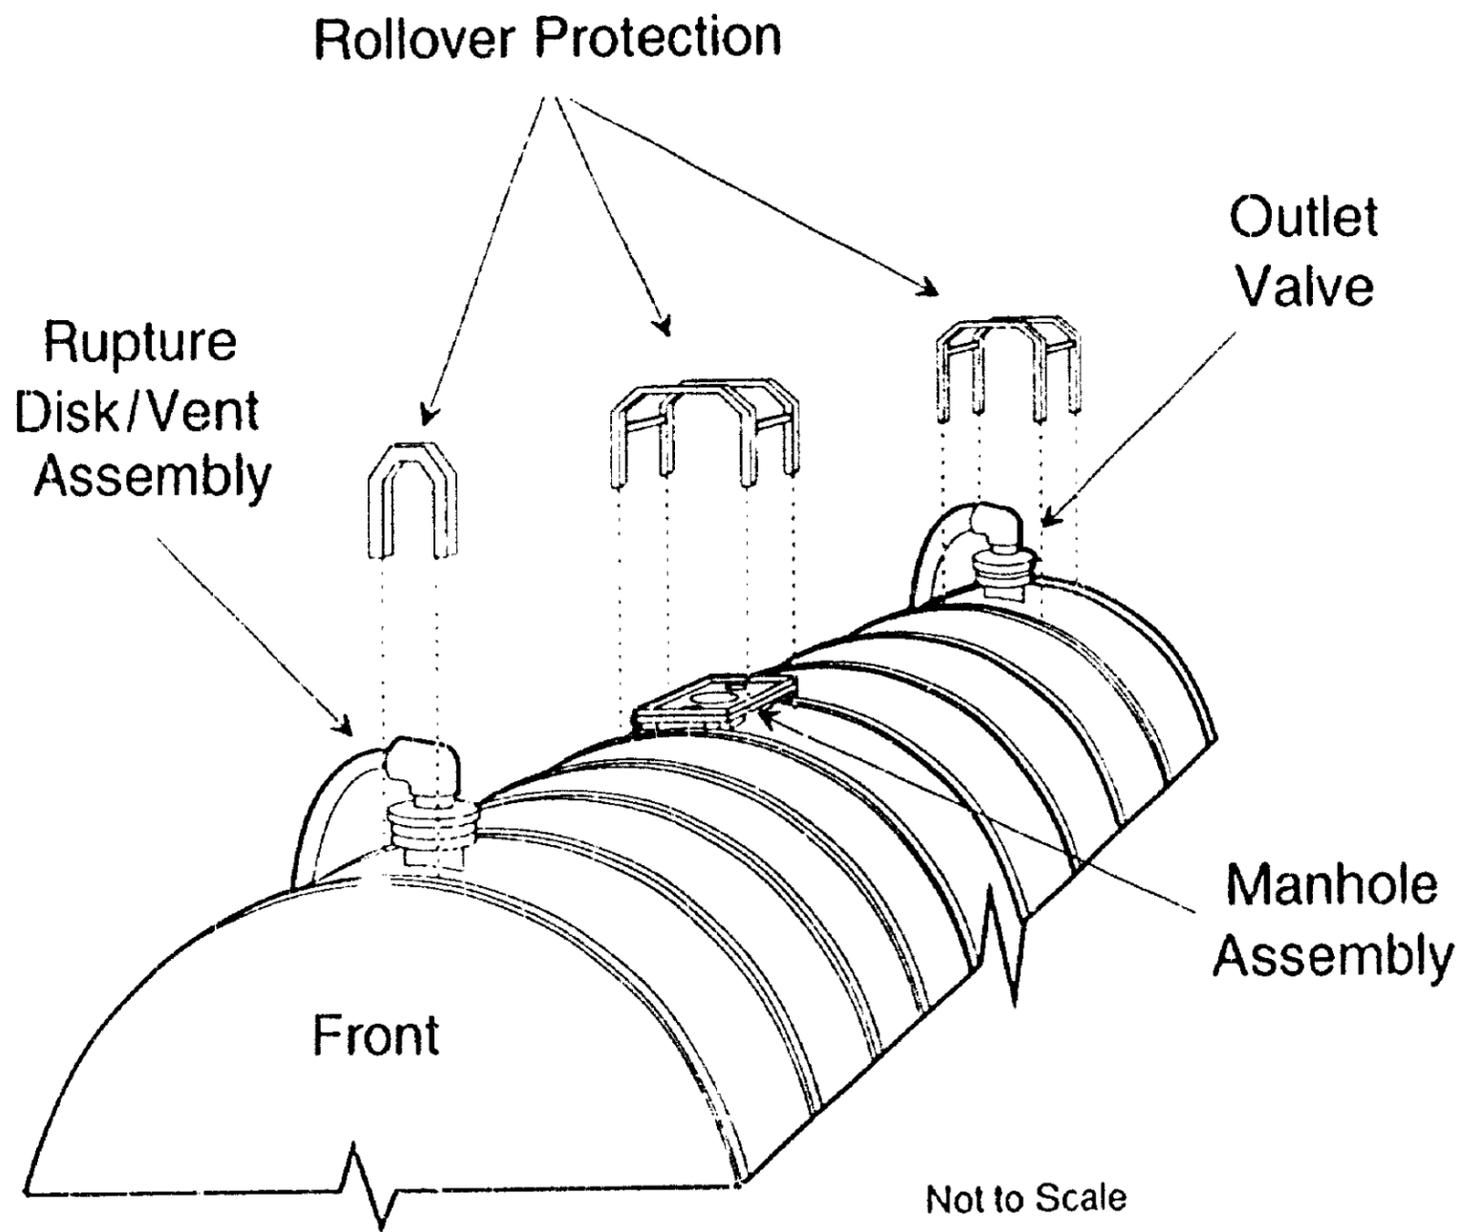
The cargo tank, a DOT specification MC 312 tank constructed of steel, was manufactured by Acro Trailer Company in 1981. The cargo tank was equipped with three fittings on the top of the tank: a rupture disk⁶ mounted on a neck flange, a manhole assembly, and a cargo discharge valve mounted on a flange. To protect the fittings from damage during a rollover accident, square-formed steel tubing was welded to stiffening rings attached to the tank (fig. 2). The steel tubing was installed in front of the rupture disk assembly, and both in front of and behind the manhole assembly and discharge valve. The 2-inch square steel tubing was fabricated from 1/4-inch-thick steel plate. The dimensions of the steel tubing protection varied, depending on the size of adjacent fittings.

Figure 2.--Rollover protection and fittings on the MC 312 accident cargo tank (Albuquerque, NM) manufactured by Acro Trailer Company.

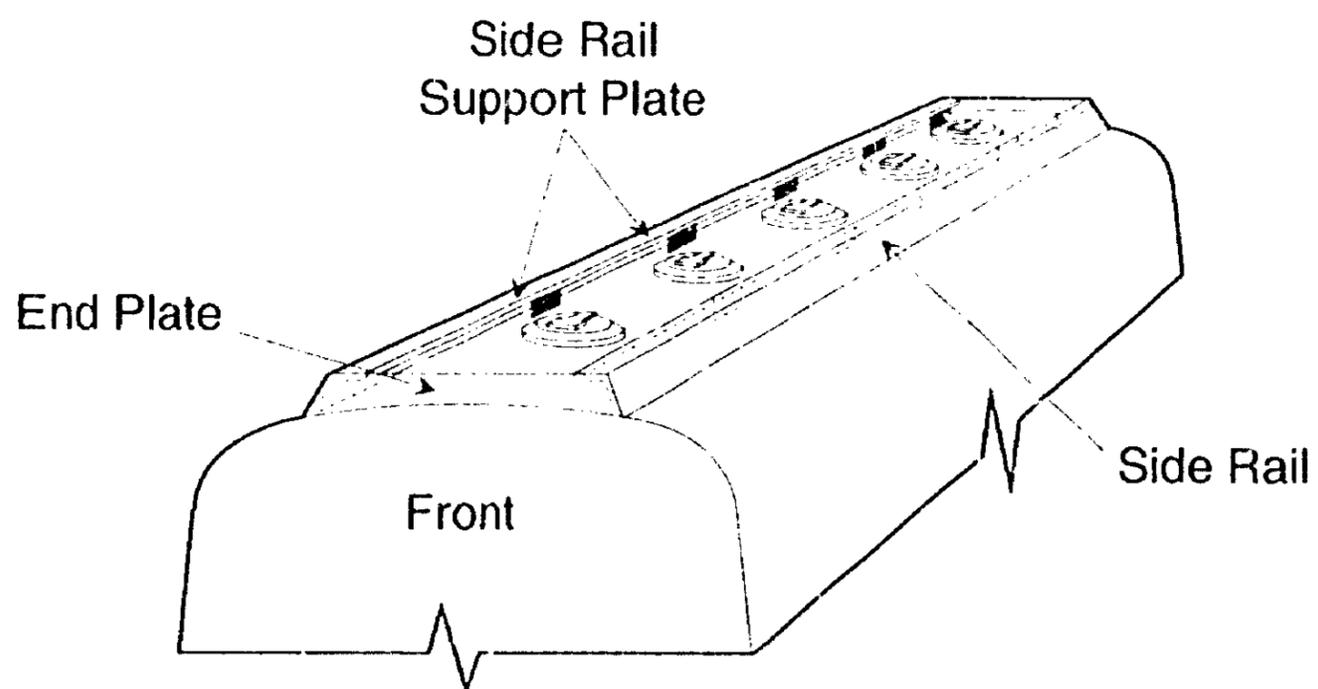
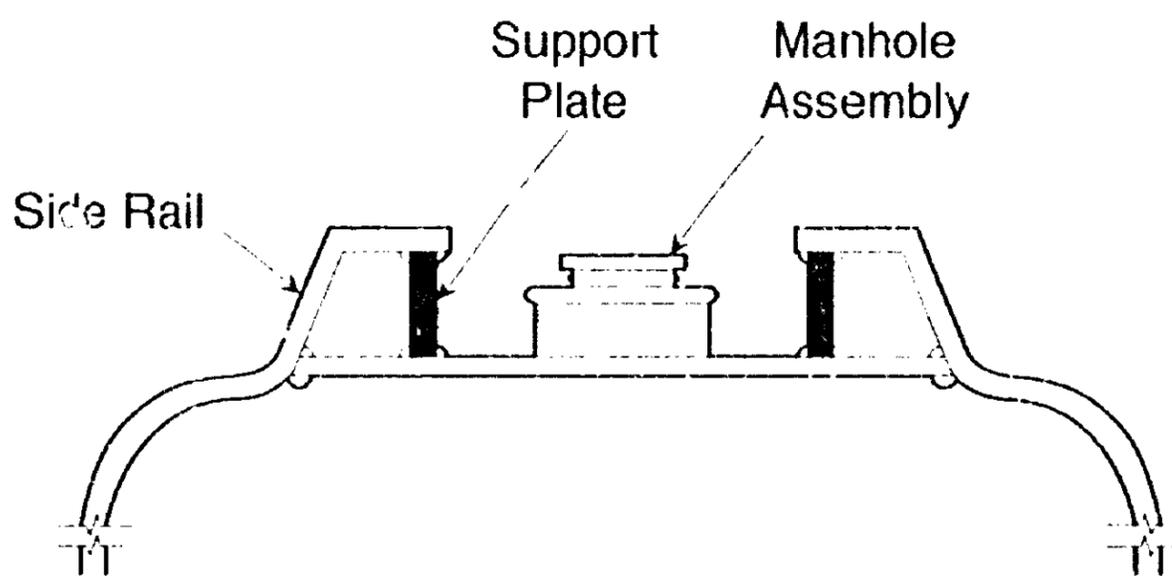
The MC 306 cargo tank, which was constructed of steel, was manufactured by Progress Industries, Inc., in 1990. The cargo tank had five compartments, and each compartment was fitted with a top manhole assembly. To protect the fittings from damage during an overturn, two 0.1046-inch-thick steel rails were formed into the sidewall of the tank and extended along the length of the cargo tank on each side (fig. 4). Each rail was reinforced and supported by five 1/4-inch-thick steel plates. There were also 0.1046-inch-thick plates crossing between these rails at each end of the cargo tank. The side rails and end plates extended about 1 1/2 inches above the top of the manhole assemblies.

Figure 4.--Rollover protection and fittings on the MC 306 accident cargo tank (Hamilton, OH) manufactured by Progress Industries, Inc.: general configuration (top), and end view cross section (bottom).

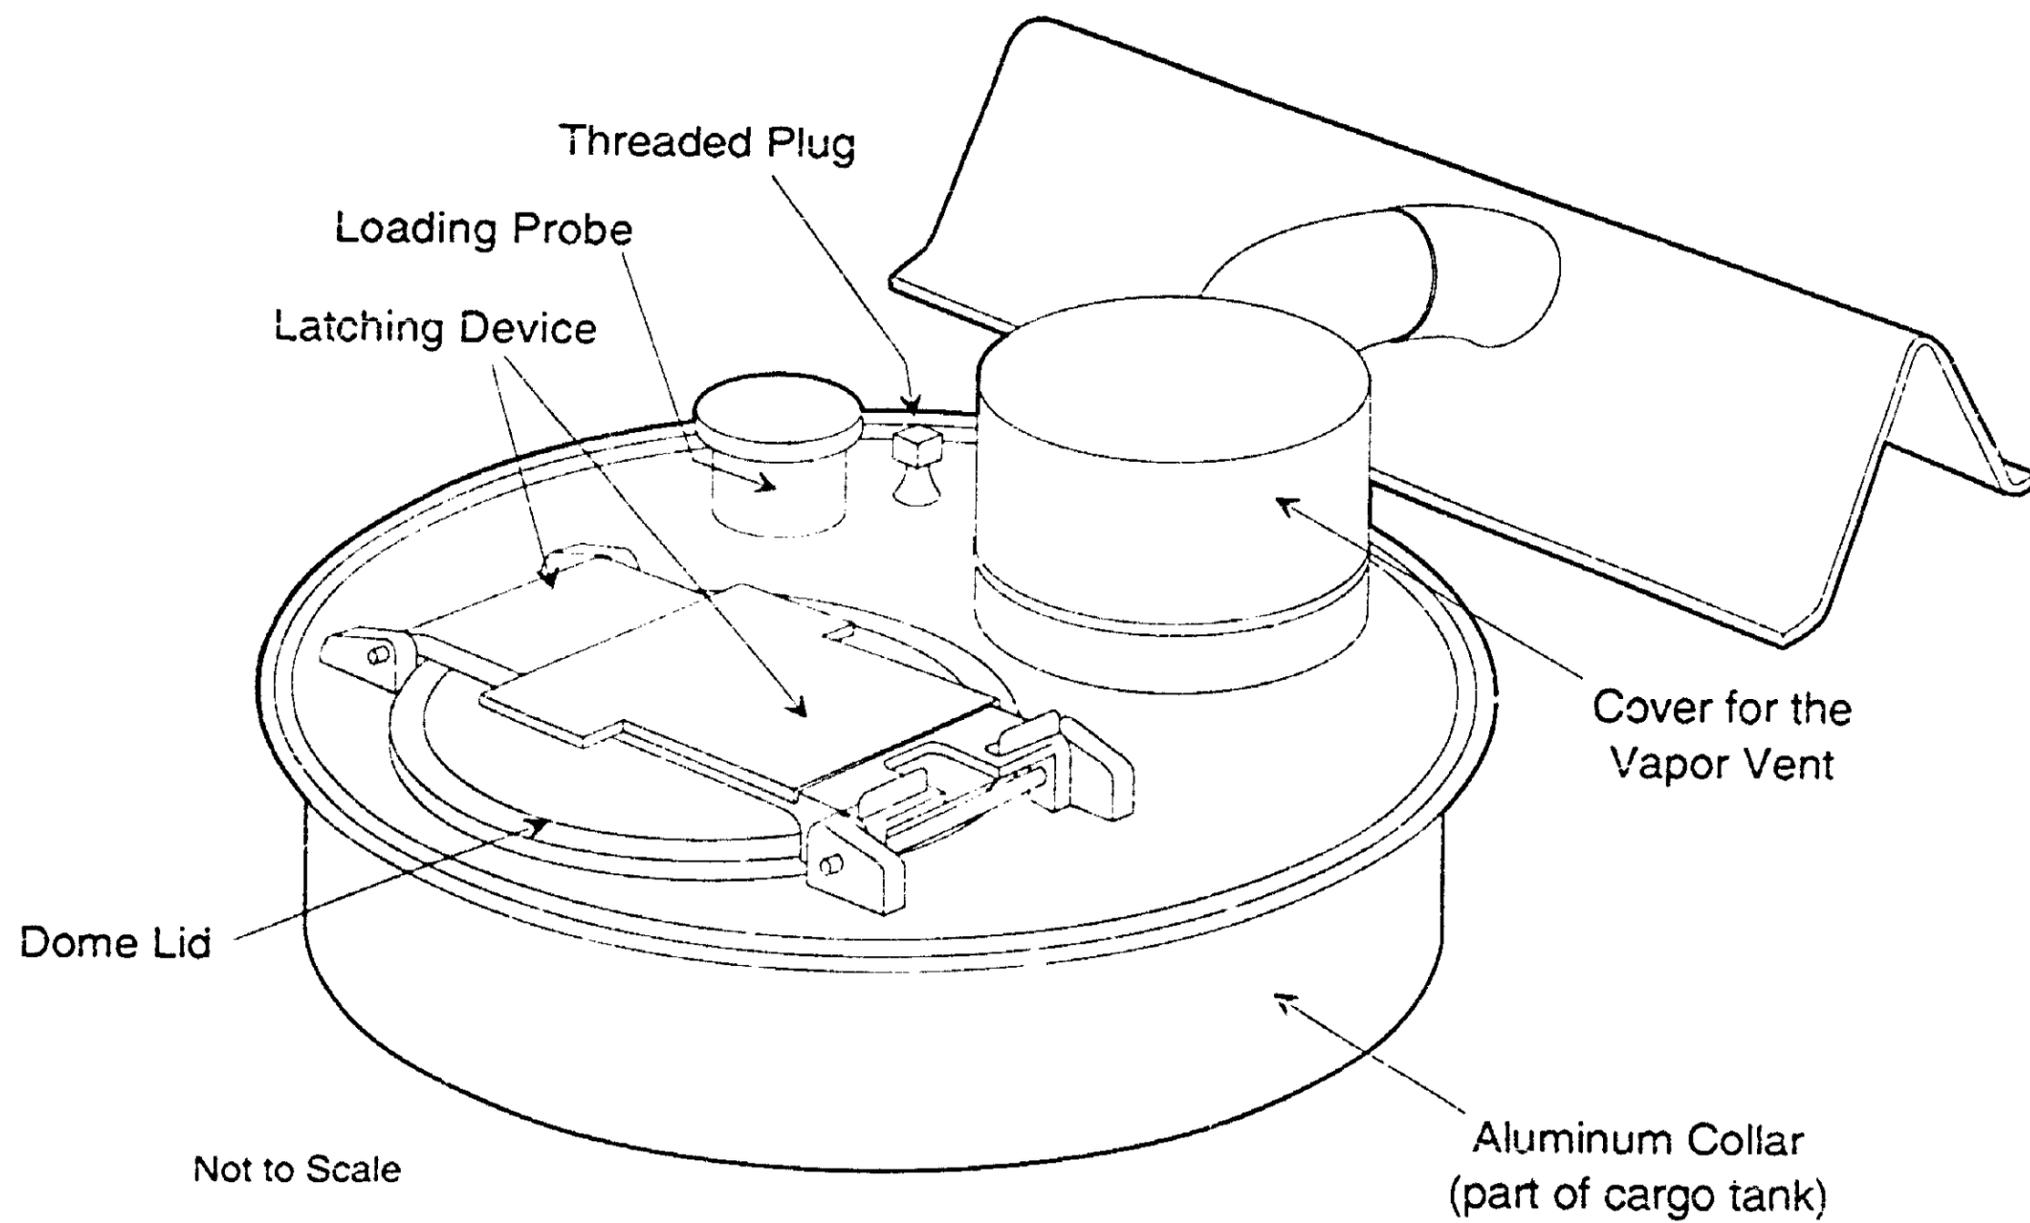
The aluminum MC 306 cargo tank was manufactured by Fruehauf Corporation in 1983. The cargo tank was equipped with five compartments, and a manhole was installed in the top of each compartment. Each manhole was equipped with a steel plate manhole cover, and each manhole cover held three fittings: a dome lid, a vapor vent, and a loading probe (fig. 6).

Figure 6.--Manhole assembly on the MC 306 accident cargo tank (Lantana, FL) manufactured by Fruehauf Corporation.

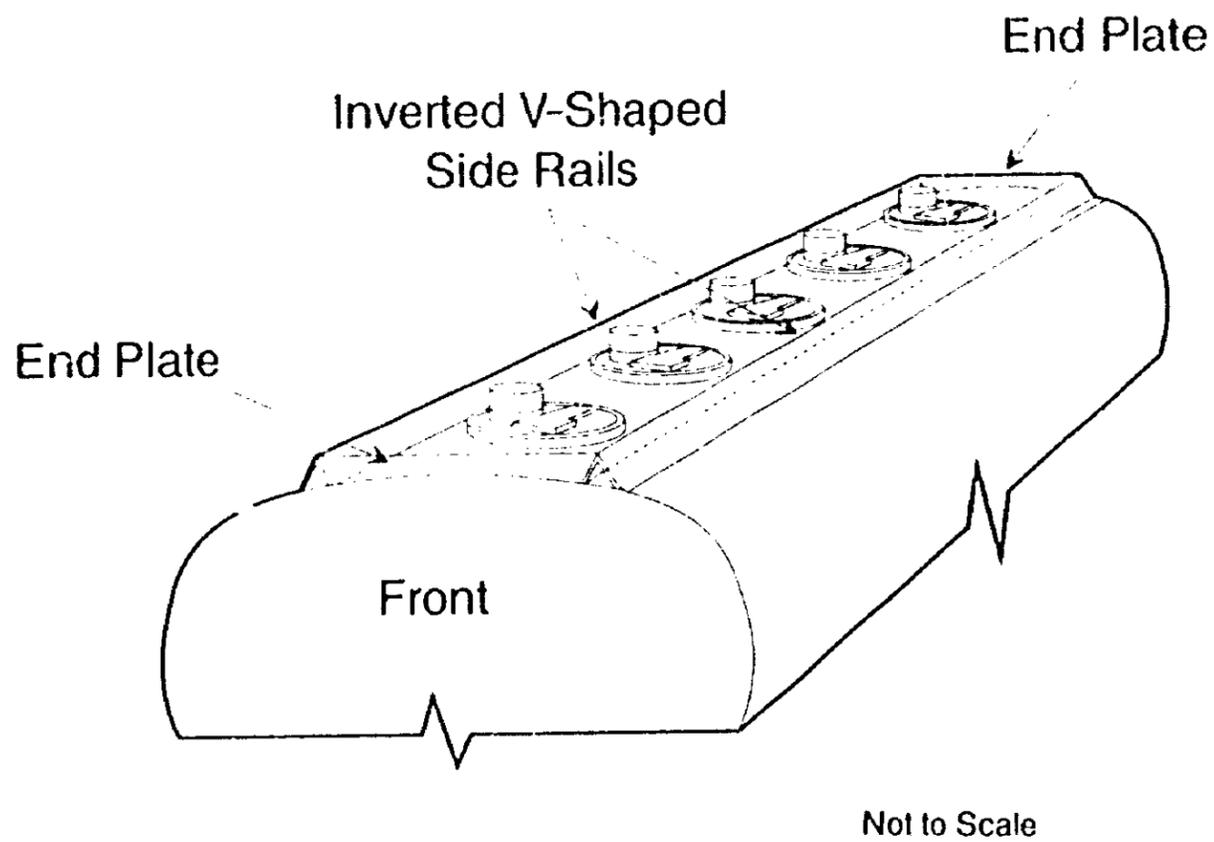
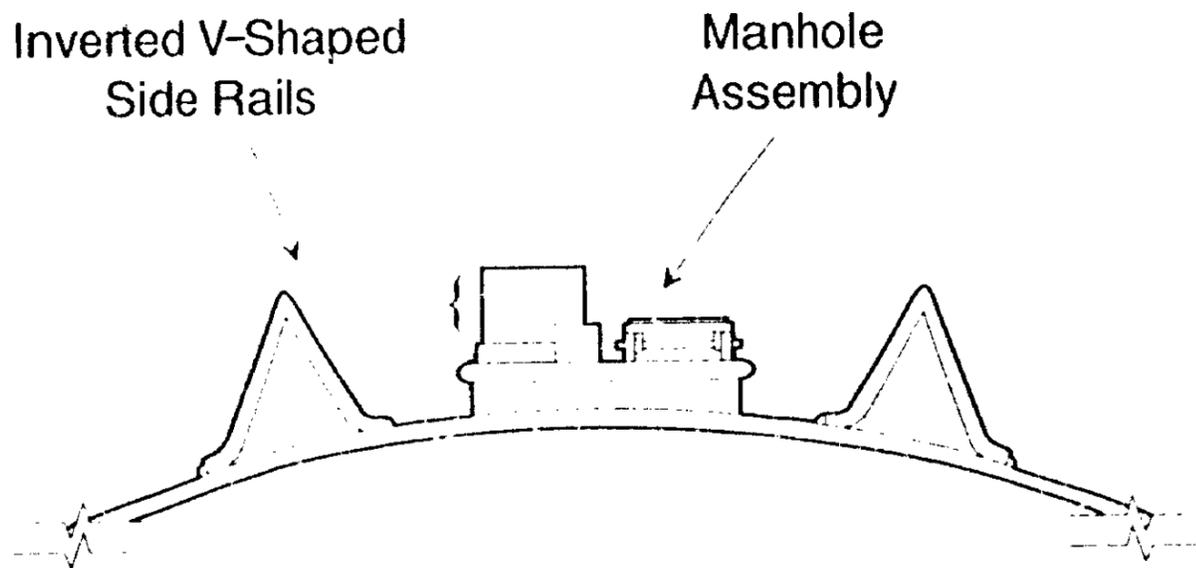
Two 8-inch-high extruded aluminum rails were welded to the top of the cargo tank shell to protect top fittings from damage during a rollover accident. The inverted V-shaped rails were 5/32 to 5/32 inch thick and ran the entire length of the cargo tank. Aluminum plates, 8/32-inch-thick, crossed between the rails at the each end of the cargo tank (fig. 7). These side rails and end plates extended 1 1/4 inches above the dome lids, 1 1/2 inches above the loading probes, and 2 1/4 inches above the vapor vent. The rubber cover for the vapor vent was 1 1/4 inches higher than the side rails and end plates; however, dislodgement of the cover would not cause a release of cargo. During a postaccident inspection of the cargo tank, a Safety Board investigator documented the damage to the rollover protection rails and to the top fittings. The rear half of the right side rail was damaged; the most severe damage occurred between the fourth and fifth compartments. The rail at this location was split at the top of the inverted V, bent toward the centerline of the tank, and compressed down about 1 1/4 inches; however, the rail was not bent below the top of the tallest fitting. The dome lid on the second compartment was distorted and fractured. This dome lid was open and would not reseat on the manway cover. All other dome lids were closed. Additionally, two aluminum loading probes on two manway covers displayed evidence of external strikes and were dislodged from their respective manway covers. A third loading probe was also dislodged but was not located. Each dislodged probe left a 2 1/4-inch-diameter opening through the manhole cover to the cargo compartment (fig. 8). Metallurgical examination of the two recovered probes and the damaged manway cover also determined that a zinc residue from the smears found on the damaged areas of the probes and the manway cover was consistent with a zinc-coated object striking the probes and the manway cover. The highway guardrails at this location were zinc-coated.

Figure 7.--Rollover protection and representative fittings on the MC 306 cargo tanks manufactured by Fruehauf Corporation and the Heil Company: general configuration (top) and end view cross section (bottom). The tube extending from the cover for the vapor vent (brace) to the side rail is not shown; the tube is depicted in figure 6.

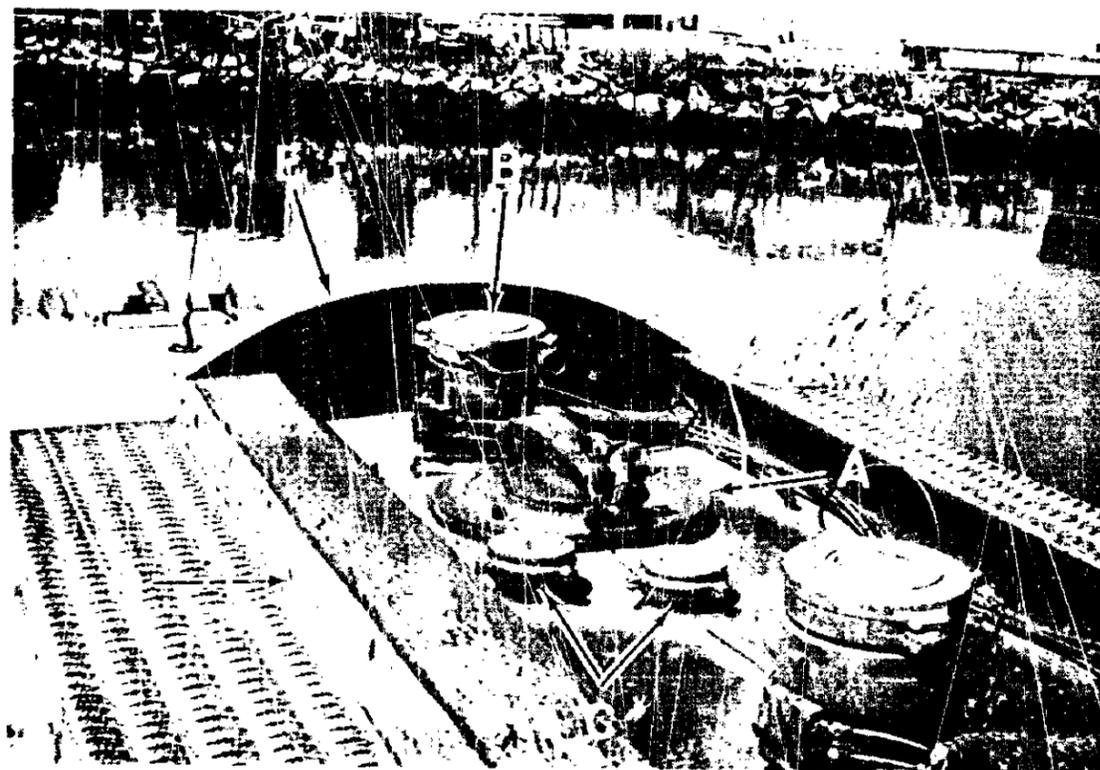
The steel MC 306 cargo tank was manufactured by Bomar Tank Discharge Systems, Inc., in 1984. The cargo tank was constructed with five compartments, each equipped with five fittings on the top of the tank: a manhole assembly, an adapter for a fill line, two vents, and a connection for the control rod to the internal emergency shut-off valve located at the bottom of the compartment. To protect these fittings from damage during a rollover accident, four curved transverse 3/16-inch-thick steel plates had been welded, evenly spaced, along the top of the tank. The plates were about 3 1/4 inches higher than the manhole cover, but less than 3/4 inch higher than the adapter for the fill line. The plates were joined to two side rails that ran the length of the tank; the primary function of these side rails was to contain cargo spilled during transfer operations. The side rails were 1 inch below the top of the manhole covers and 4 inches below the top of the loading adapter fitting (figs. 11 and 12).

Figure 11.--Rollover protection and fittings for the forward compartment on an MC 306 cargo tank comparable to the accident cargo tank (Bronx, NY) manufactured by Bcomar Tank Discharge Systems, Inc.: manhole assembly (A), fill adapter (B), vents (C), side rail (D) and transverse rollover plate (E). A control rod connection for the internal emergency shut-off valve is obscured by the fill adapter of the next compartment.

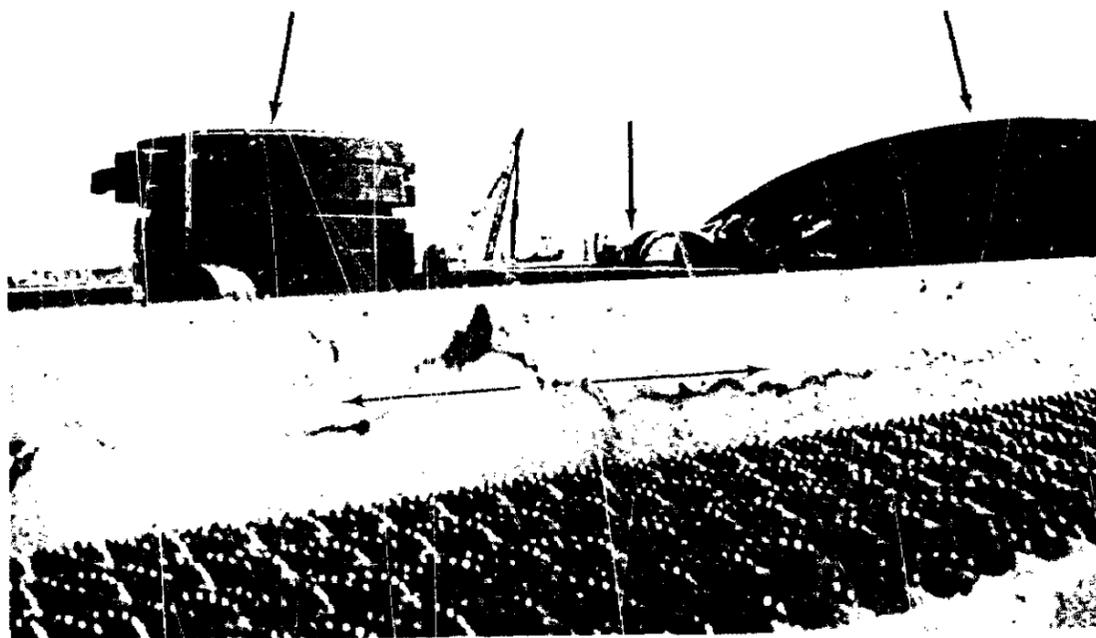
Figure 12.--The fill adapter (A) and manhole cover (B) above the side rail (C) on the accident cargo tank (Bronx, NY). The height of the transverse rollover plate (D) extends $3/4$ inch above the fill adapter.

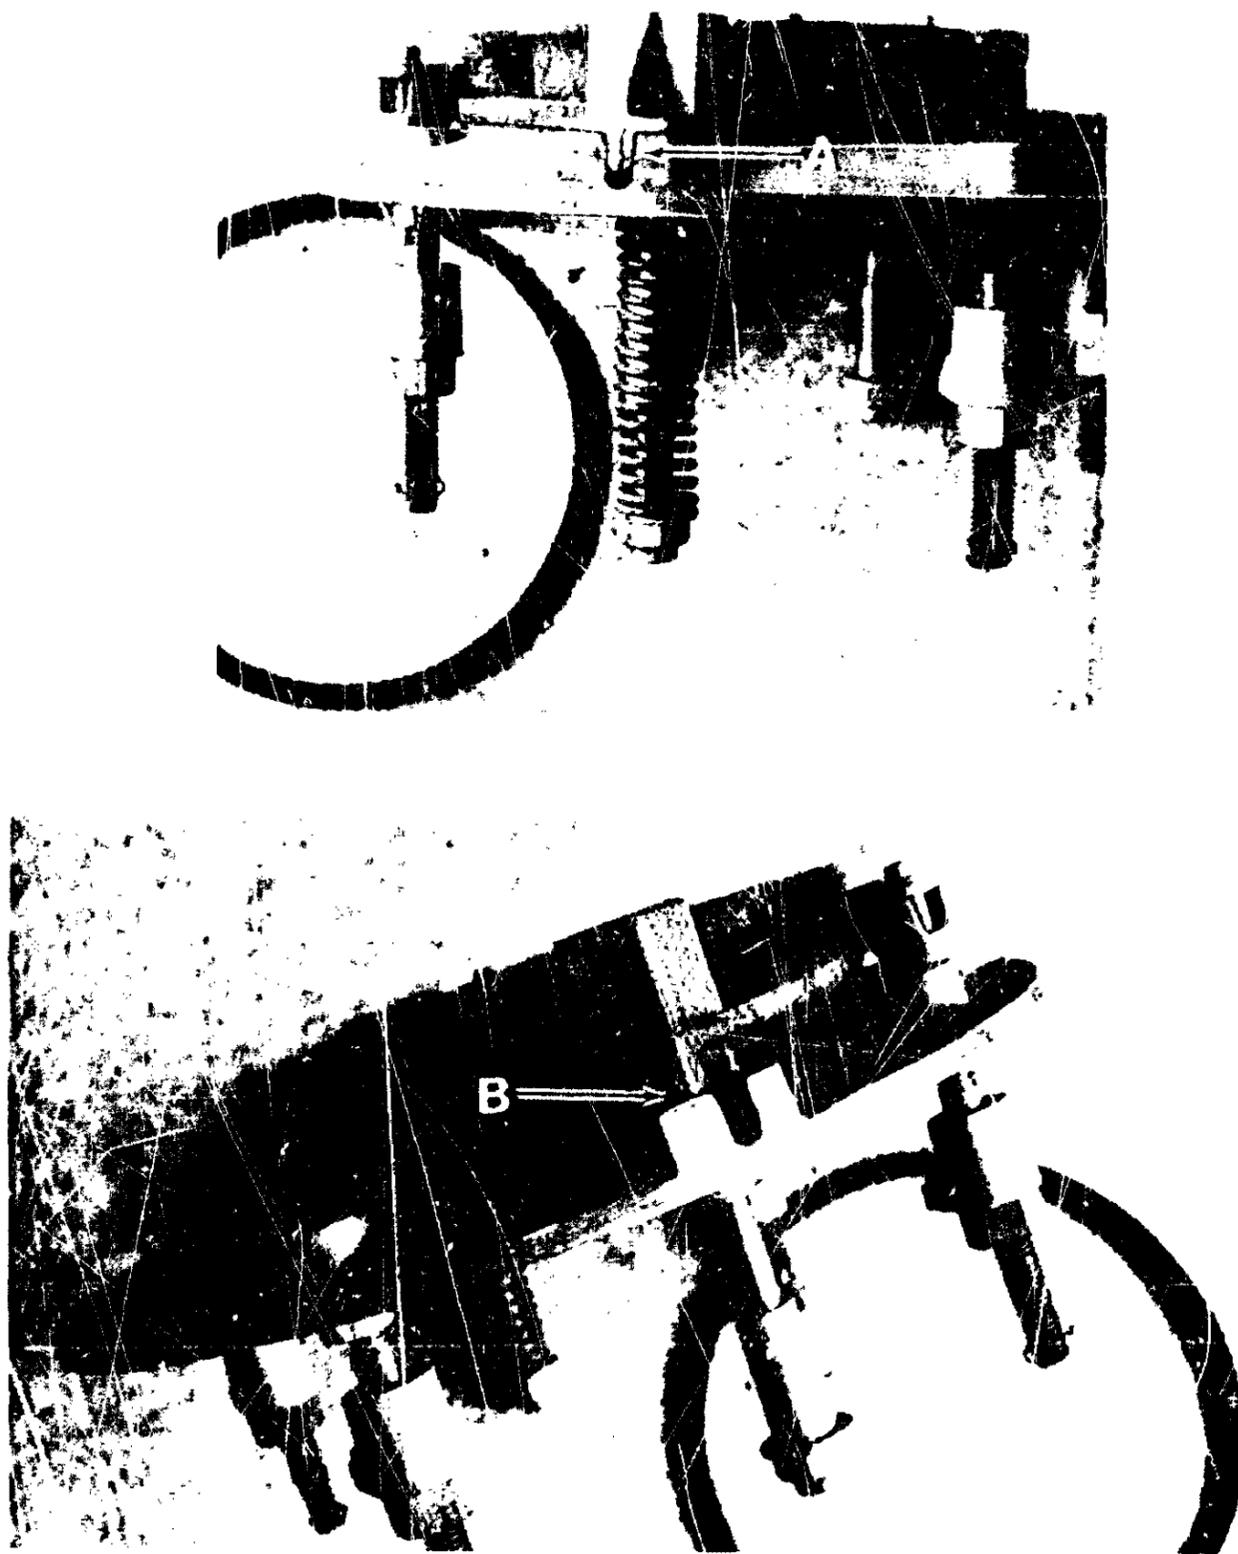
The aluminum MC 306 cargo tank was manufactured by Fruehauf Corporation in 1979. The cargo tank was equipped with a top-mounted manhole cover with a dome lid manufactured by CB Corporation, a loading probe, and a vapor recovery valve assembly for each of the tank's five compartments. To provide rollover protection for these fittings, the cargo tank had inverted aluminum V-shaped side rails running the length of the tank and aluminum plates at each end, like those on the Fruehauf cargo tanks involved in the accidents in Lantana, Florida, and Ethelsville, Alabama. The side rails on the tank extended about 1 1/4 inch above the top of the manhole covers.

Figure 15.--Dome lid manufactured by CB Corporation representative of the lids on the accident cargo tank (Columbus, GA): spring-loaded locking mechanism seated to the closed position (A), and mechanism prevented from seating to the closed position (B). (The spring has been removed for demonstration).

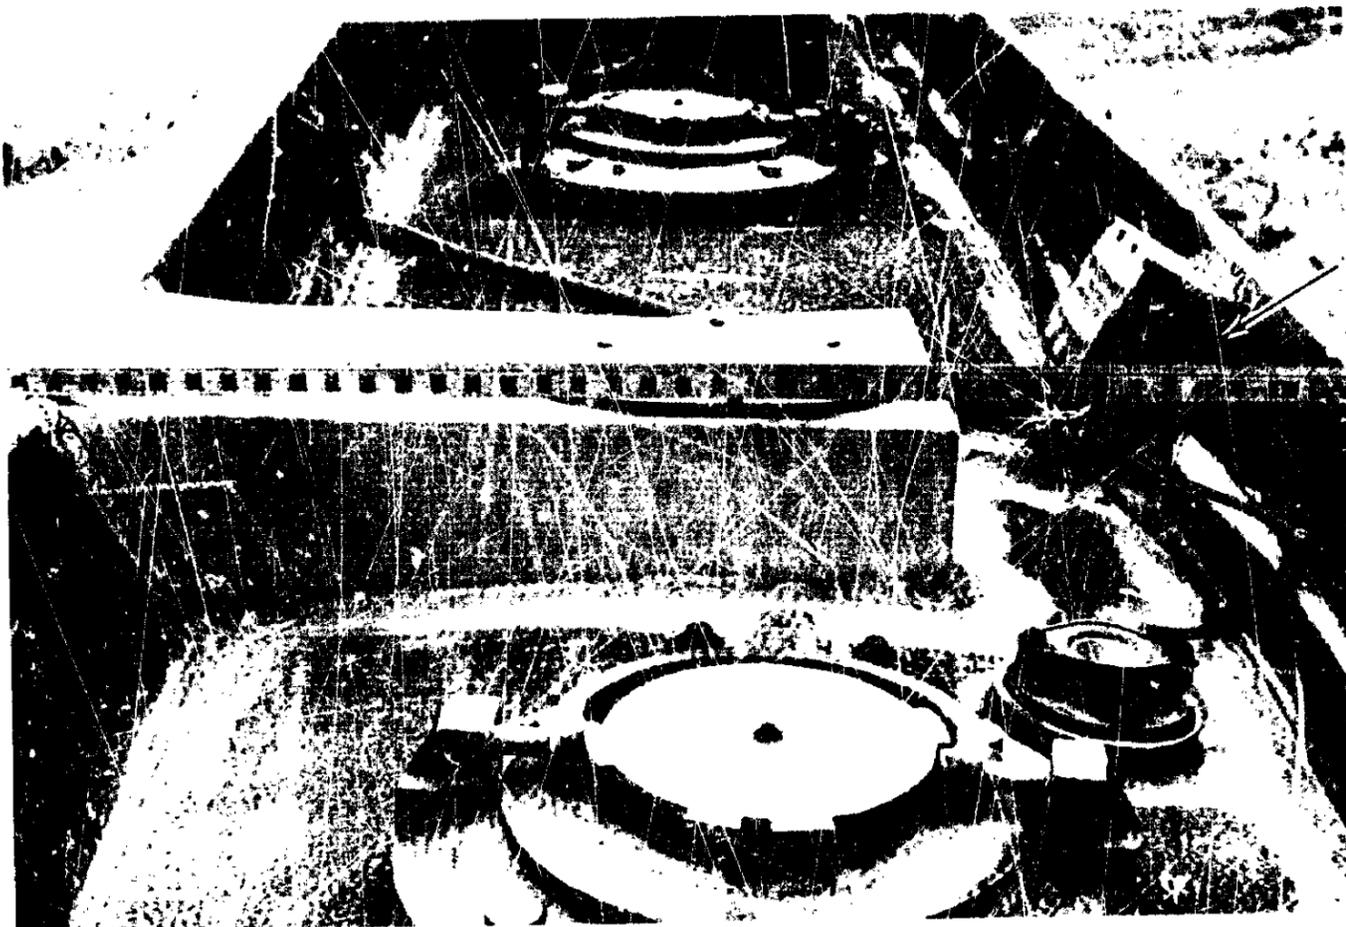
During a postaccident inspection of the cargo tank, a Safety Board investigator observed little damage to the rollover protection rails, although the front metal plate was bent rearward. The carrier stated that four of the five manhole dome lids were open after the accident. The dome lids, which are designed to lift and automatically reseal to relieve an internal pressure surge, can be mechanically prevented from resealing by rotation of the locking mechanism for the dome lid (fig. 15). Scrape marks were observed on two of the five dome lid closure assemblies. The orientation of the scrape marks was consistent with an impact that could cause a rotating force on the dome lids. Dirt and grass were also wedged between an electrical box and the inside of the rollover protection rail near the third and fourth compartments (fig. 16).

Figure 16.--Grass and dirt wedged between an electrical box and the rollover protection rail (Columbus, GA).
