National Transportation Safety Board Special Investigation Report  
Piper Aircraft Corporation, PA-46 Malibu/Mirage  
Accidents/Incident, May 31, 1989 to March 17, 1991

PIPER AIRCRAFT CORPORATION  
PA-46 MALIBU/MIRAGE  
ACCIDENTS/INCIDENT  
MAY 31, 1989 TO MARCH 17, 1991

NTSB/SIR-92/03

Adopted: July 21, 1992  
Notation 5803

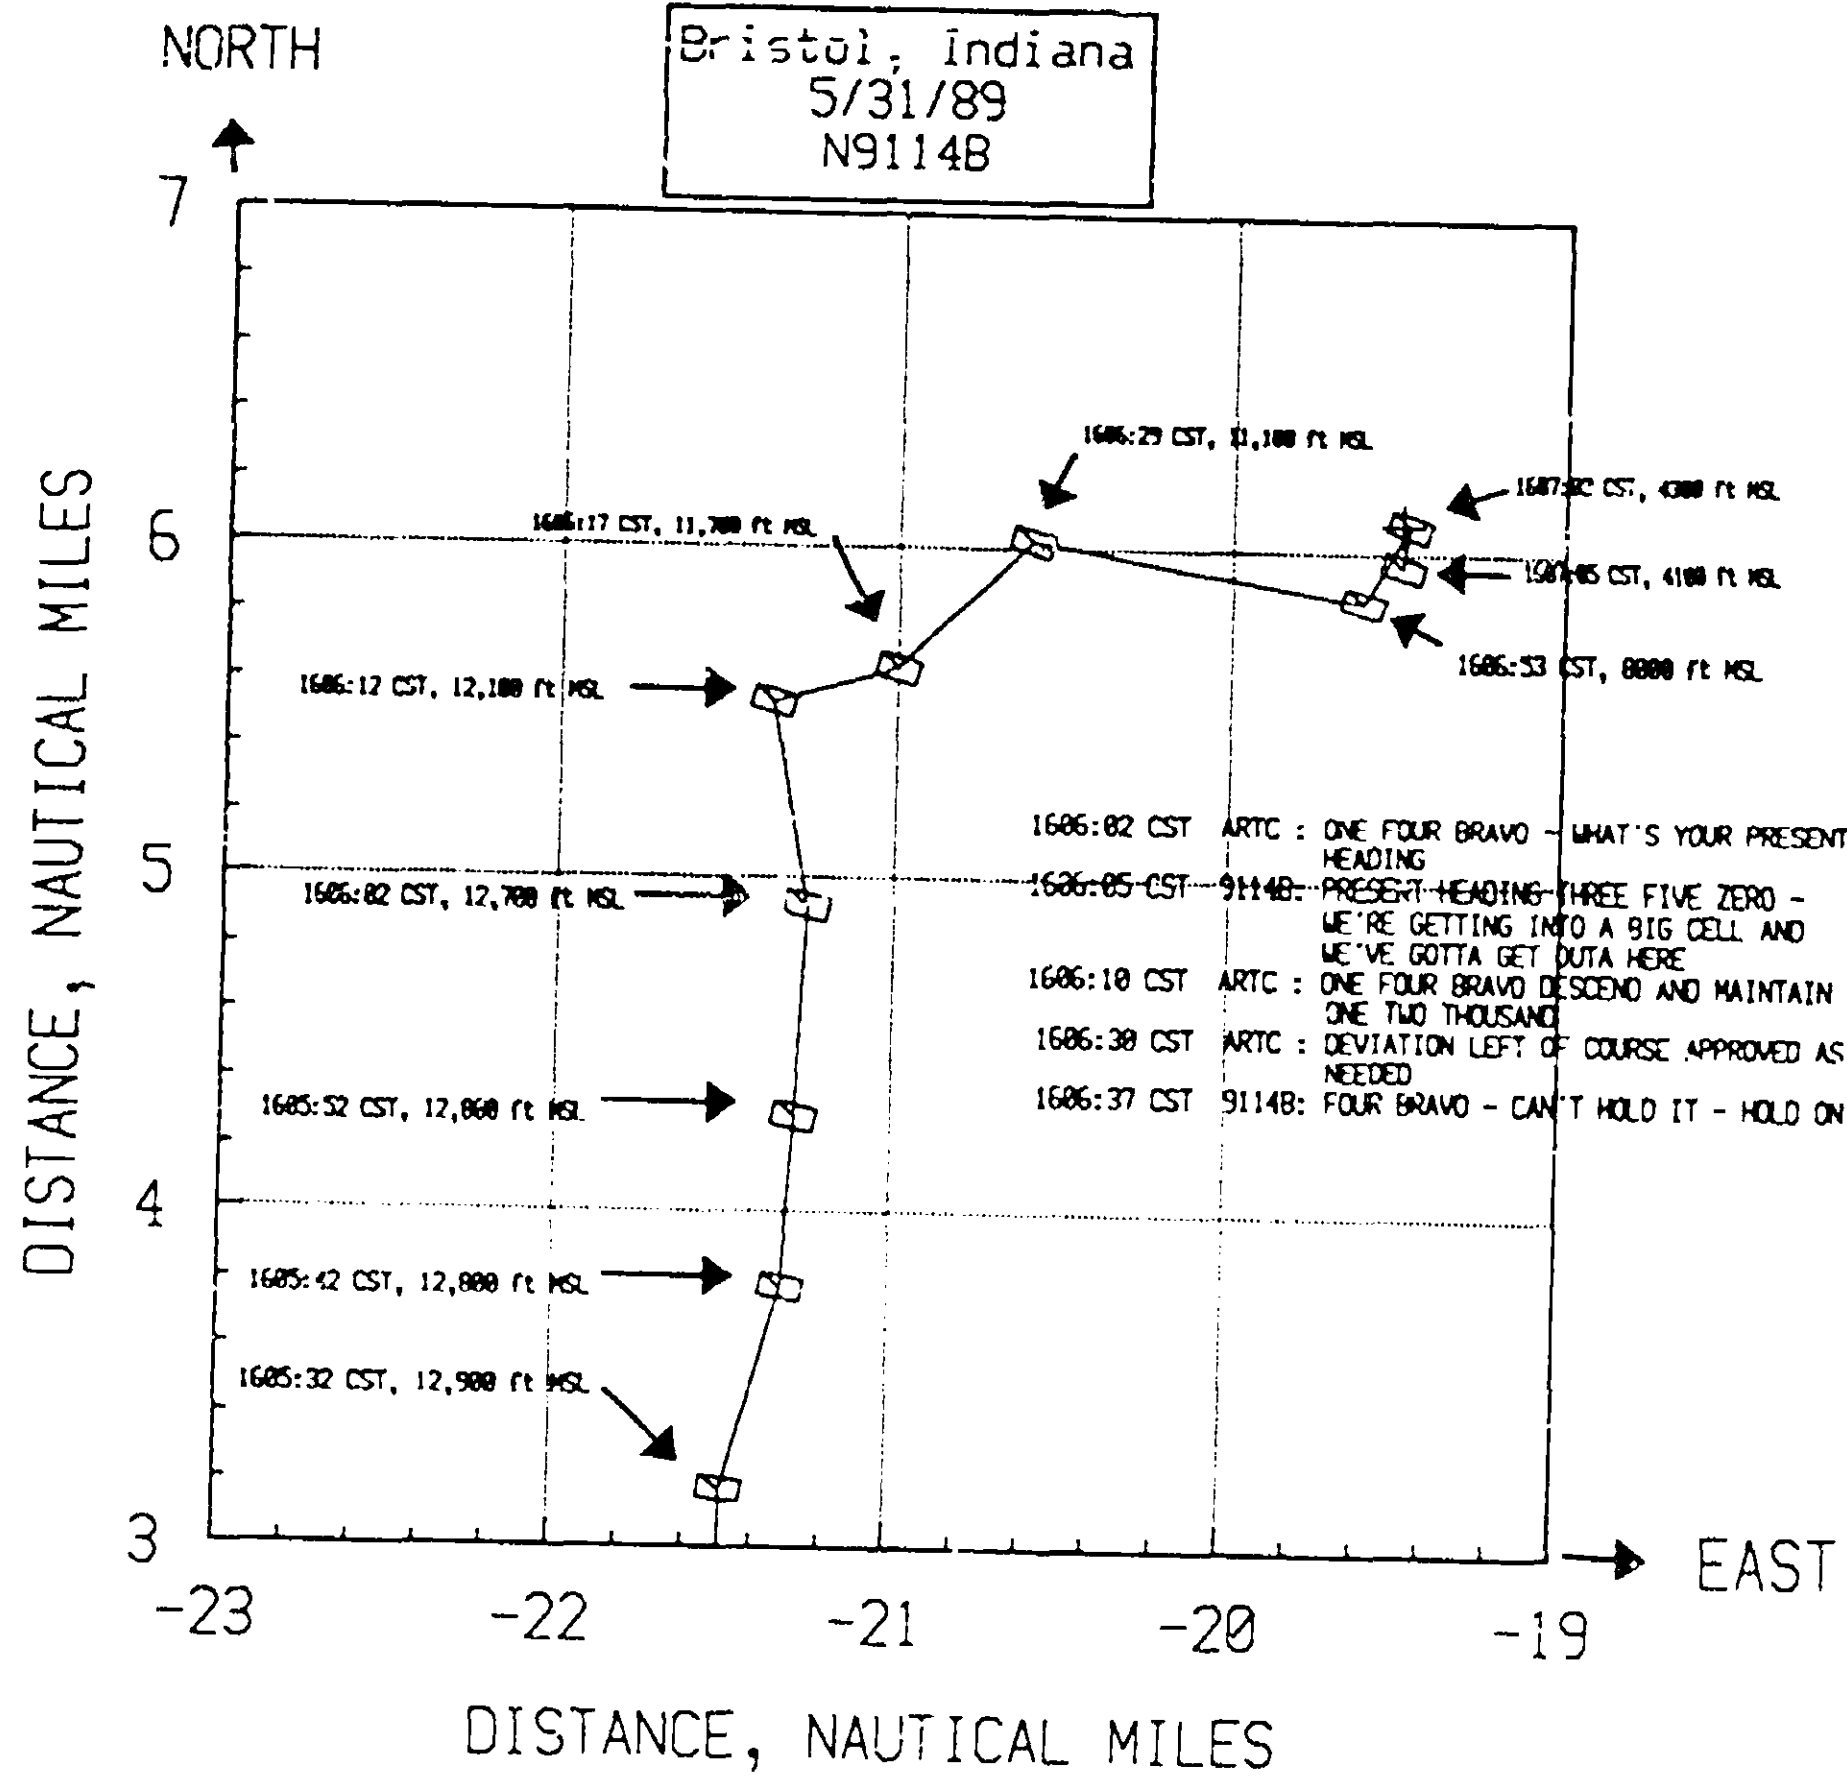
FIGURE 2

A flightpath study of recorded air traffic control (ATC) radar data (See Figures 2 and 3) was conducted for the accident by a Safety Board airplane performance engineer. Airplane performance calculations derived from recorded radar data indicate

Bristol, Indiana  
5/31/89  
N9114B

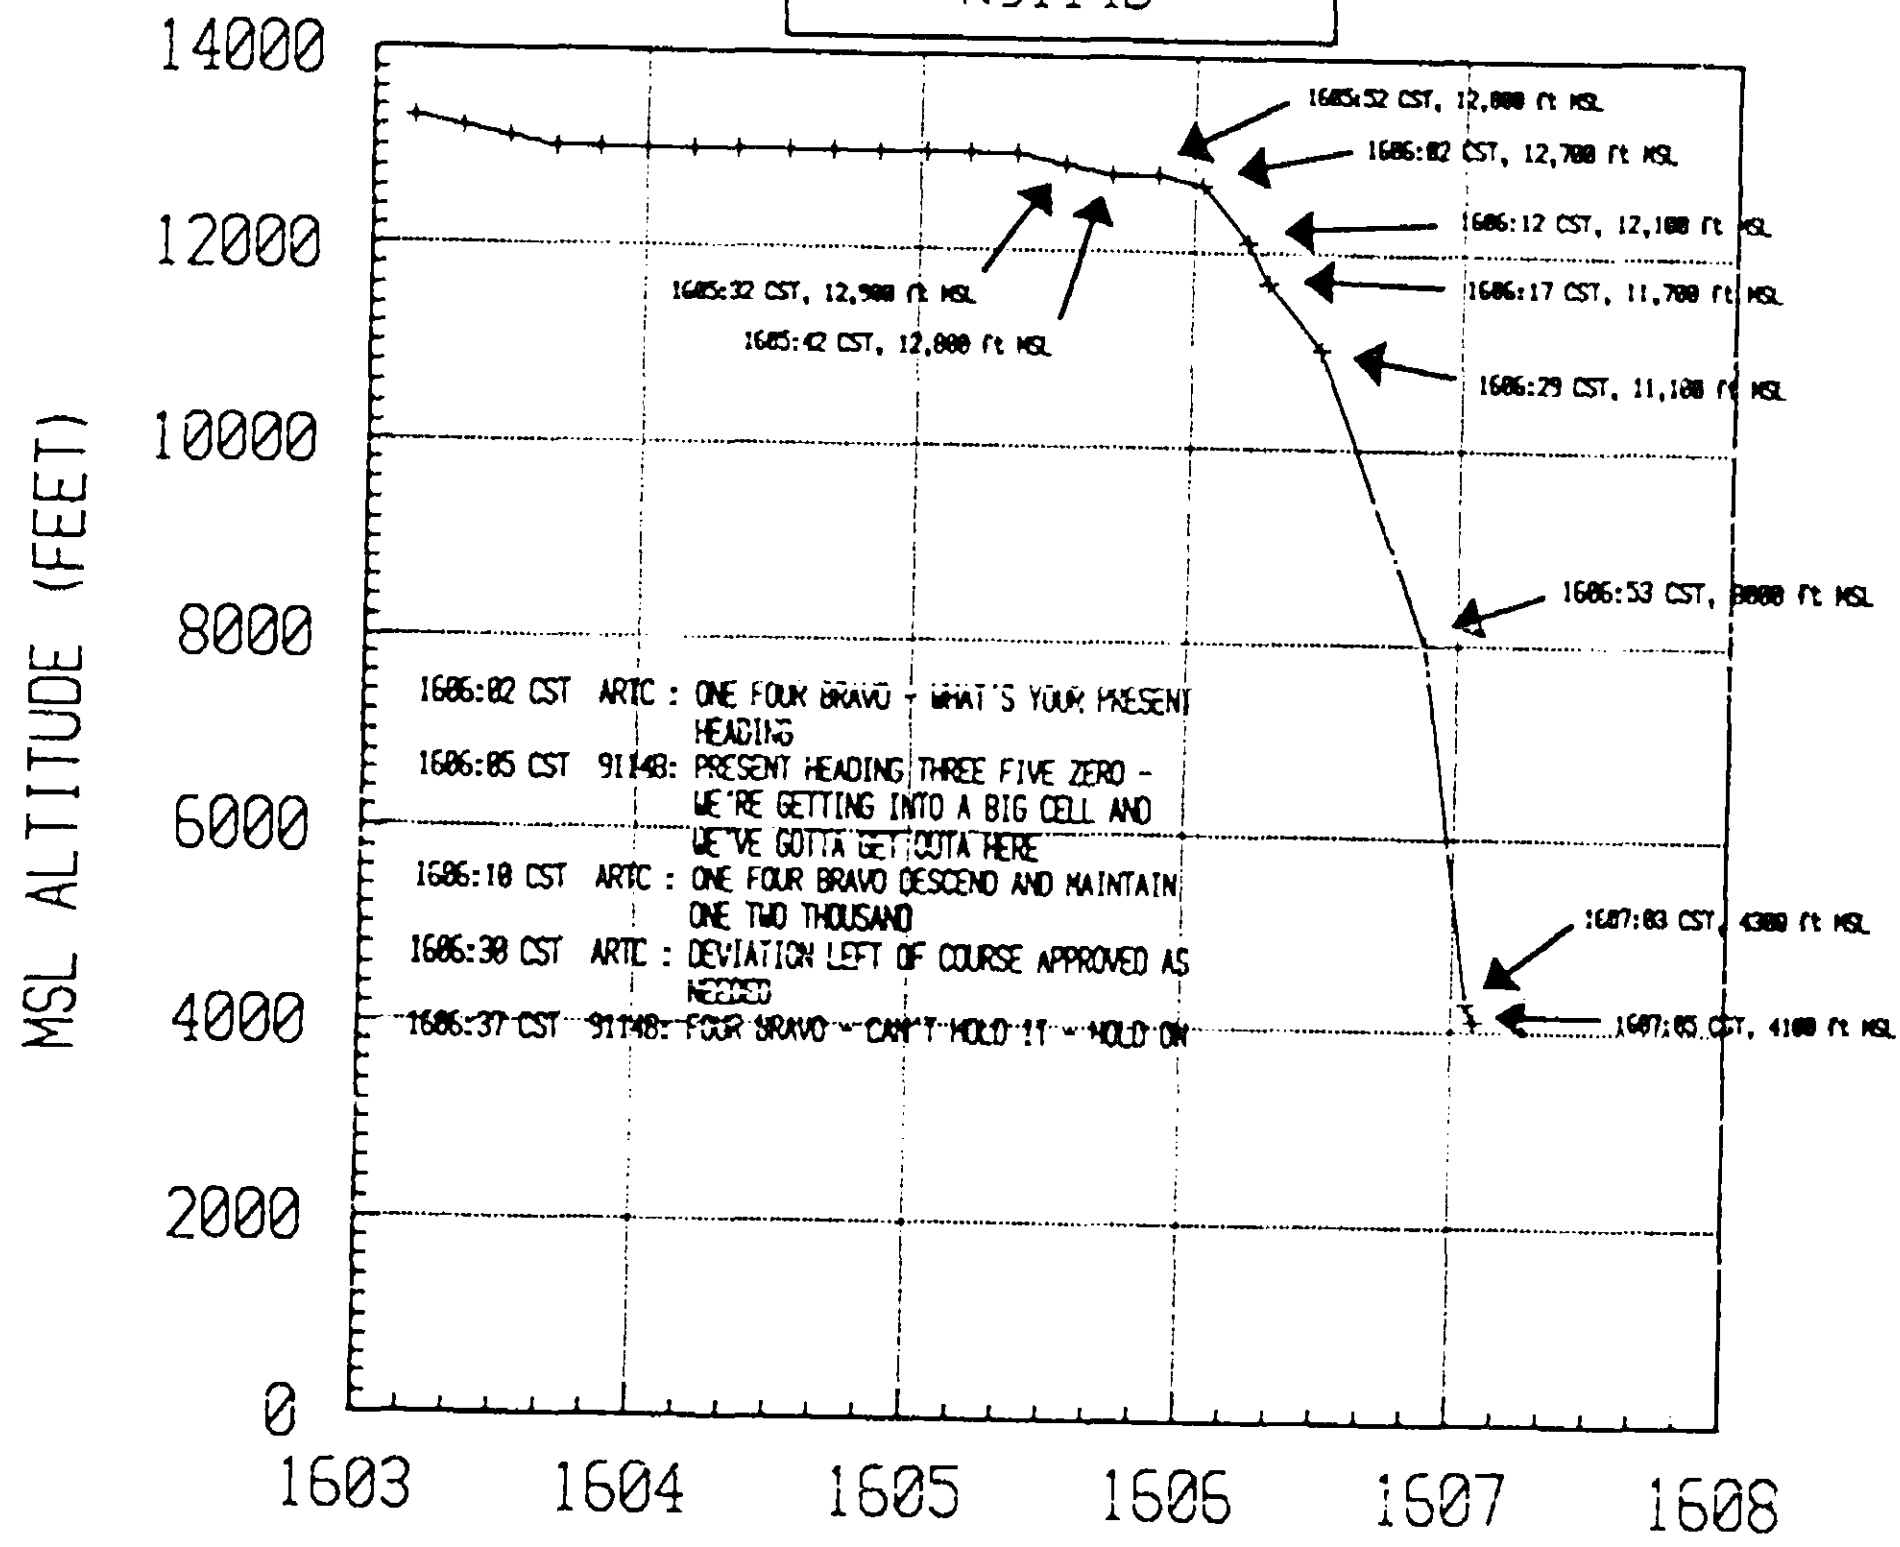
FIGURE 3

1606:02 CST ARTC : ONE FOUR BRAVO - WHAT'S YOUR PRESENT  
HEADING  
1606:05 CST 9114B: PRESENT HEADING THREE FIVE ZERO -  
WE'RE GETTING INTO A BIG CELL AND  
WE'VE GOTTA GET OUTA HERE  
1606:10 CST ARTC : ONE FOUR BRAVO DESCEND AND MAINTAIN  
ONE TWO THOUSAND  
1606:30 CST ARTC : DEVIATION LEFT OF COURSE APPROVED AS  
NEEDED  
1606:37 CST 9114B: FOUR BRAVO - CAN'T HOLD IT - HOLD ON

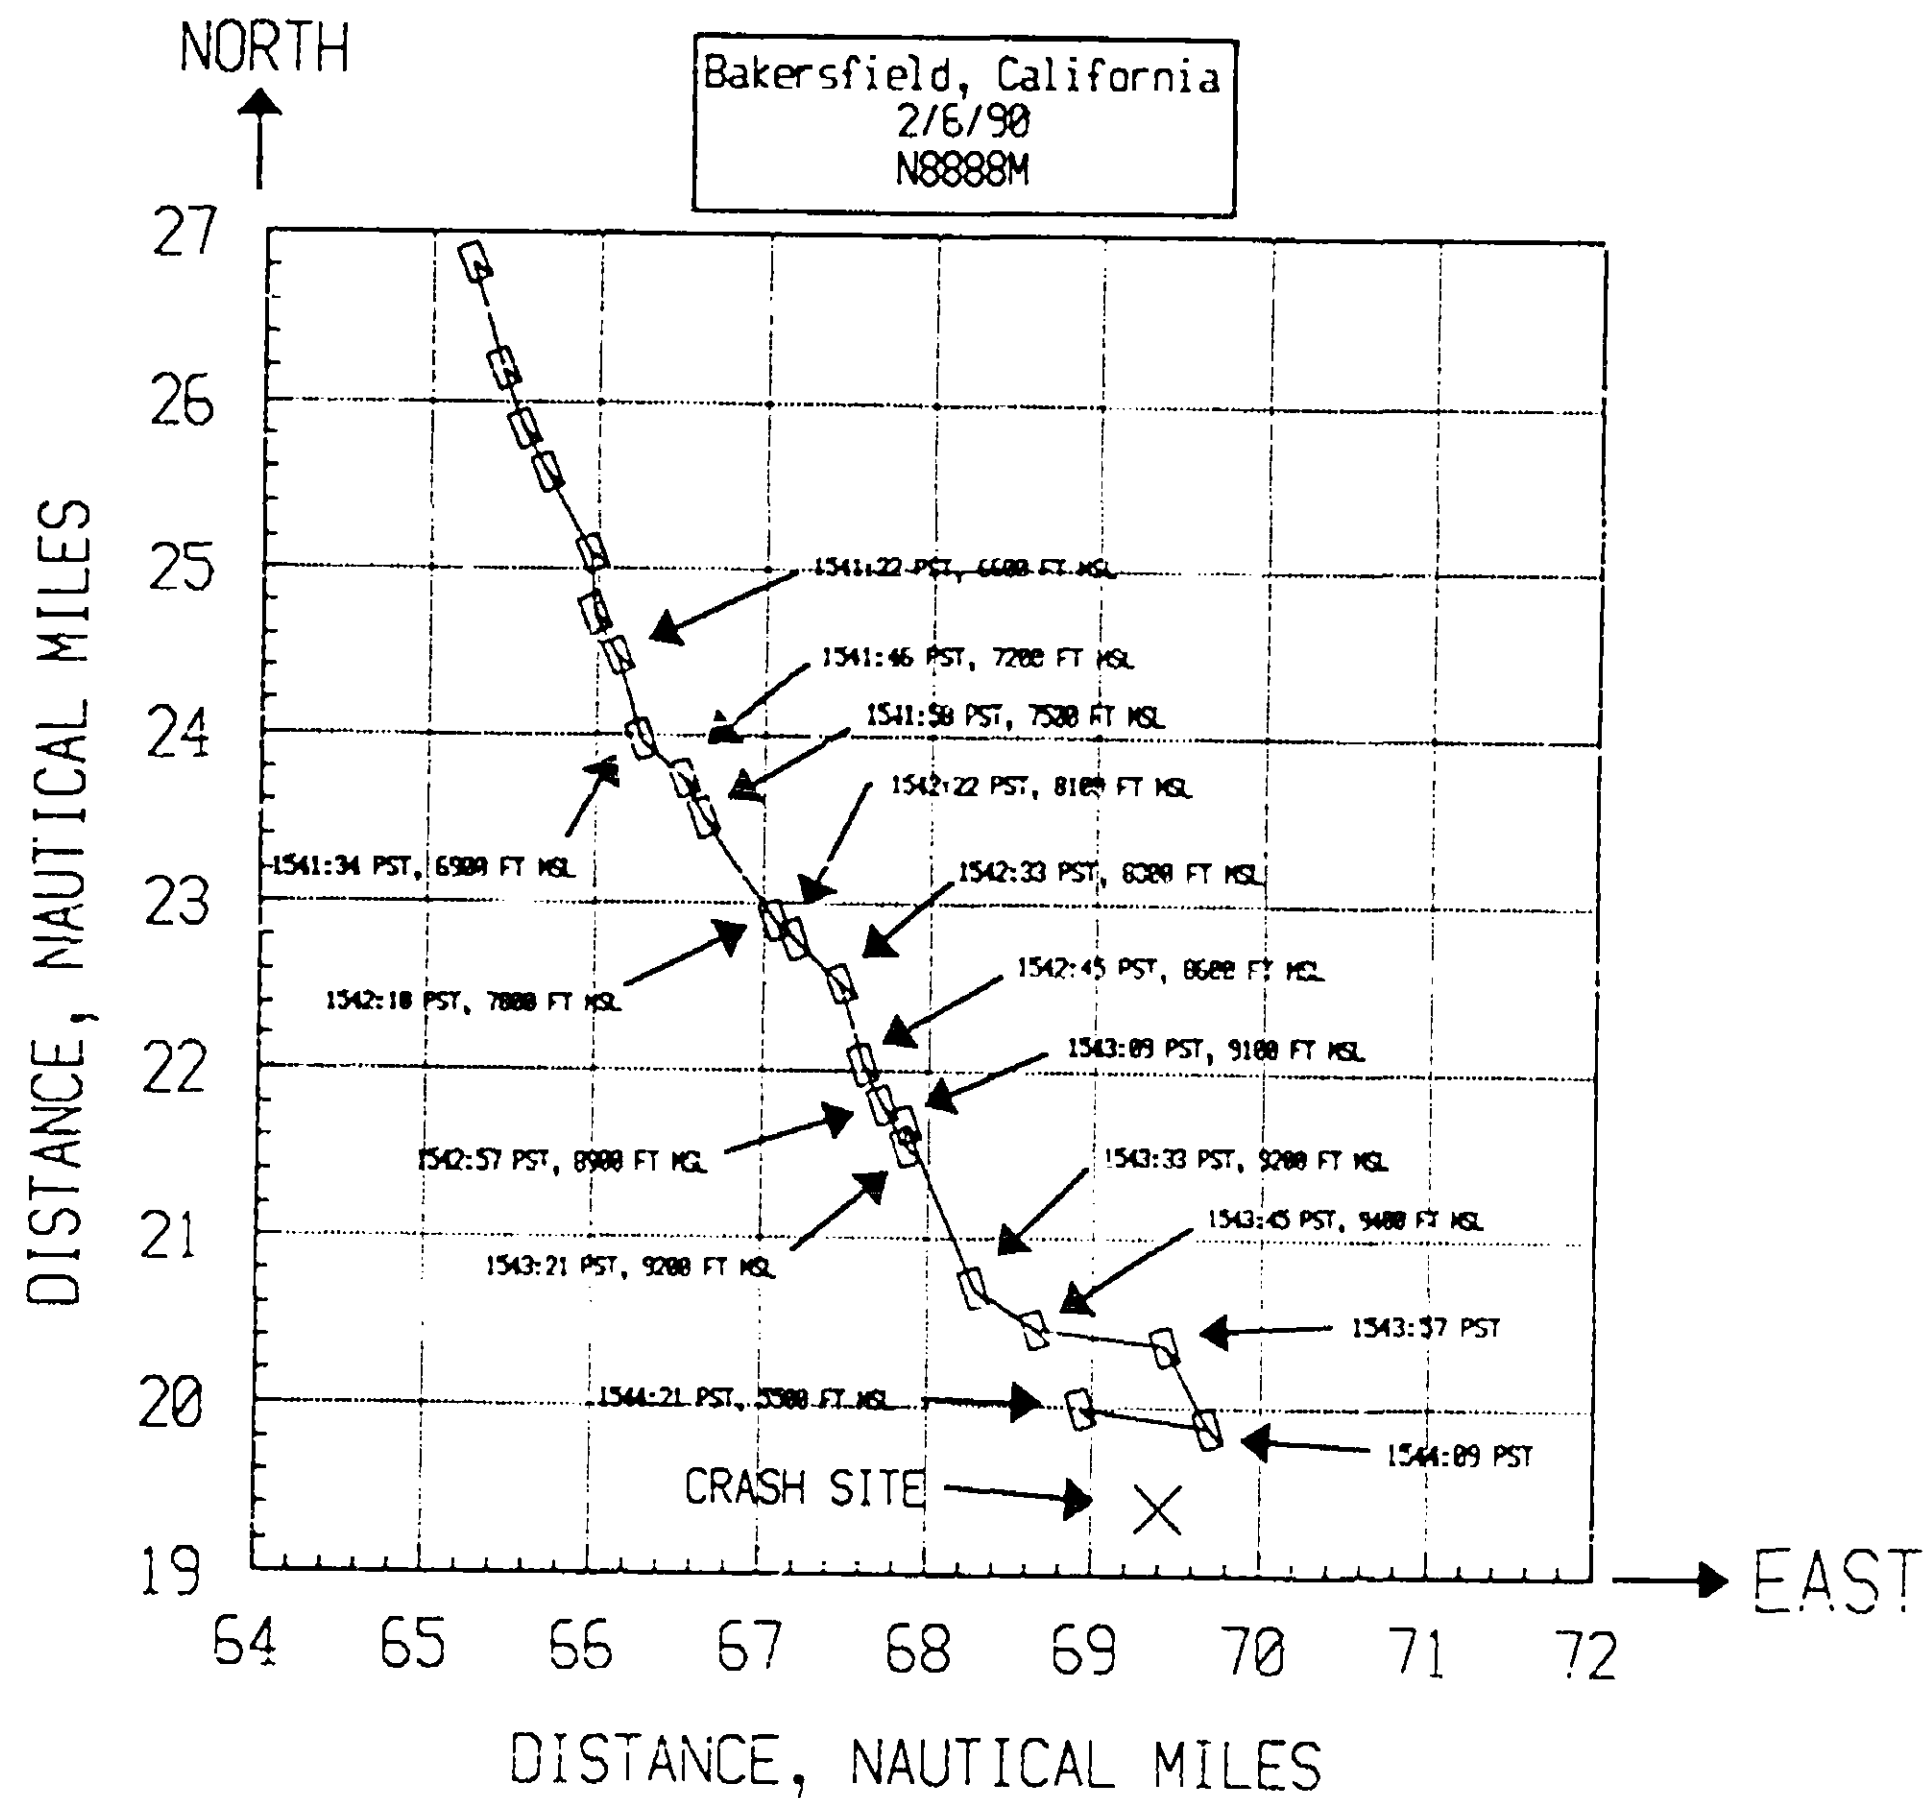
FIGURE 4

A flightpath study was performed for this accident by Safety Board aircraft performance engineers from recorded ATC radar data (See Figures 4 and 5). Airplane performance derived from the data indicate that the airplane initially was ascending at a rate of about 1,500 feet per minute (fpm) at an indicated airspeed of 100 KIAS. Near 8,000 feet, the vertical speed decreased to about 1300 fpm and the airspeed decreased from about 100 KIAS to about 90 KIAS over the next 35 seconds. Near 9000 feet, the vertical speed decreased to near zero while the airspeed was near 100 KIAS. Over the next 25 seconds, the airplane reached 9,200 feet, and the airspeed increased to 135 KIAS. The airplane then started a turn to the left, climbed 200 feet to 9,400 feet in about 15 seconds during the initial part of the left turn, and the airspeed increased to about 140 KIAS. Within the next 20 seconds, the airplane started a turn to the right and descended rapidly with the airspeed increasing to about 190 KIAS. Within the next 10 to 15 seconds, the rate of descent increased, the airspeed increased to over 220 KIAS, and the rate of turn to the right

BAKERSFIELD, CALIFORNIA  
2/6/93  
N8888M

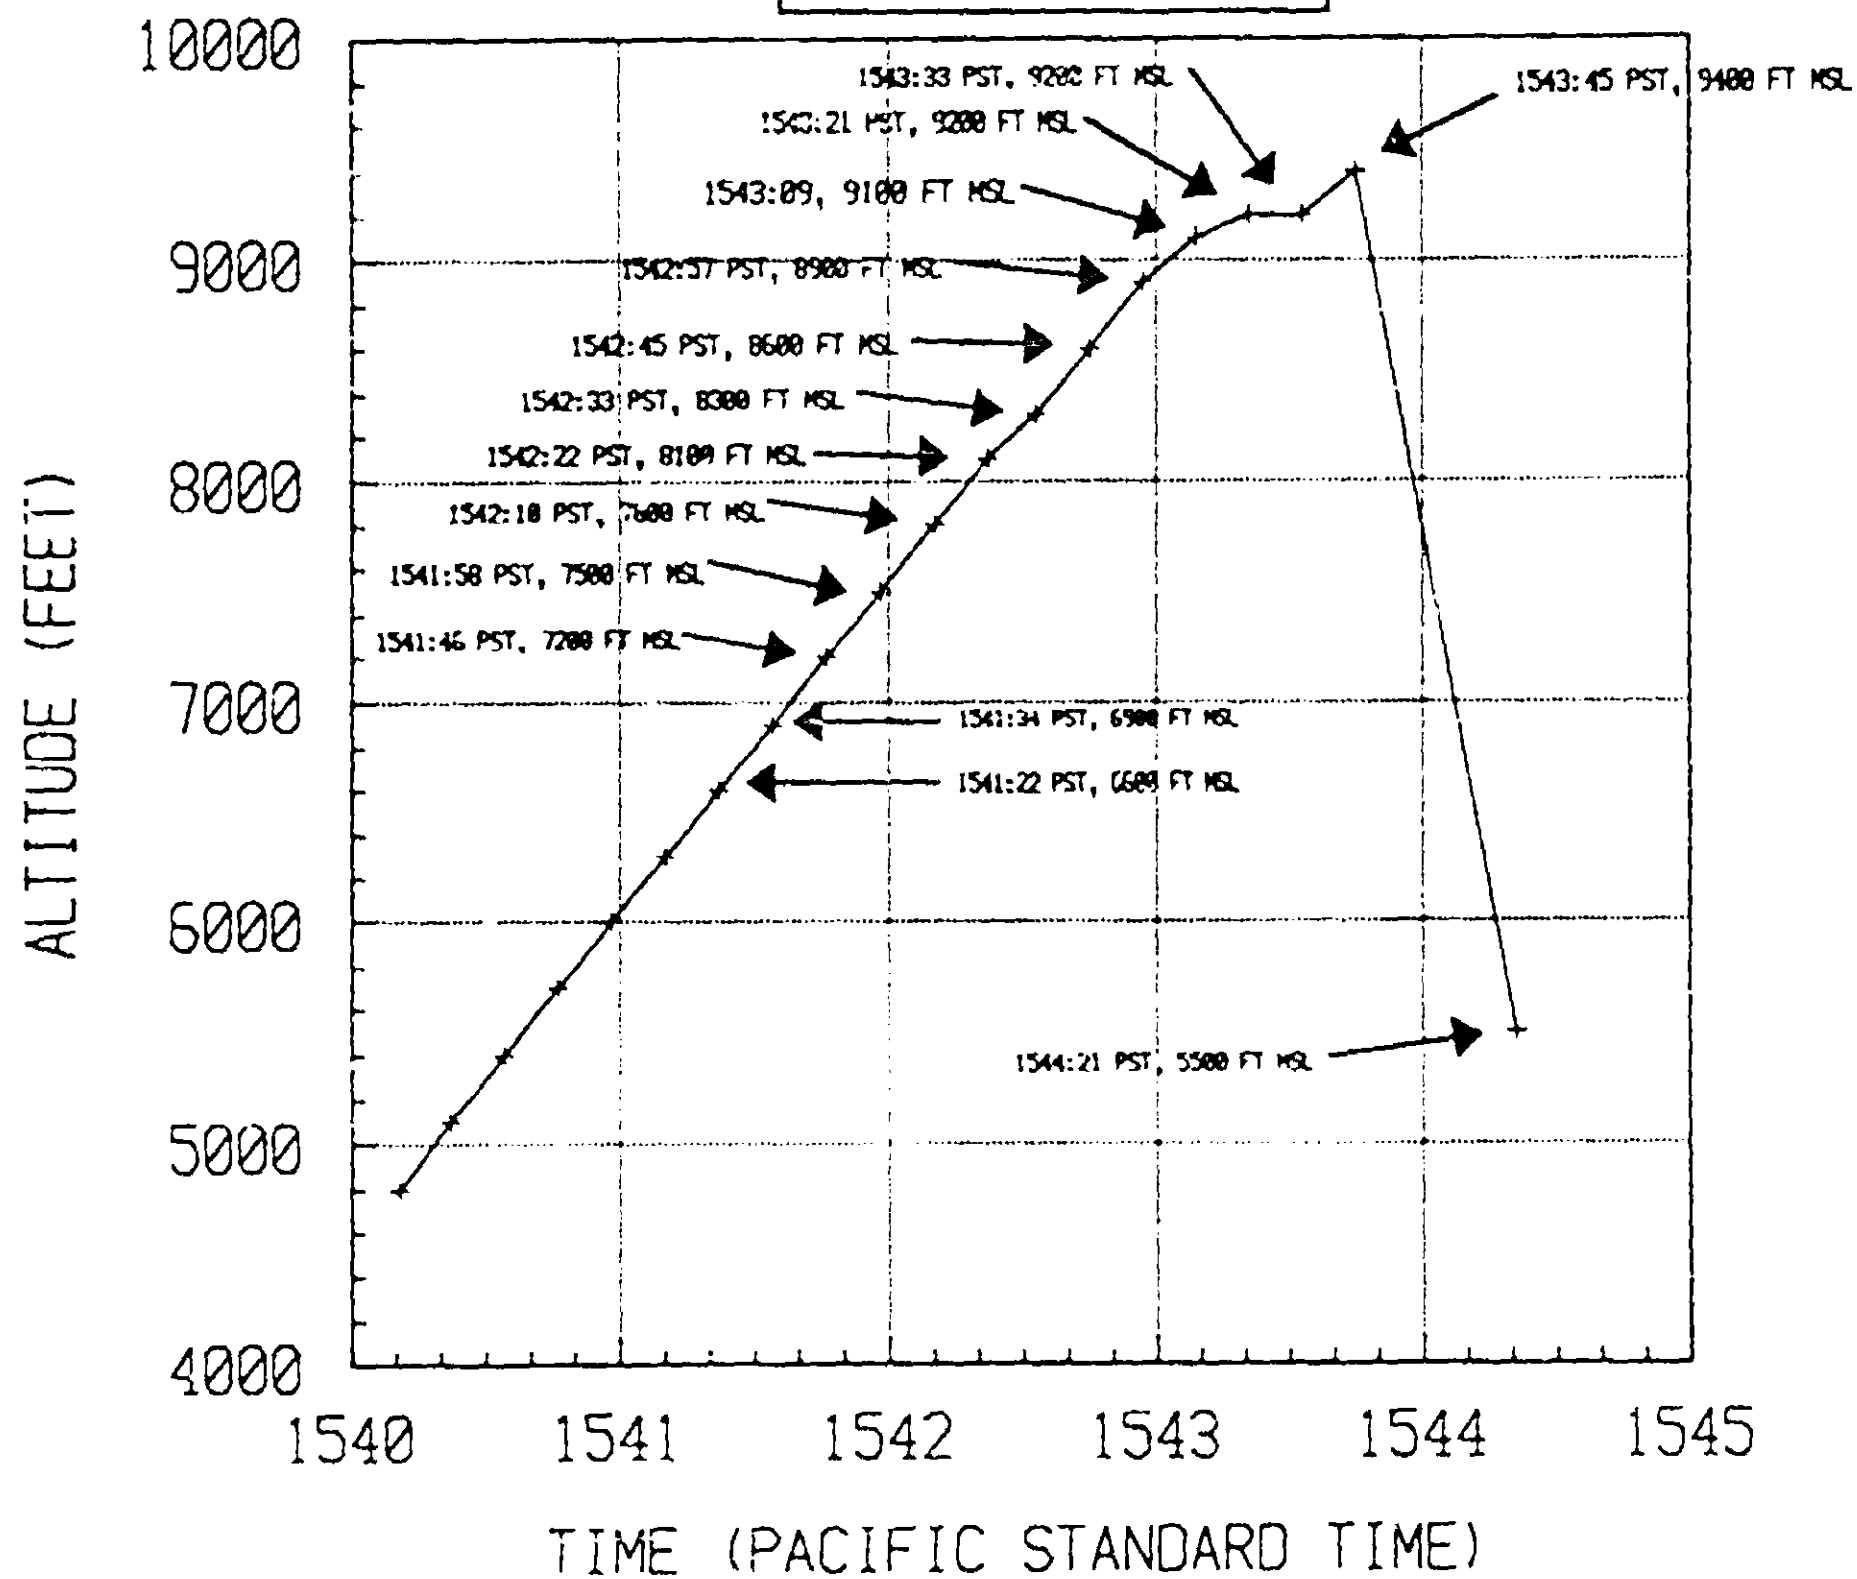
FIGURE 5

increased significantly. Trajectory studies of airplane wreckage and the derived flight path are consistent with an in-flight breakup that occurred between 4,500 feet and 6,500 feet while in a descent angle of 50 degrees with an airspeed in excess of 265 KIAS.

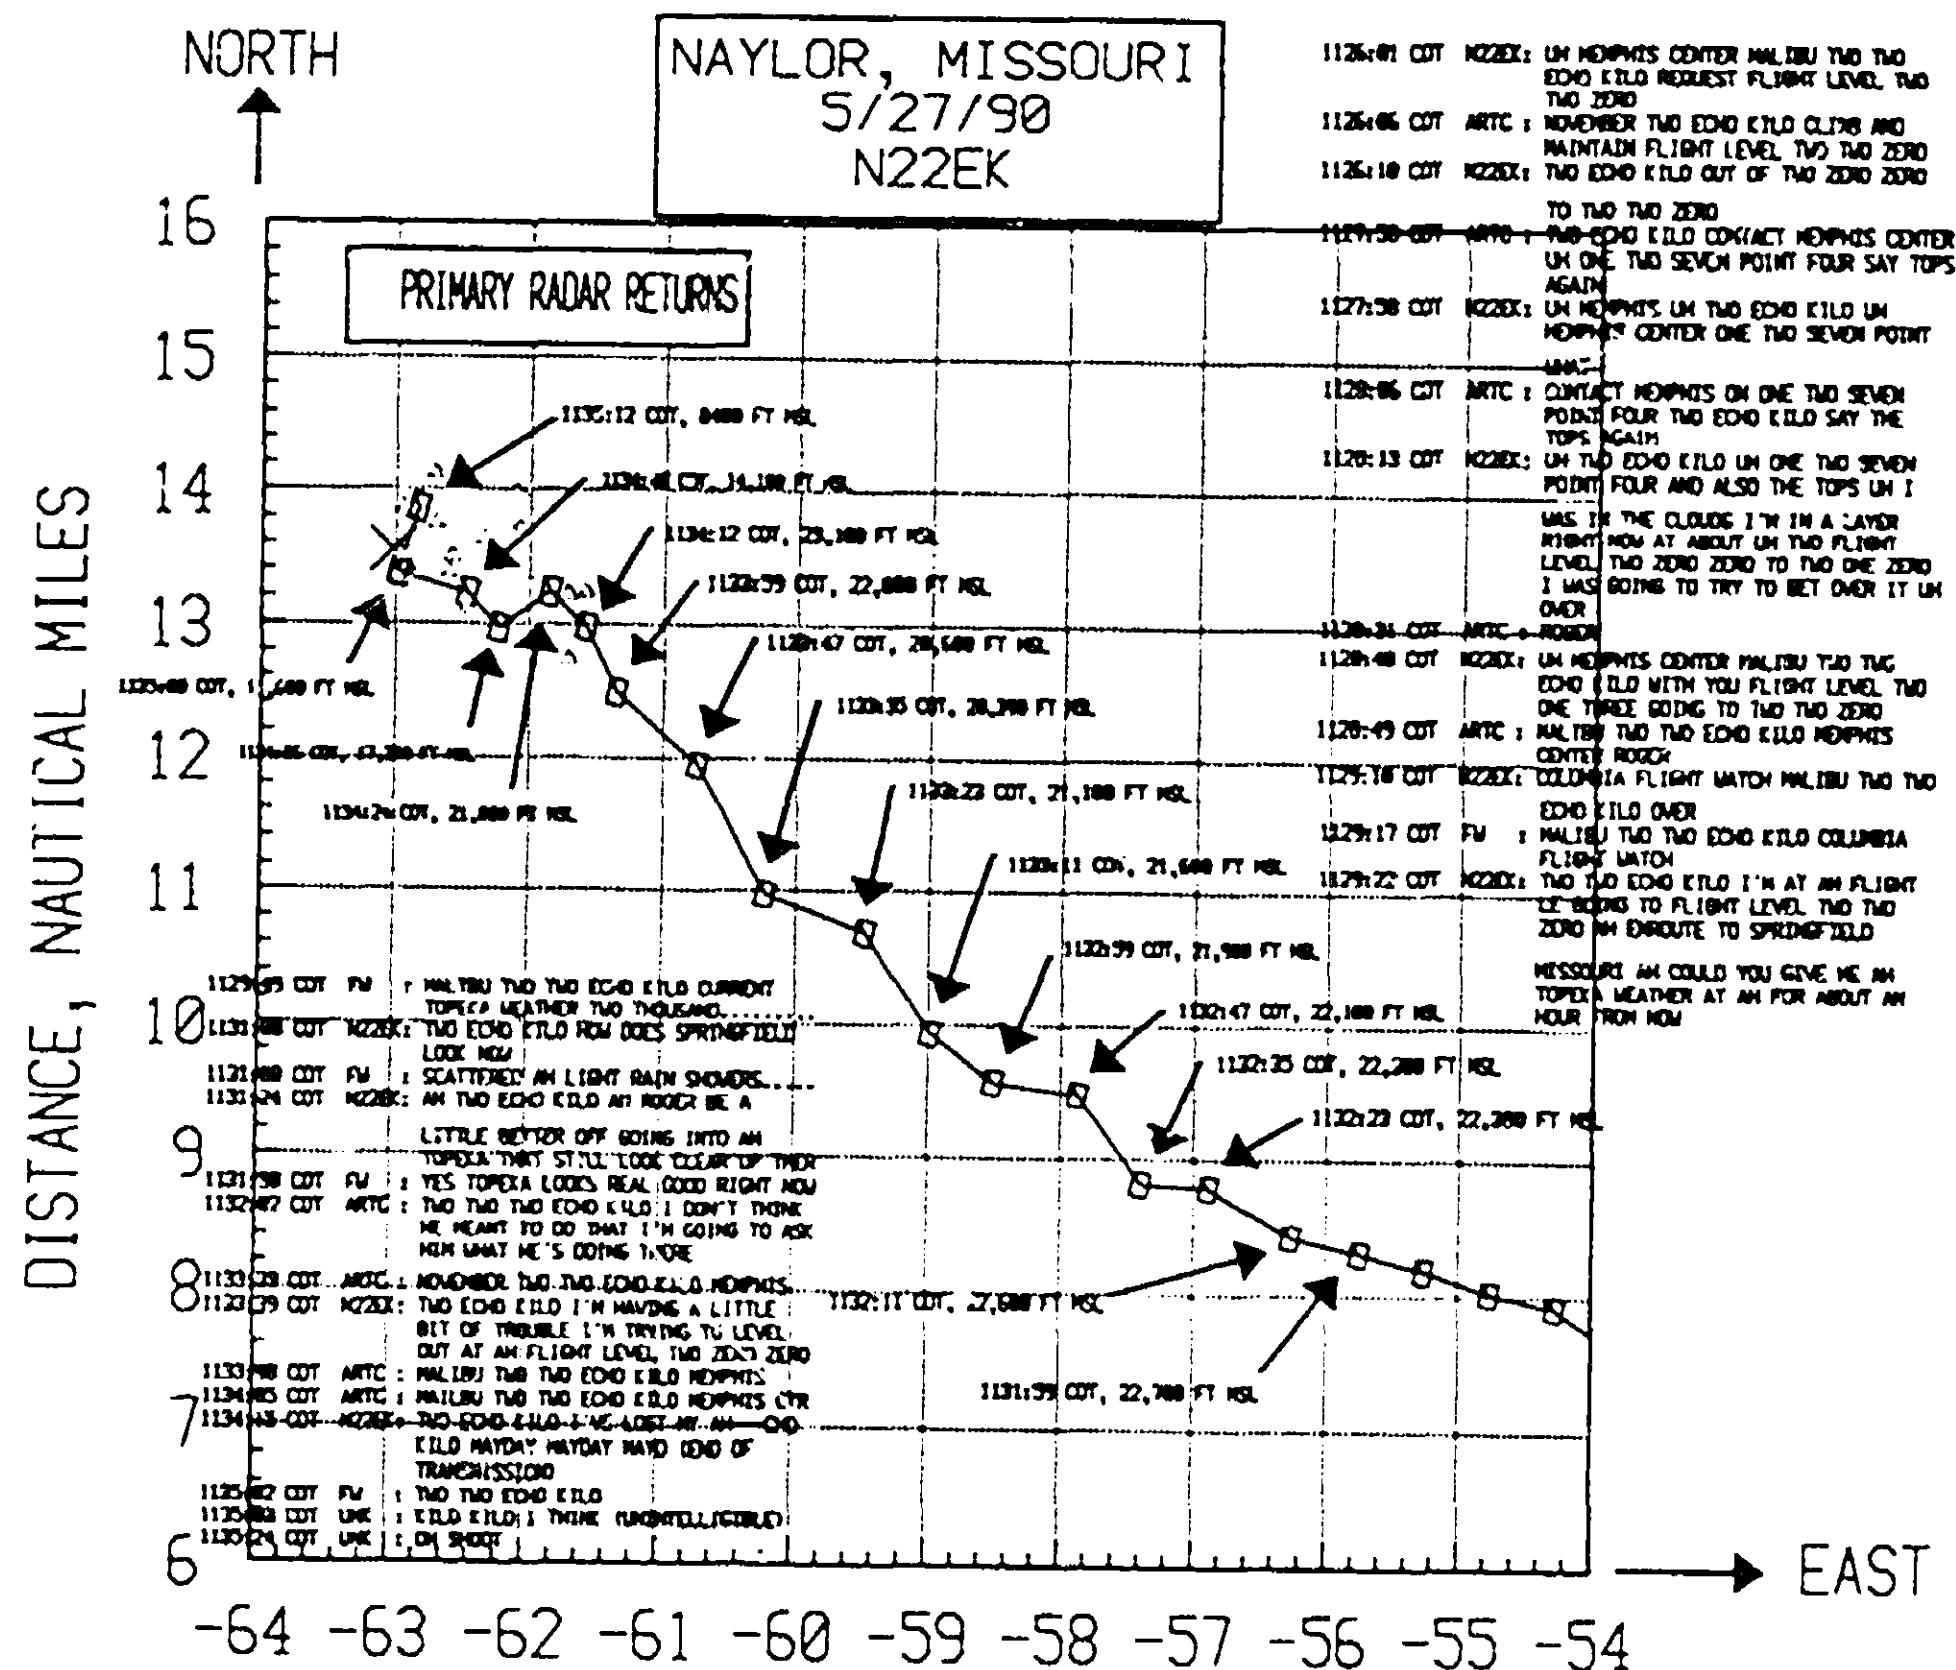
FIGURE 6

The flightpath study conducted from ATC radar data (See Figures 6 and 7) for this accident by Safety Board airplane performance engineers showed that as it ascended from FL200 to FL227, the airplane was climbing at a rate of about 500 feet per minute and was slowing from about 130 KIAS to about 110 KIAS. The airplane stopped ascending about FL227 and then began to descend for 90 seconds. The airplane descended about 2,300 feet to about FL204, reached a vertical speed of about 3,200 feet per minute during the descent, and the airspeed increased from about 110 KIAS to 198 KIAS. The airplane's descent stopped at FL204, and a climb to FL231 feet began. During the ascent to FL231, the airspeed decreased to well within the range of stall while the airplane achieved a climb angle of about 25 degrees.

NAYLOR, MISSOURI  
5/27/90  
N22EK

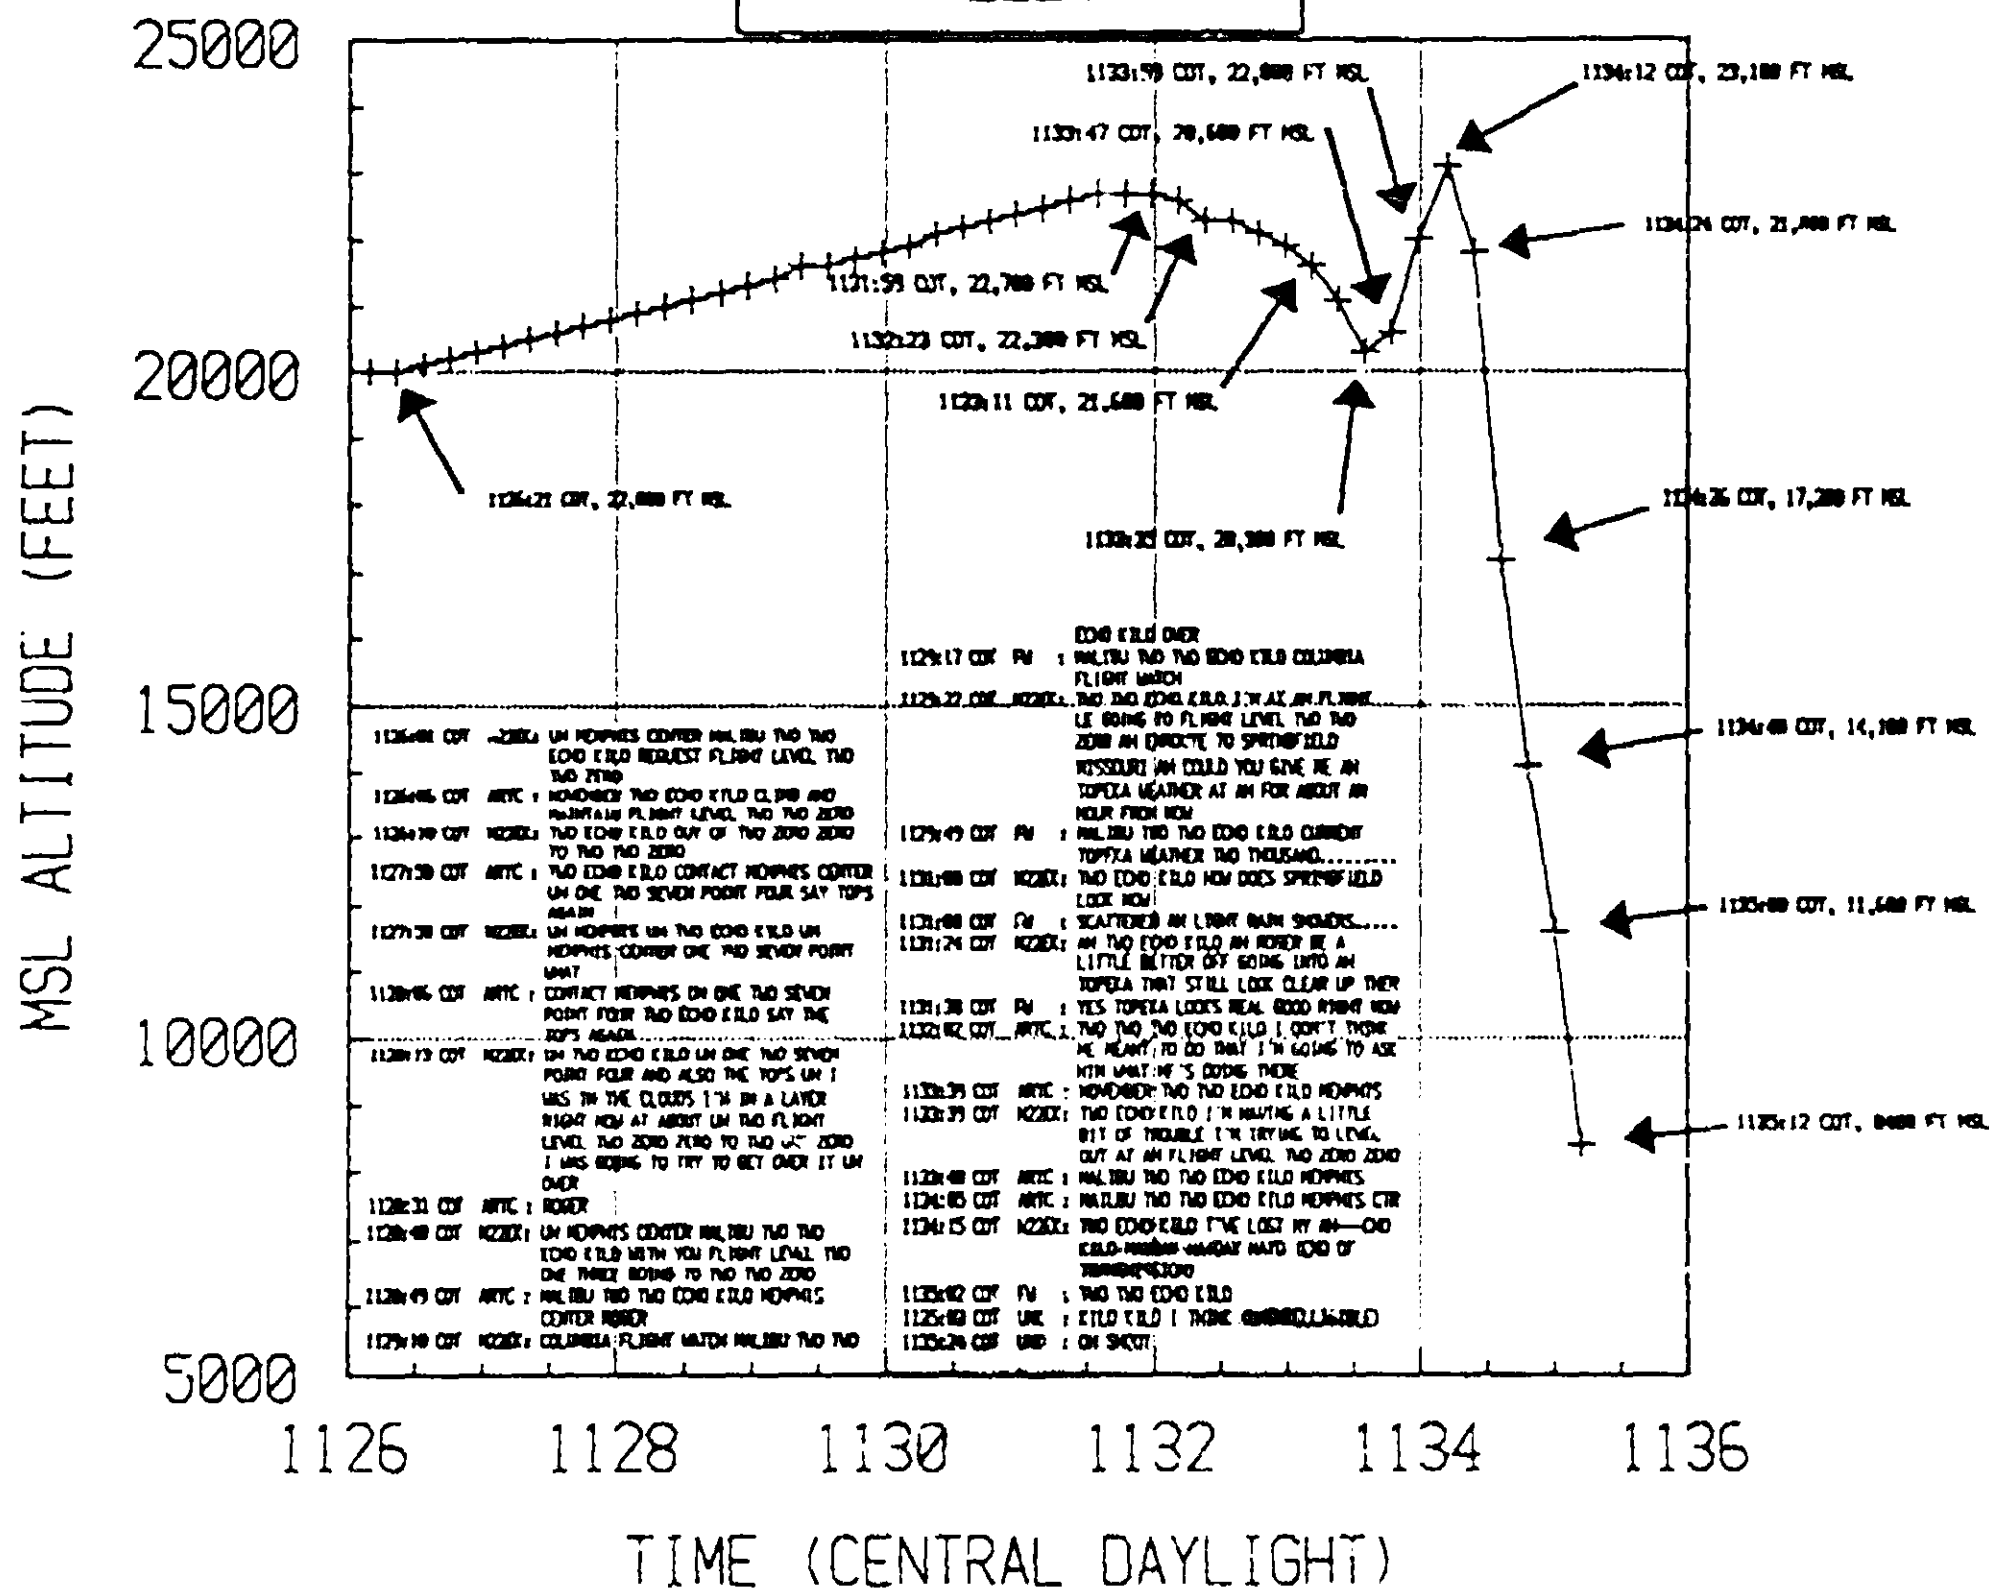
Correlation of the communications transcripts with the flightpath study revealed that near FL204 where the airplane began to climb to FL 231, the pilot remarked on the radio to the Columbia FSS that he was "...having a little bit of trouble, I'm trying to level out at ah flight level two zero zero." In addition, near the point where the airplane apparently stalled at FL231, the pilot transmitted "I've lost my..." Shortly thereafter, the pilot transmitted a "Mayday."
