National Transportation Safety Board Special Investigation Report  
Piper Aircraft Corporation, PA-46 Malibu/Mirage  
Accidents/Incident, May 31, 1989 to March 17, 1991

PIPER AIRCRAFT CORPORATION  
PA-46 MALIBU/MIRAGE  
ACCIDENTS/INCIDENT  
MAY 31, 1989 TO MARCH 17, 1991

NTSB/SIR-92/03

Adopted: July 21, 1992  
Notation 5803

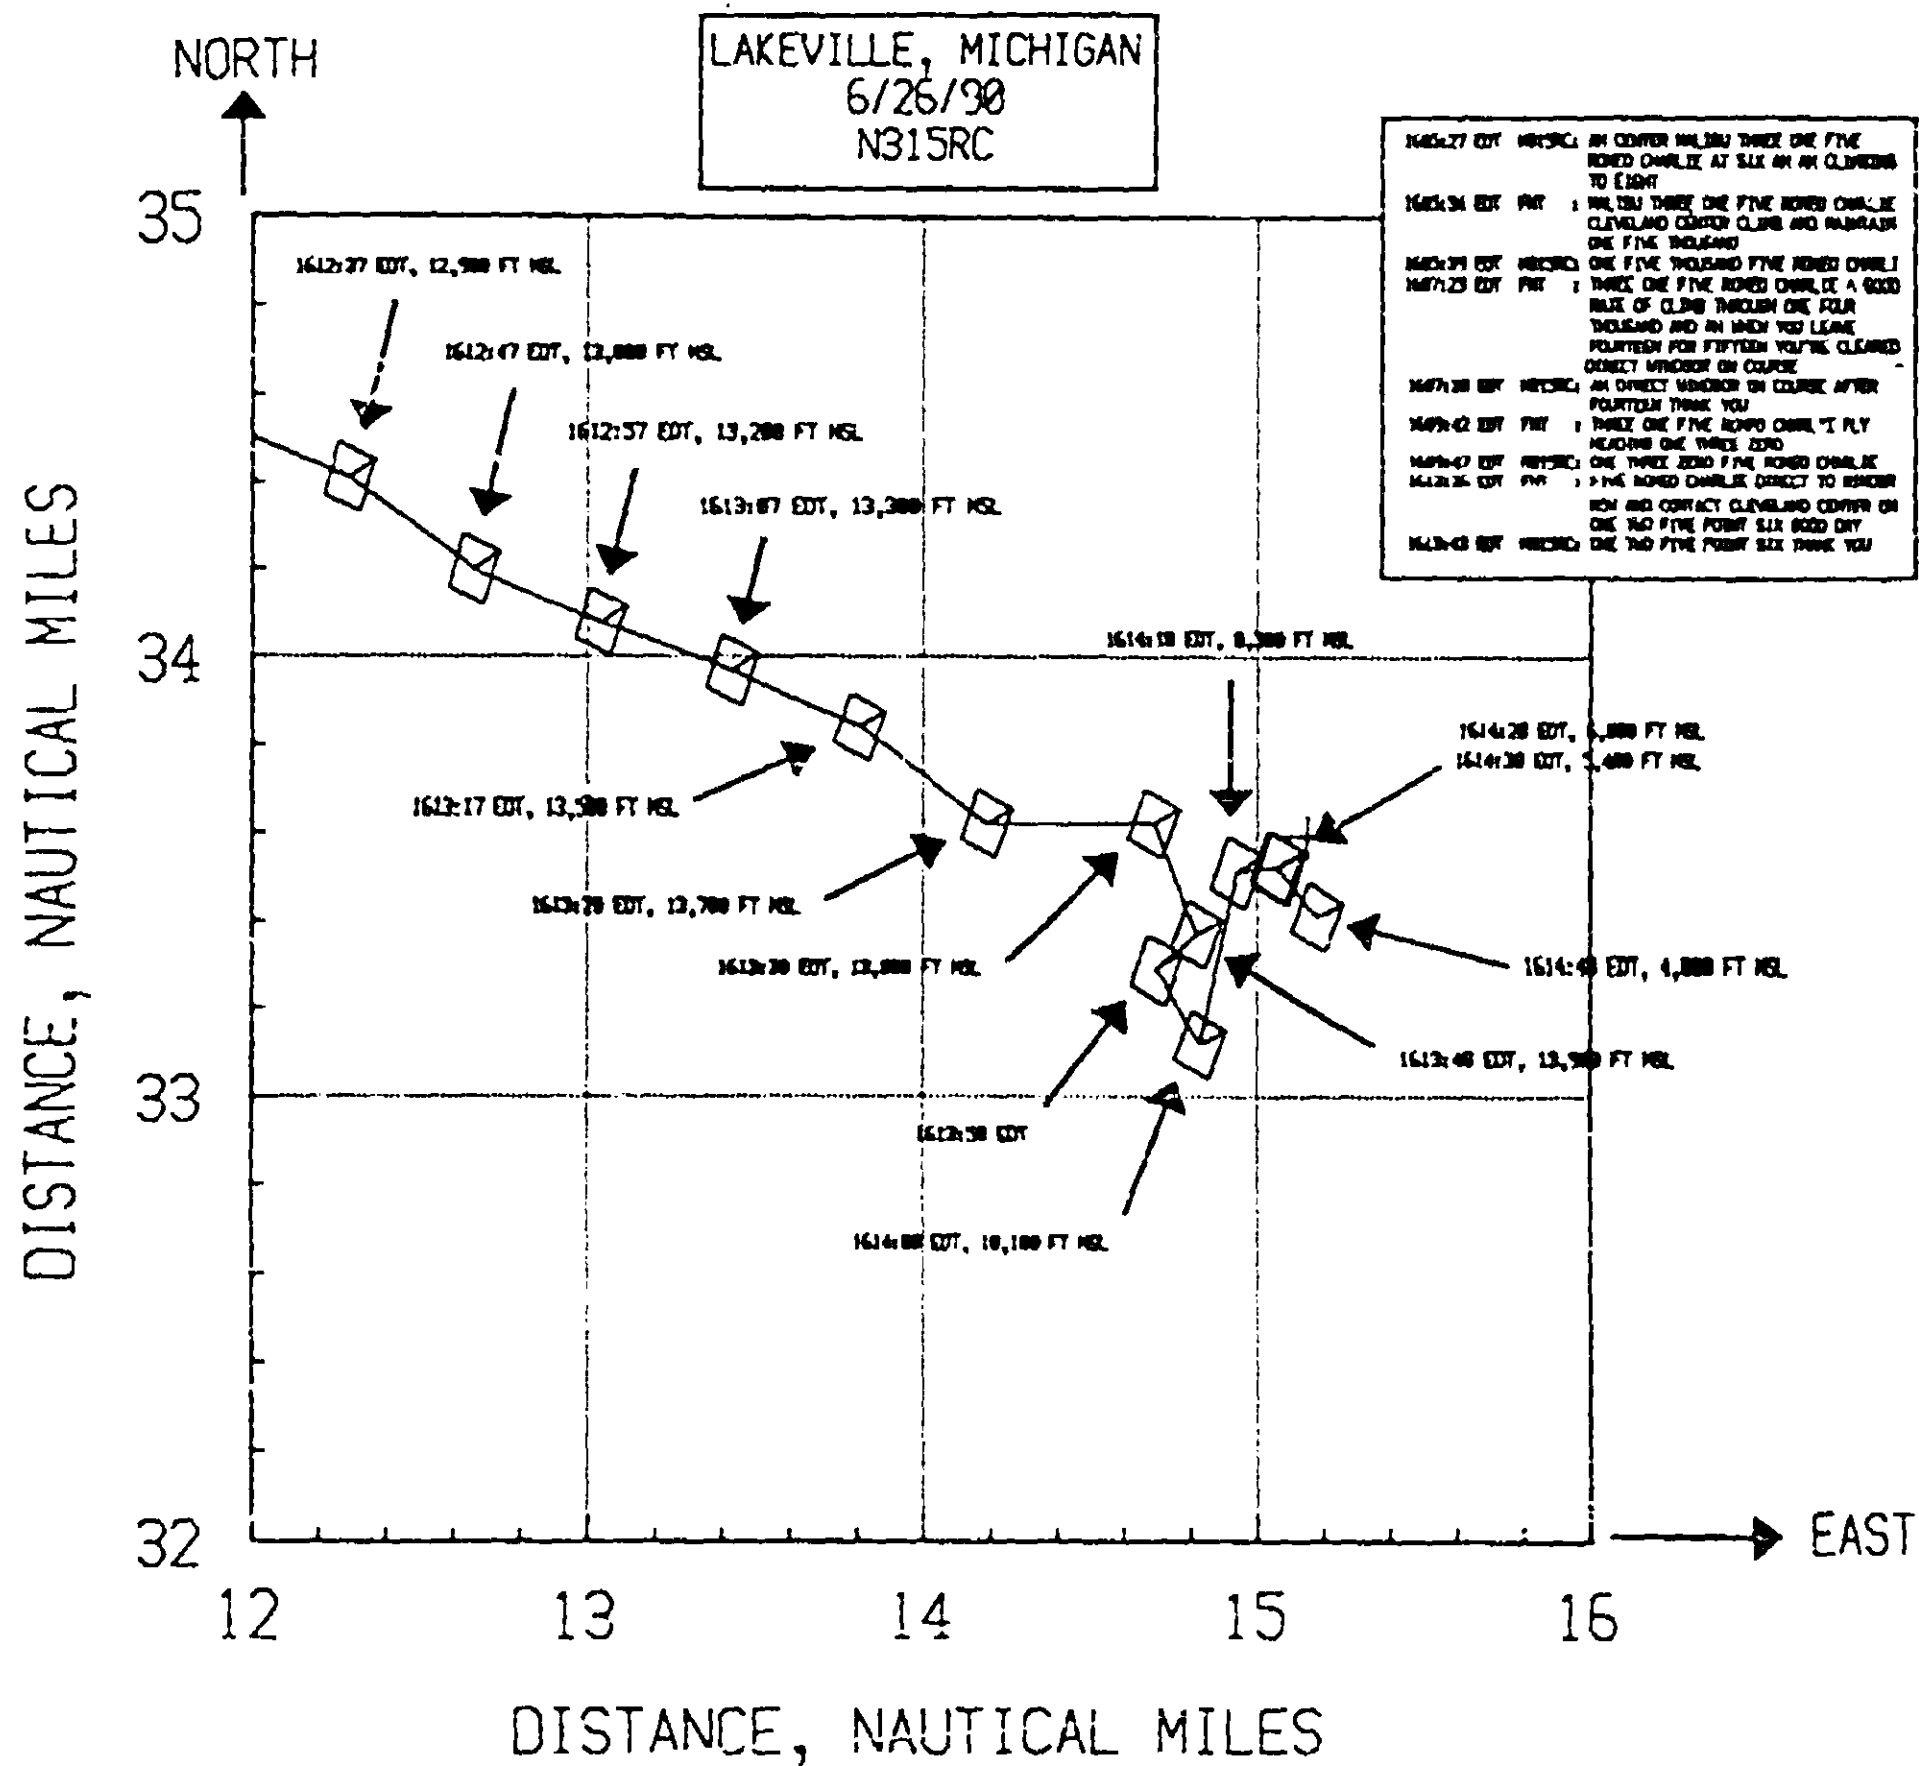
FIGURE 9

LAKEVILLE, MICHIGAN  
6/26/90  
N315RC

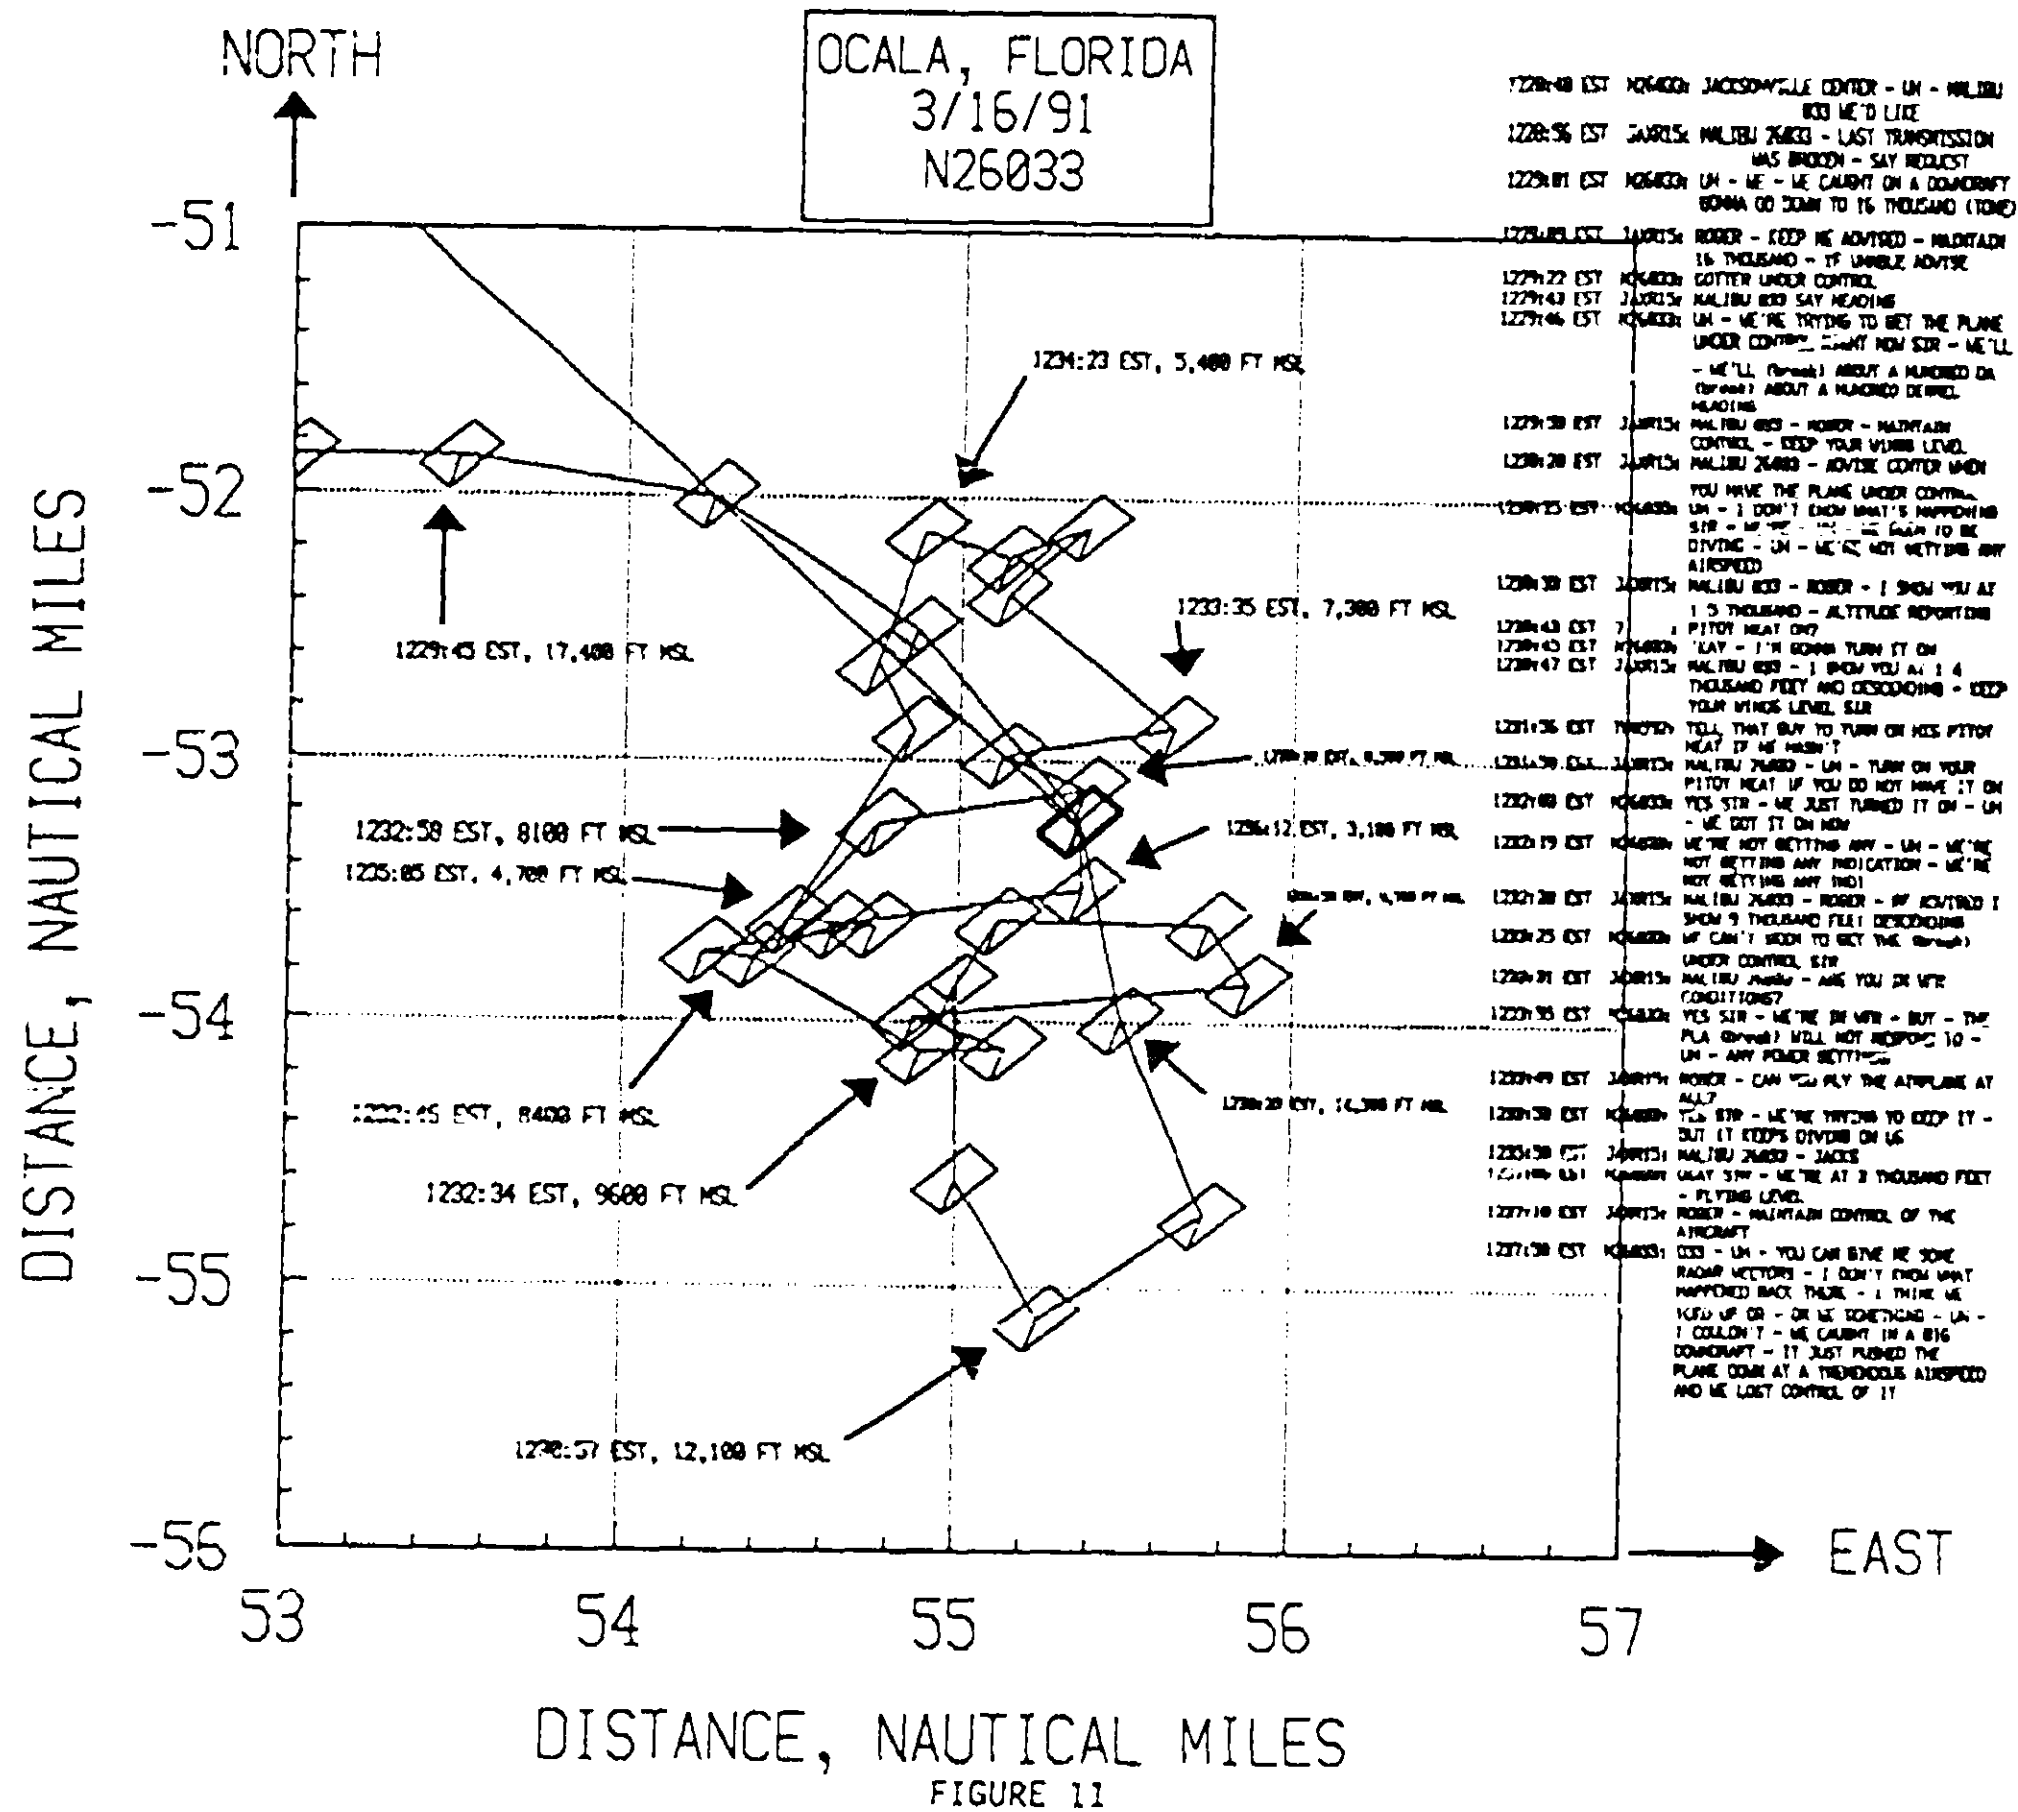
Safety Board airplane performance engineers again used ATC recorded radar data (See Figures 11, 12 and 13) to reconstruct the flightpath of the airplane. The flightpath study revealed that before significant flightpath deviations began, the airplane was at FL181 and heading north at approximately 150 KIAS. At 1228:07, while in a turn to the northwest, the airplane began to descend; it descended about 300 feet and then returned to FL180, at 1228:32, while in a sharp right turn that began about 1228:26. While in the right turn, the

OCALA, FLORIDA  
3/16/91  
N26033

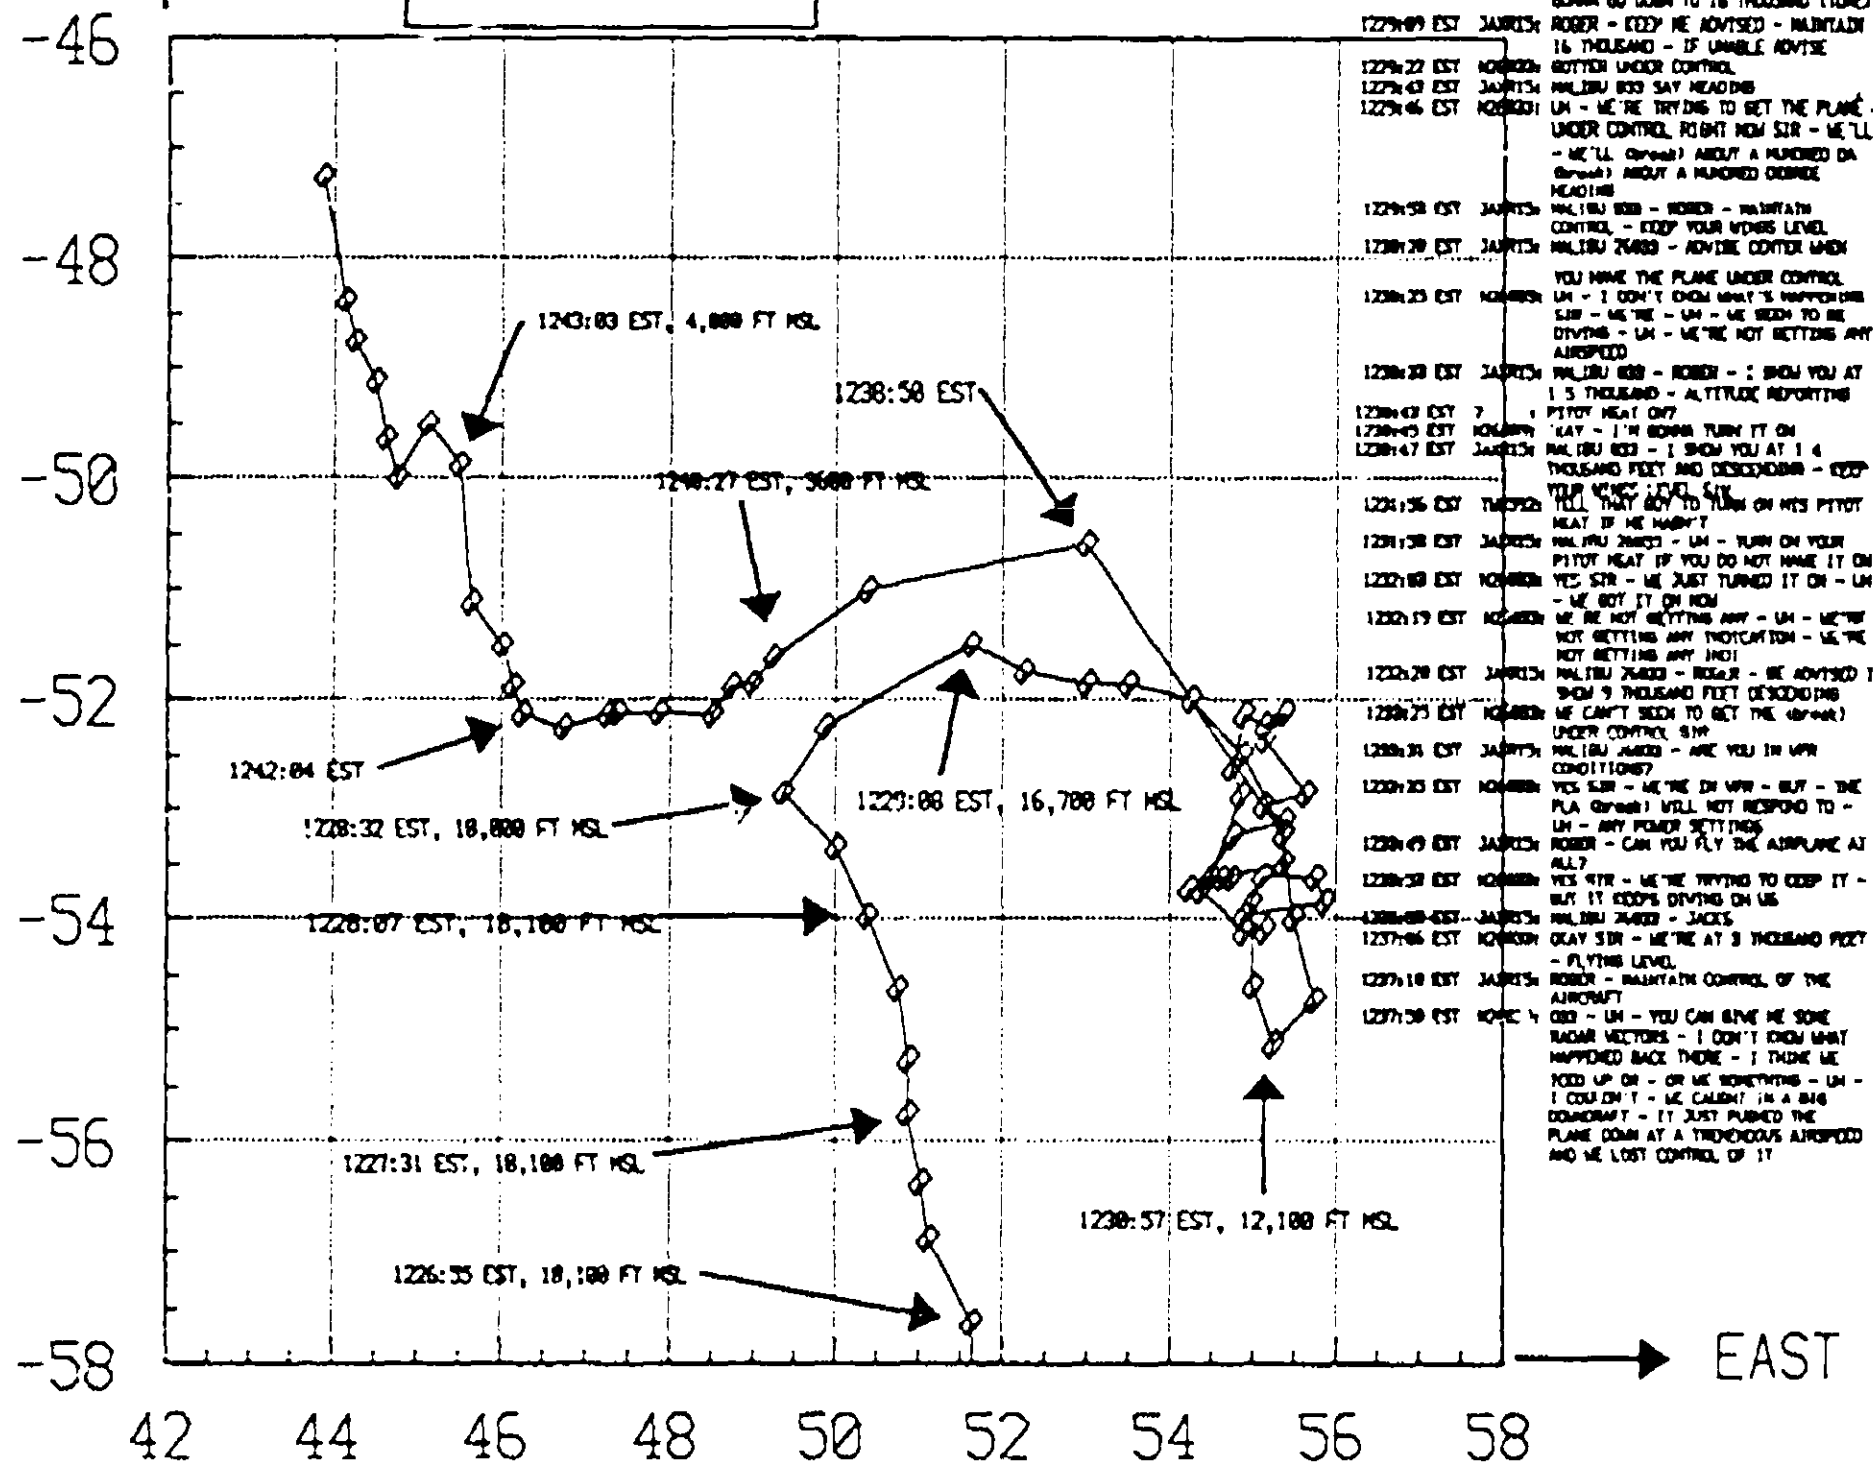
FIGURE 12

1229:48	EST	NOB4820	JACKSONVILLE CENTER - UM - MIL18U 833 ME'D LIFE
1229:56	EST	JA0015	MIL18U JAMES - LAST TRANSMISSION WAS BROKEN - SAY REQUEST
1229:01	EST	NOB4820	UM - ME - WE CAUGHT ON A DOWNDRIFT BOMB GO DOWN TO 16 THOUSAND (TONE)
1229:09	EST	JA0015	ROBER - KEEP ME ADVISED - MAINTAIN 16 THOUSAND - IF UNABLE ADVISE
1229:22	EST	NOB4820	GOTTEN UNDER CONTROL
1229:43	EST	JA0015	MIL18U 833 SAY HEADS UP
1229:46	EST	NOB4820	UM - WE'RE TRYING TO GET THE PLANE UNDER CONTROL RIGHT NOW SIR - WE'LL - WE'LL (GROAN) ABOUT A HUNDRED DA (GROAN) ABOUT A HUNDRED DEGREE HEADLINE
1229:58	EST	JA0015	MIL18U 833 - ROBER - MAINTAIN CONTROL - KEEP YOUR VIBES LEVEL
1230:20	EST	JA0015	MIL18U JAMES - ADVISE CENTER WHEN YOU HAVE THE PLANE UNDER CONTROL UM - I DON'T KNOW WHAT'S HAPPENING SIR - WE'RE - UM - WE SEEM TO BE DIVING - UM - WE'RE NOT GETTING ANY AIRSPEED
1230:38	EST	JA0015	MIL18U 833 - ROBER - I SHOW YOU AT 15 THOUSAND - ALTITUDE REPORTING PILOT HEAT ON?

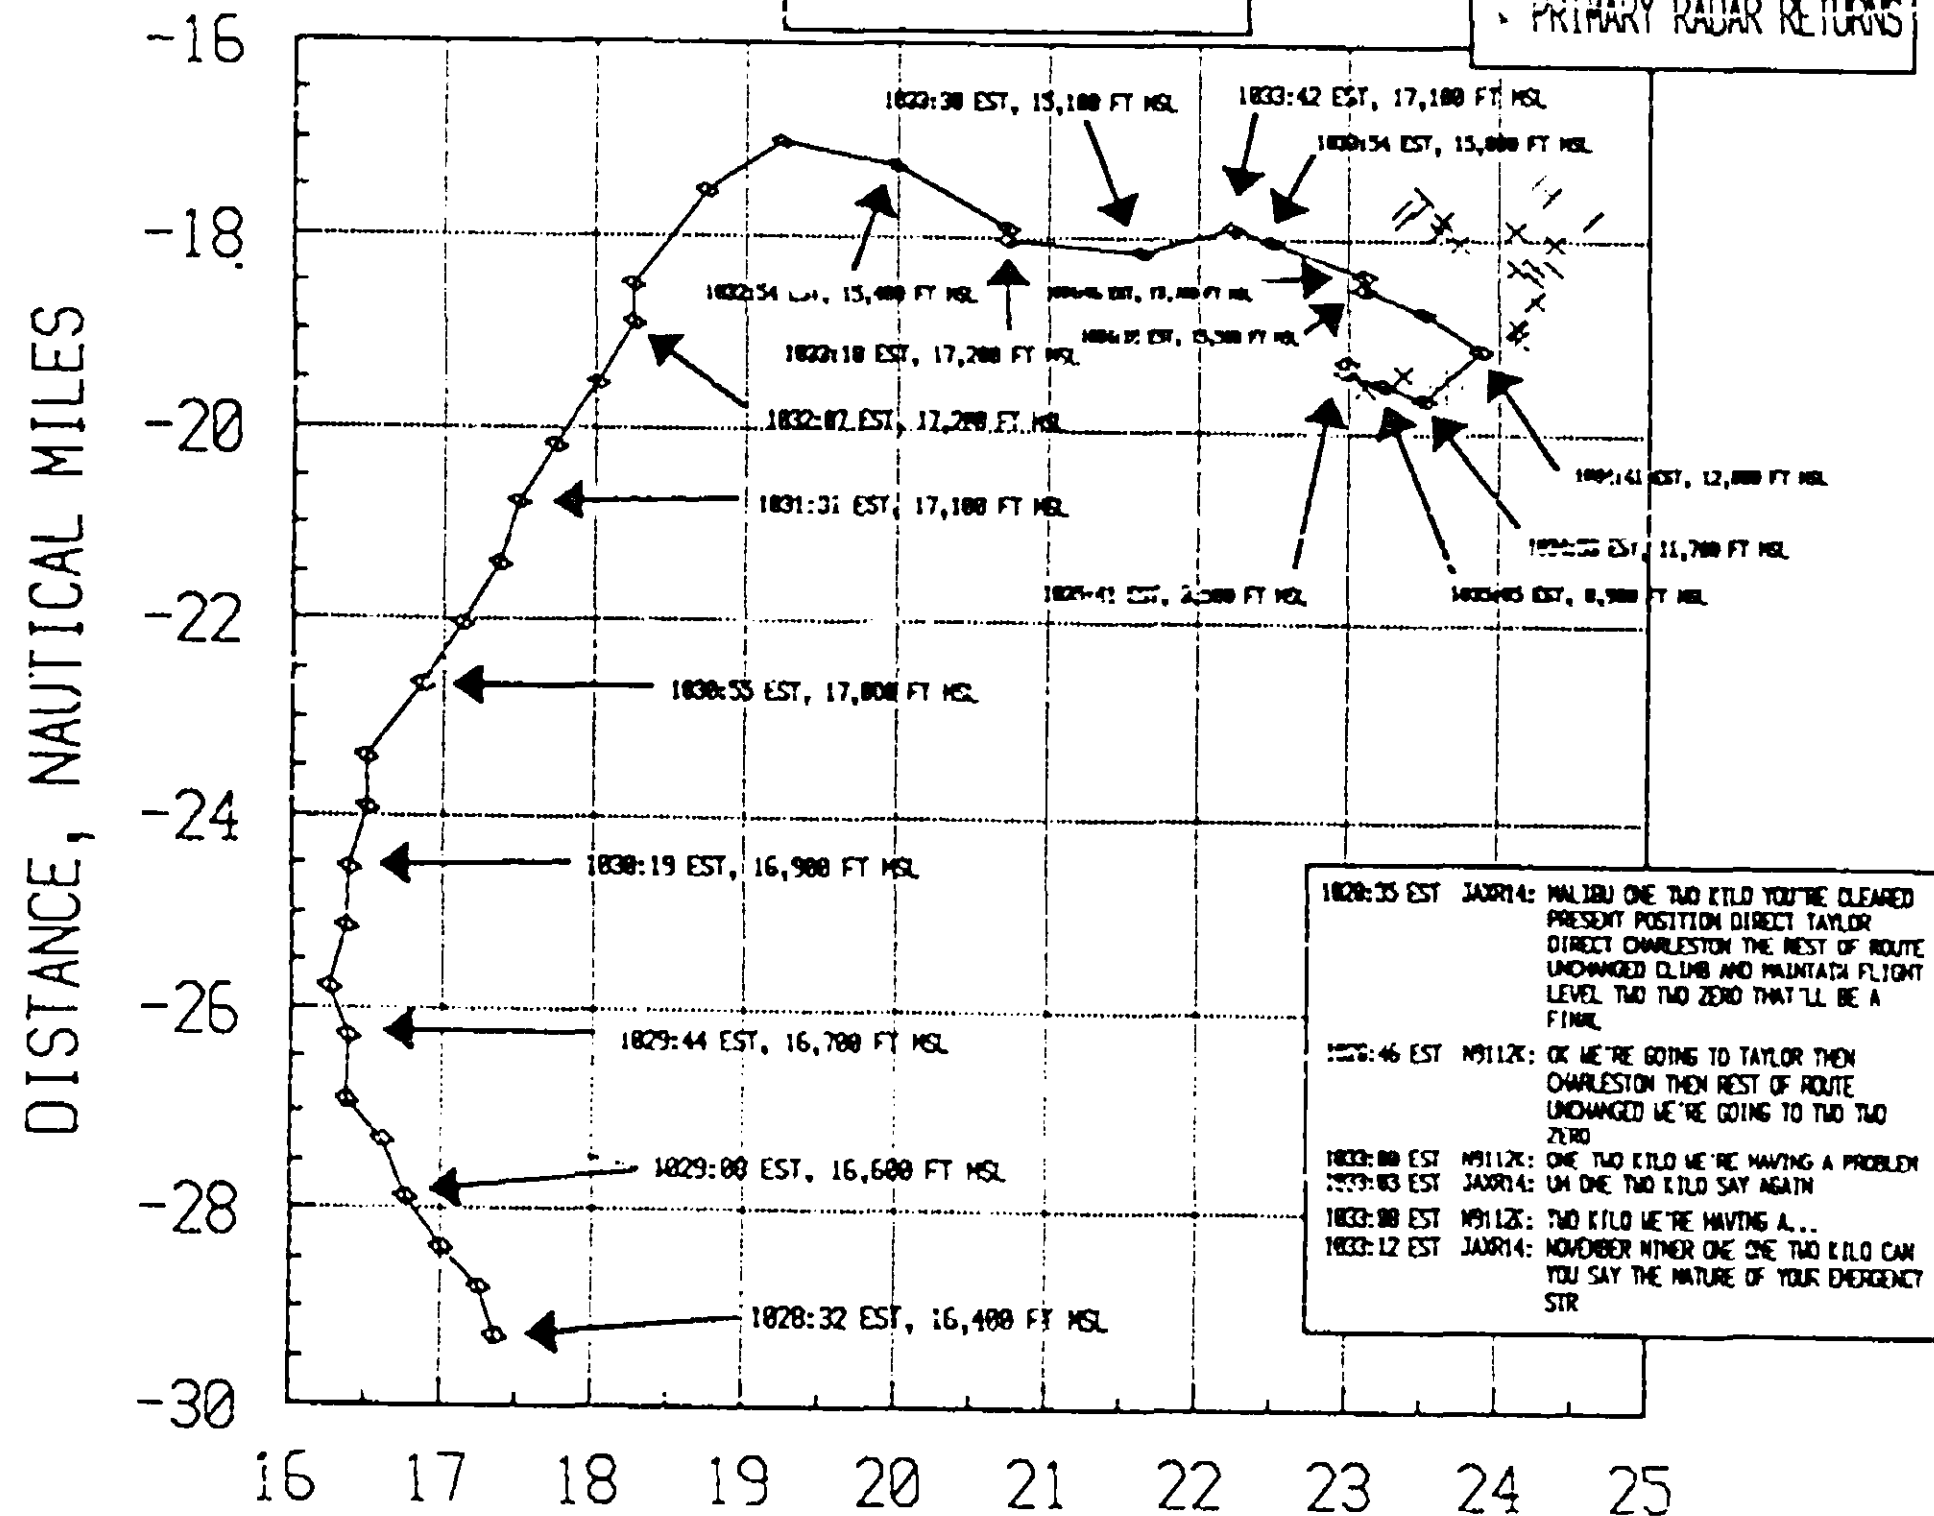
FIGURE 14

BRONSON, FLORIDA  
3/17/91  
N9112K

PRIMARY RADAR RETURNS

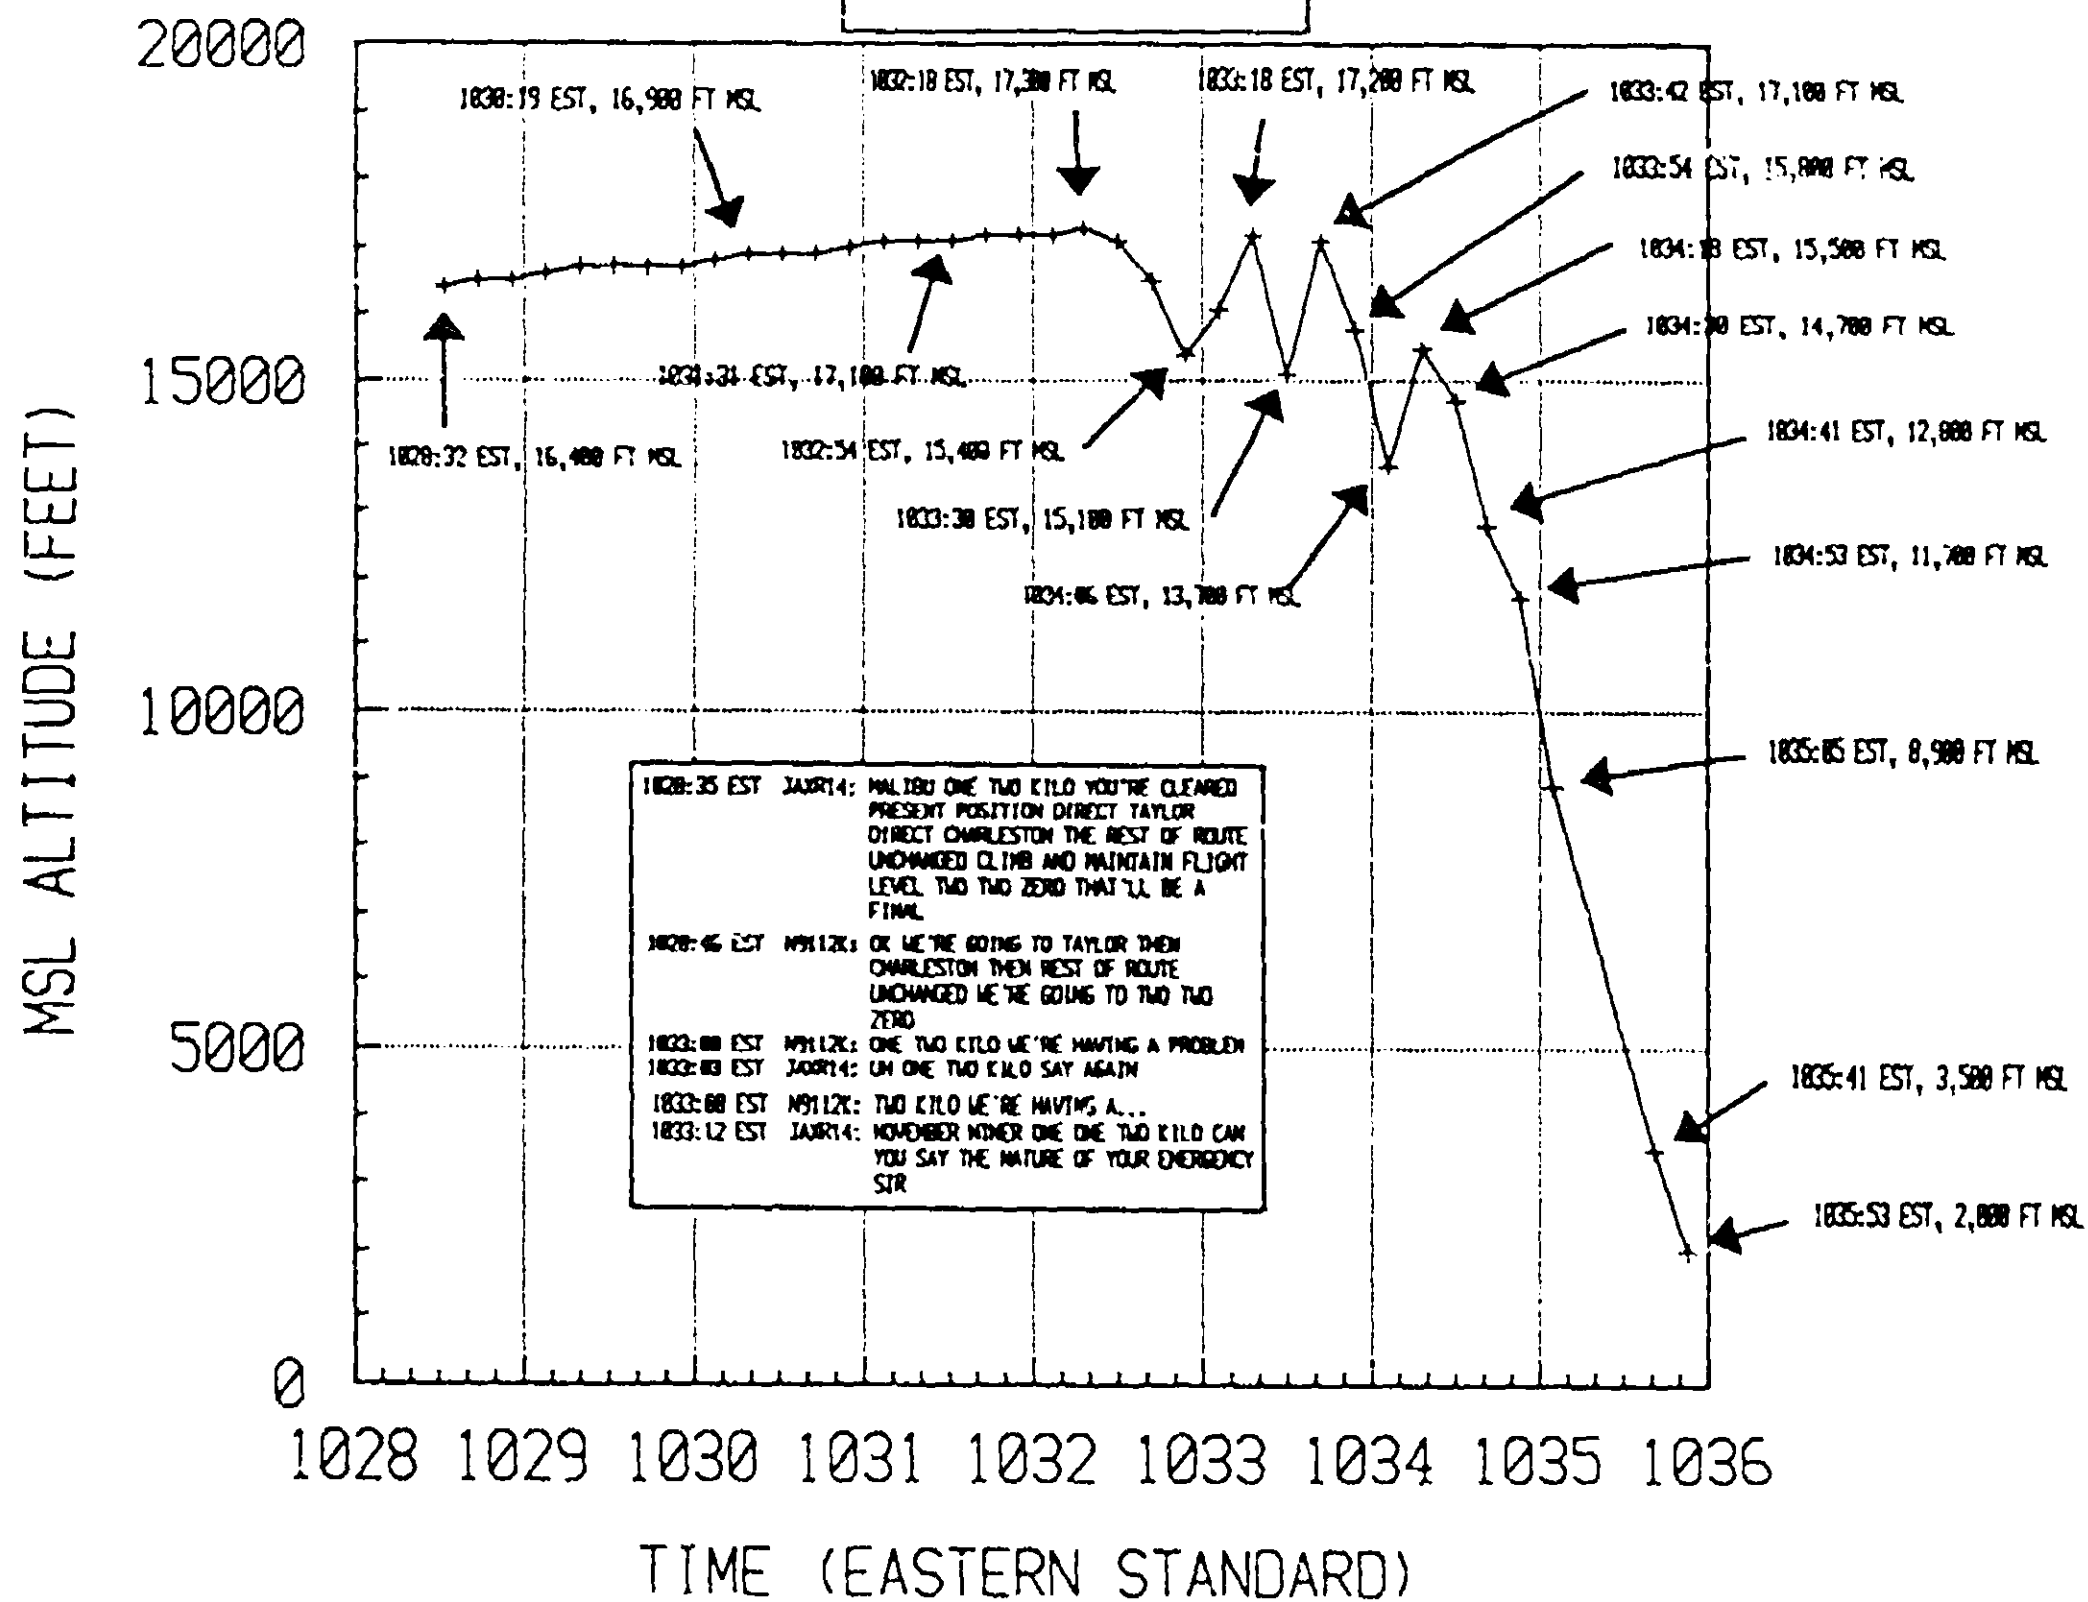
BRONSON, FLORIDA  
3/17/91  
N9112K

The airplane's altitude decreased to 15,400 feet, and it accelerated to more than 230 KIAS while attaining the near easterly heading. The airplane then ascended to about 17,200 feet while losing much of its airspeed in about 20 seconds. The airplane descended and climbed two more times before entering a final descent with a large right bank angle. About 3 minutes elapsed from the first indication of a descent to the final descent. The aircraft crashed about 6 nmi east of its original ground track.
