PB92-917004  
NTSB/SIR-92/04

# NATIONAL TRANSPORTATION SAFETY BOARD

## SPECIAL INVESTIGATION REPORT

### MEDIUM/HEAVY TRUCK WHEEL SEPARATIONS

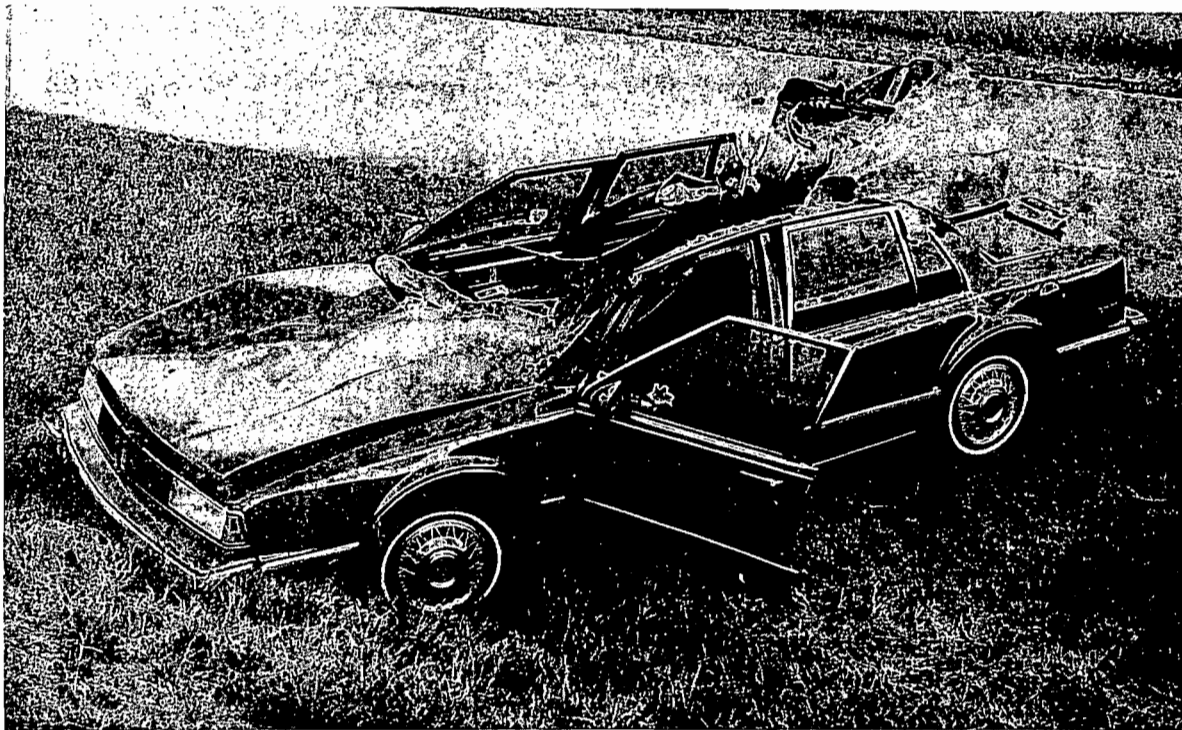
**Warrior, Alabama** -- On September 19, 1991, a 1986 tractor in combination with a loaded 1985 two-axle Great Dane 40-foot van semitrailer was traveling southbound on Interstate 65 and descending a grade when the left front dual wheels disengaged from the trailer. The loose wheels crossed the highway median and struck an oncoming 1989 Oldsmobile passenger car, killing the passenger and seriously injuring the driver. (See figure 3.)

Figure 3.--Damage to a 1989 Oldsmobile struck by a left front dual wheel in Warrior, Alabama.

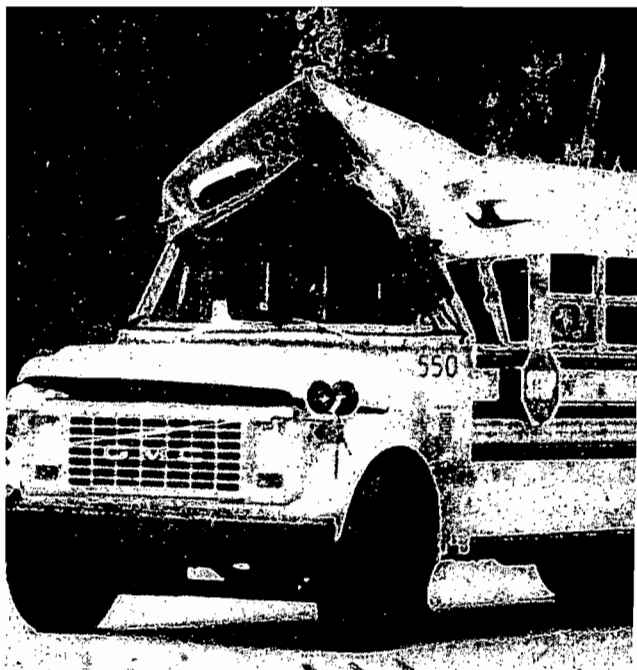
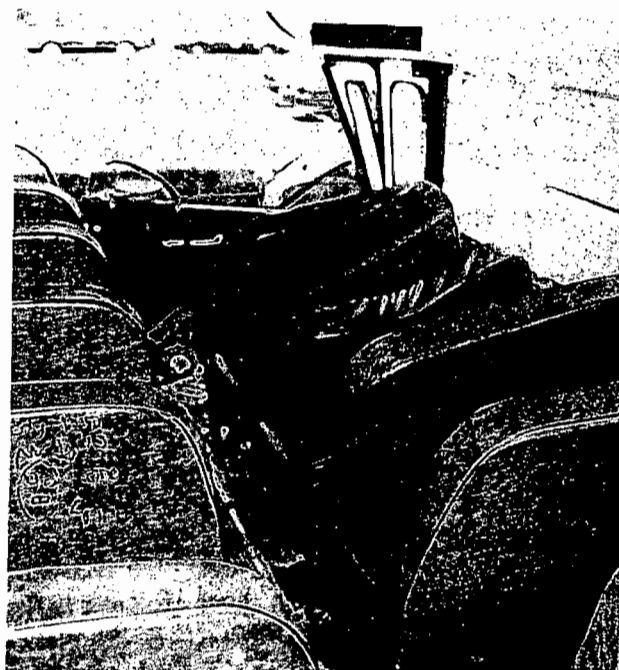
**Miami, Florida** -- On October 14, 1991, a 1986 Mack two-axle cargo van was traveling eastbound in heavy traffic on State Route 836 when the left front wheel, hub intact, disengaged. The loose wheel angled left across the highway, bounced over the 32-inch-high concrete center barrier, and struck an oncoming, occupied schoolbus. The wheel entered the front of the bus, killing two children and fatally injuring a chaperon, who died 10 days later. (See figure 4.)

Figure 4.--Left photograph shows damage to Miami, Florida, schoolbus. Right photograph shows interior damage caused when the truck wheel penetrated the front windshield of the bus.

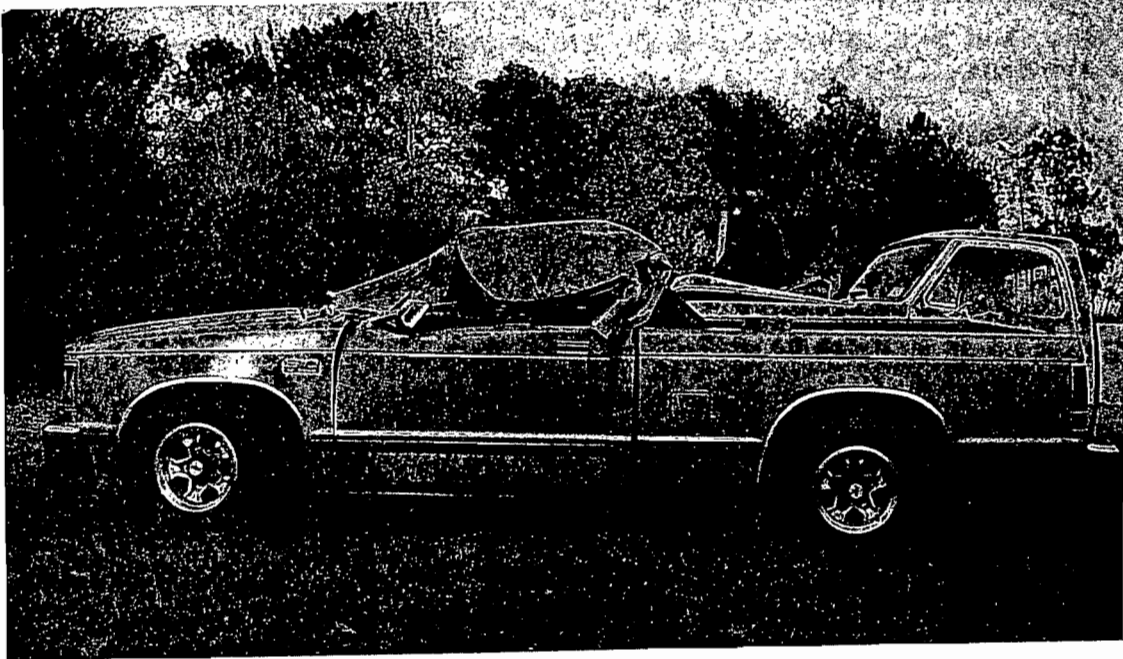
**Marion, North Carolina** -- On October 16, 1991, a 1989 Freightliner tractor in combination with a 40-foot semitrailer was traveling northbound on U.S. Route 221 when the left front drive wheels disengaged from the tractor. The wheels separated, and one careened into an oncoming pickup in the southbound lane, killing the driver. (See figure 5.)

**Figure 5.--Damage sustained by pickup truck near Marion, North Carolina.**

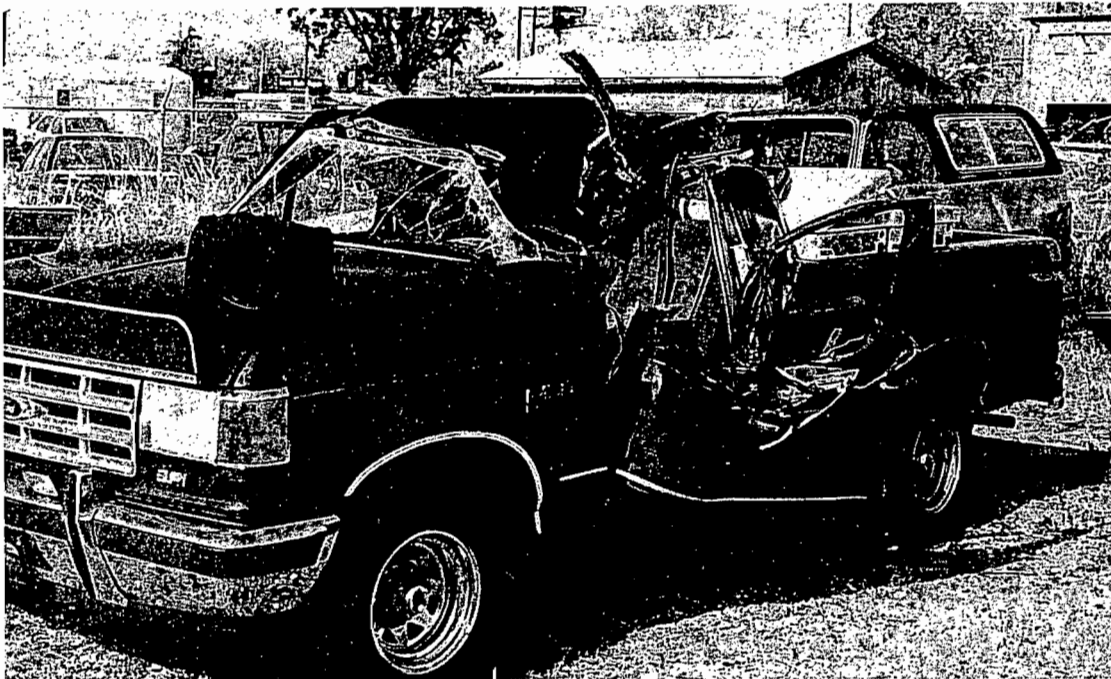
**Figure 6.--Damage sustained by pickup near Greensboro, North Carolina.**

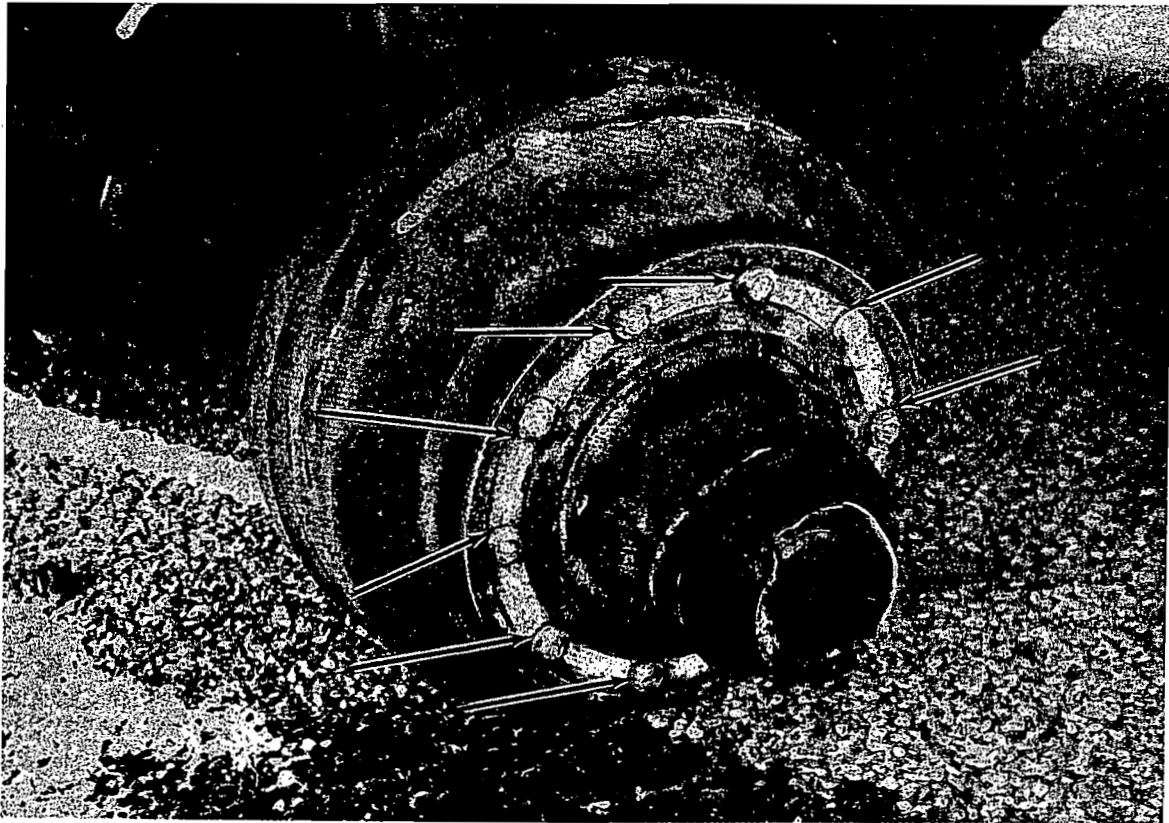
**Warrior, Alabama** -- In the postcrash examination of the tractor/semitrailer, the Alabama Department of Public Safety investigators reported rust streaks near the stud bolts and nuts of the vehicle's third axle leftside, fourth axle rightside, and fifth axle rightside. Figure 7 shows the sheared bolts on the hub assembly of the accident vehicle.

Examination of four bolts from the wheel that separated from the trailer disclosed surface markings indicative of fatigue cracking. Most of the fractures were representative of rotating bending fatigue. If a nut is loose on a stud, when the wheel turns, the stud will bend and become subject to fatigue from all directions. Analysis showed that fatigue markings extended completely through the fractured cross section of three of the four studs examined. The full extent of cracking in the fourth stud could not readily be determined.

The Safety Board concluded that such fatigue would occur if the studs were not properly tightened. Inadequate clamping forces between the wheel and hub allow relative movement between these members. When this occurs, studs are subjected to rotating bending stress when the wheel rotates.

**Figure 7.--Hub assembly showing fractured bolts. Arrows point to rust build-up.**

Rust, metal burrs, and paint build-up between the wheel and hub can prevent the surfaces from fully contacting each other during tightening of the nuts. During service, rust, paint, and metal burrs can flatten or wear, causing a loss of clamping force and reduced torque on the nuts. The loss of force would allow the nuts to back off. The loose nuts cause excessive rotating bending stress in the stud that eventually results in stud failure.

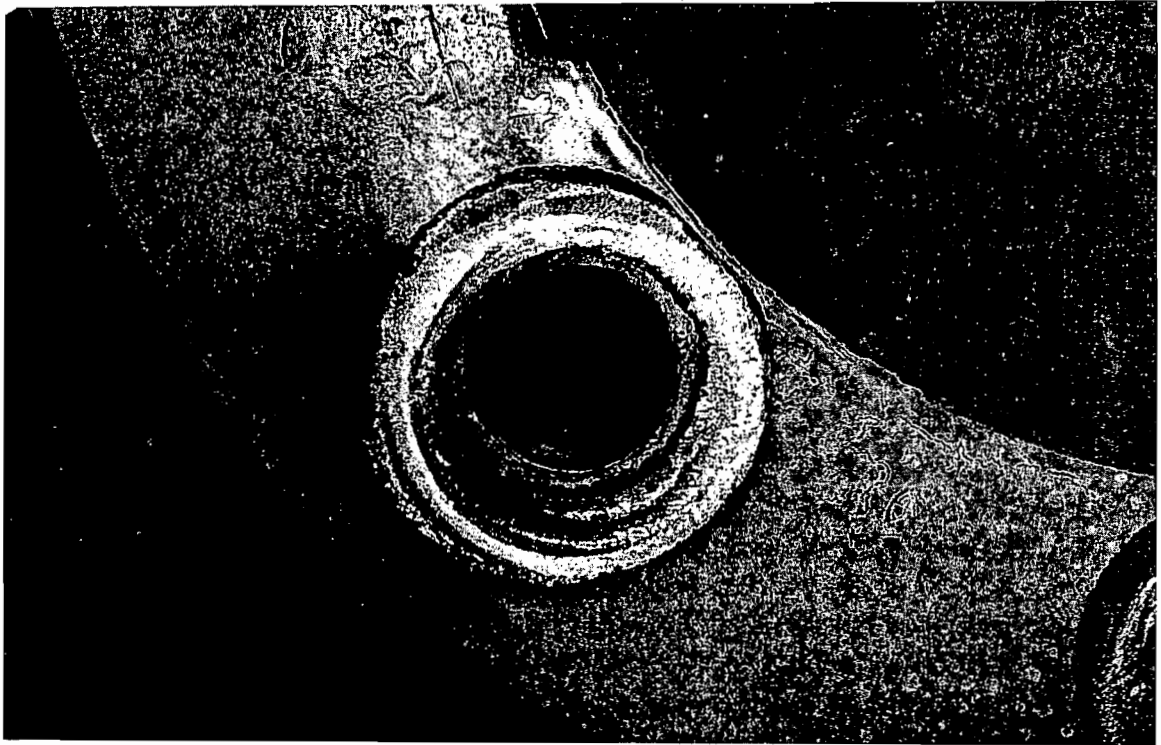
...the most probable scenario for the loss of torque on the mounting nuts appears to be...[due to the wear] of the paint coats on the mating surfaces of the rims under the initial clamping force.... The movement of the paint coat from under the mounting nut would allow some loss of the elastic elongation present in the cone washer and the wheel mounting bolt. The...[loss of] the paint coat on the rims can be observed in the photographs [see figures 8 and 9] of the wheel assemblies....

Figure 8.--Mounting face wear on outboard wheel assembly.

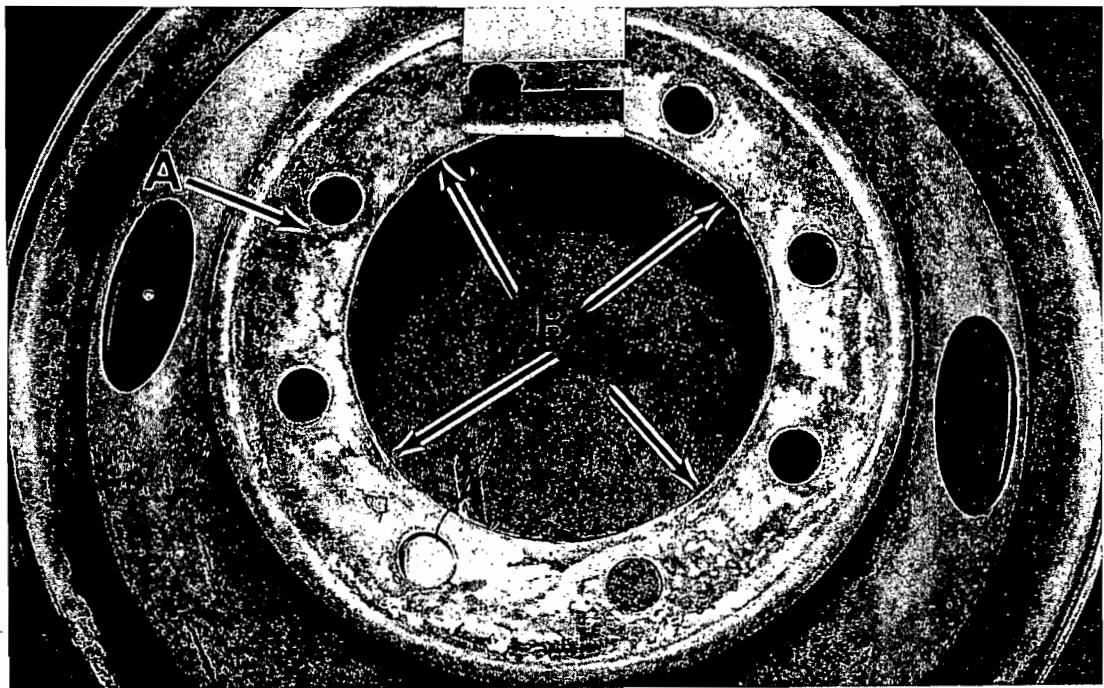
Figure 9.--Mounting face of inboard wheel assembly. Area at A shows a loss of paint from the mounting face. The inside rim between the bolt holes shows wear from the pilots.

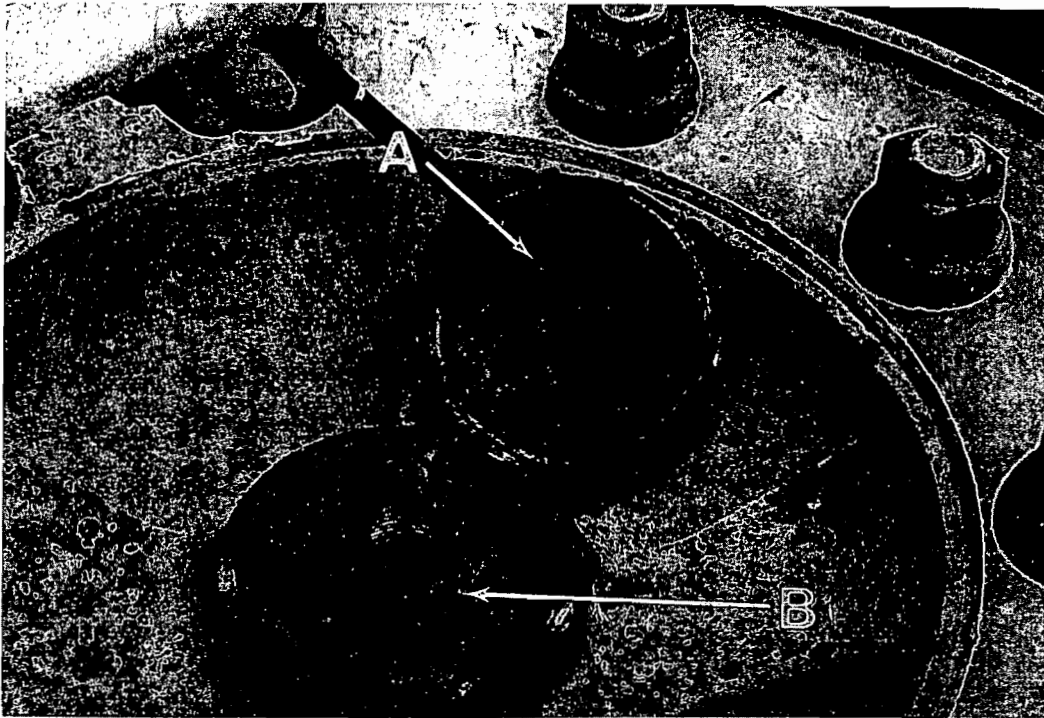
Miami, Florida--At the postaccident inspection, Safety Board investigators were assisted by two engineers from Mack Trucks, Inc., the manufacturer of the accident vehicle. Investigators found a cotter pin fragment embedded in "cooked," or overheated, grease on the inside surface of the cap (see figure 10). The heat had fused the nut, lockwasher, and inner race of the outer bearing (see figure 11). A portion of the fused pieces had considerable accumulated rust. The excessive heat had also burned up the bearing and destroyed the bearing cage.

Figure 10.--View of overheated grease from the left front wheel assembly. (Arrows A and B point to the hub cap and lock nut, respectively.)

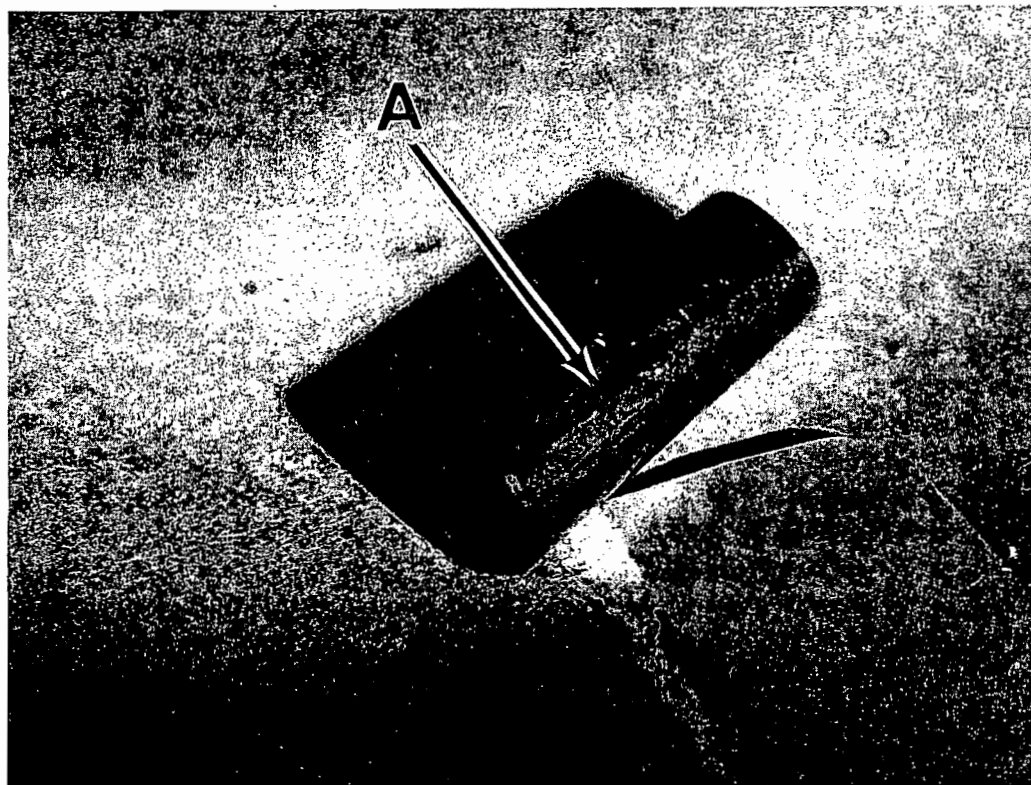
The investigators found the roller bearings had some flat spots, "galling," and "pitting" (see figure 12). According to engineers, these deficiencies are characteristic of "long-time" wear resulting from a lack of grease, improper grease, or the presence of water. When they checked the hub cavity, investigators found that the amount of grease was "almost unmeasurable," as opposed to 9 ounces specified by the manufacturer.

On-scene investigators concluded that lack of maintenance, specifically, proper lubrication, caused the wheel bearing to seize. They determined that the lack of grease on the wheel bearing, together with accumulated rust on the spindle and outside bearing, resulted in the following scenario:

**Figure 12.--Roller bearing with flat spots (A) and pitting.**

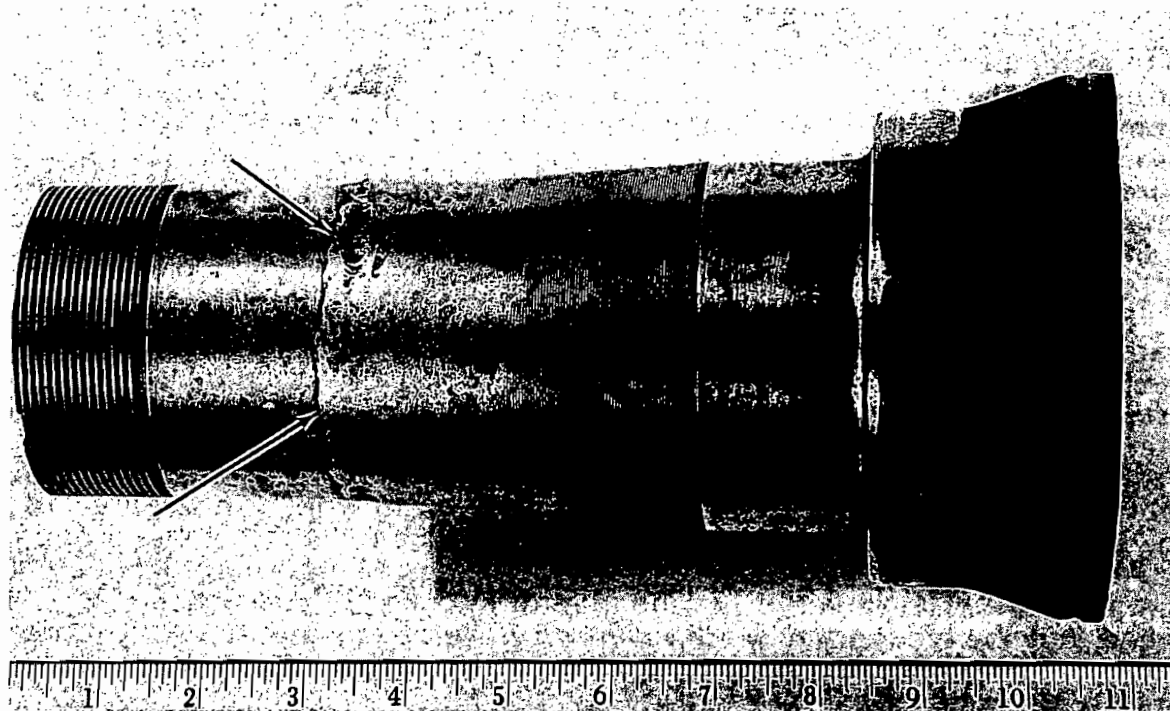
Maintenance officials must discourage maintenance practices that could create bearing problems. During the Safety Board truck-wheel separation investigation, NHTSA officials were shown a wheel assembly that had worn out two sets of bearings and could have resulted in a wheel separation (see figure 18). NHTSA is

**Figure 18.--An improper spindle repair. Arrow highlights the weld.**

examining a remanufacturer's process to restore a spindle that was damaged due to bearing failure. The process involves cutting off the damaged part of the spindle and placing part of a manufactured spindle repair kit on the end between the bearing races, using a jig, and welding the new part on. If the welds are not correct, eccentricity or offset can be introduced that wear bearings out prematurely. When put in a lathe, the spindle appeared to be out of plumb by as much as 0.25 inch. The ATA has put out warnings against using this practice.
