National Transportation Safety Board Special Investigation
Report: Safety Issues Related to Wake Vortex
Encounters during Visual Approach to Landing

SPECIAL INVESTIGATION REPORT

Special Investigation Report NTSB/SIR-94/01
Notation 6264

Washington, D.C.
February 1994

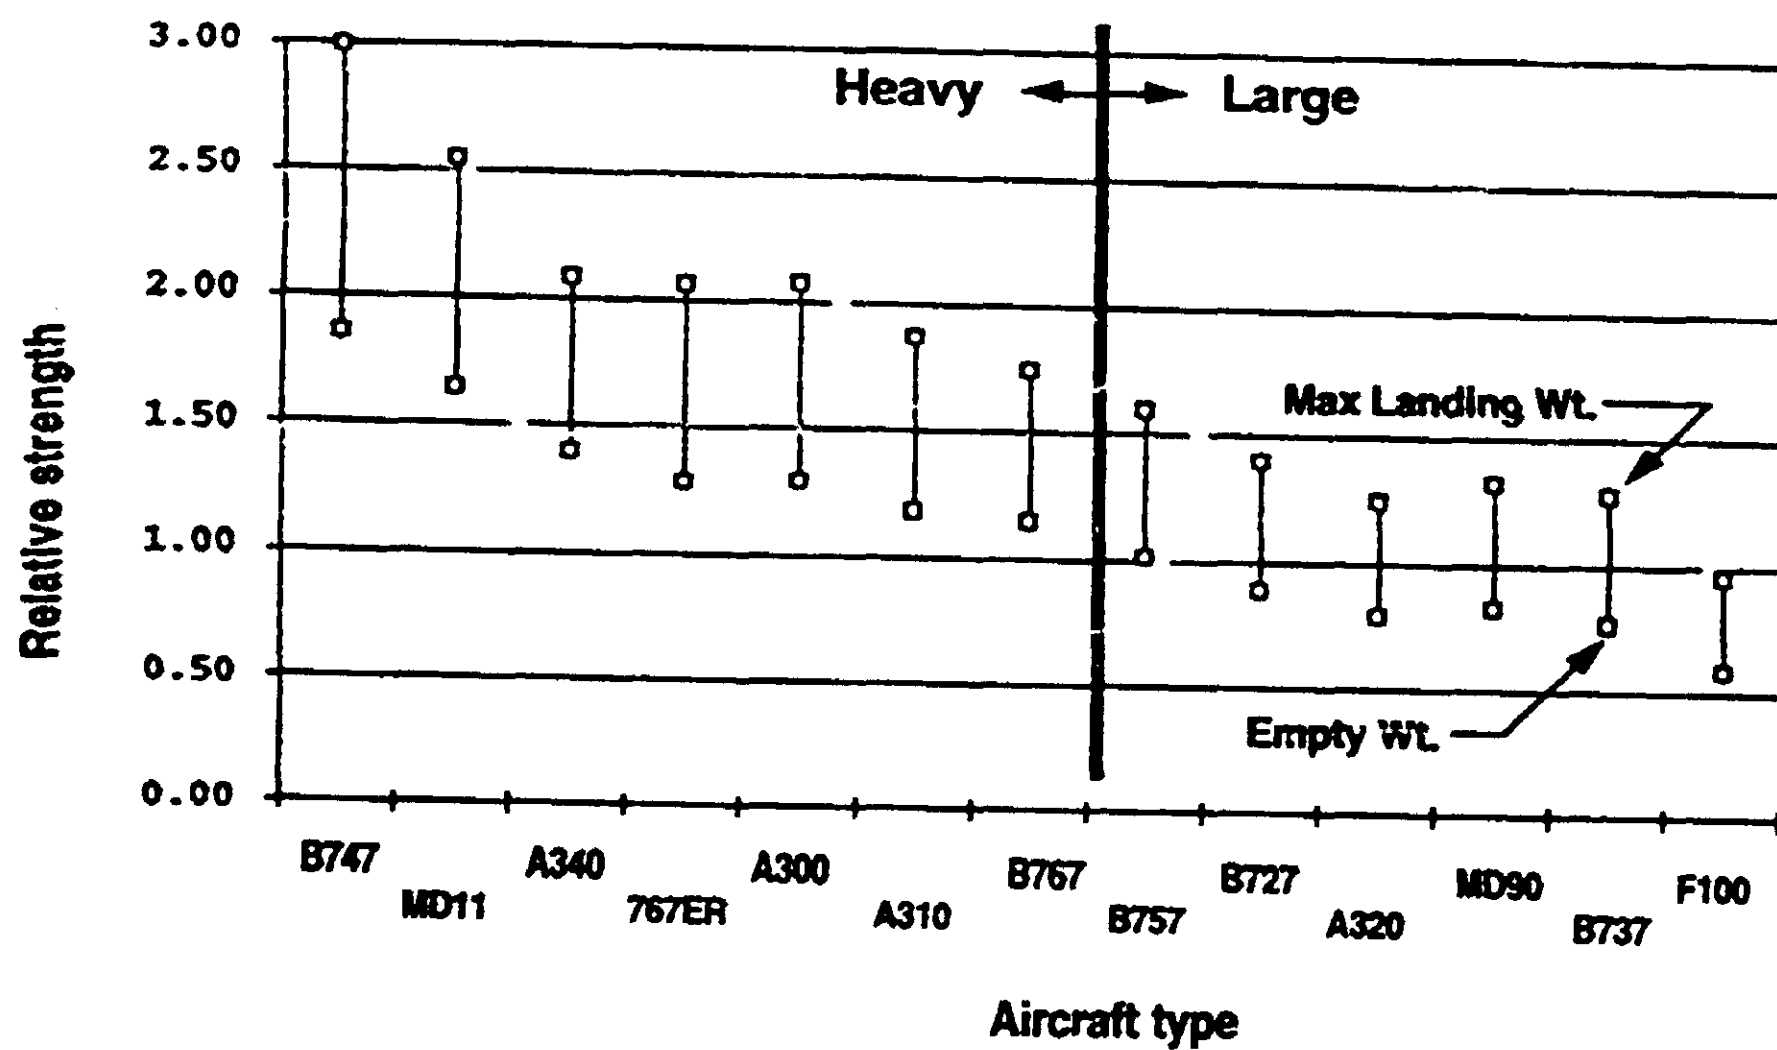
The Safety Board's investigations of the preceding cases initially focused on why the B-757 appeared to be involved in a disproportionate number of wake vortex encounters. Several reports indicated that the B-757 generated wake vortices that were more severe than would be expected for an airplane of its weight. However, as a result of a thorough study and analysis of the issue, the Safety Board found little technical evidence to support the notion that the wake vortex of a B-757 is significantly stronger than indicated by its weight. Figure 1 presents the calculated initial relative vortex strength of the B-757 and other airplanes. The calculated initial vortex strength is closely related to the weight of the airplane. Of note, the B-757 is the heaviest airplane in its weight category, and there are no other airplanes of similar weight.

Figure 1—Calculated initial vortex strength of aircraft types. (Courtesy of the National Aeronautics and Space Administration.)

Conduct additional tests of the Boeing 757 to determine the persistence and strength of its wake vortex and the effects of atmospheric conditions on B-757 vortices. (Class II, Priority Action) (A-94-55)

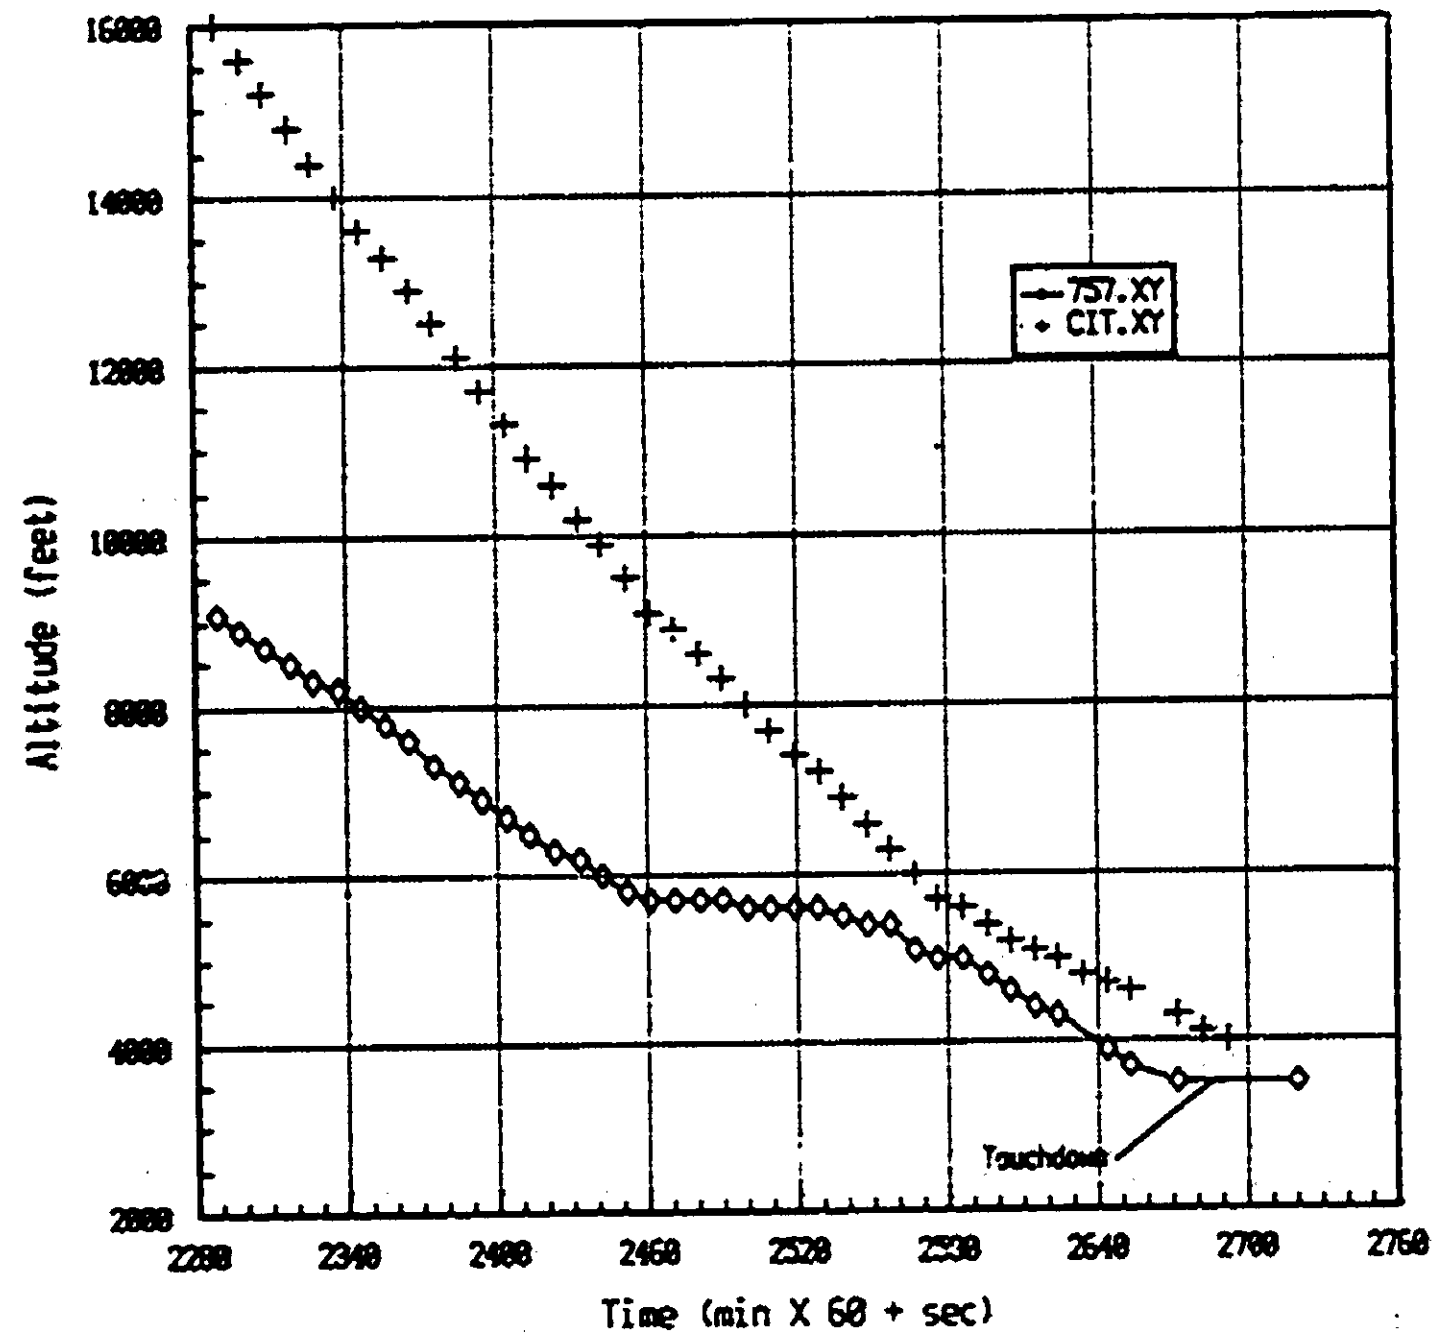
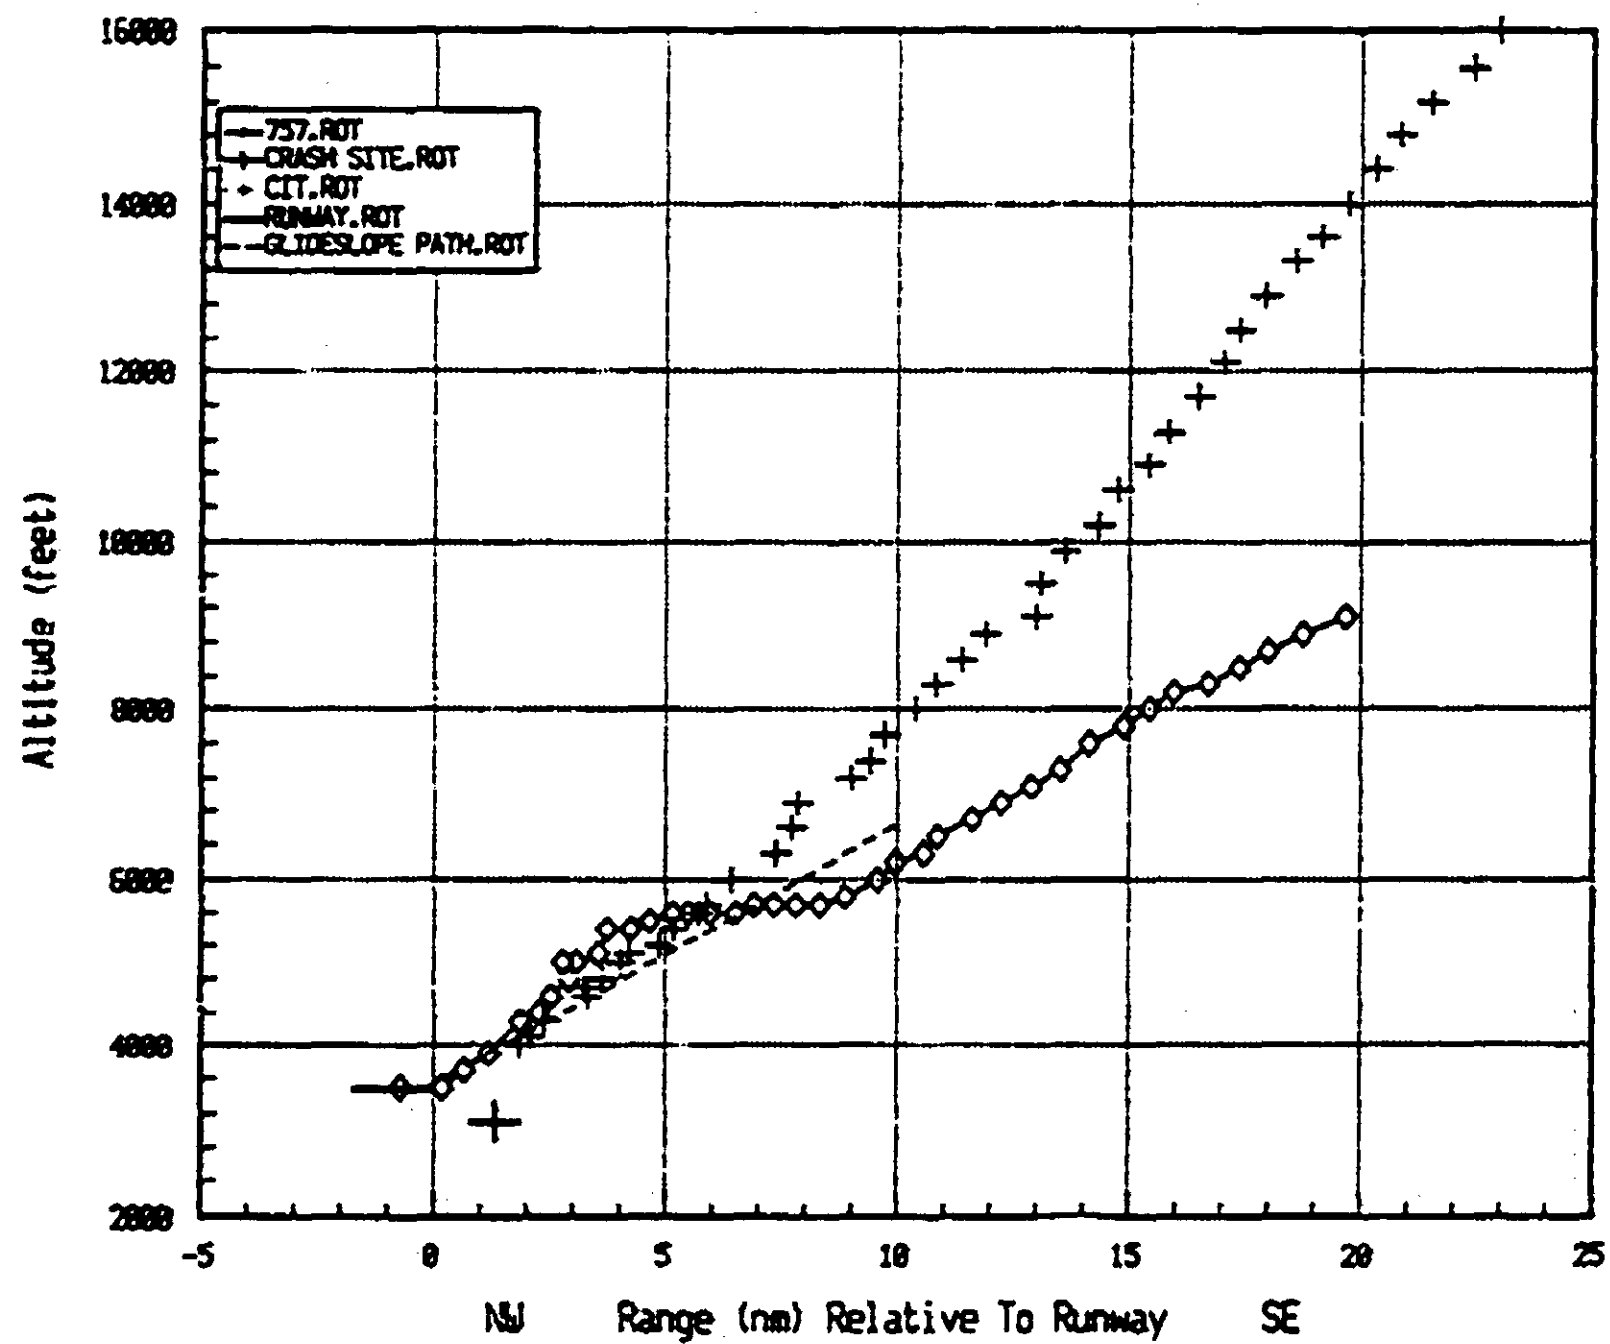
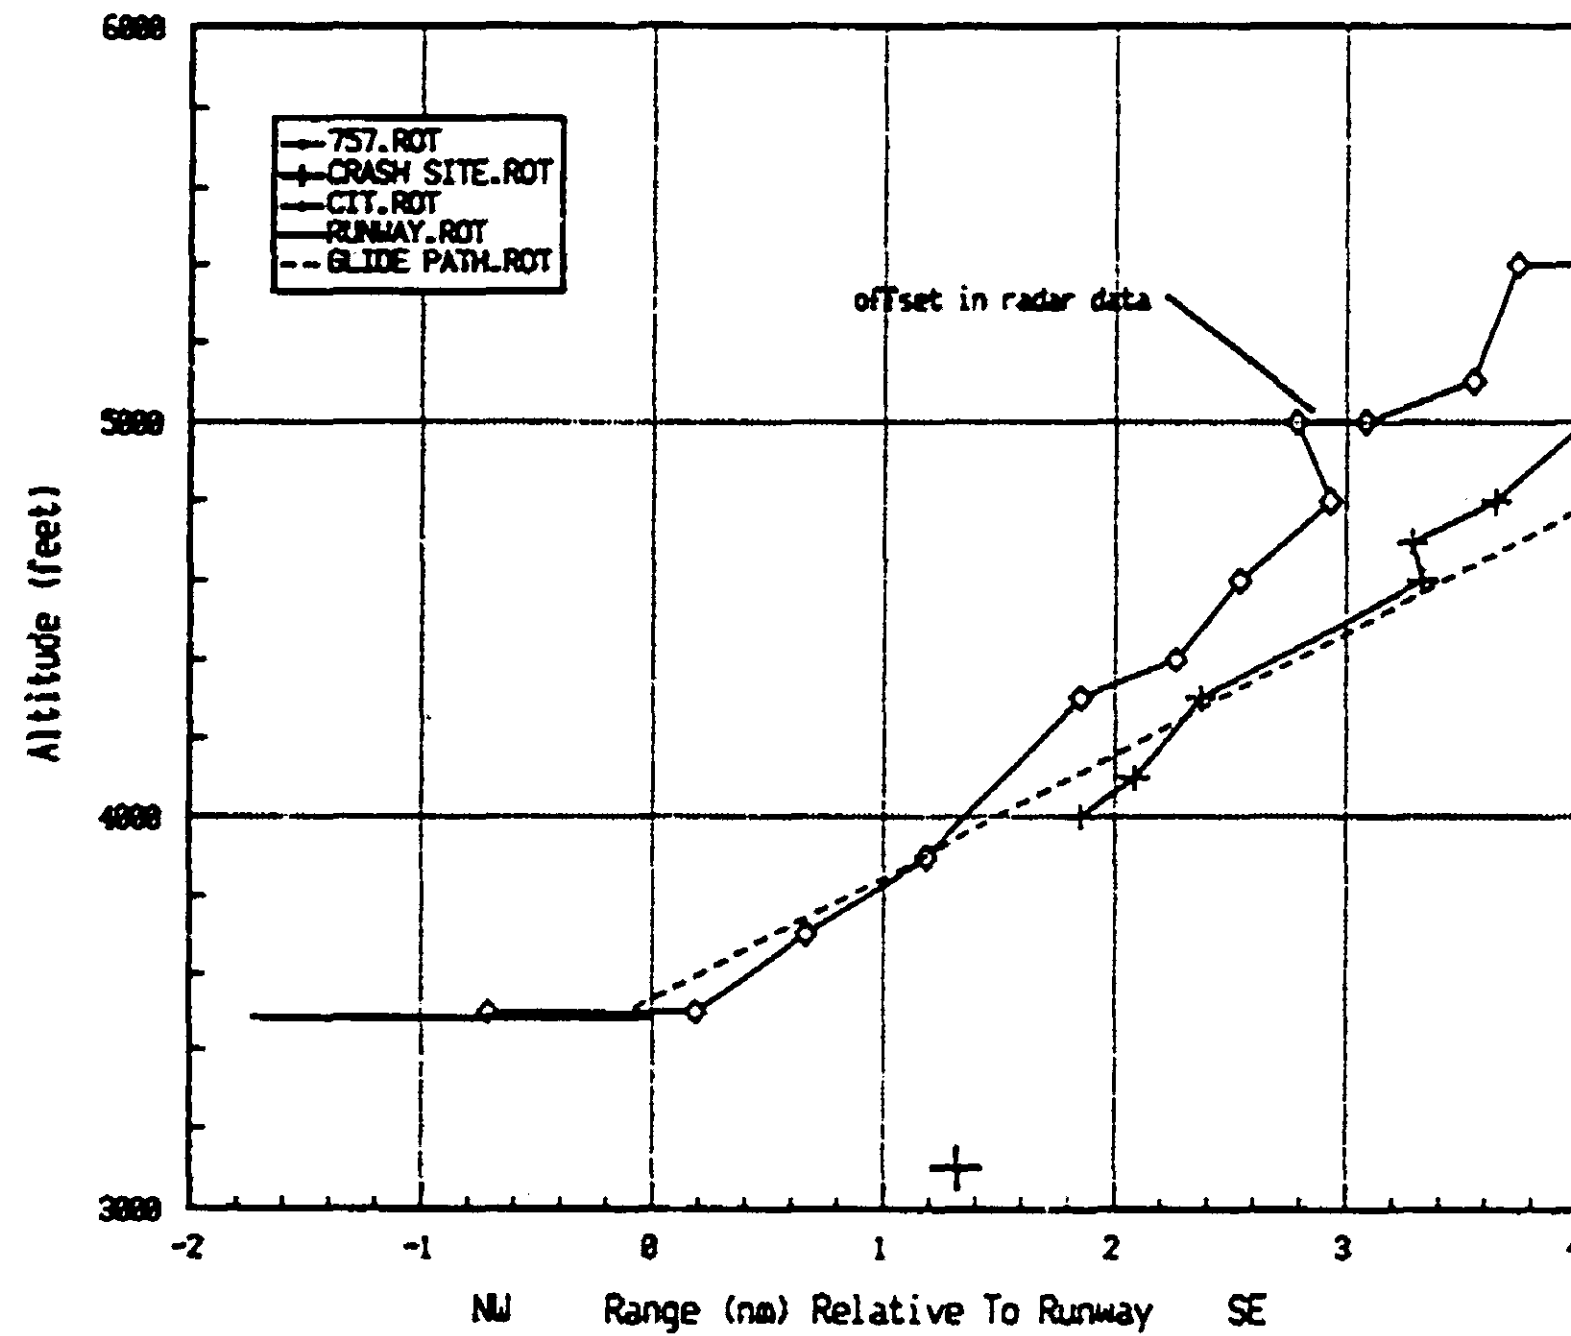
**Altitude Profile of B-757 and Cessna Citation 550
at Billings, Montana, on December 18, 1992**

The Citation's rapid and extreme departure from controlled flight occurred when the airplane was about 2.78 nm (about 74 seconds) behind the B-757. Calculations indicate that an additional 0.22 nm (about 6 seconds) would have provided the required 3 nm of longitudinal IFR separation had the pilot not requested the visual approach clearance. However, available data show that under the existing atmospheric conditions, a vortex would not likely have diminished an appreciable amount in the next 6 seconds. Consequently, this accident indicates that lighter weight airplanes in the large category, such as the Cessna Citation, require a separation distance greater than 3 nm when following heavier airplanes in the large category, such as a B-757.

The only cue available to the Citation pilot to determine his flight path relative to the flight path of the B-757 would have been the Citation pilot's visual alignment of the B-757 and objects on the ground. For example, assuming that the B-757 was on a relatively constant flight path, the Citation flight path would have been similar to that of the B-757 if the Citation pilot had observed that the B-757 was aligned with the runway touchdown zone. If the B-757 were aligned with the far end of the runway, the flight path of the Citation would have been lower than the flight path of the B-757. If the B-757 were aligned with the approach lights, the flight path of the Citation would have been above the flight path of the B-757.

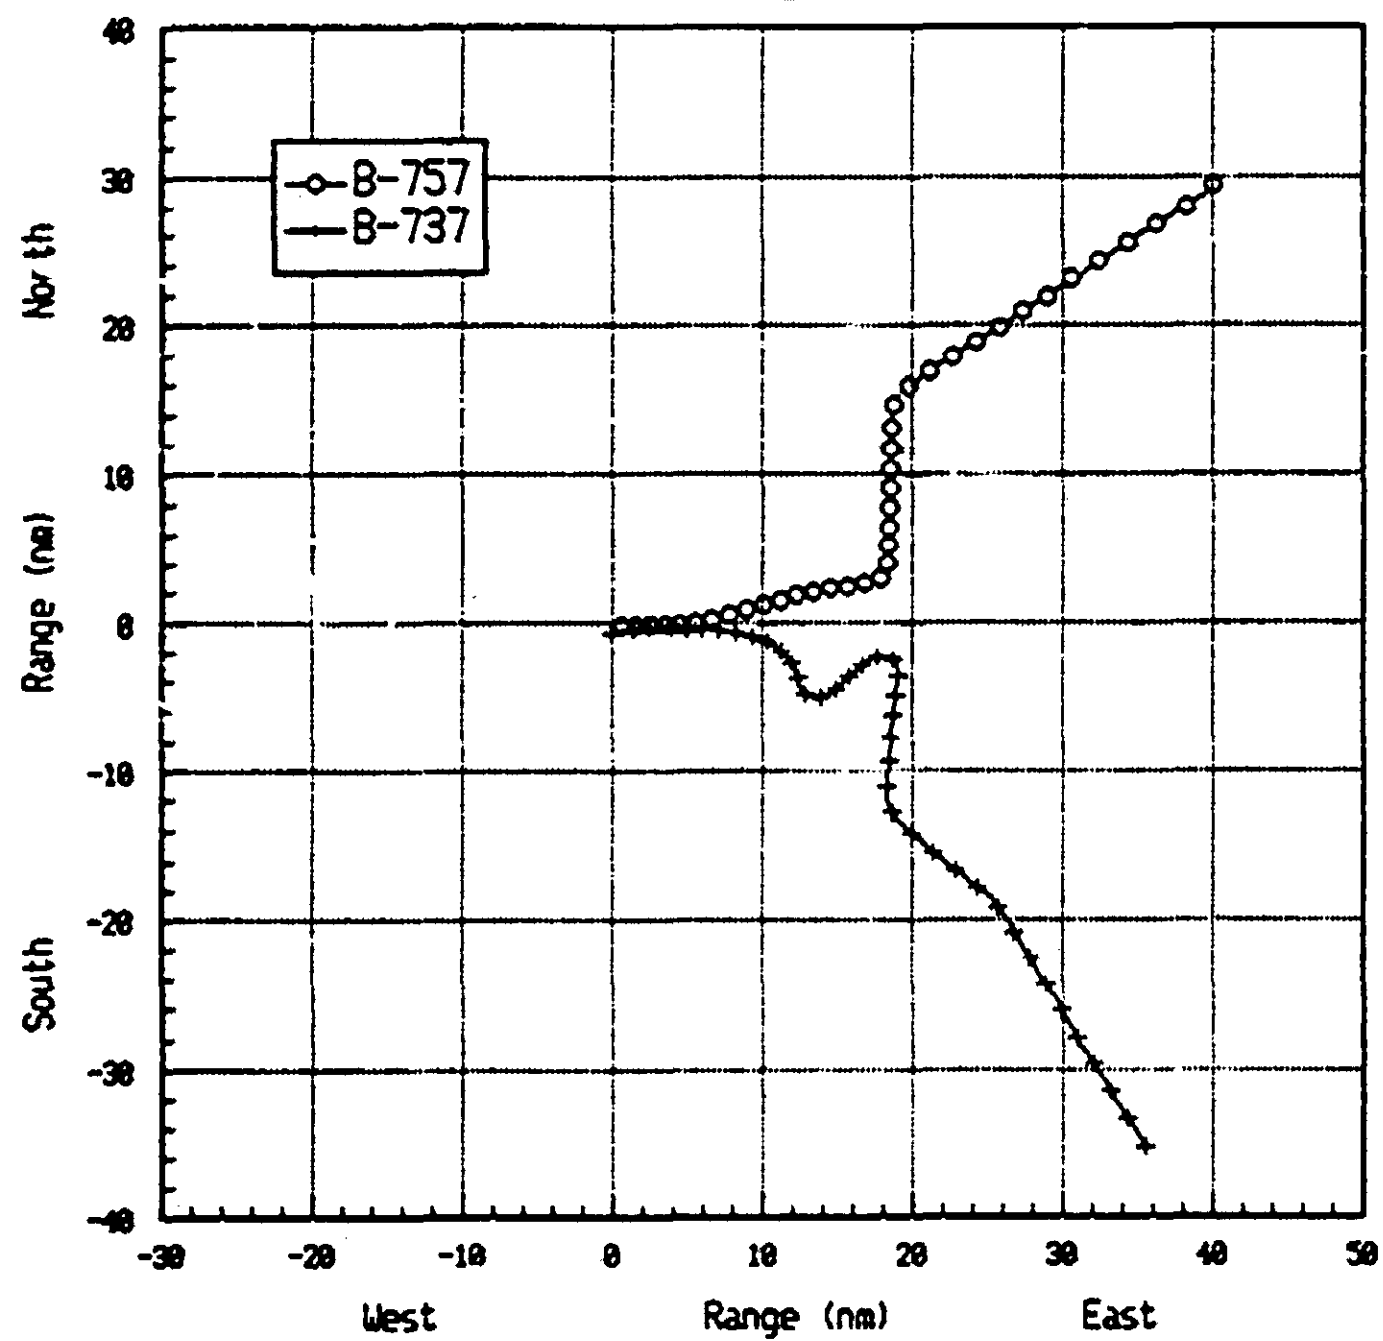
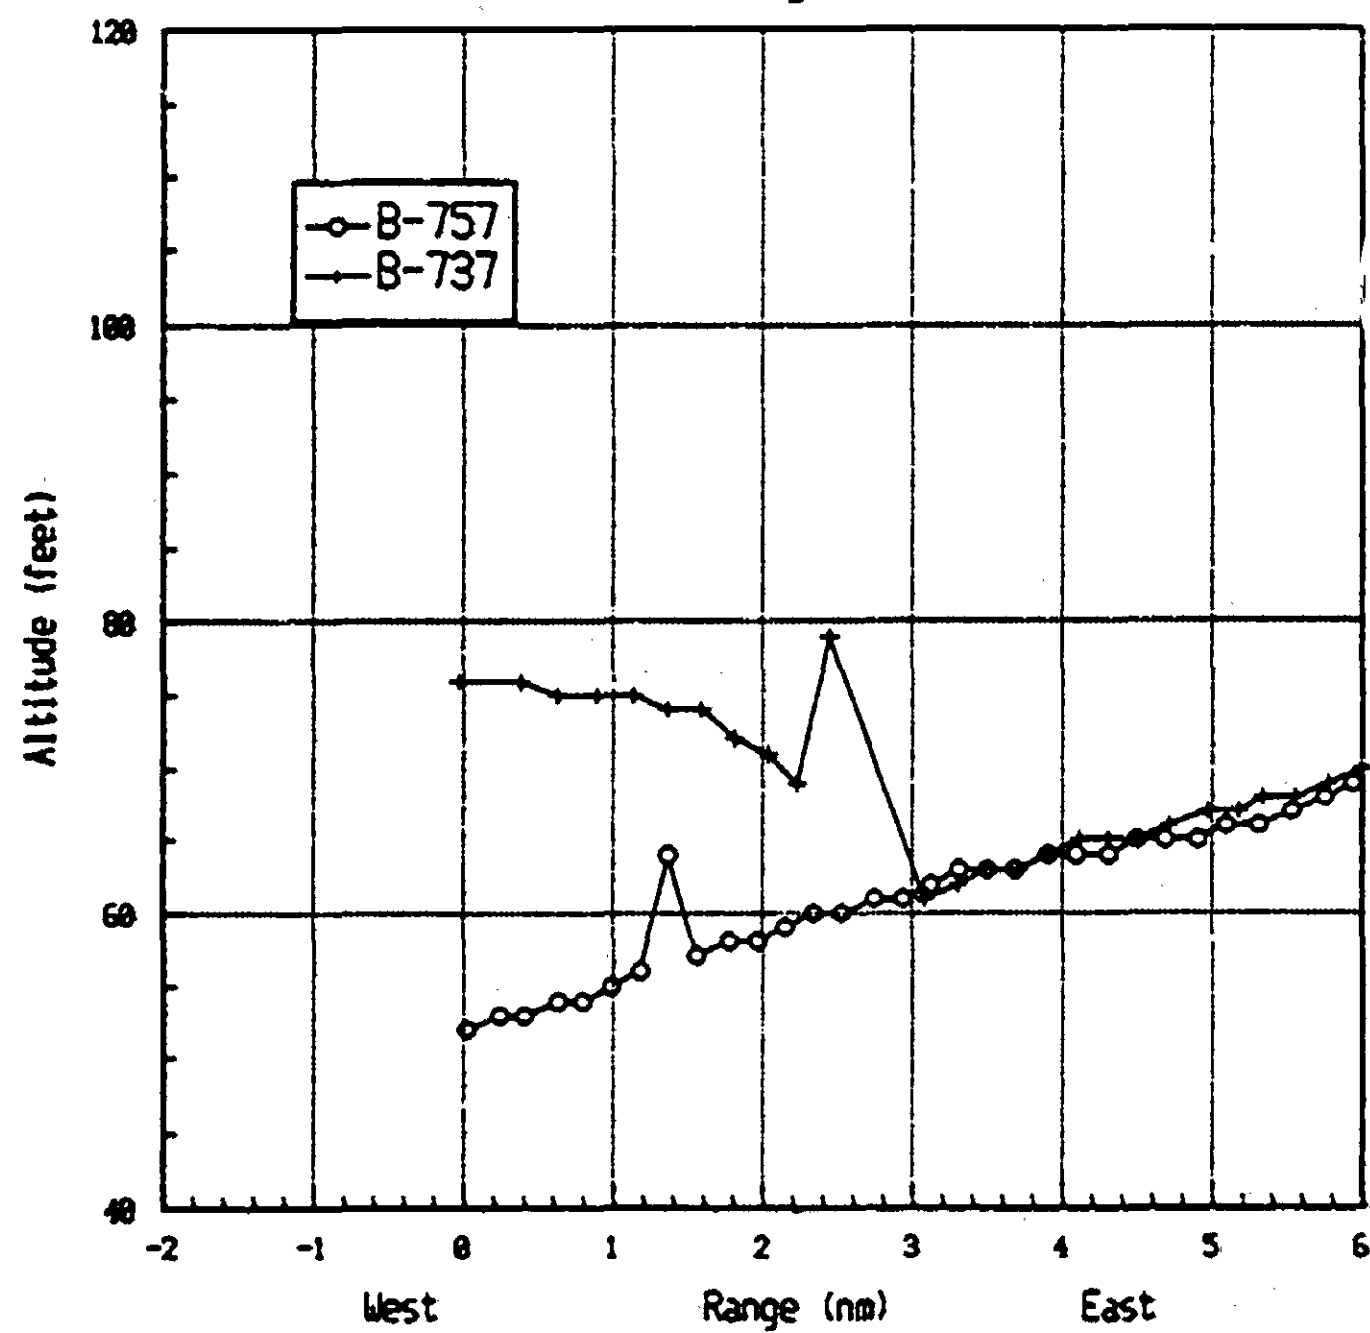
**Ground Track of B-757 and B-737
at Denver, Colorado, on April 24, 1993**

Runway 26L is parallel to, and displaced 900 feet south of runway 26R. The threshold of runway 26L is offset about 1,300 feet to the east of the threshold of runway 26R, resulting in a flight path to 26R that is about 70 feet higher than the flight path to 26L. Under the existing wind conditions, a wake vortex from the B-757 would descend and move to the south, toward a standard flight path to runway 26L.
