## **SPECIAL INVESTIGATION REPORT**

**MAINTENANCE ANOMALY RESULTING IN  
DRAGGED ENGINE DURING LANDING ROLLOUT  
NORTHWEST AIRLINES FLIGHT 18  
BOEING 747-251B, N637US  
NEW TOKYO INTERNATIONAL AIRPORT  
NARITA, JAPAN  
MARCH 1, 1994**

**Adopted: December 20, 1994  
Notation 6487**

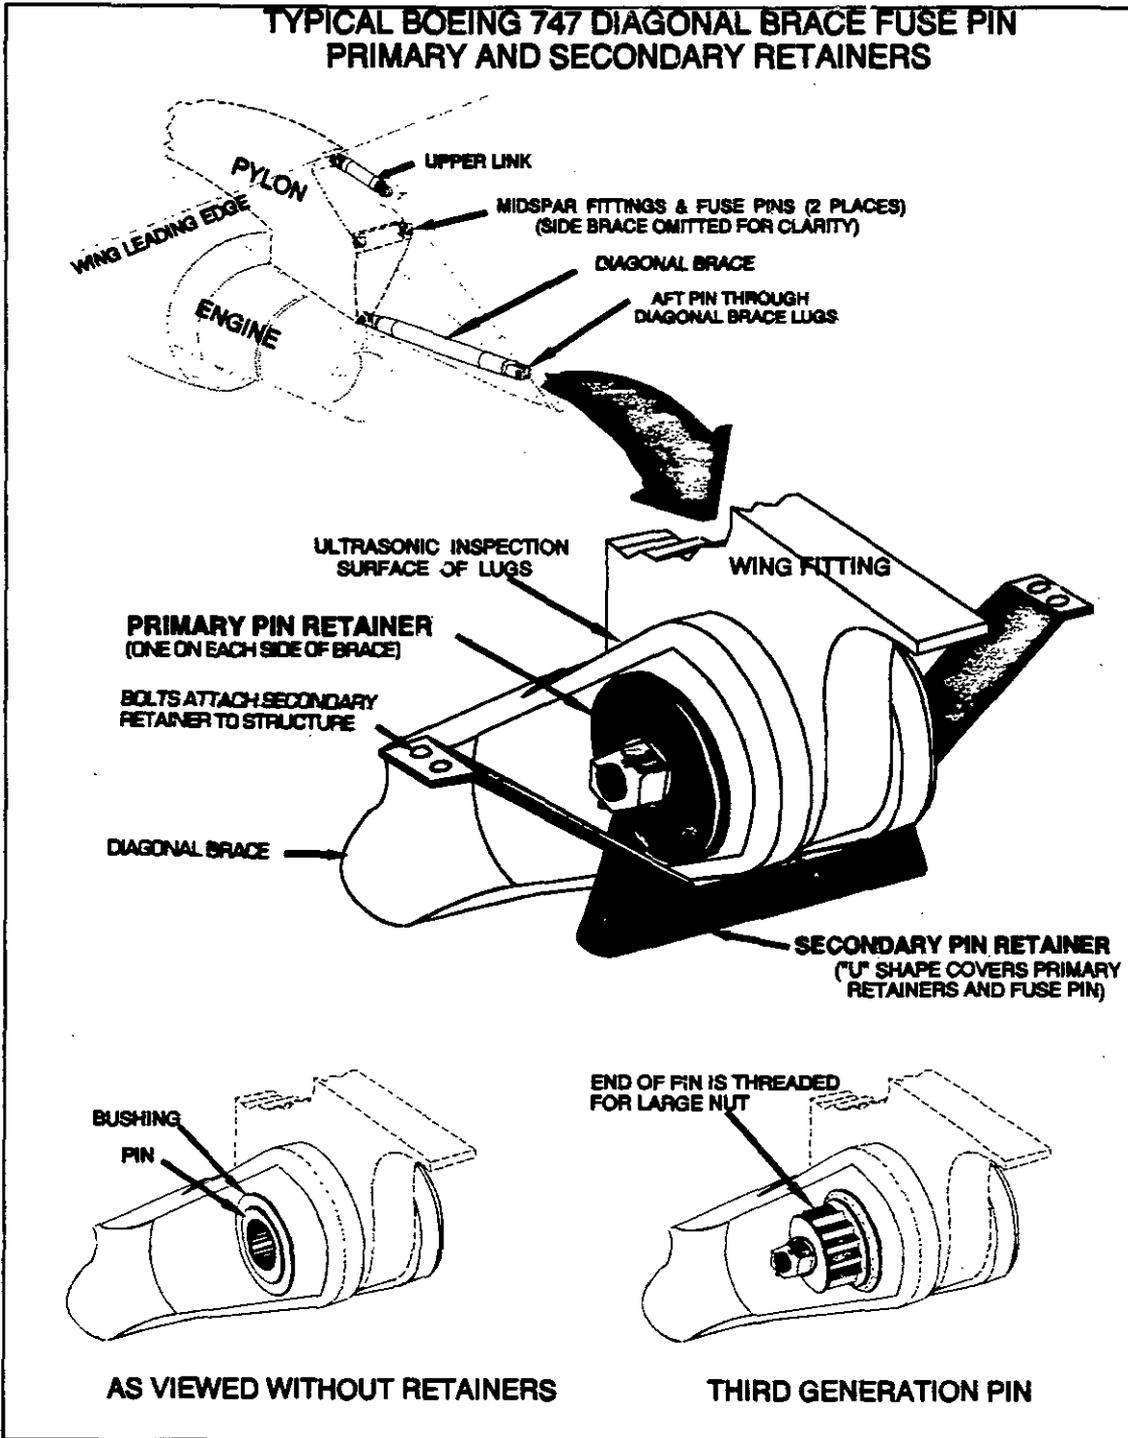
Figure 2.--Diagonal brace attachment details.

Prior to this landing, at some unknown time, the aft fuse pin on the pylon diagonal brace had migrated out of its fitting. The pin was found loose in the pylon structure. It was intact, undamaged, and had no evidence of preexisting defects. The aft diagonal brace fuse pin is normally retained by both a primary retainer (two washer-like retainer caps and a through bolt) and a secondary retention clip (a bolt-on C-shaped bracket). (See figure 2). However, a search of the airplane pylon and engine area, as well as the runway surface at Narita, revealed neither the aft diagonal brace fuse pin primary nor secondary retaining devices.

The No. 1 pylon aft diagonal brace primary fuse pin retainer was removed for some unknown reason, at some unknown time, during the "C" check. It was not reinstalled. The secondary retainer was removed in accordance with step 4 of the CITEXT card, but was not reinstalled, as required by step 10 of that card. Specifically, the mechanic was instructed, in part, to: "Reinstall fuse pin secondary retainer at forward and aft lug locations if removed per step 4 above." The Safety Board believes that the failure to reinstall the primary and secondary fuse pin retainers on the pylon of engine No. 1 was the result of a series of errors.

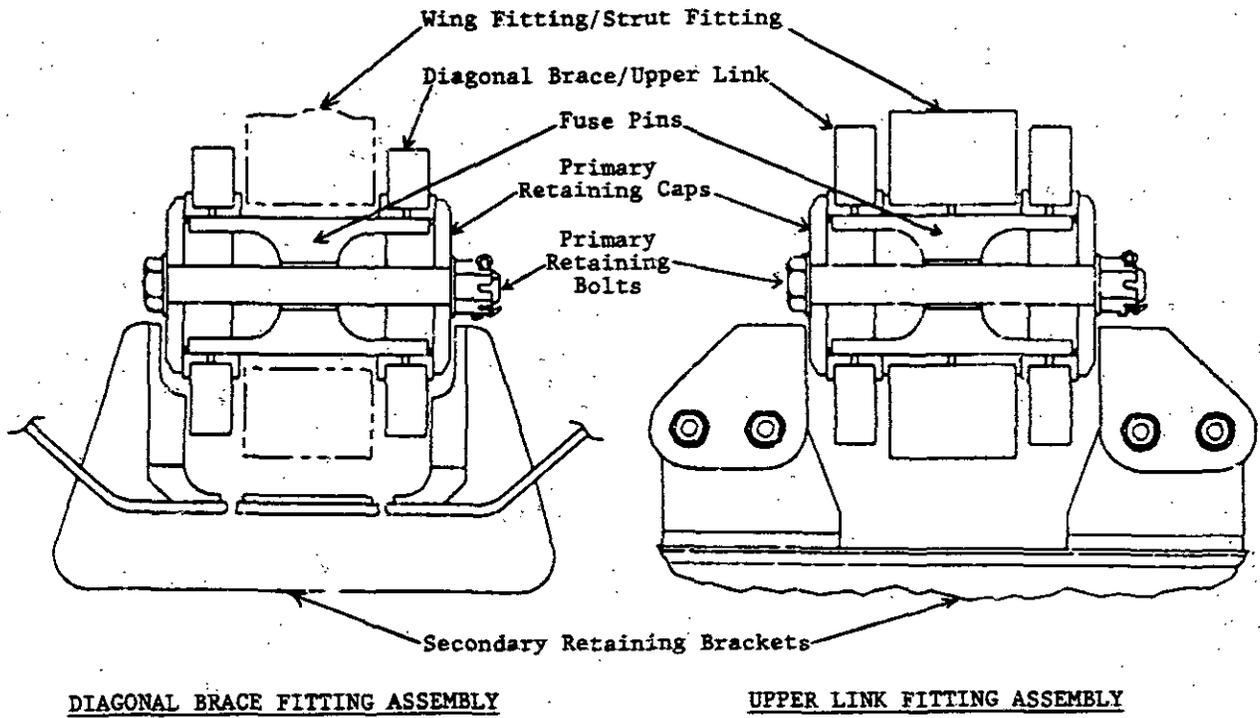
Figure 3.--Diagonal brace and upper link fitting assemblies.

The fractured forward upper link fuse pin from the No. 1 pylon was recovered in three pieces and was retained by the JAAIC for metallurgical examination. Examination of the pin revealed that it fractured in static overload and that there was no evidence of preexisting fatigue.
