# Safety Risks to Emergency Responders from Lithium-Ion Battery Fires in Electric Vehicles

NTSB/SR-20/01  
PB2020-101011

## Safety Risks to Emergency Responders from Lithium-Ion Battery Fires in Electric Vehicles

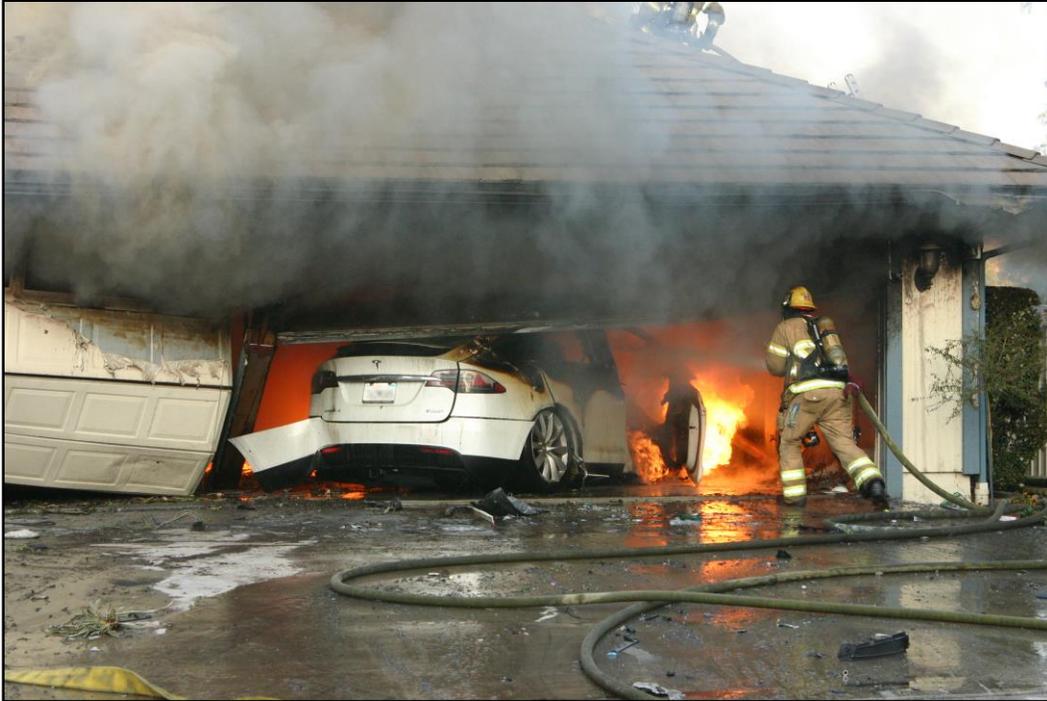
**Figure 2.** Postcrash view of garage showing firefighter directing water onto burning SUV and smoke coming from garage roof. (Source: Orange County Sheriff's Department)

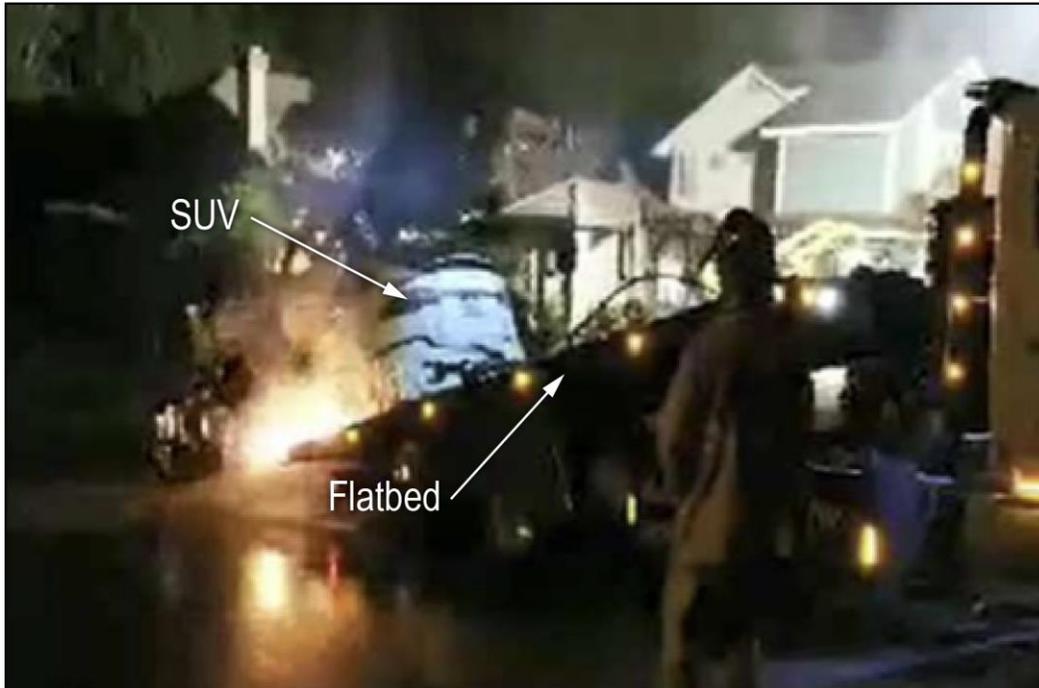
**Figure 3.** Still image from video taken by sheriff's department officer showing SUV reloaded on flatbed of tow truck. (Source: Orange County Sheriff's Department)

The battery reignited for a few seconds while the SUV was being unloaded at the tow yard. Although the vehicle emitted smoke, it did not catch fire, and the tow driver did not call for an emergency response.<sup>34</sup> The SUV was positioned at the tow yard as far from other vehicles or buildings as possible—about 40 feet from other vehicles on two sides, about 20 feet from other vehicles on the third side, and about 10 feet from a concrete wall on the fourth side. According to the towing log, the job was completed at 1:15 a.m.

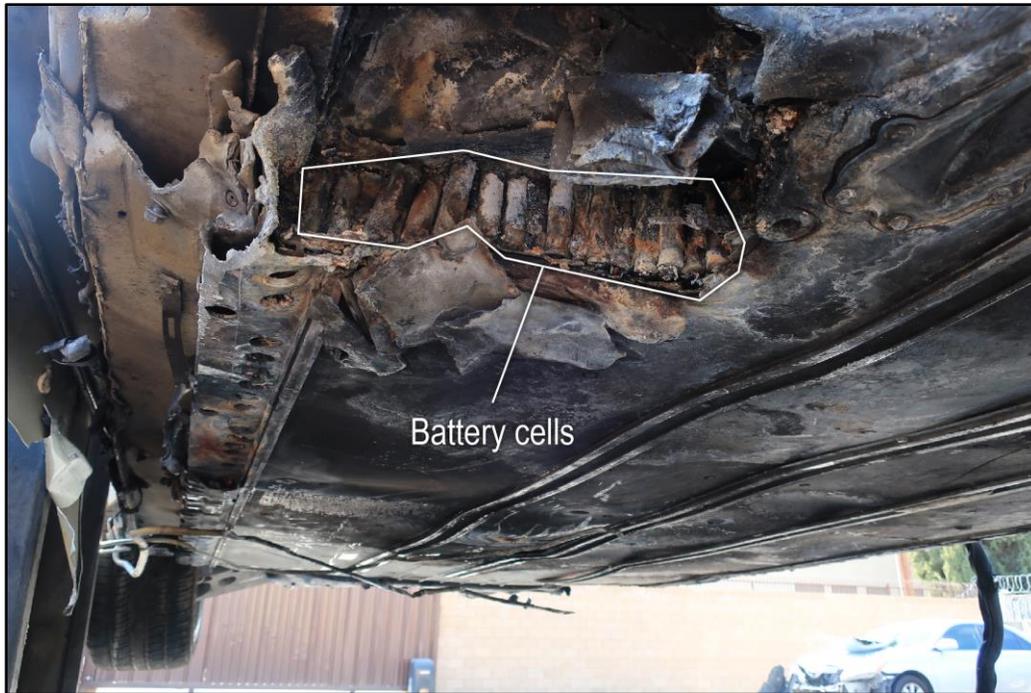
**Figure 4.** View from below and toward rear of SUV's underside showing ruptured right front corner of battery case and highlighting individual battery cells uncovered by rupture. Right rear wheel is visible in background.

The SUV's lithium-ion battery contained 16 modules (figure 5).<sup>35</sup> The rupture exposed parts of modules 13 and 15 at the right front corner, in line with where the right front wheel, brake disk, and other components had been displaced, most likely in the SUV's collision with the drainage culvert. Modules 11 and 9, directly behind module 13, were damaged. Battery cells from modules 13 and 15 had been dislodged or displaced, and individual cells were found on the street, in the driveway, and in the drainage ditch.<sup>36</sup>

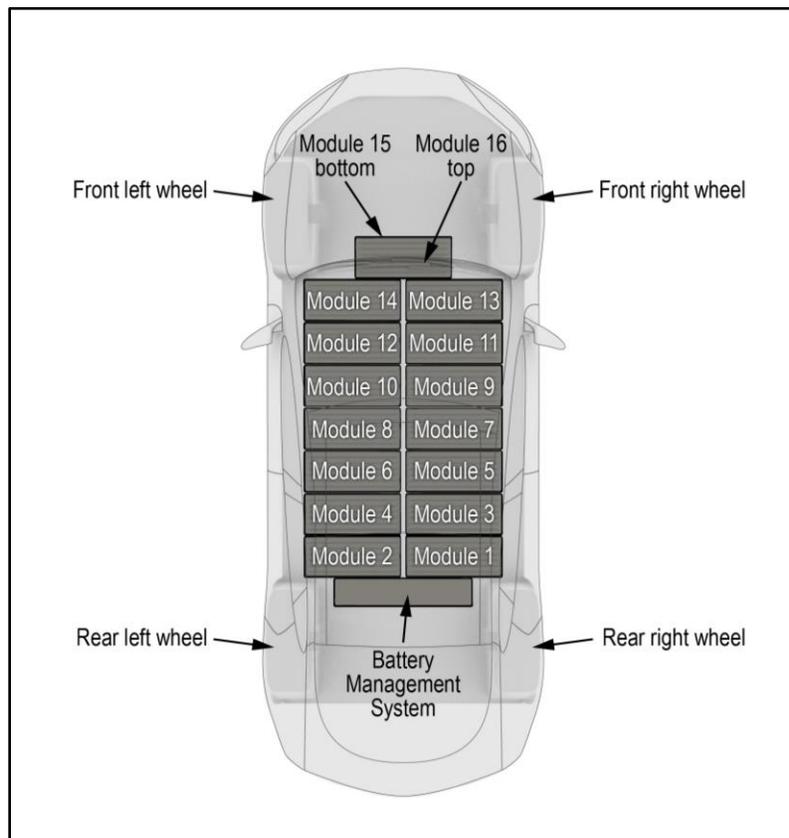
**Figure 5.** Arrangement of SUV's lithium-ion battery modules.

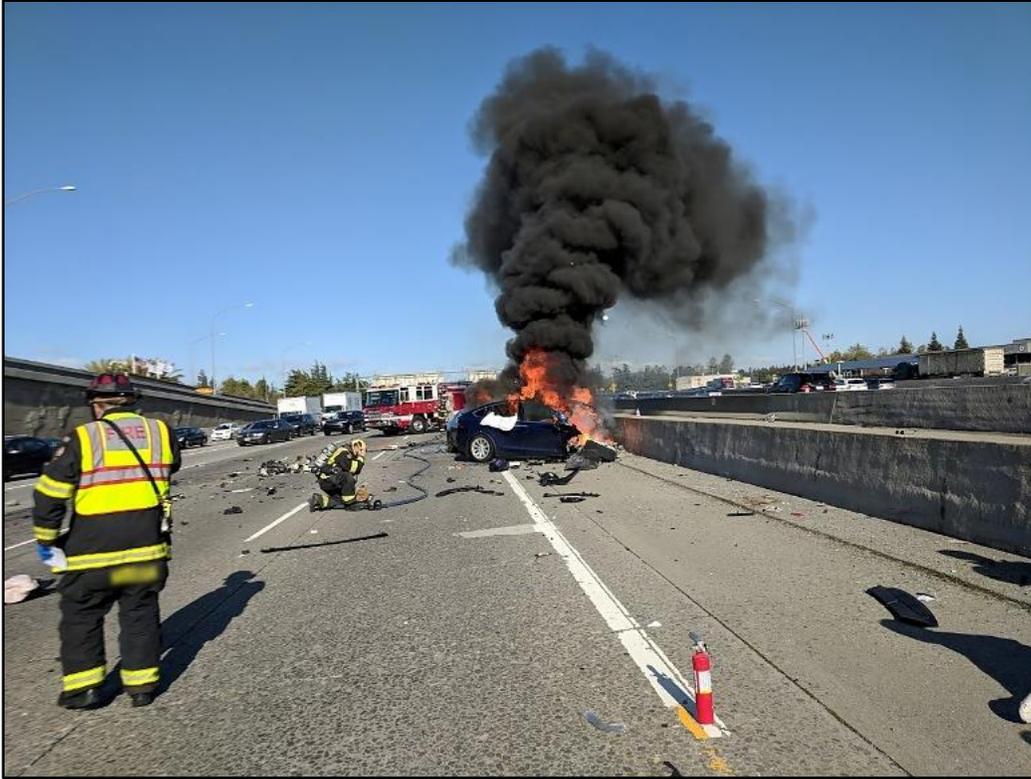
**Figure 6.** Burning SUV on northbound US-101 postcrash. (Source: witness S. Engleman)

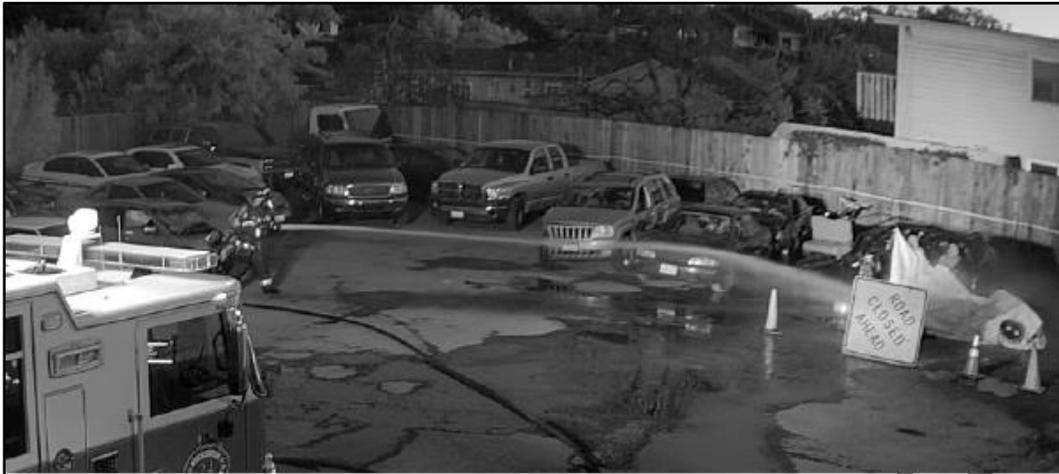
According to the San Mateo Fire Department's dispatch log, firefighters arrived at 7:09 p.m. and reported flames 8 to 12 inches high coming from the right front side of the SUV. Firefighters suppressed the fire using water and foam. A security camera recorded a firefighter applying water and foam onto the SUV, which was still partly covered by the tarp and a road sign that had been used to anchor the tarp (figure 7).

**Figure 7.** Image from security video at impound yard showing firefighter pouring water onto SUV at right, partly covered by tarp and road sign; fire engine is visible on left. (Source: Atlas Towing)

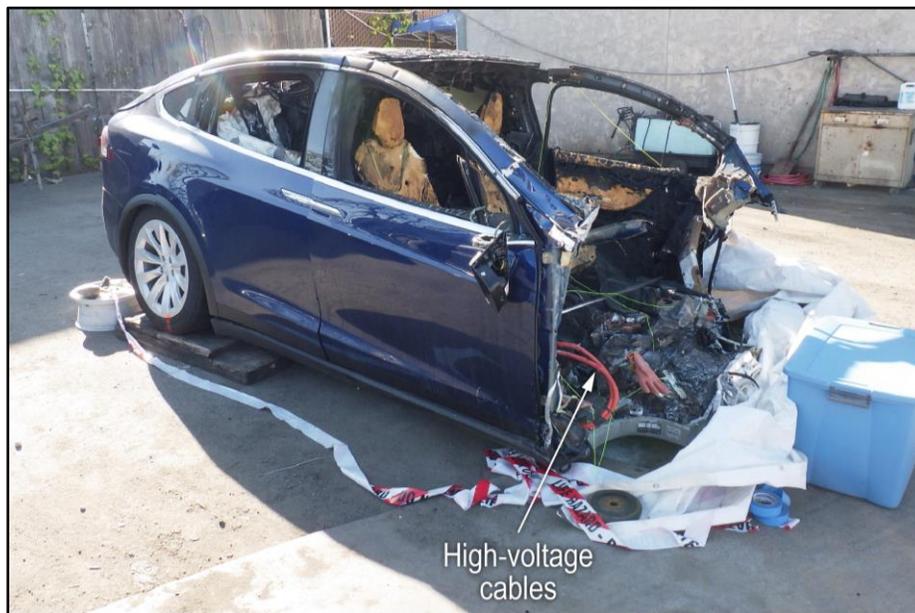
The front of the SUV was extensively damaged. The high-voltage cut loop, normally located at the base of the windshield, was missing, as was the entire front electric motor and other components.<sup>46</sup> The orange cables that led to the motor and other high-voltage connection points were exposed (figure 8). Attempts to measure the voltage were inconclusive, and any exposed terminals, as well as damaged battery components, were assumed to pose a high-voltage risk.

**Figure 8.** Damaged SUV with exposed orange high-voltage cables forward of front seat.

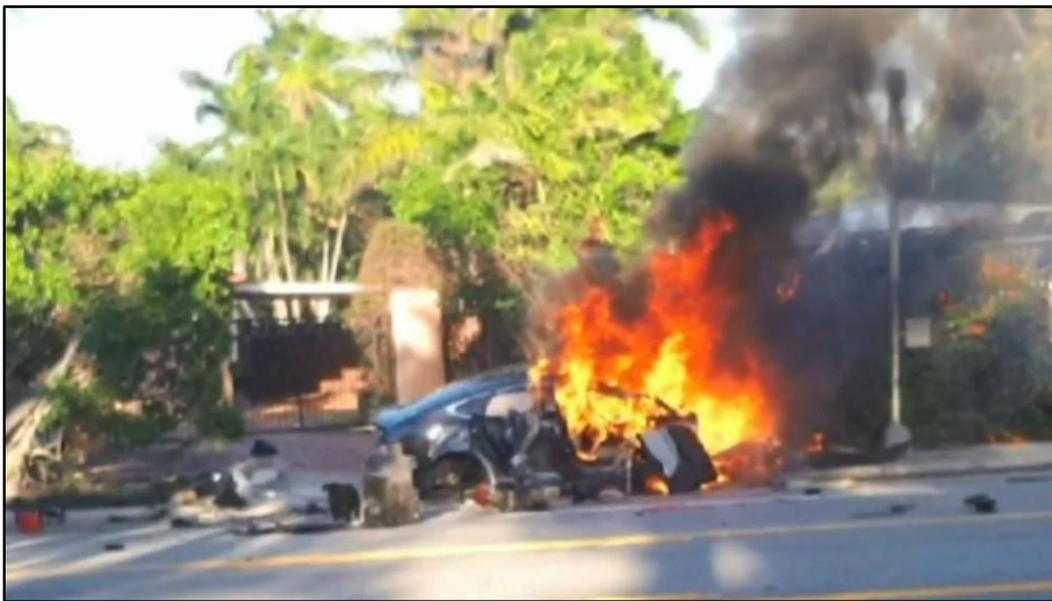
**Figure 9.** Car burning next to residential driveway postcrash. (Source: CBS4 Miami)

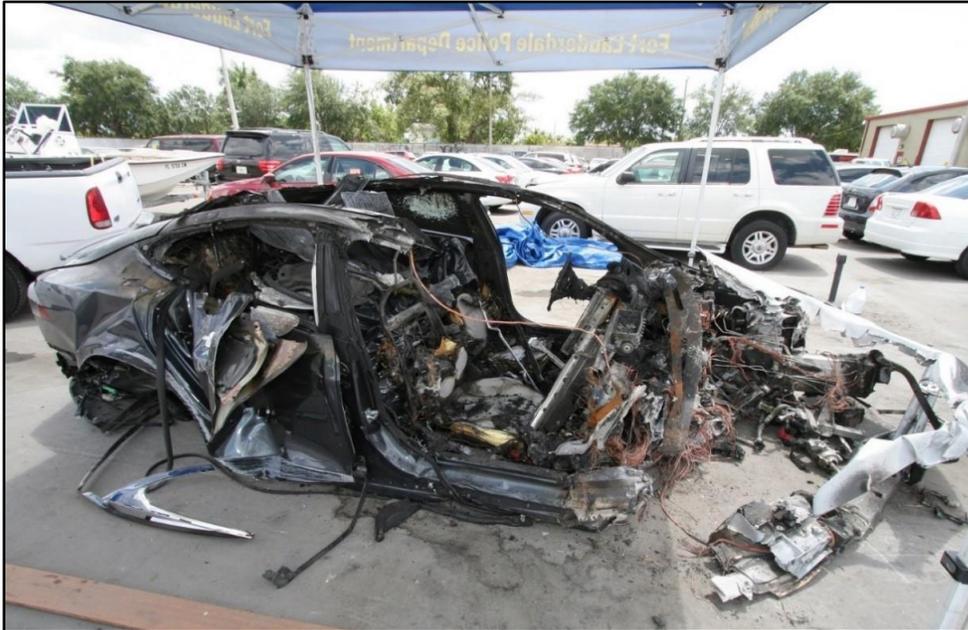
On June 7, 2018, the NTSB met at the tow yard with representatives of the Fort Lauderdale Police Department and Florida Highway Patrol to inspect the vehicle (figure 10) and the debris piles. The items wrapped in the tarp were removed and placed near the vehicle. Individual loose battery cells were found in the tarp, as well as the right front tire and small debris. Large items, including the left front door, front electric motor, right front wheel assembly, and damaged battery modules that had separated from the vehicle (determined to be modules 15 and 16), were found on top of the battery case in the second debris pile (figure 11).

**Figure 10.** Car parked at tow yard showing severe crash and fire damage.

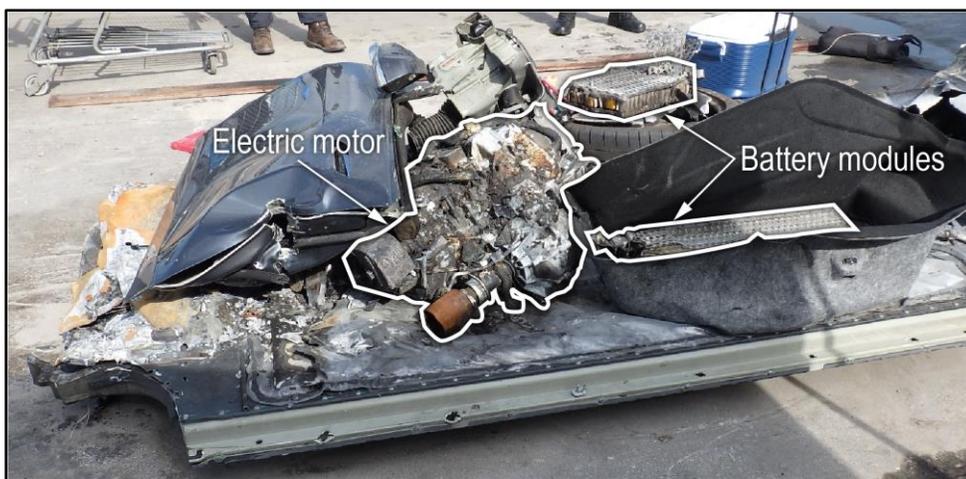
**Figure 11.** Debris pile on pallet with remains of electric motor and battery modules highlighted.

The high-voltage cut loop was found attached to the front electric motor and had not been cut. Firefighters told investigators that the cut loop was inaccessible during the fire response. Review of the cut loop, emergency response guidance, and exemplar vehicles revealed a minor inconsistency in the cut loop instructions, such that in some vehicles, the cut loop label might be obscured from view under a trim panel. This vehicle model, manufactured after June 2013, also had a cut loop at the left rear door frame, in case the front cut loop was not accessible. Reaching the rear cut loop required penetrating the door frame with a circular saw at a depth indicated by a label at the location of the cut loop. The label was found to have been attached incorrectly to the vehicle's right rear door, where no cut loop was installed. Firefighters had not attempted to use the rear cut loop.

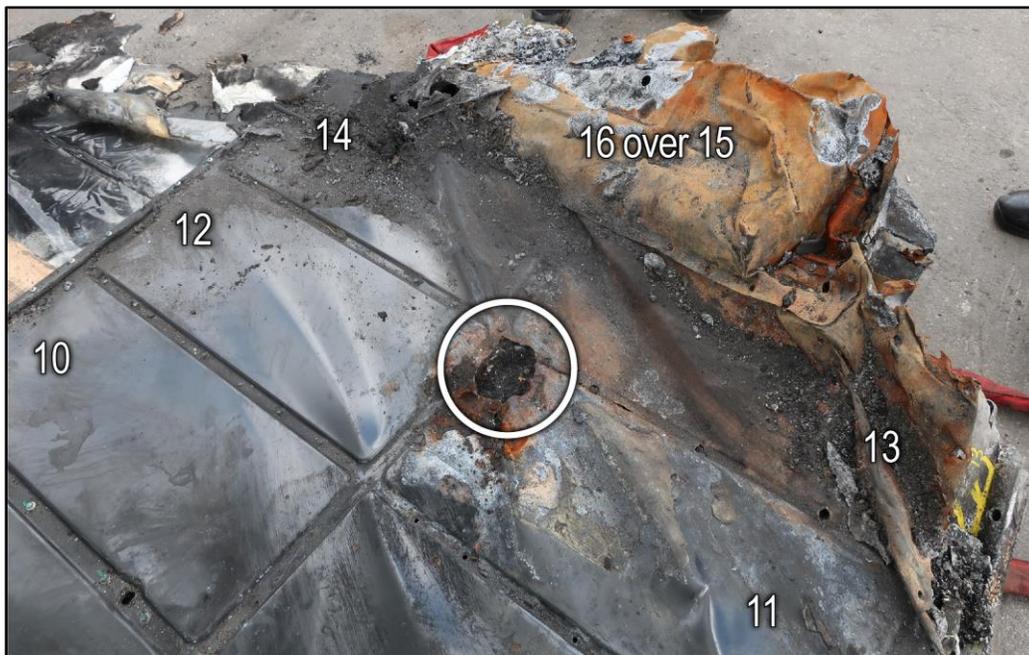
The battery case was severely damaged and ruptured along the entire length of the front surface and extending into the area of modules 13 and 14, which were mounted just behind modules 15 and 16 (figure 12).<sup>52</sup> Two irregular holes had melted through the battery case, ranging from 3 to 5 inches in diameter. One was on the top of the battery case and would have been between the front seats in the intact vehicle. The other was on the bottom of the case and corresponded to a hole through the floor of the vehicle in roughly the same location. The photograph in figure 12 shows the steel cover on the top of the battery case. The location corresponds to the intersection of four battery modules (Nos. 11, 12, 13, and 14) and is the location of high-voltage connection points. The battery case was significantly warped and deformed in this area.

**Figure 12.** Top surface of forward part of battery case showing damage to front and hole melted through steel cover (circled), with modules numbered.

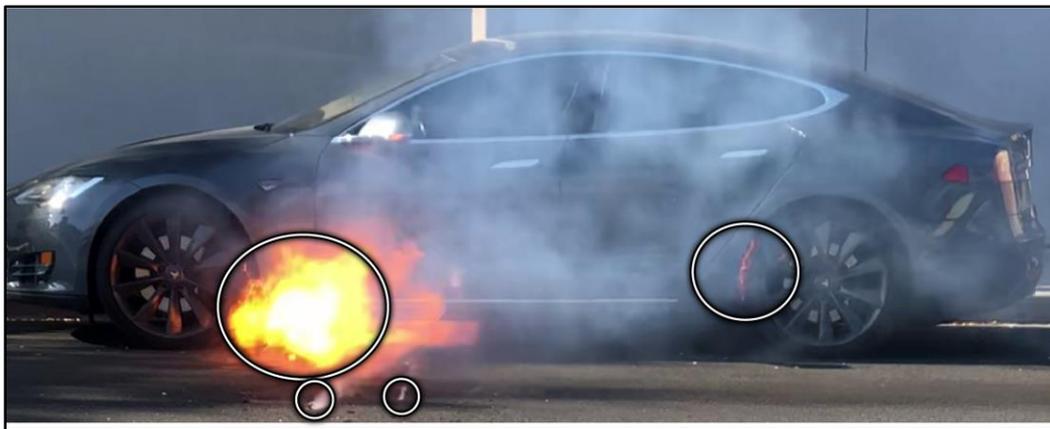
Two people captured videos of the event—a bystander and the driver. Video taken by the bystander captured the left side of the car. Figure 13 is a still image taken from the bystander's video showing fires behind the left front wheel and in the left rear wheel well (large circles), as well as pieces of material ejected from the vehicle (small circles). The image was taken 26 seconds from the start of the bystander's recording and occurred within 2 minutes of the start of the incident.

**Figure 13.** Image from bystander's video with fire visible behind left front wheel and in left rear wheel well. (Source: Los Angeles County Sheriff's Department)

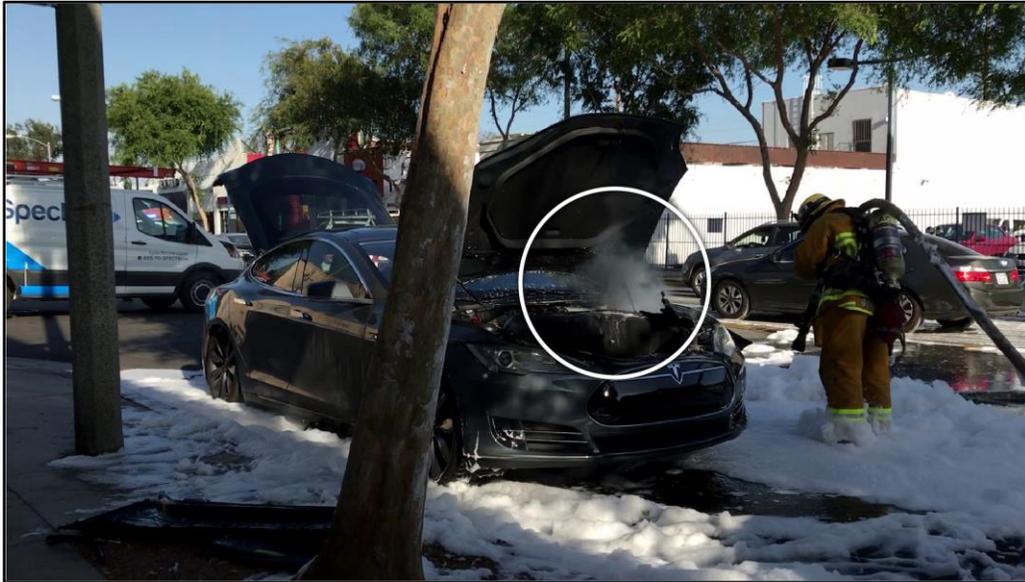
**Figure 14.** Image from driver's video showing car after flames were extinguished but with smoke still rising (circled). (Source: car's driver)

The fire captain told NTSB investigators in a postincident interview that the flames were extinguished quickly, but that smoke continued to come from the vehicle. He was surprised that the vehicle continued to emit smoke and said that firefighters applied water for longer (about 30 minutes) than he would have expected for such an event. He estimated that firefighters used 300 gallons of water and foam and said that they did not connect to a hydrant.

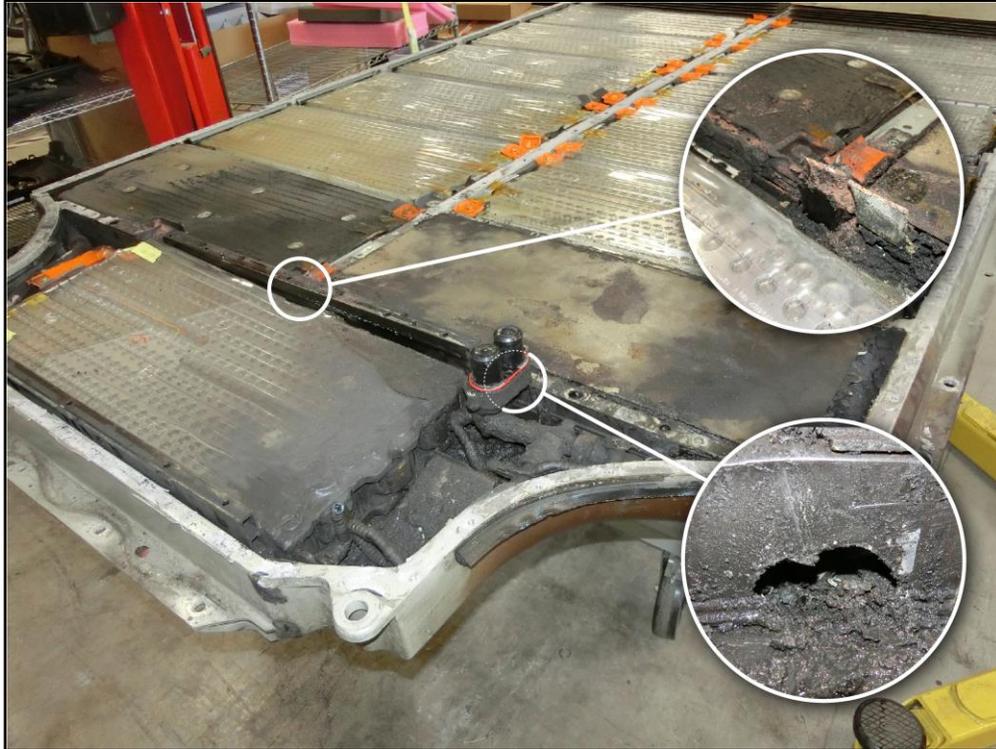
**Figure 15.** Battery pack with top cover removed to show location of holes in battery case and insets showing closeups of damaged areas.

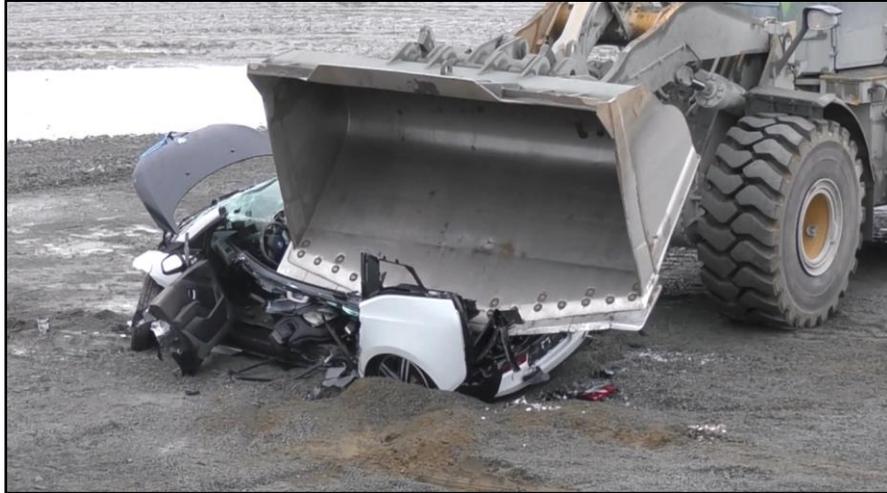
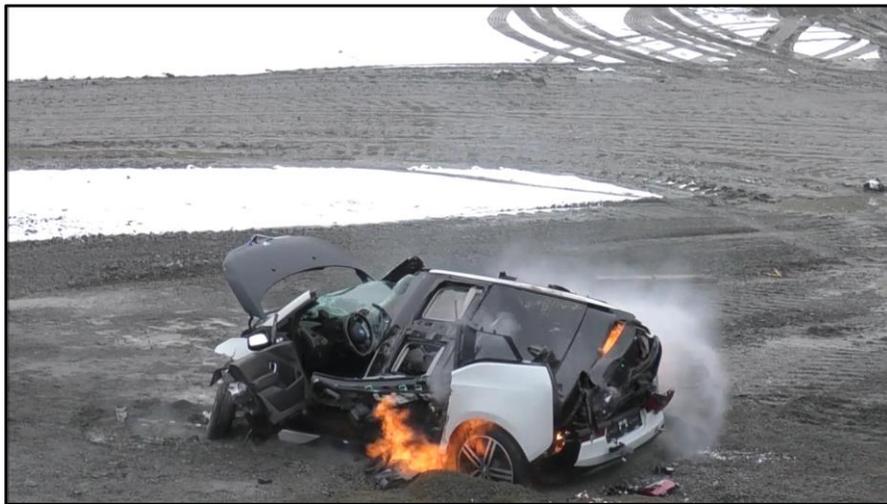
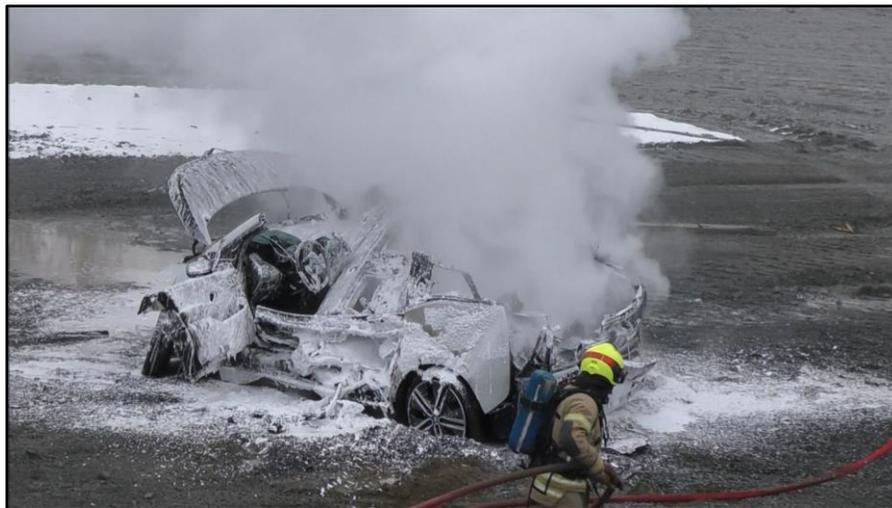
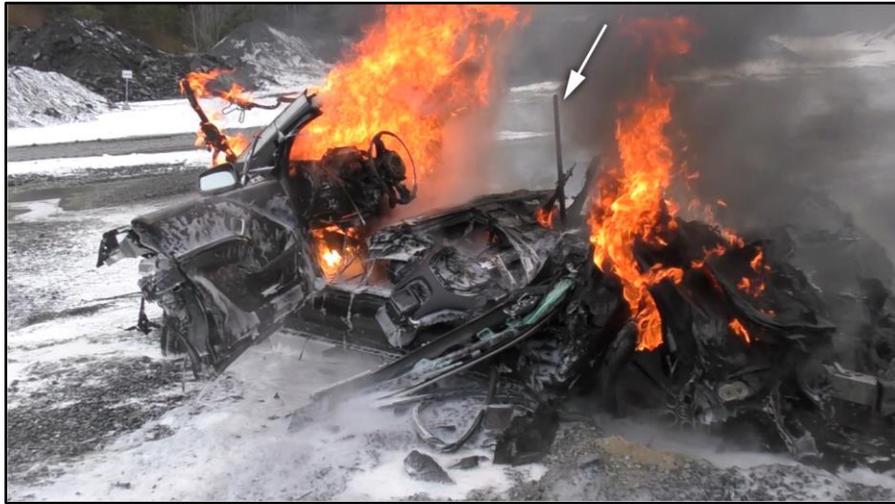
**Figure 16.** Series of images showing (a) attempt to trigger short circuit by crushing car with bulldozer; (b) flames erupting 8 minutes after piercing car with metal rod; (c) flames no longer visible, but battery continuing in thermal runaway; and (d) fire burning itself out, with arrow pointing to metal rod. (Source: NFRD video)

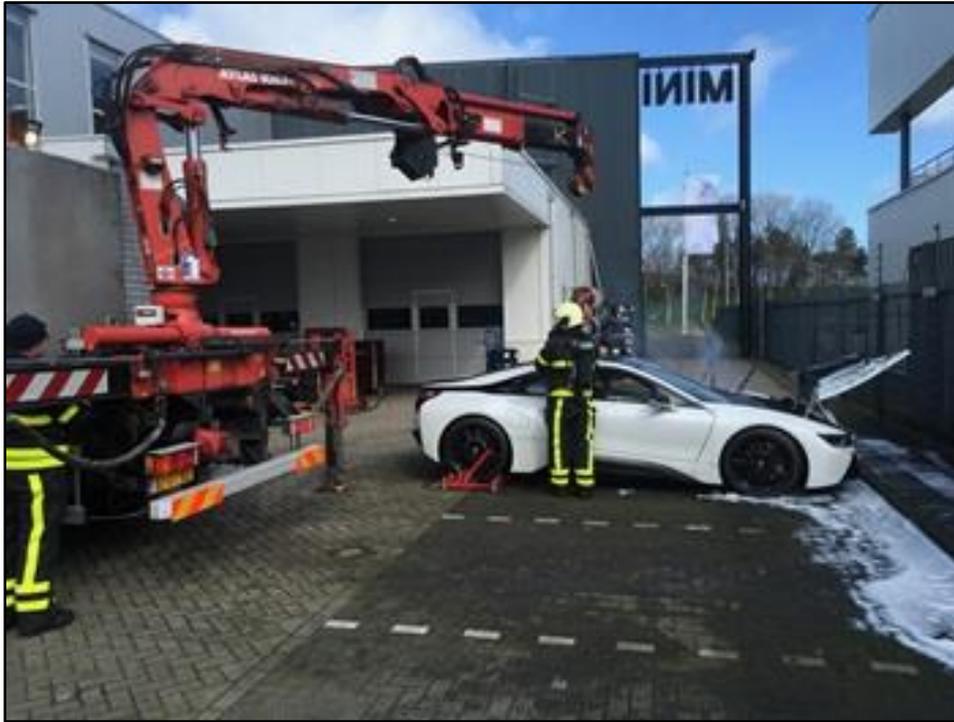
On March 25, 2019, in Tilburg, the Netherlands, firefighters dropped a BMW model i8 coupe into a water bath after the car began smoking while on display at a dealership (see figures 17 and 18).<sup>64</sup> The car was kept in the water for 24 hours. As the Central and West Brabant Fire Brigade explained in a message on its Facebook page, “Extinguishing an electric car requires a lot of water for a longer period of time, partly because the battery packs are difficult to reach and the fire flares up again cell after cell.”<sup>65</sup>

**Figure 17.** BMW after firefighters attempted to extinguish fire, with crane positioned above and faint plume of smoke visible above car's windshield. (Source: Central and West Brabant Fire Brigade)

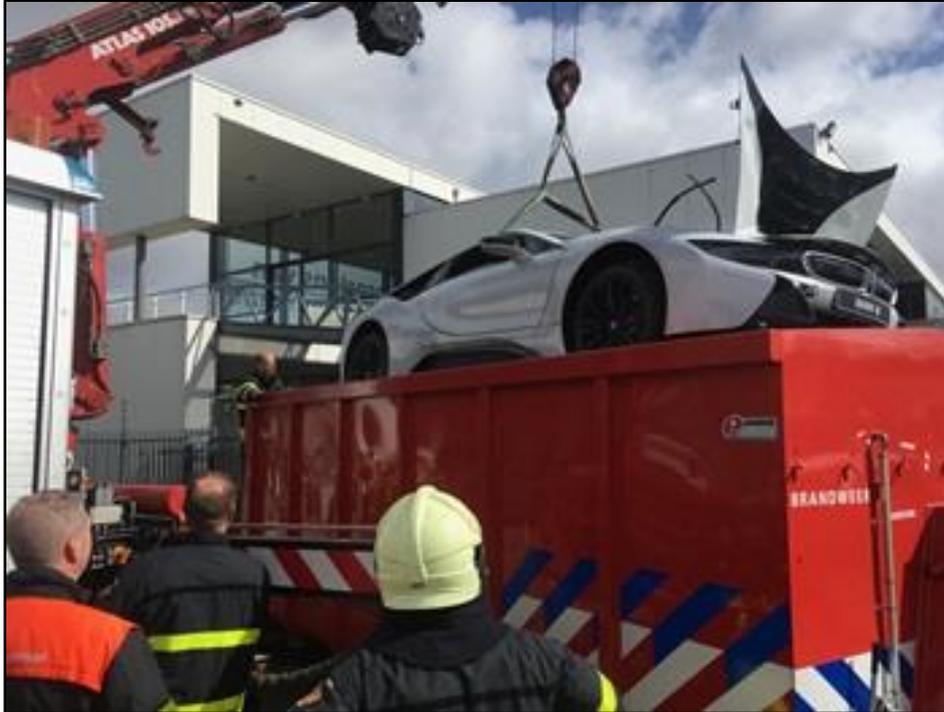
**Figure 18.** BMW being loaded into tank filled with water. (Source: Central and West Brabant Fire Brigade)
