**Special Investigation Report: Design-Induced  
Landing Gear Retraction Accidents in Beech  
Baron, Bonanza, and Other Light Aircraft**

## **SPECIAL INVESTIGATION REPORT**

**DESIGN-INDUCED LANDING GEAR  
RETRACTION ACCIDENTS IN  
BEECHCRAFT BARON, BONANZA, AND  
OTHER LIGHT AIRCRAFT**

**NTSB-SR-80-1**

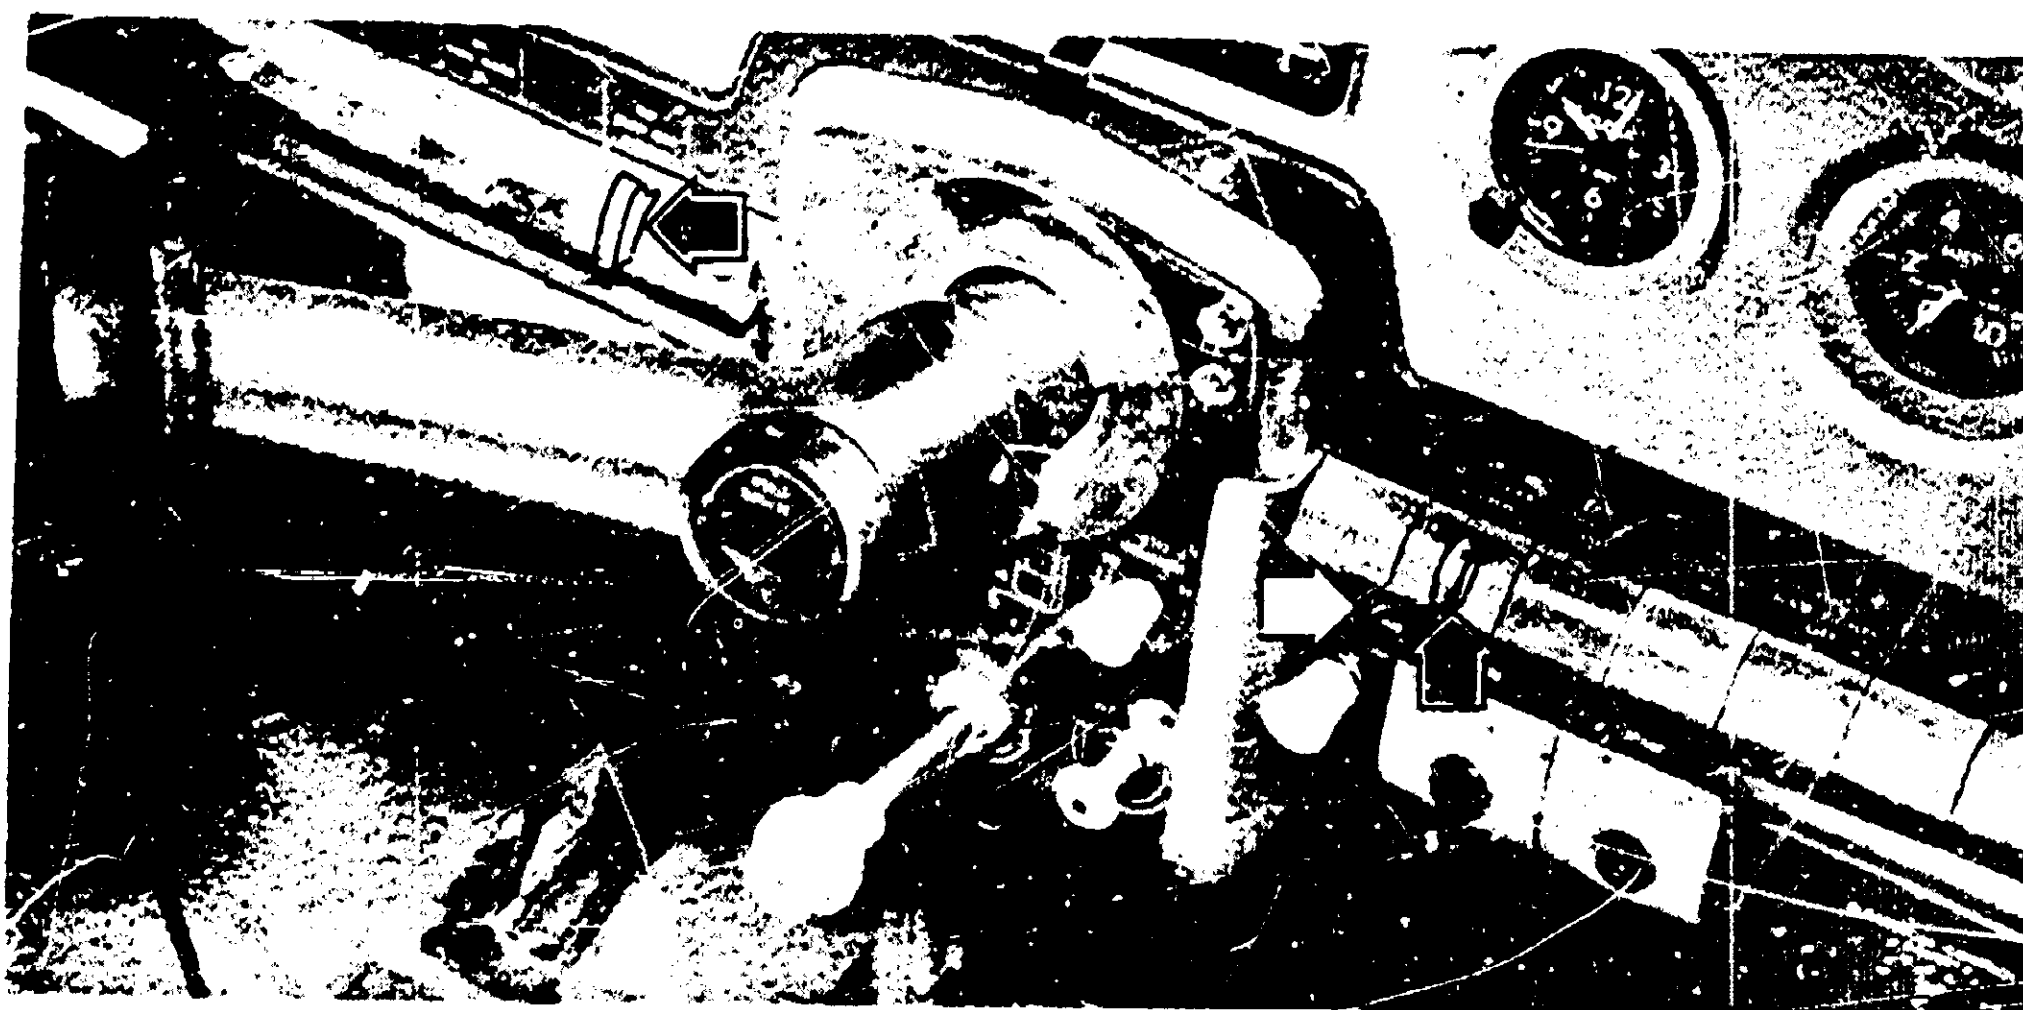
Figure 4.—Bonanza (circa 1955) with tab-type switches incorporating small protrusions on flap control and landing gear control on left and right, respectively. (See black arrows.) The safety latch for the landing gear switch is indicated by the white arrow.

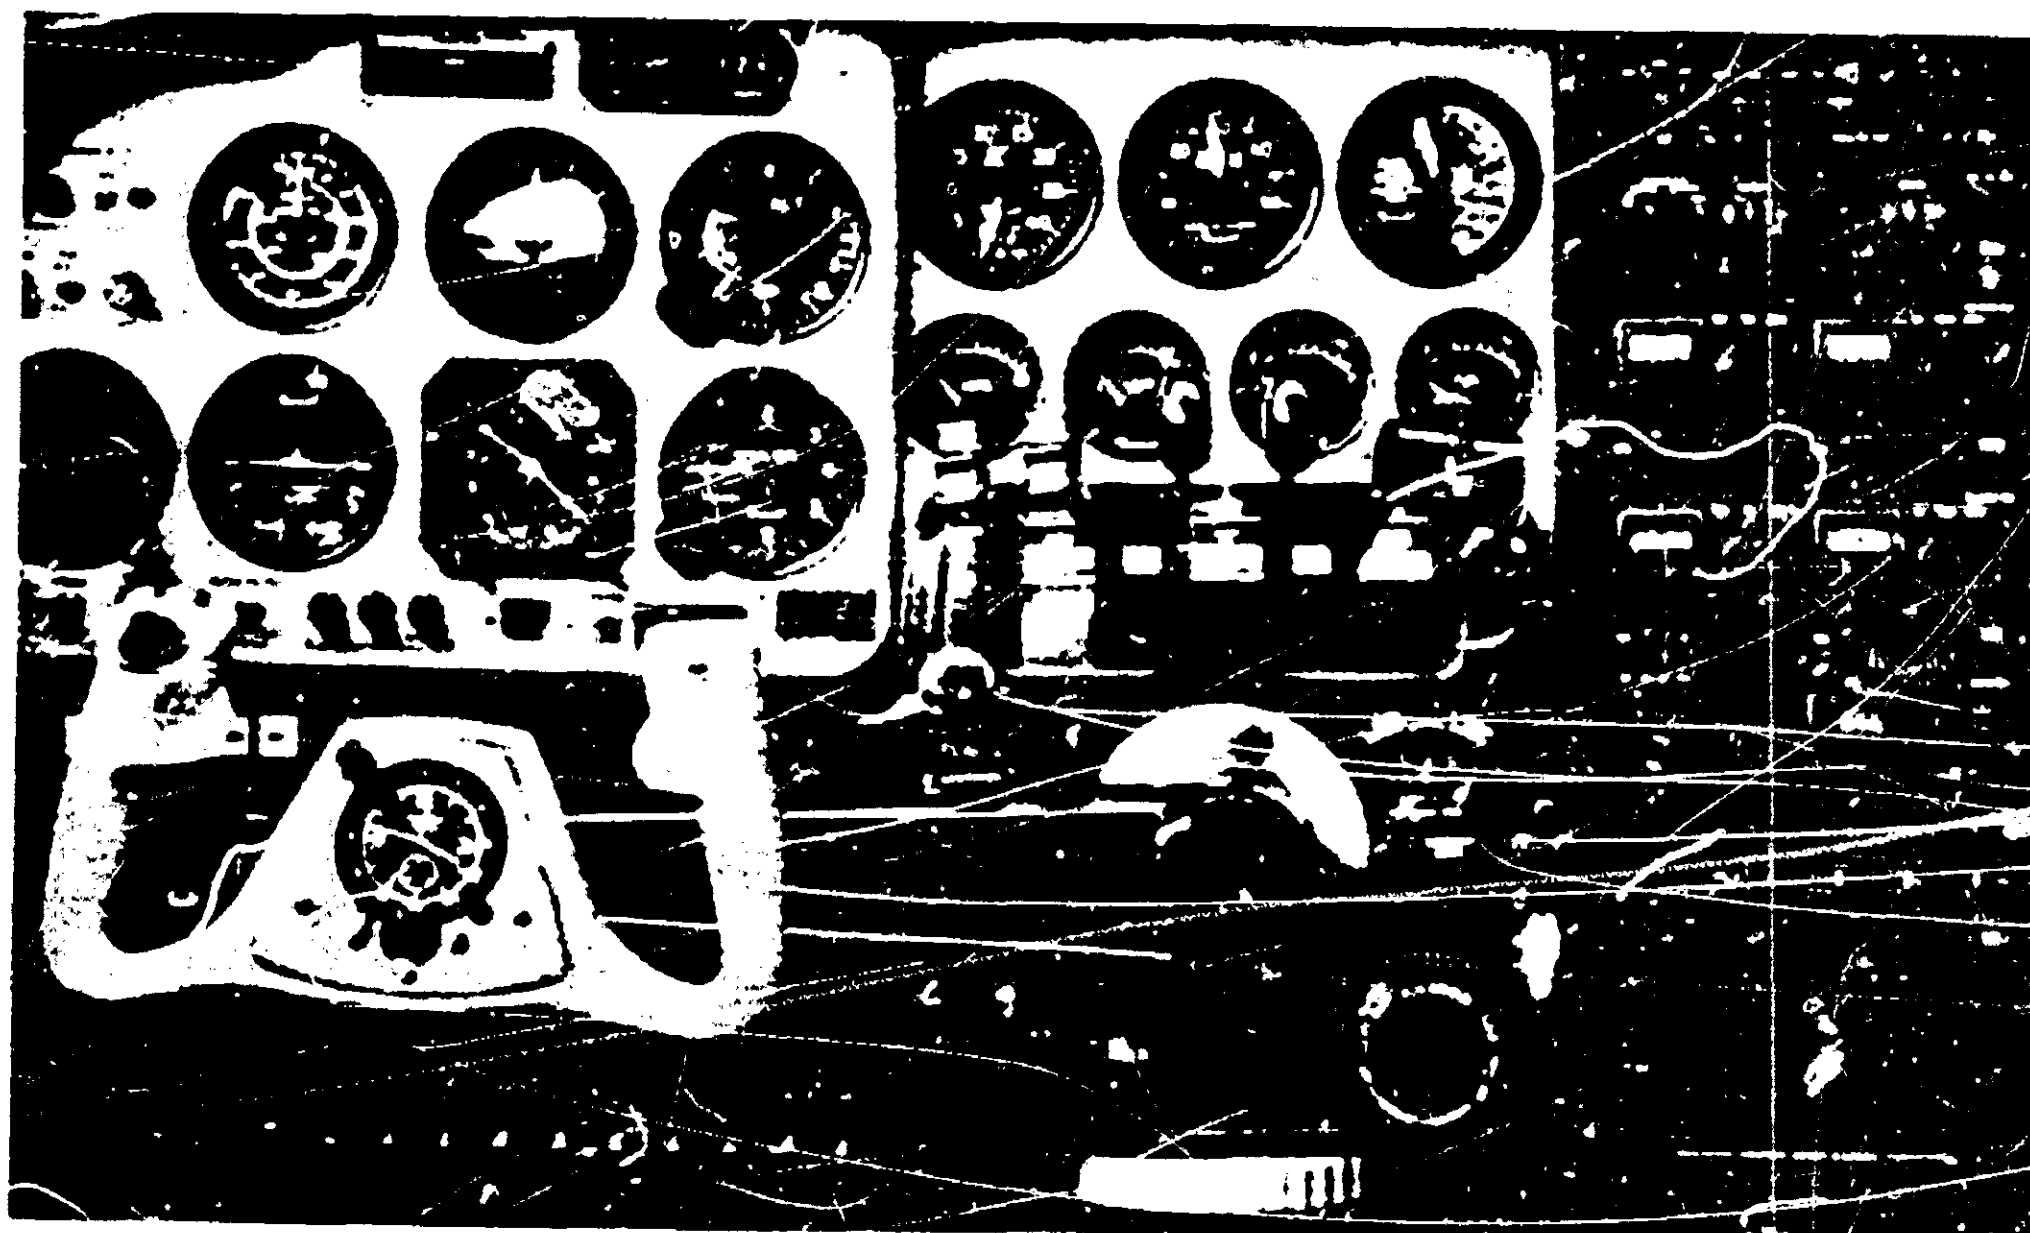
Figure 5.—Single control wheel mounted on a "throw-over" bar (late model Baron).

Obscuration of Controls.--The problem of inadvertent gear retraction on the Bonanza and Baron aircraft is compounded further by a design feature of the flight control system which is unique to these two aircraft. The system utilizes a large horizontal cross-bar on which the control wheel (or wheels) is mounted. The two versions of this control system are (1) the single control wheel with a "throw-over" mechanism which allows the wheel to be placed in front of either the left or the right front seat (see figure 5), and (2) the dual control model where wheels are available to both seats (see figure 6).

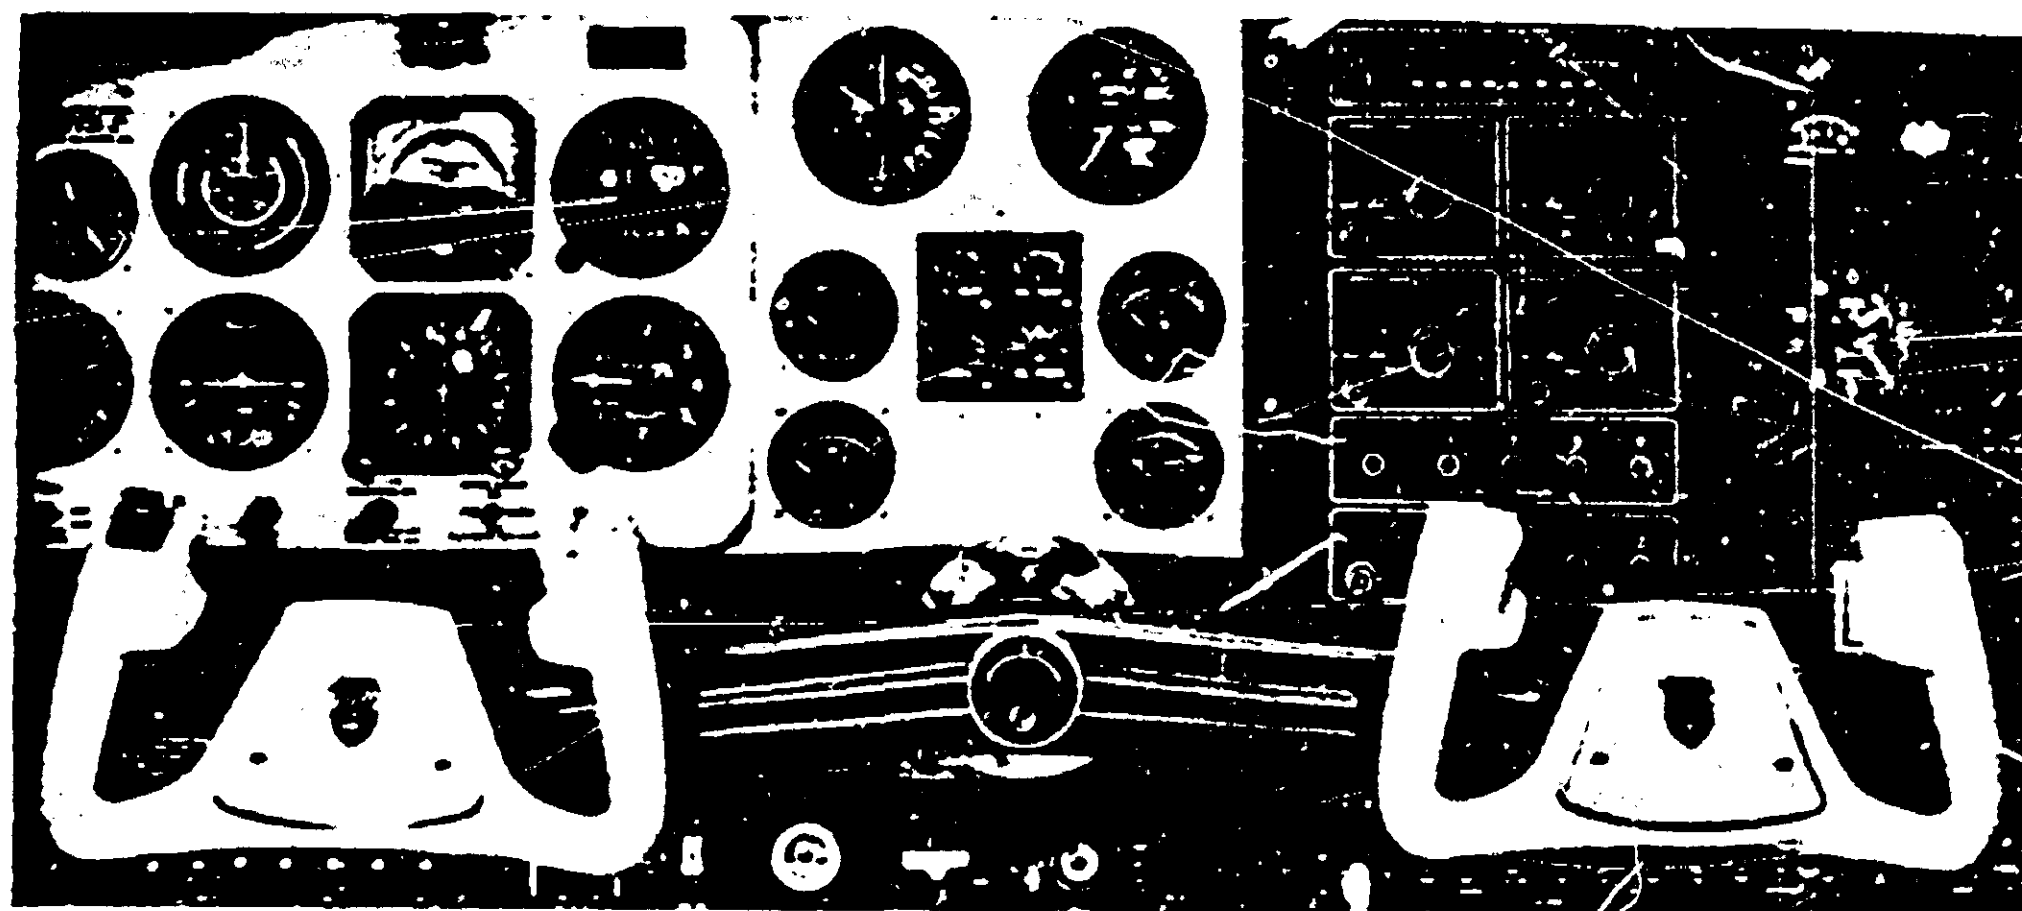
Figure 6.—Dual control wheels on bar (late model Bonanza).
