# NATIONAL TRANSPORTATION SAFETY BOARD

## SAFETY REPORT

GENERAL AVIATION CRASHWORTHINESS  
PROJECT: PHASE III - -  
ACCELERATION LOADS AND  
VELOCITY CHANGES OF SURVIVABLE  
GENERAL AVIATION ACCIDENTS

NTSB/SR-85/02

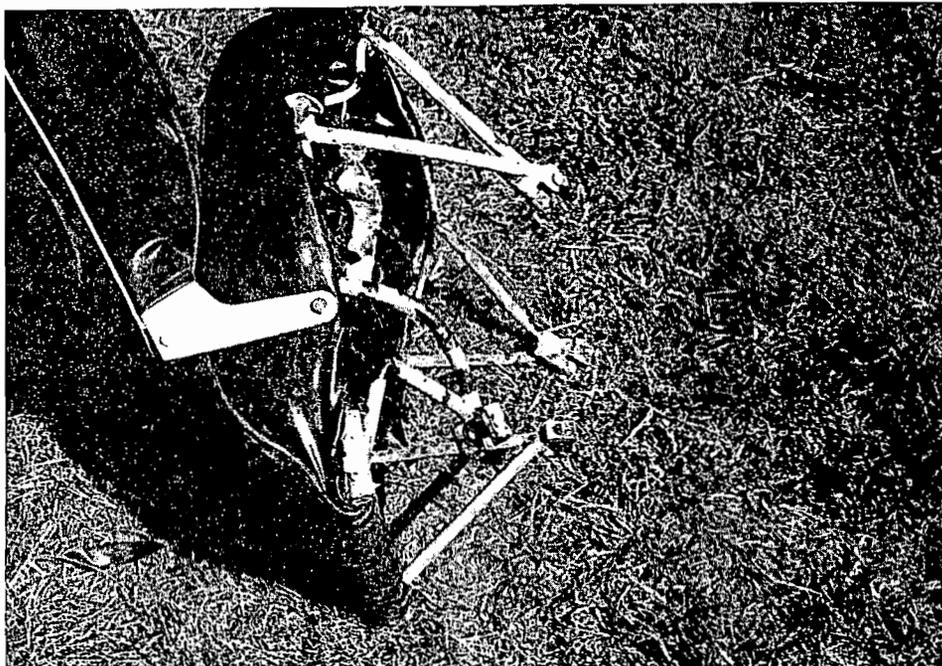
Case 13 is an example of inadequate seat frame strength. There were no braces between the front and aft legs of the seat and since the front legs had adjustment pins in the tracks, they resisted all of the forward loads exerted on the seat during the crash. As the seat was forced to move forward, the frame bent allowing the rear legs to move closer to the front legs (photograph 1). When the frame broke, the rear legs were free to move forward on the tracks until they contacted the front legs. During this process, the rear of the seat rotated down accelerating the occupant toward the floor.

Photograph 1.--Pilot's seat with buckled seat frame due to lack of support bar between the front and rear legs.

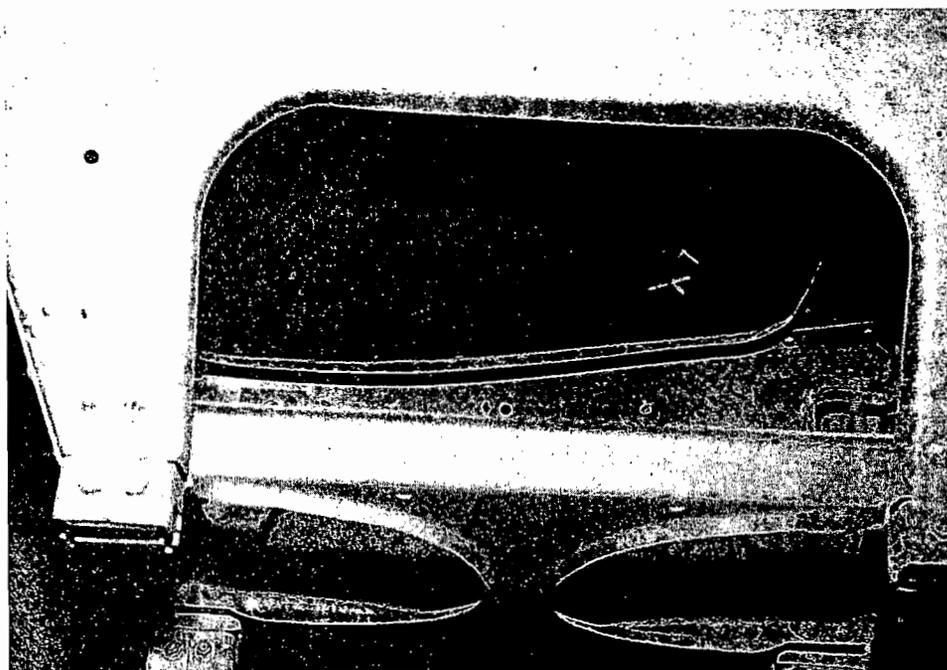
Many of the seats separate because of small side loads to the seat coupled with the warping of the floor and seat tracks. Seat separations because of side loads are directly related to low side load test requirements. The side load requirement of 1.5 G's is totally inadequate. With a misalignment of only 10 degrees, a 9 G forward acceleration can create a side load of 1.5 G to the seat feet. Small side loads can result in seat separation because the seat feet spread (cases 1, 9, 12, 18, 25, and 27). To combat this problem, several manufacturers have added extra structure to the seat foot area (cases 20 and 23). Beech Aircraft has designed an extra bracket (photograph 2) for the seat feet in their Model 23 series of airplanes, and Piper Aircraft has recommended adding two large washers to each seat foot in many of the PA-28 series of its airplanes (photograph 3).

Photograph 2.--Extra bracket added to strengthen the seat feet.

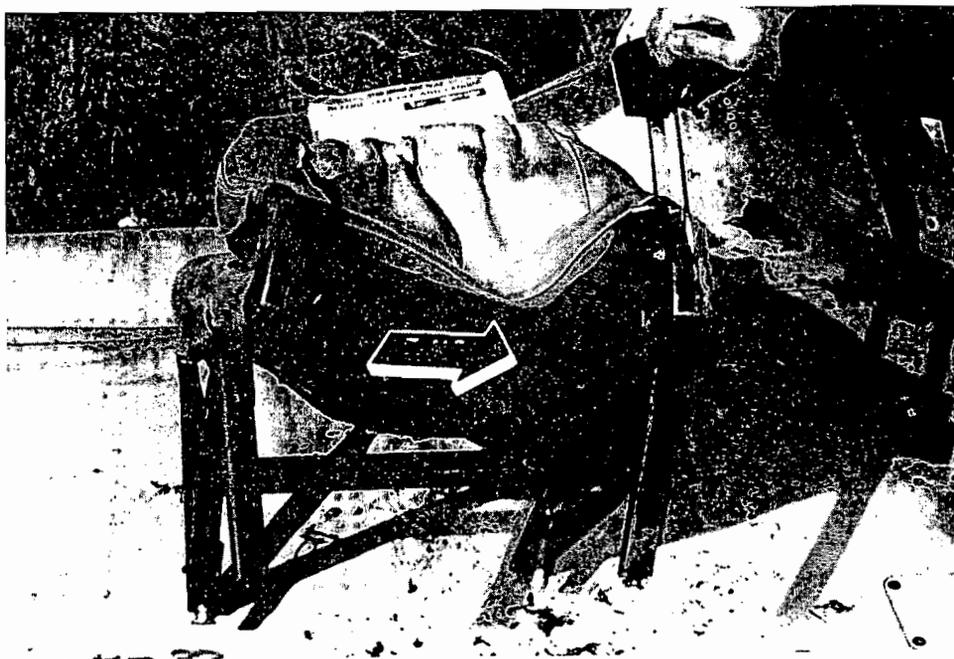
Photograph 6.--Seat hit from behind by another occupant and it separated.

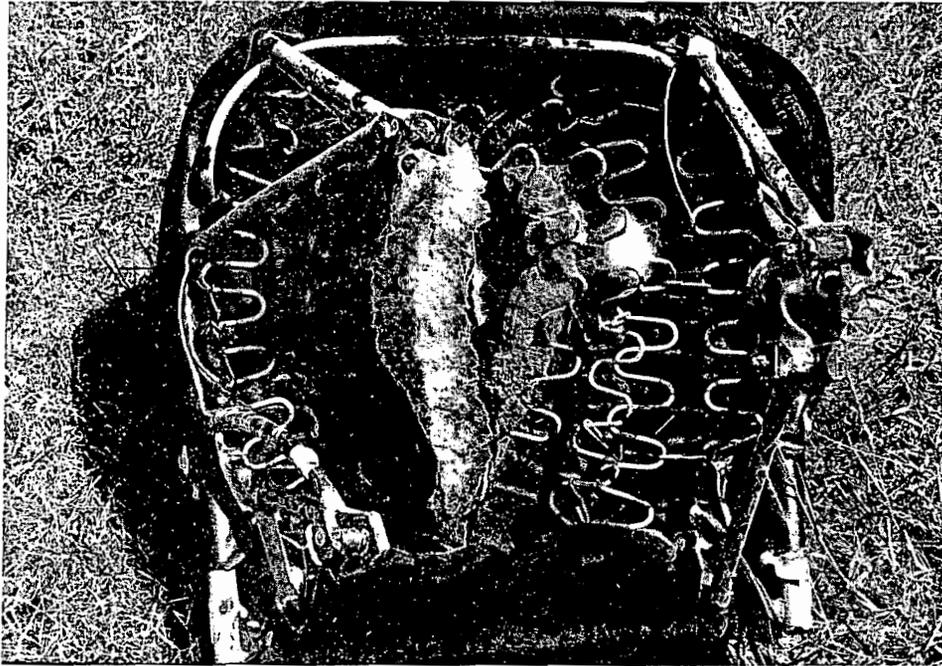
Photograph 9.--Split springs.

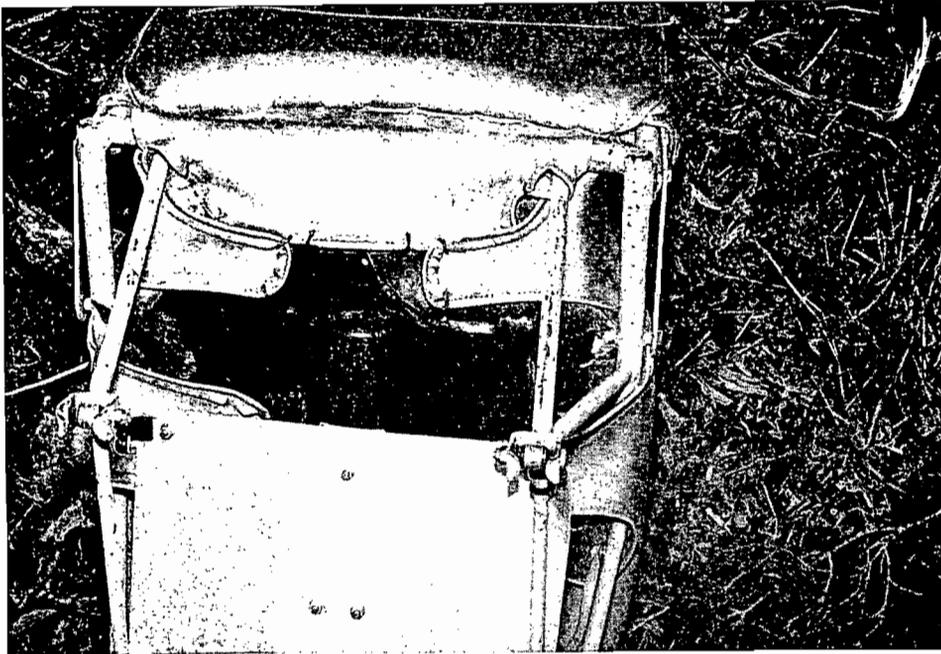
The seatpans in Case 4 presented another problem. The pans were made from a neoprene material that had deteriorated with age. (See photograph 12.) Although the crash generated relatively minor loads in the vertical direction, the seatpans had separated at the steel fittings and were held in place only by the foam rubber comfort cushions.

Photograph 12.--Split seatpan and add-on equipment.

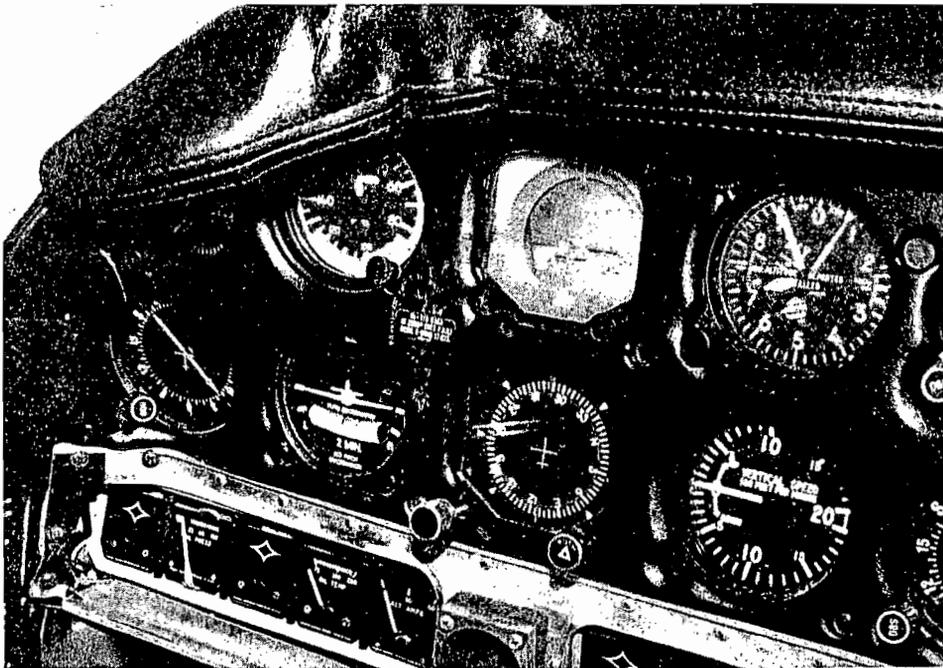
1-2 Pilot's head contact area.

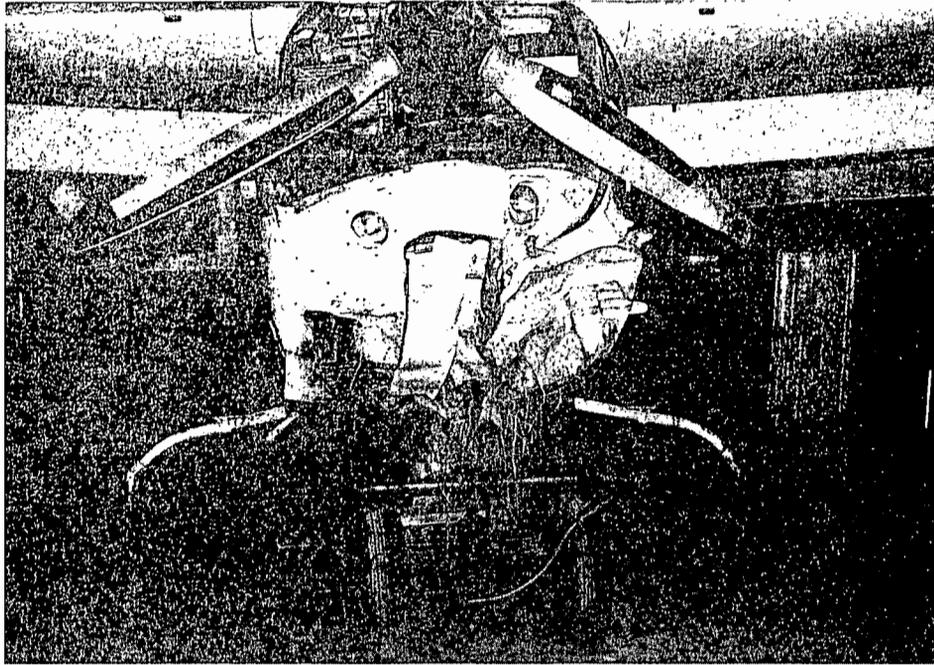
6-5. Crushing damage.

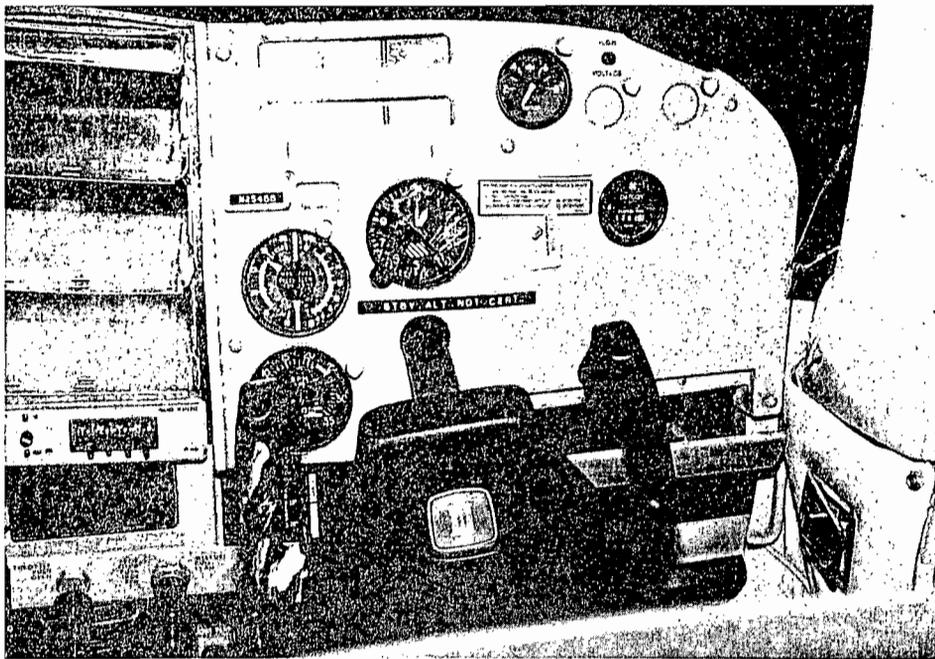
6-6. Head strike area of passenger.

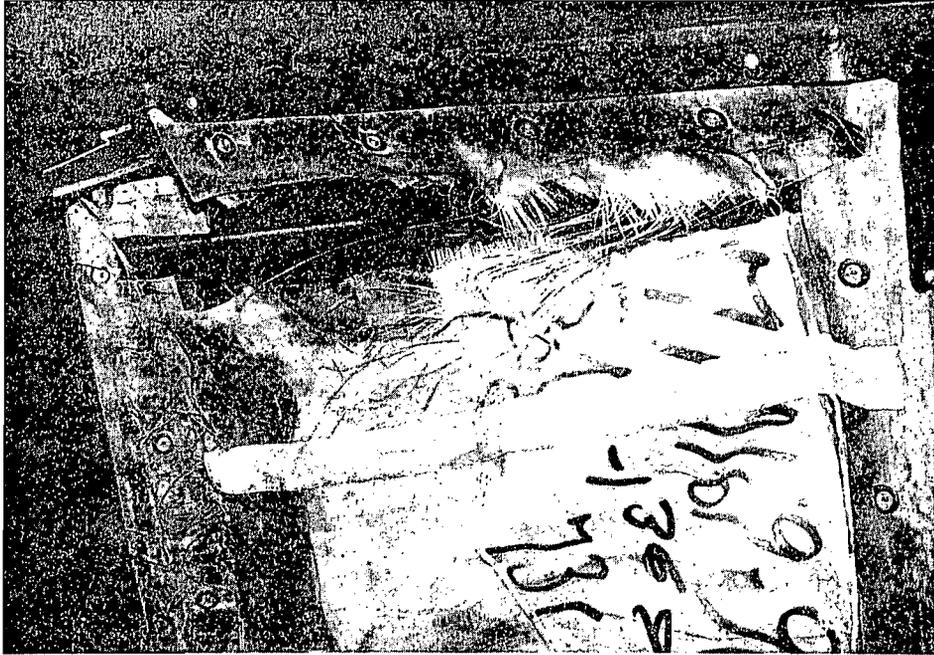
8-6. Pilot's seat as found.

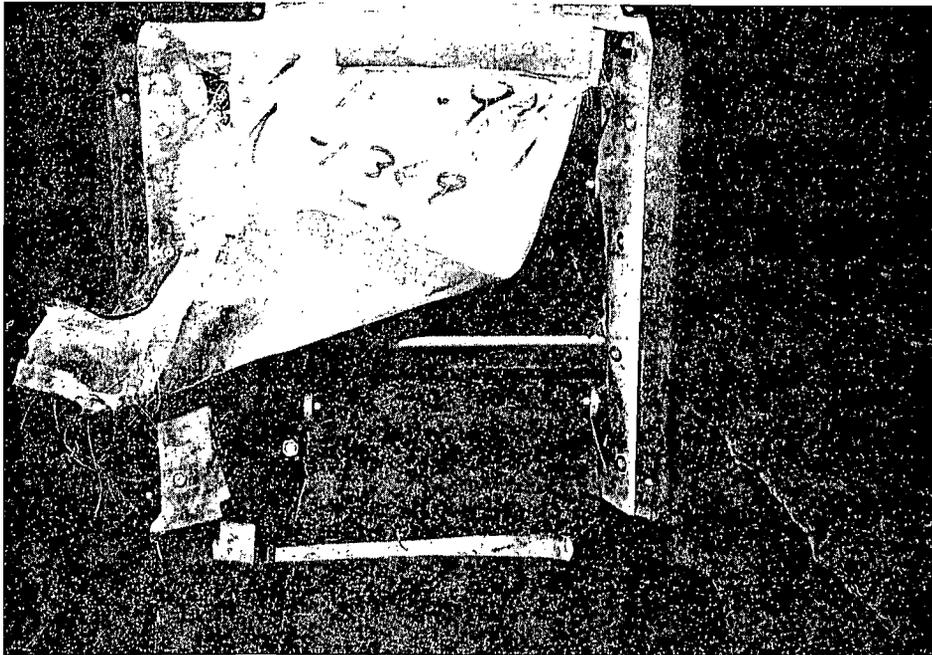
8-7. Pilot's seat as torn by hand.

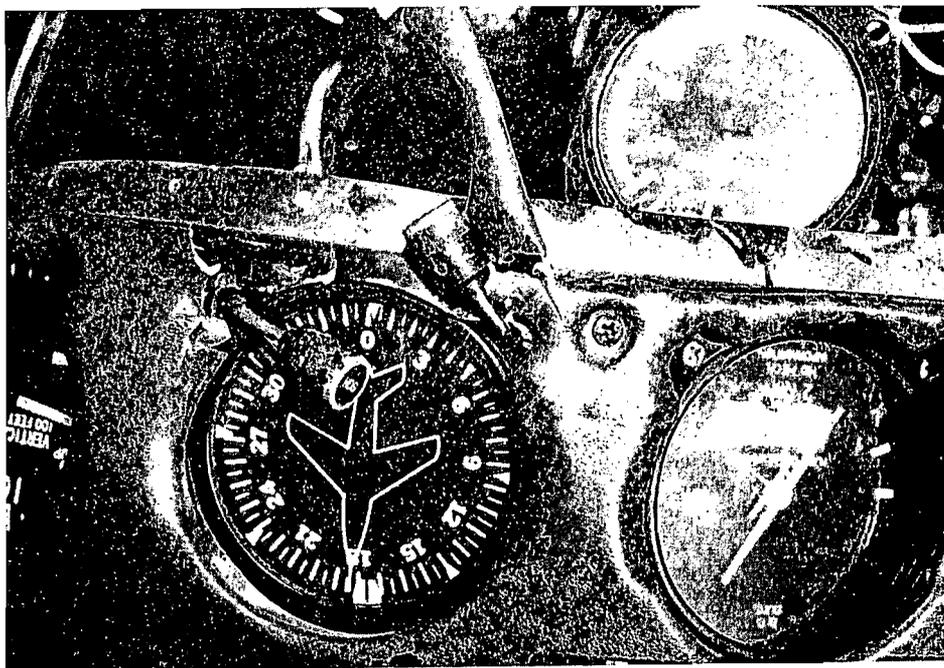
11-6. Pilot head strike area (one of multiple).

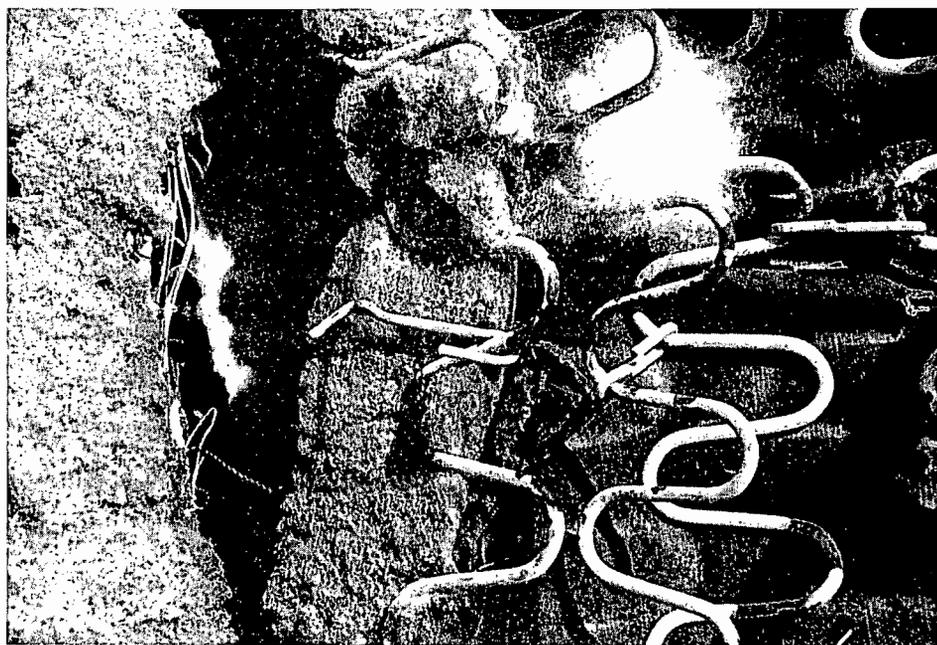
13-6. Tie wires pulled loose.

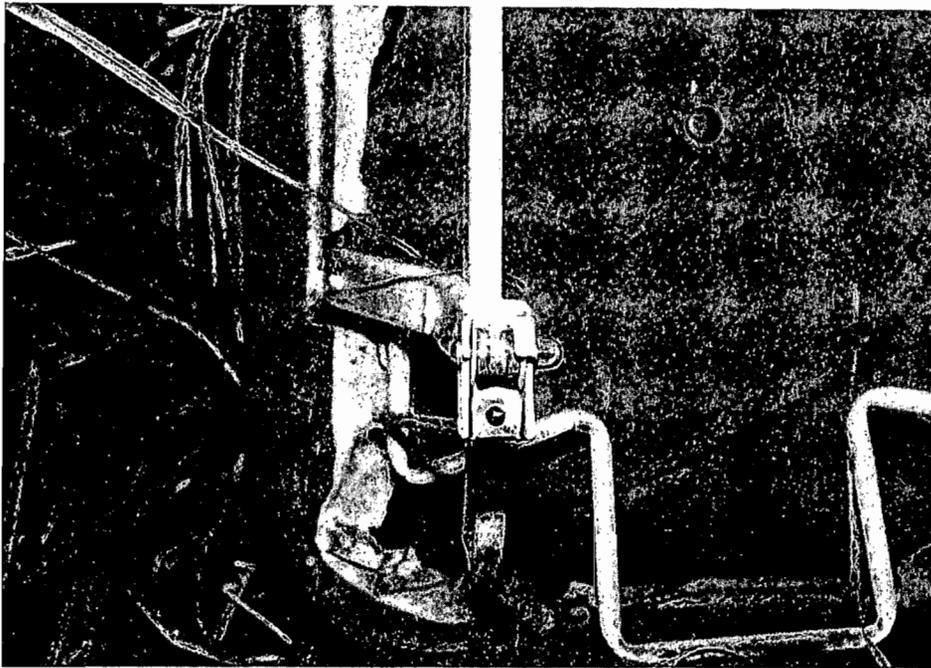
17-3. Broken foot.

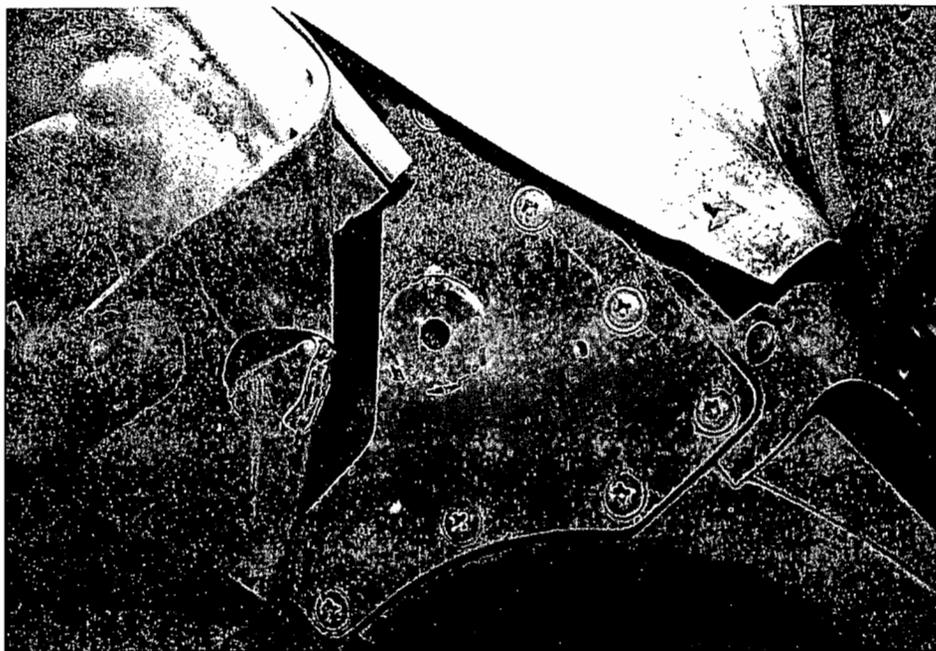
17-4. Area of separated shoulder harness bolt.

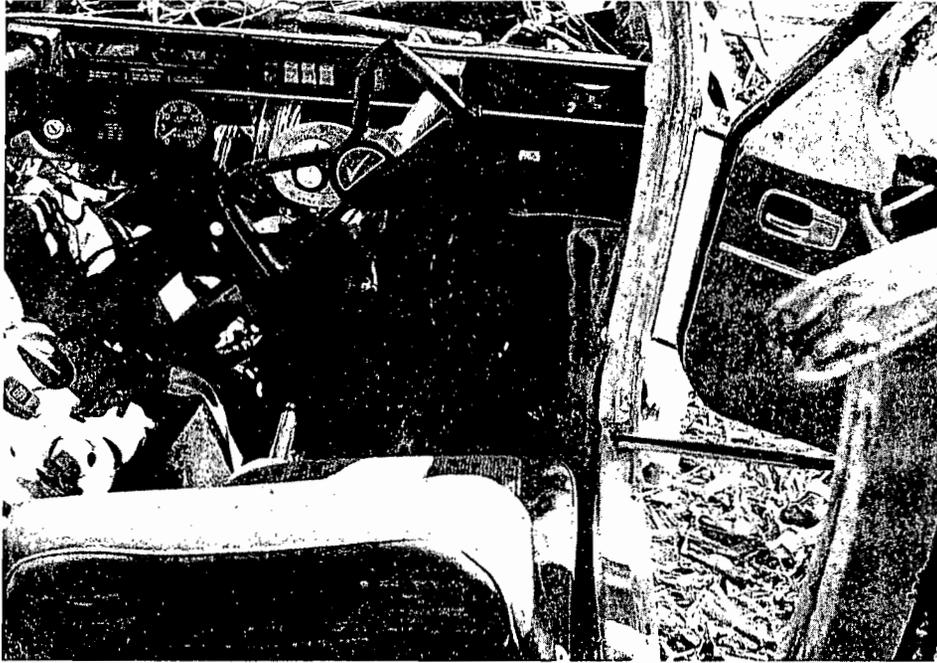
19-4. Crush damage to pilot's side of cockpit.

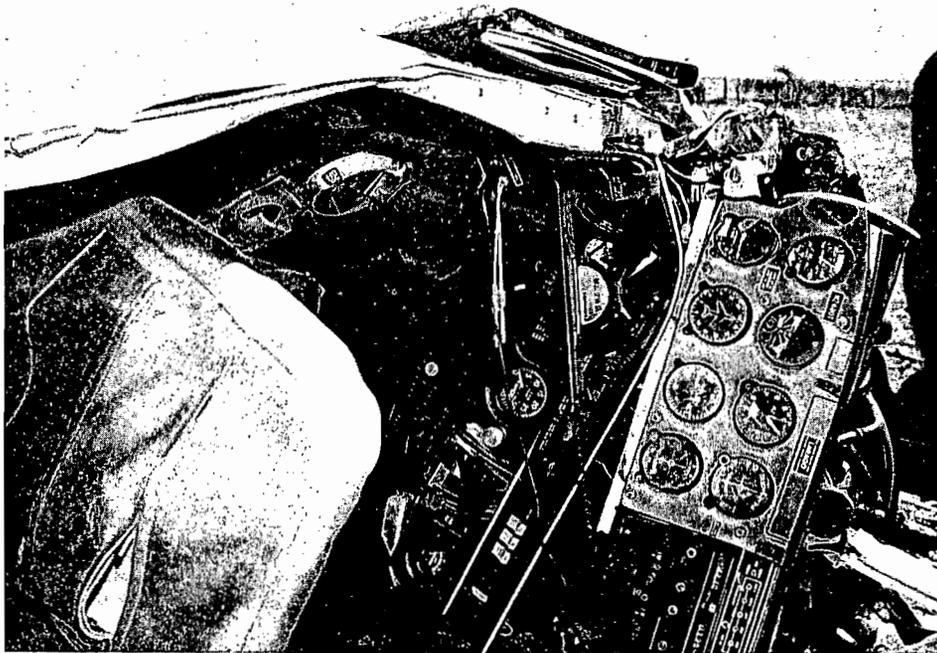
19-5. Occupant contact area of left sidewall.

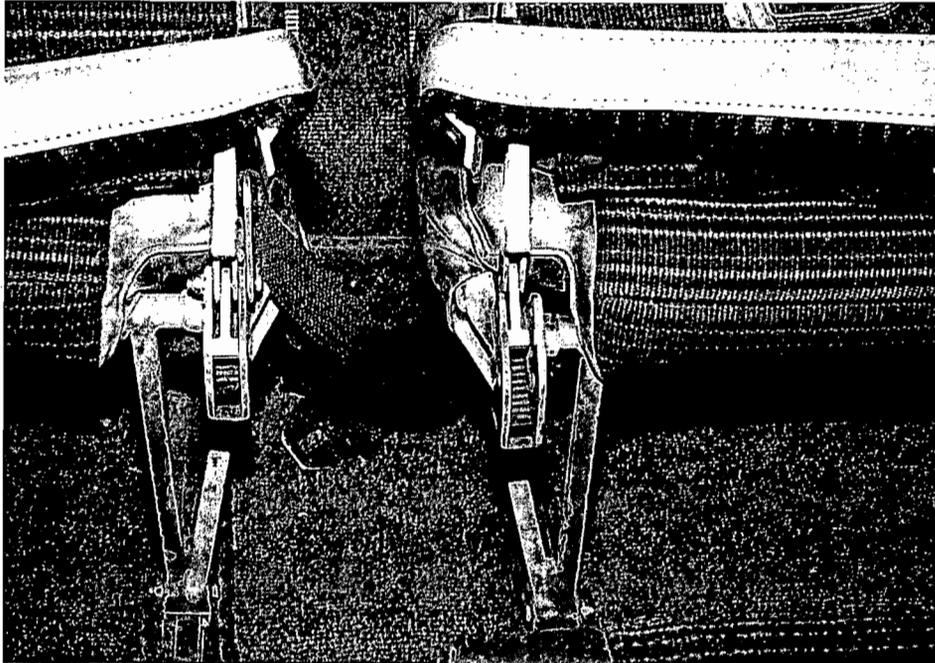
22-5. Seatback cam missing, causing bolt to shear.

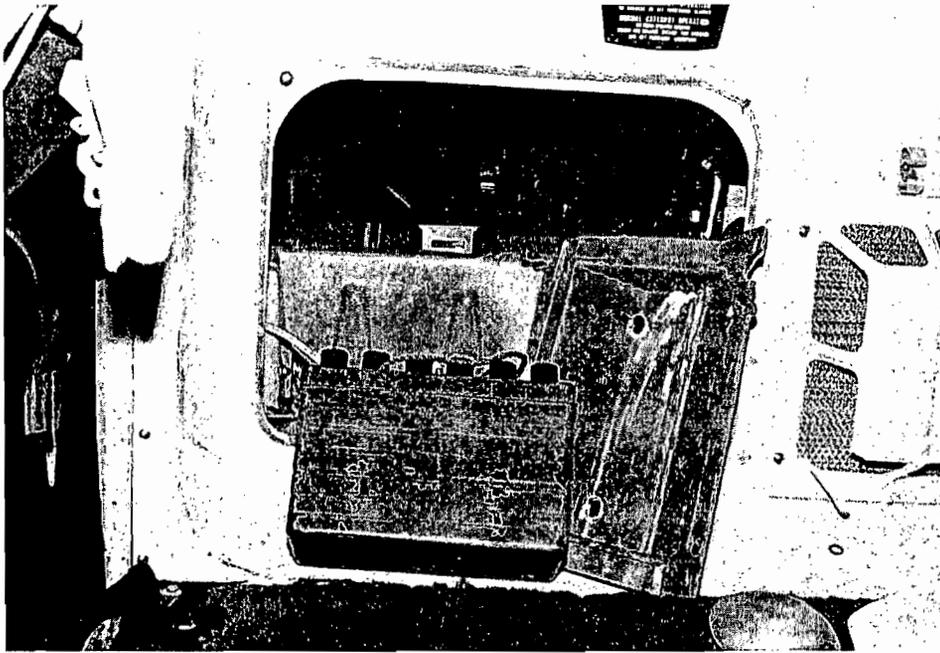
26-3. Battery pulled loose.

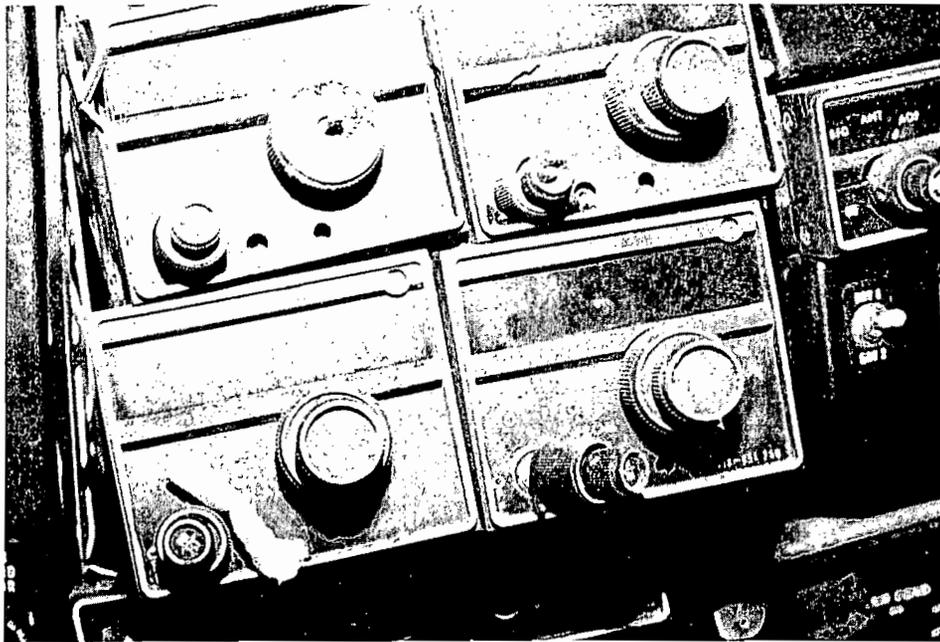
26-4. Head contact area.

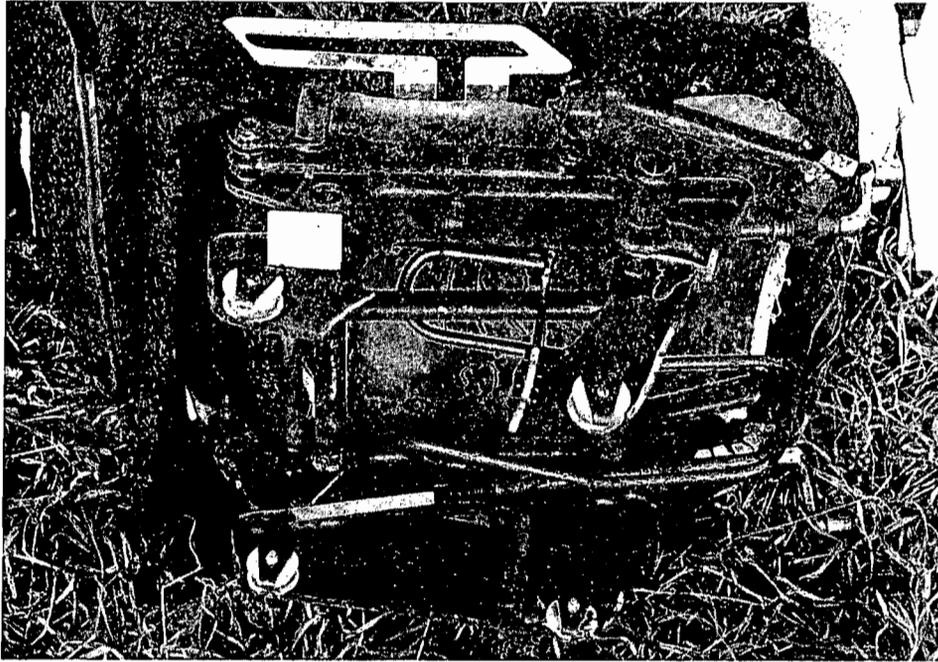
29-3. Multiple fracture to stiff seat structure.

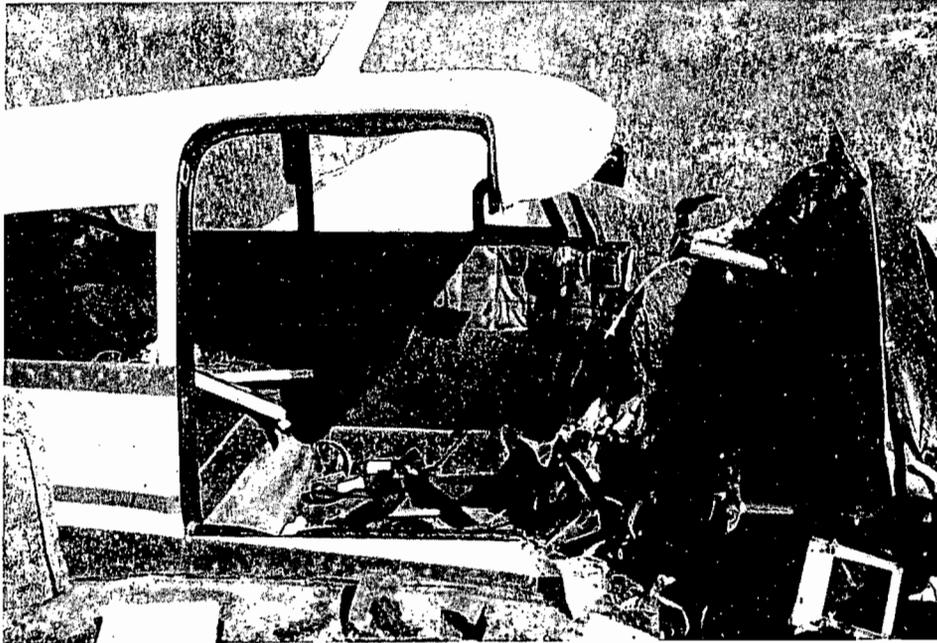
30-3. Compression damage to cockpit area.

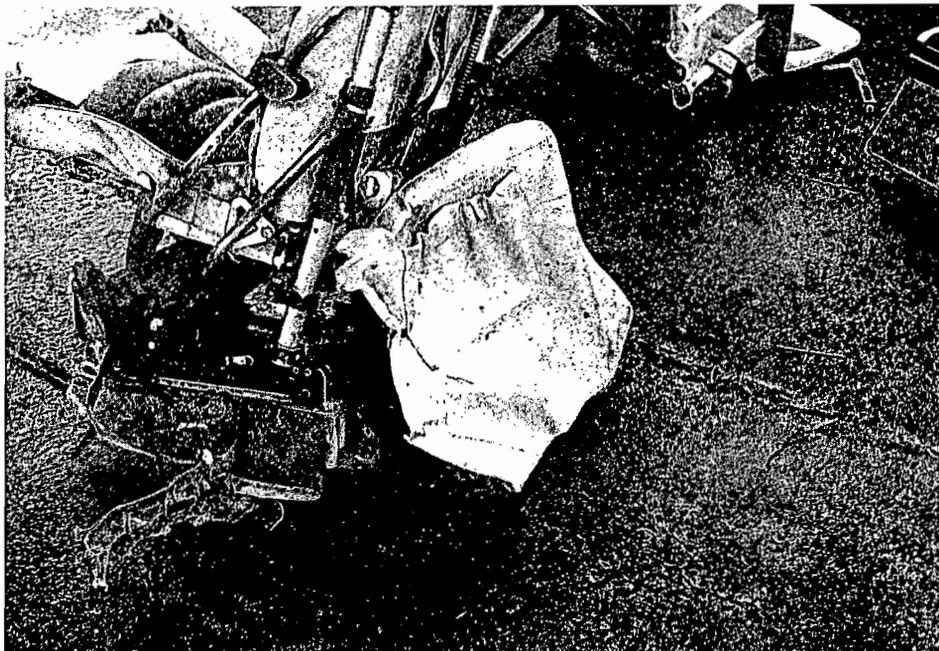
33-1. Damaged seat.

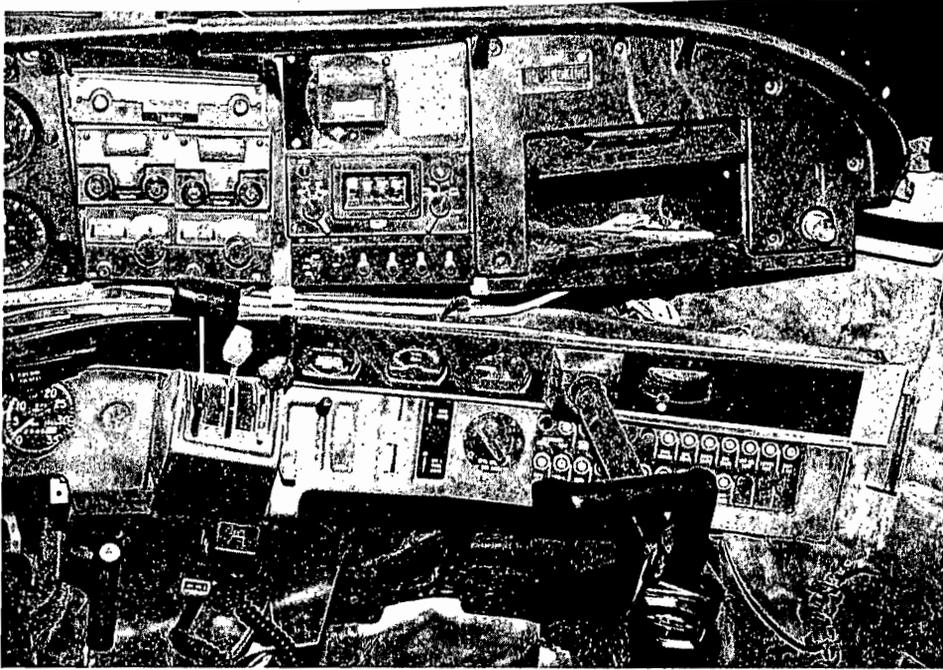
34-3. Copilot's panel.

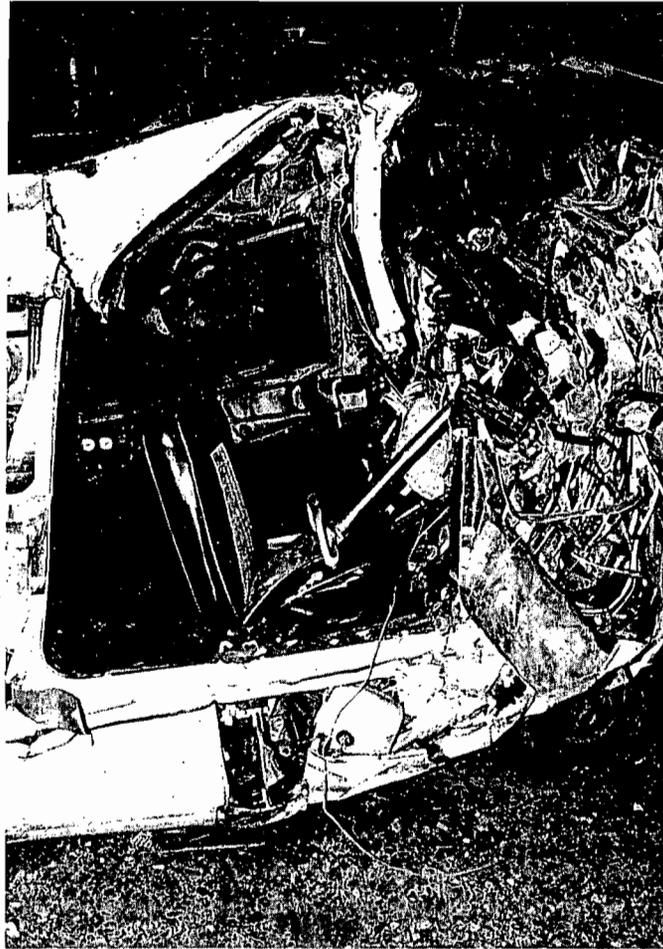
38-1. Wreckage - Crushed nose.

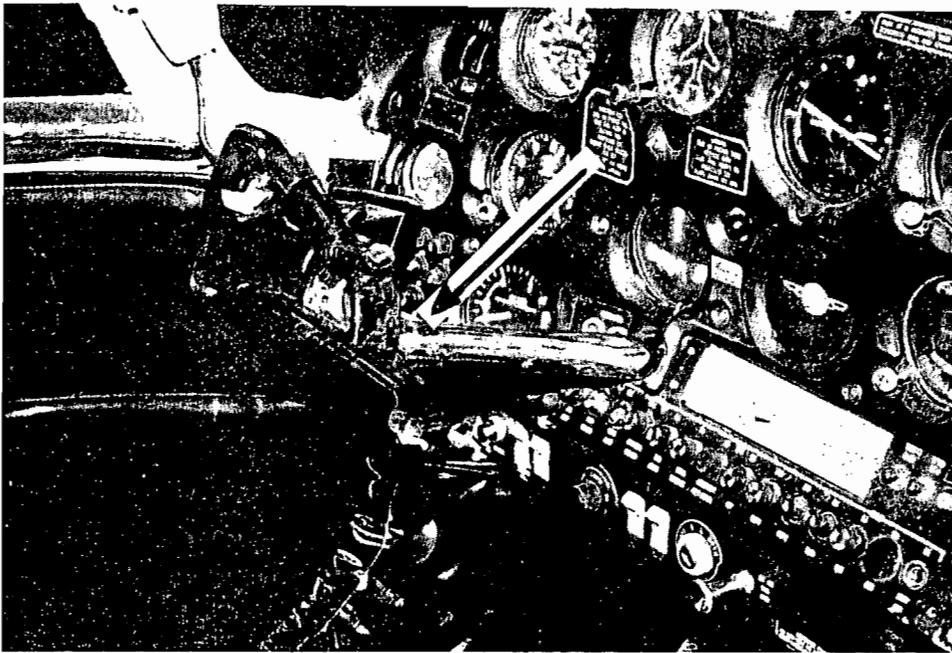
39-2. Control column damage.

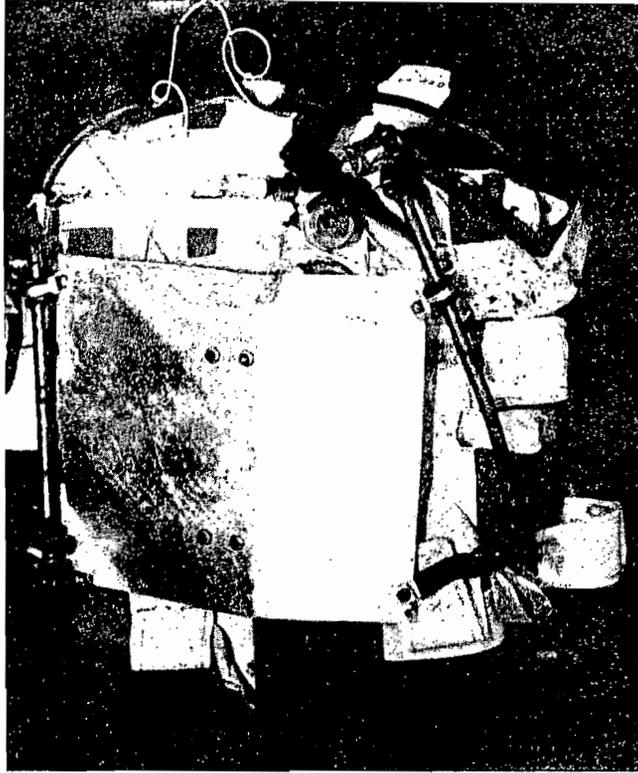
Improper seat modifications or seats in poor repair can be overlooked by a mechanic. In Case 39 one of the seatpans had been removed and replaced with lawnchair webbing which was fastened with the kind of staples used for paper. The deteriorated seatpans in Case 4 were not discovered during normal inspections. Analysis of the material indicated that the deteriorated condition of the seatpan material was of long standing.

39-3. Bottom of seatpan with lawnchair webbing and add-on equipment.

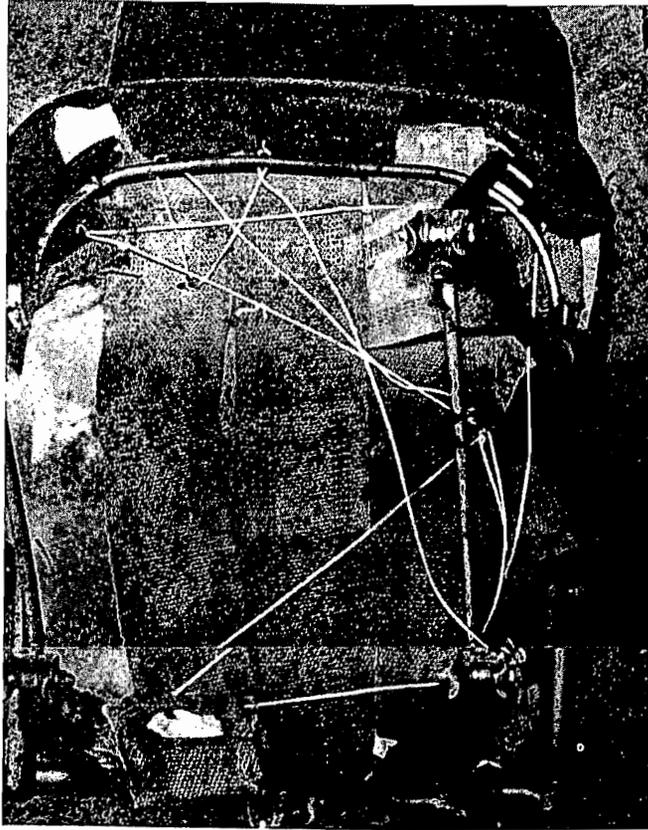
39-5. Original seatpan that had been repaired.
