Crashworthiness of Small Poststandard School Buses: Safety Study

(U.S.) National Transportation Safety Board, Washington, DC

11 Oct 89

1. Report No. NTSB/SS-89/02		2. Government Accession No. PB89-917003		3. Recipient's Catalog No.	
4. Title and Subtitle Safety Study: Crashworthiness of Small Poststandard School Buses			5. Report Date October 11, 1989

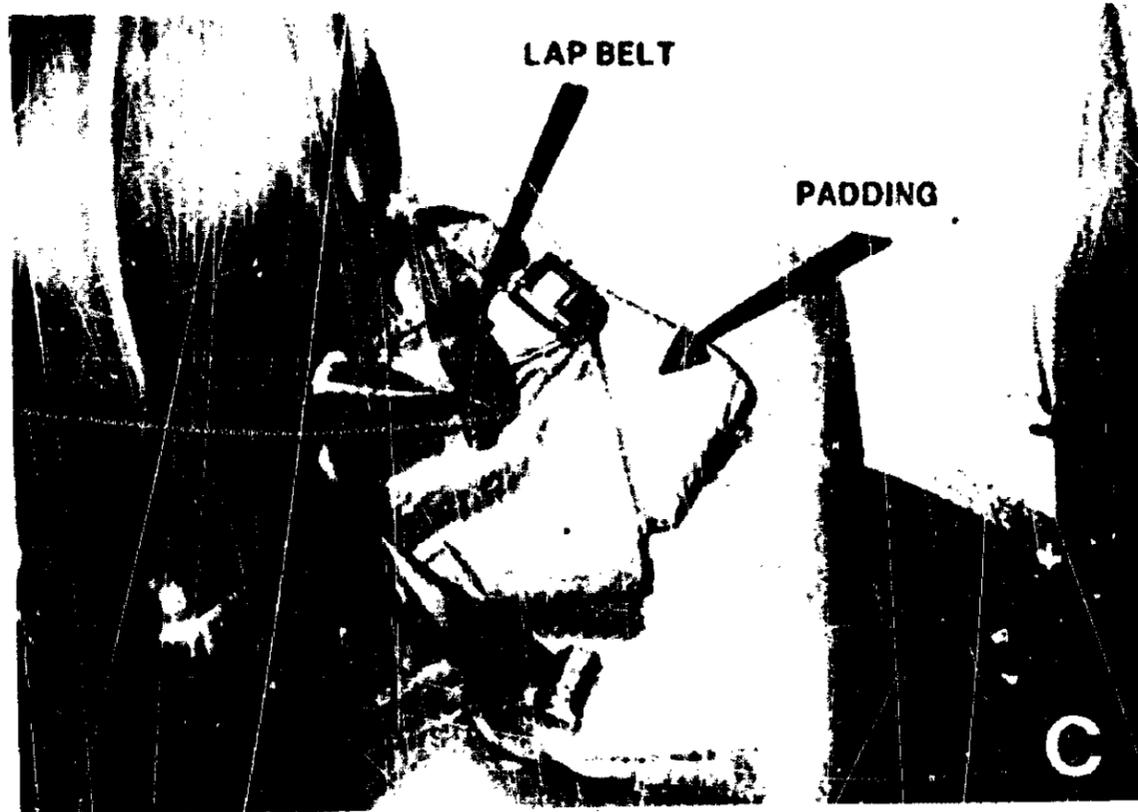
Figure 5.--Such "restraints" pose danger to the occupants. The jury-rigged loopbelt (A) and unusual three-point restraint (B and C) were found in case 24. Neither was secured to the seat or floor. Other examples of improper installation were shared seatbelt anchorages (D) and unusual configuration of buckles and latchplates (E).

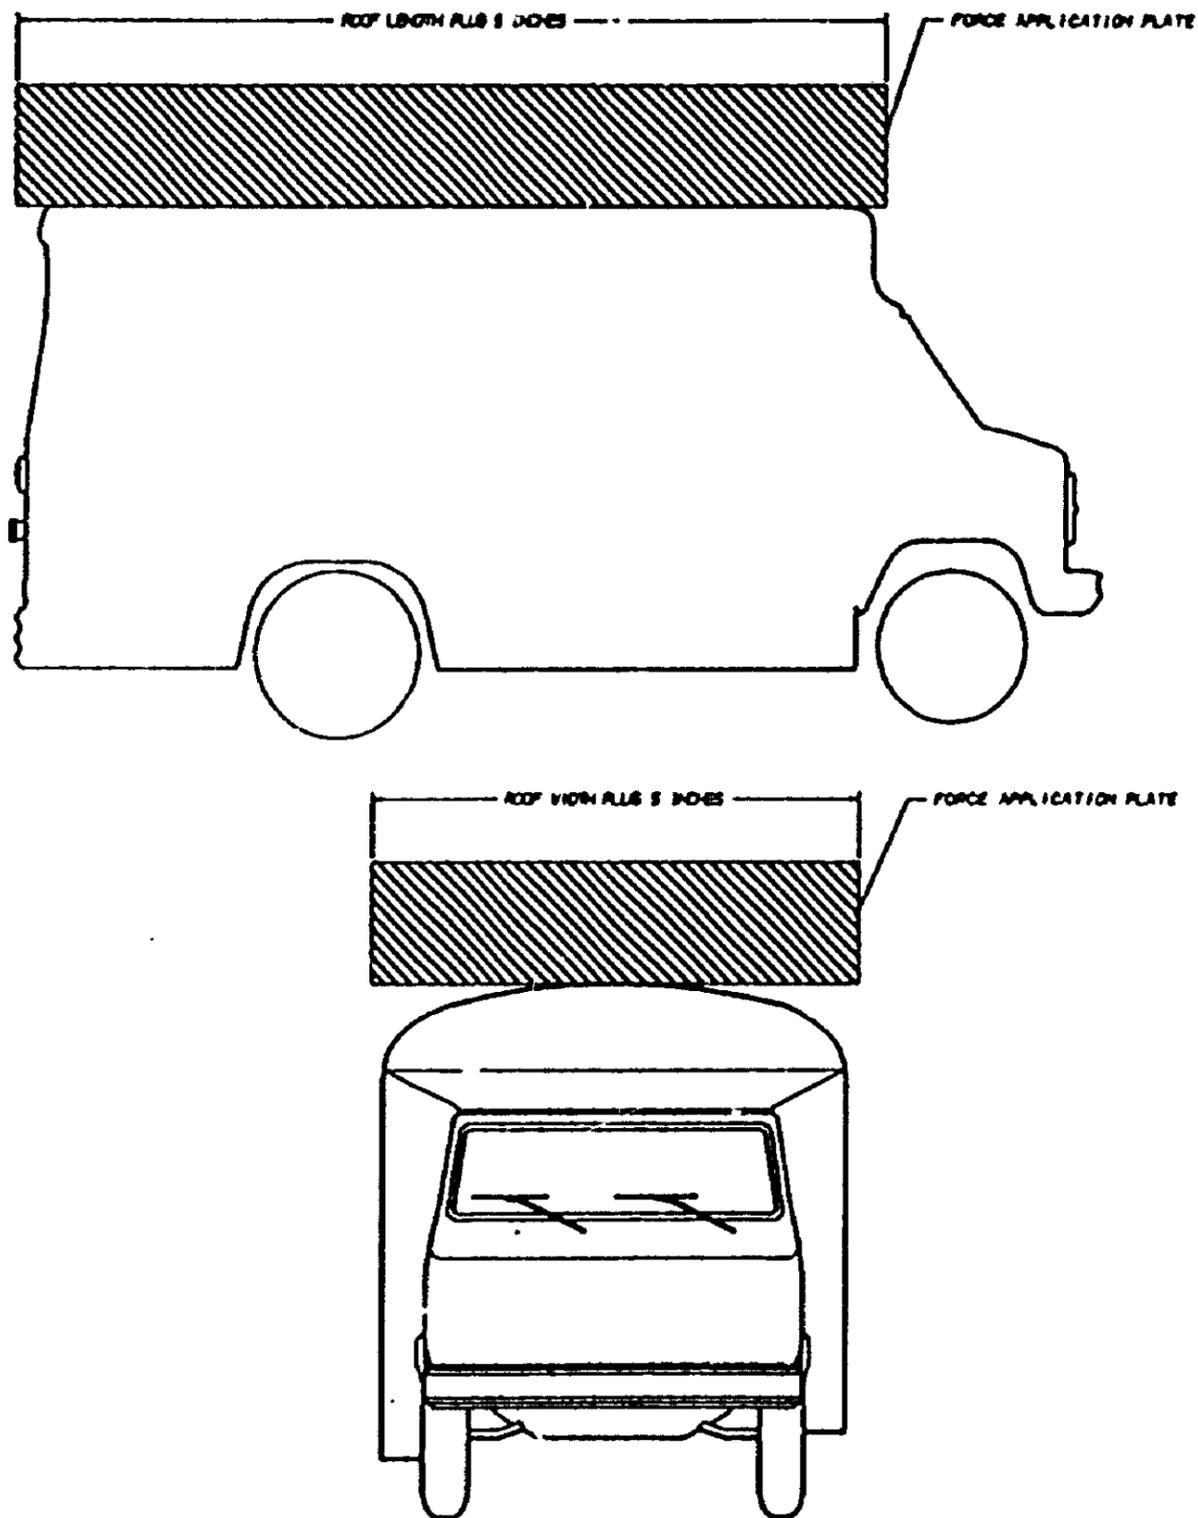
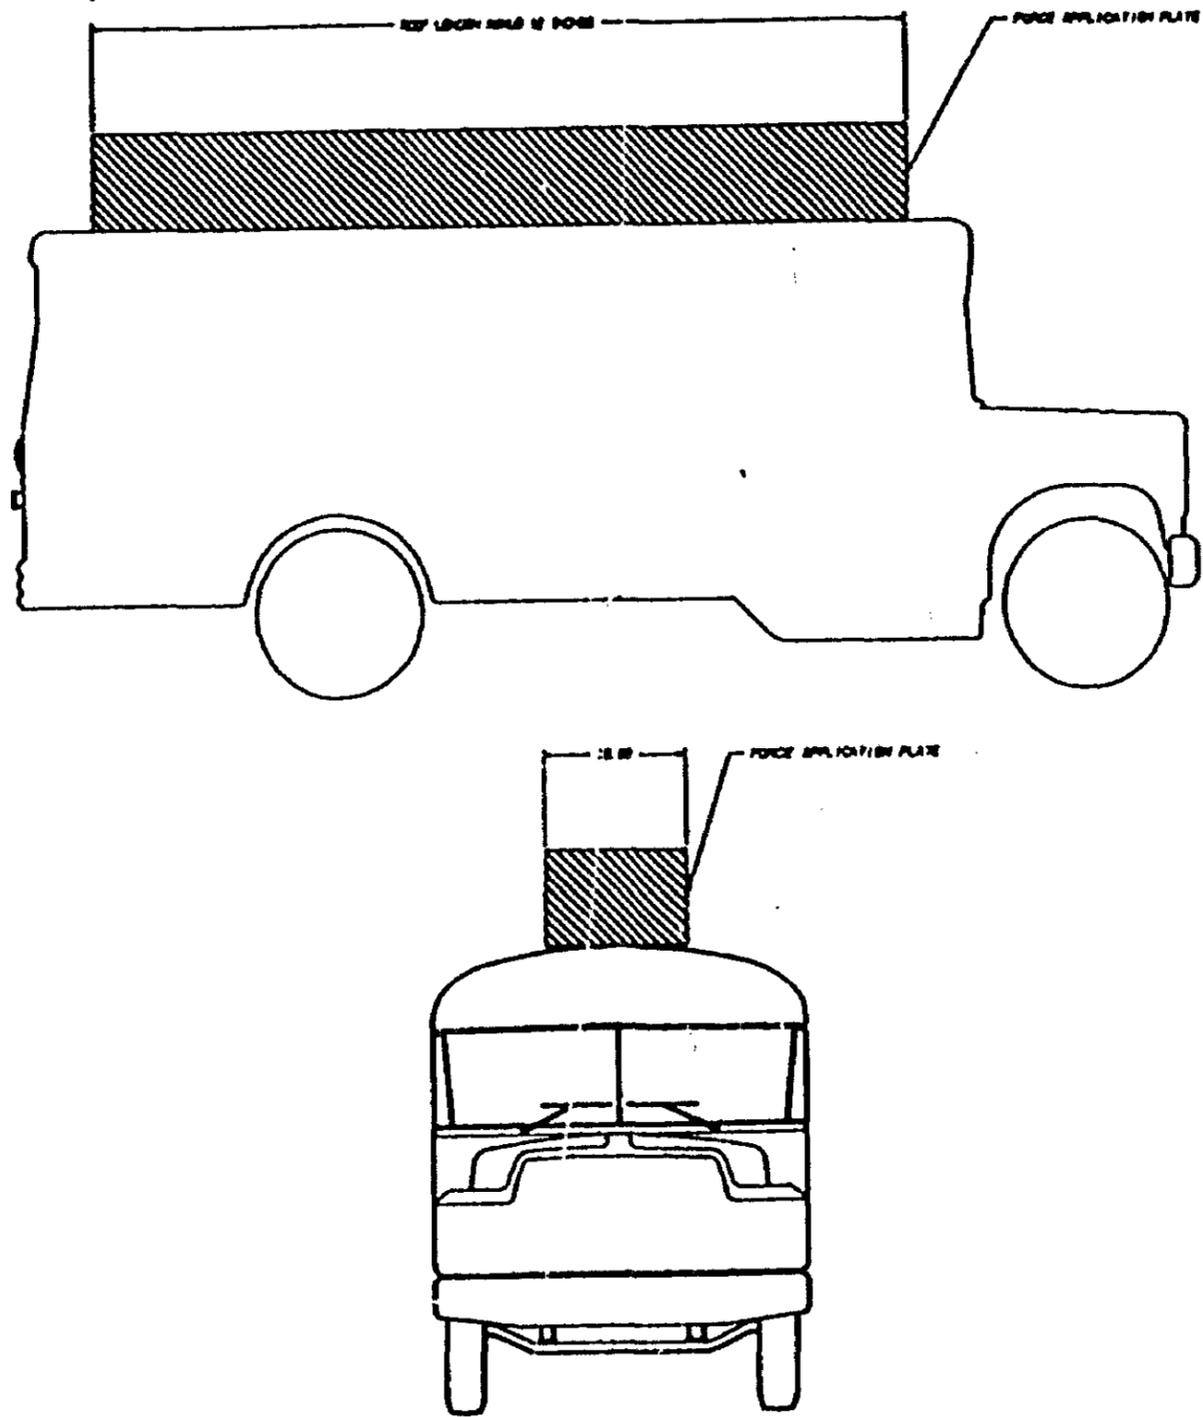
Figure 15.--A larger force application plate is used to test roof strength in small school buses compared to that used in tests of larger school buses. The result is that the roof of a small school bus must pass a less stressful test of roof rollover performance. (Source: School Bus Manufacturers Institute 1989.)
