PB92-917005
NTSB/SS-92/02

**NATIONAL
TRANSPORTATION
SAFETY
BOARD**

SAFETY STUDY

HIGHWAY WORK ZONE SAFETY

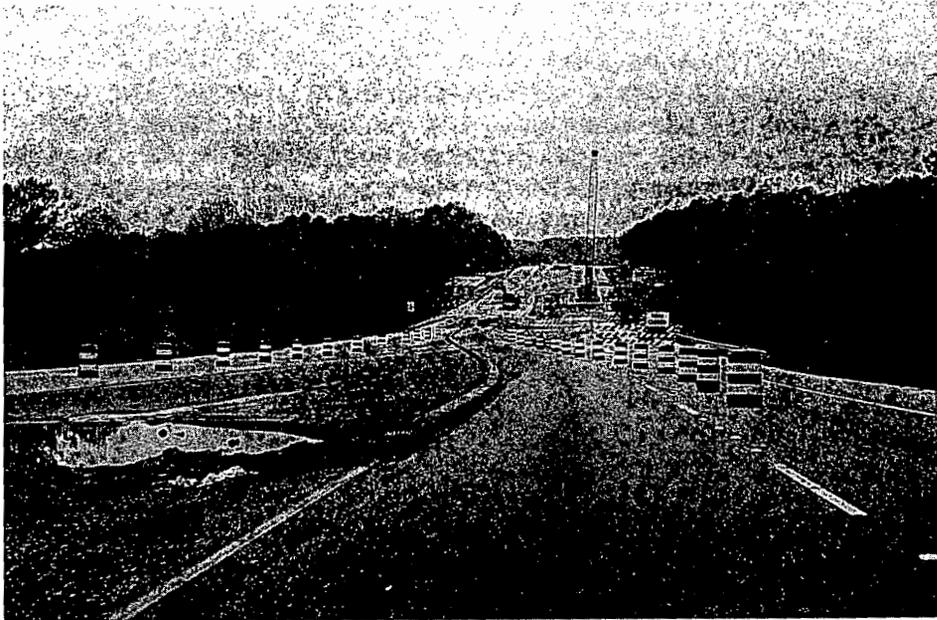
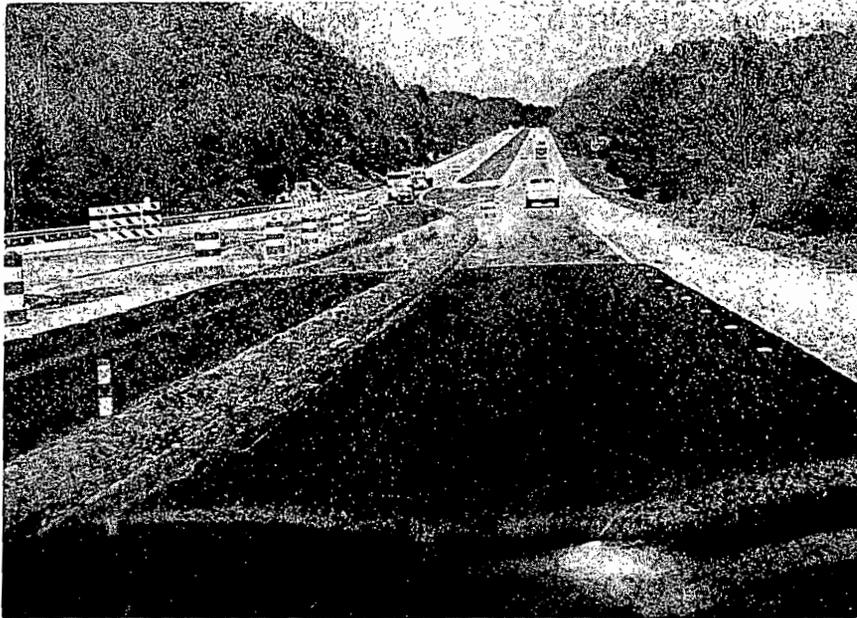
In October 1990, construction work began on a 10-mile section of Interstate 20 about 20 miles east of Birmingham, Alabama. The construction included the replacement of a bridge and a lane widening project. To perform the work, a two-lane, two-way operation (TLTWO)¹¹ was set up, which required lane reductions and a median crossover to the eastbound lanes. The speed limit approaching the work zone was 65 mph; the speed limit was reduced to 45 mph just within the work zone and prior to the lane reduction. The warning signs approaching the work zone from both directions were appropriately placed in conformance with existing guidelines. The lane closure was delineated with white and orange reflectorized barrels on the right side and a yellow edge line on the left.

Figure 5.--Two-lane, two-way operation near Birmingham, Alabama, October 1990

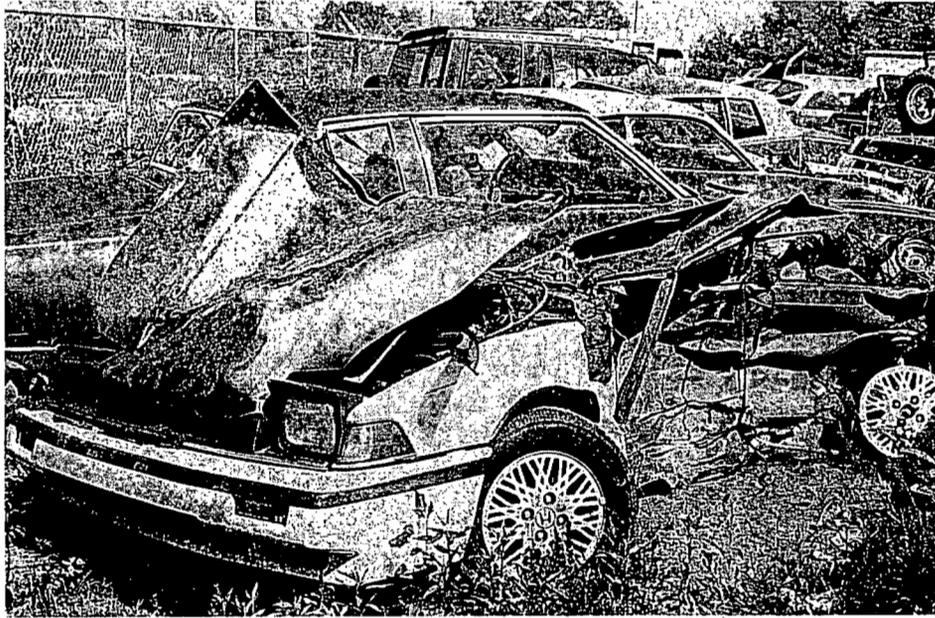
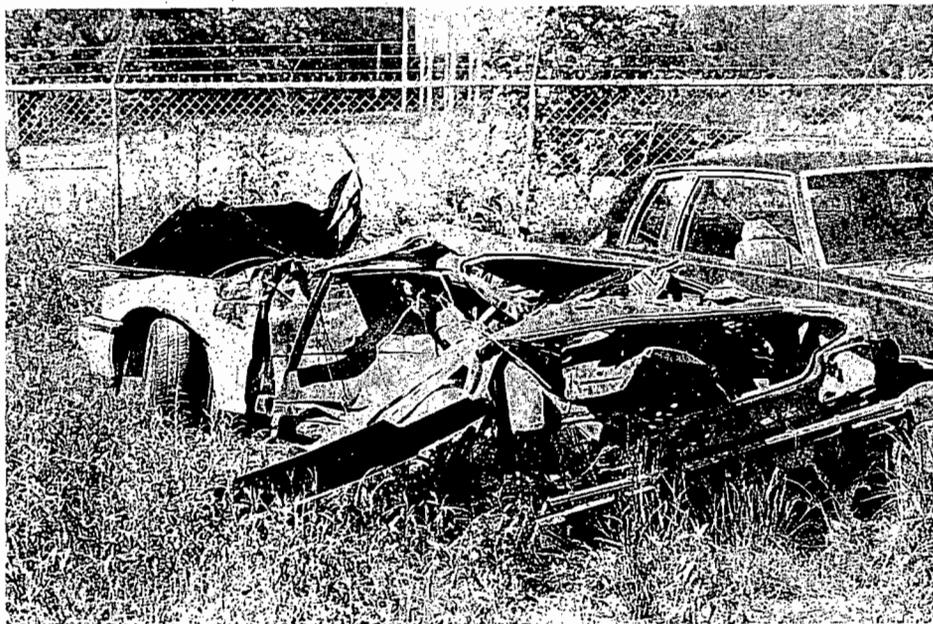
About 7 p.m. on May 3, 1991, a westbound Honda passenger car, occupied by its driver and a passenger, entered the same construction zone. An eastbound Mazda passenger car, occupied by its driver and a passenger, also entered the construction zone at the opposite end traveling at an estimated speed of 45 mph. A witness, who was traveling eastbound behind the Mazda, observed the Honda traveling at an estimated 60 mph. As the Honda entered the transition to the one-lane westbound roadway, it crossed over the 4-inch-high asphalt island and collided head on with the Mazda. After impact, the

Honda and the Mazda rotated off the right edge of the travelway, and the Honda erupted in flames. The driver and passenger of the Honda were fatally injured, and the driver and passenger of the Mazda were seriously injured. Both vehicles were destroyed by the collision and subsequent fire (see figure 6). The accident occurred during daylight on a wet road; the sky was overcast.

Figure 6.--Vehicle damage, Birmingham, Alabama, May 1991

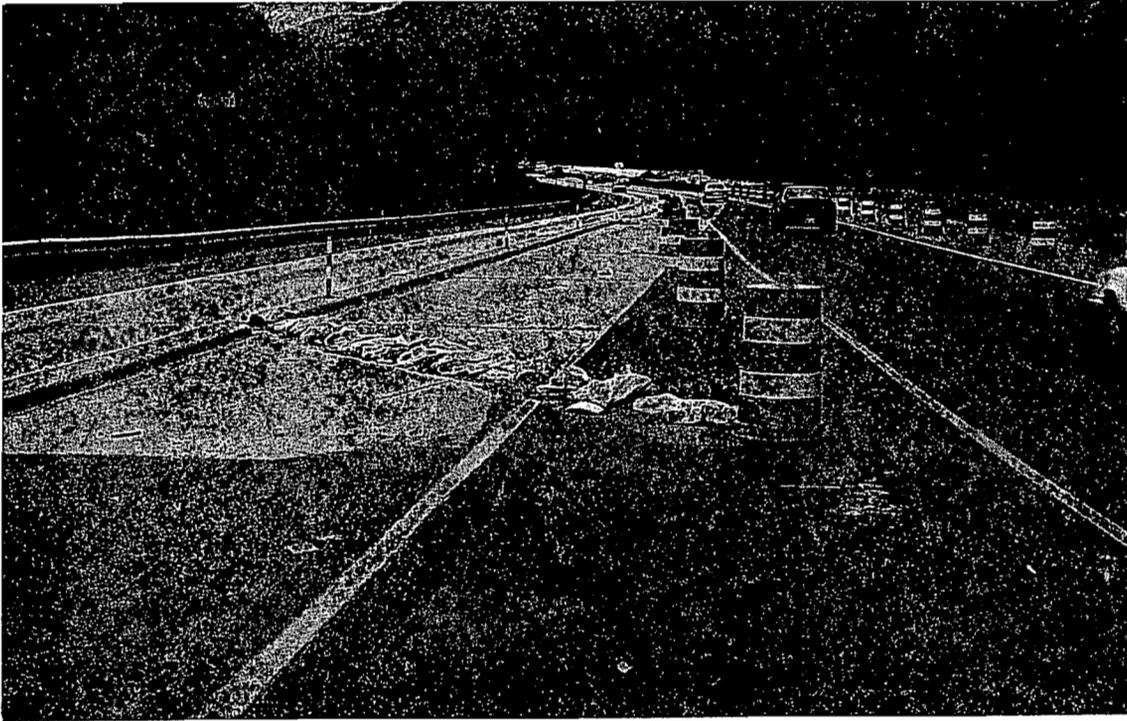
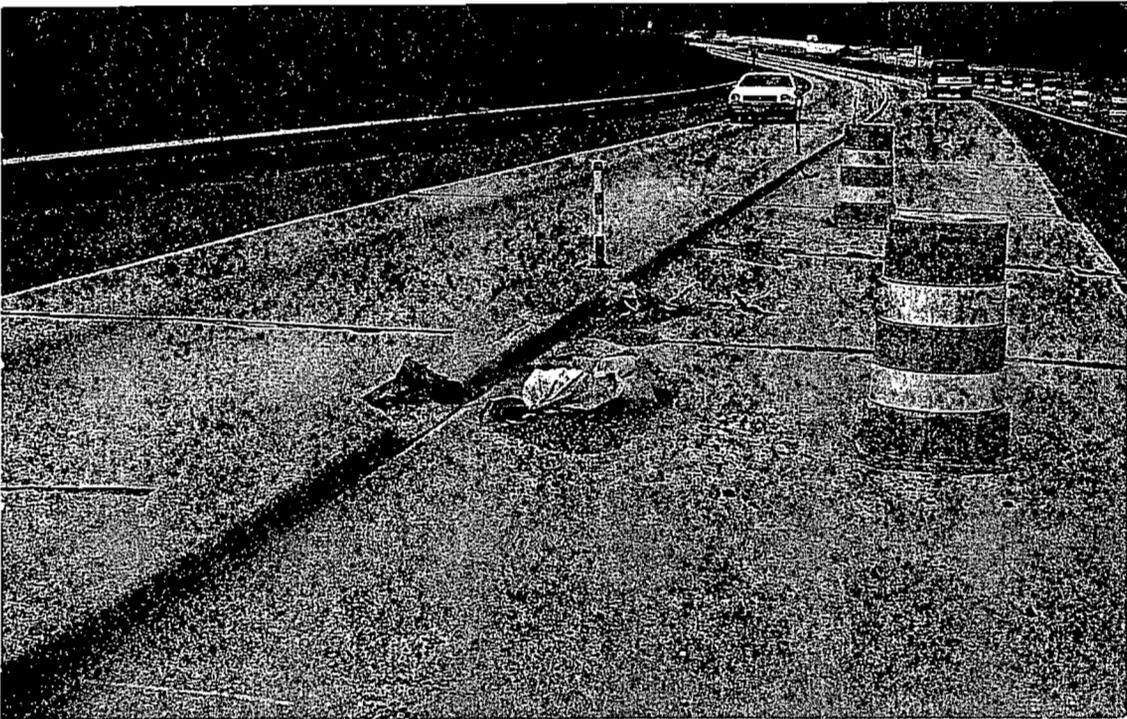
Figure 8.--Two-lane, two-way operation near Old Fort, North Carolina,
March 1990

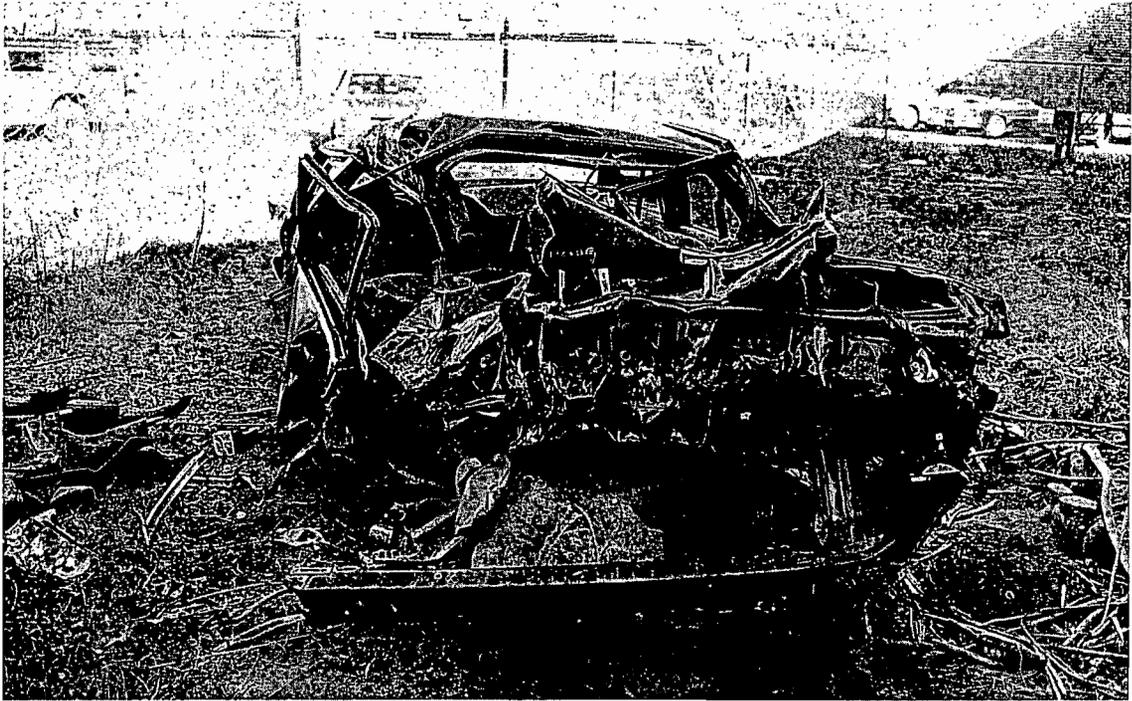
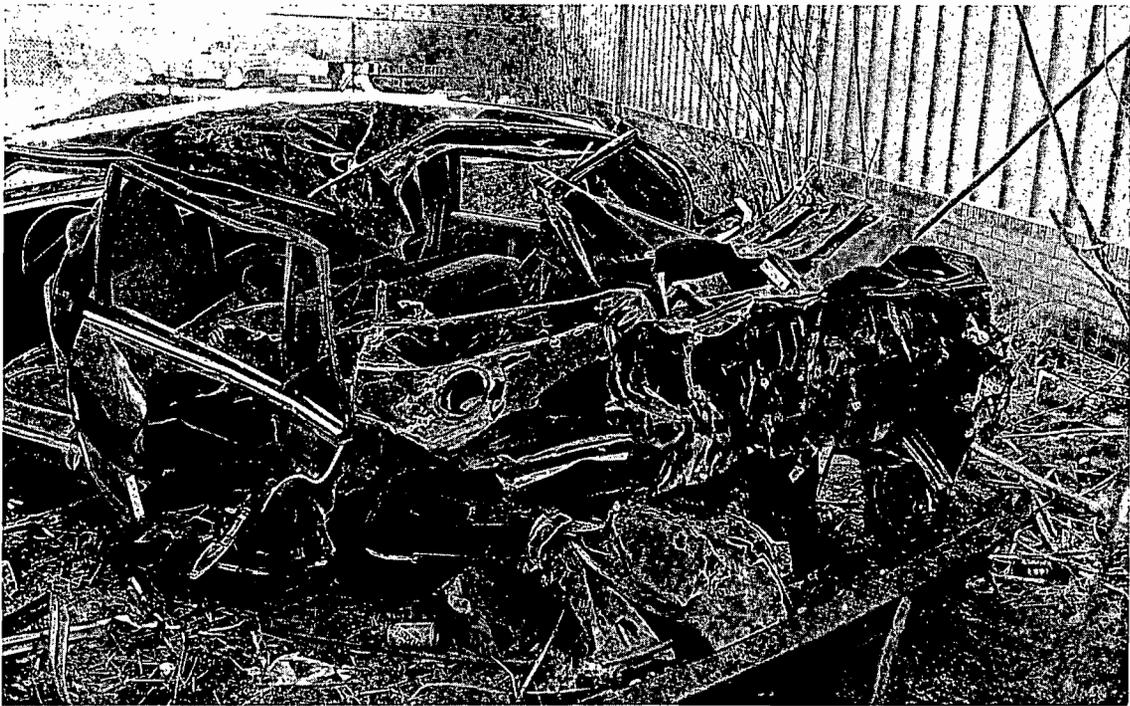
Figure 9.--Vehicle damage, Old Fort, North Carolina, March 1990

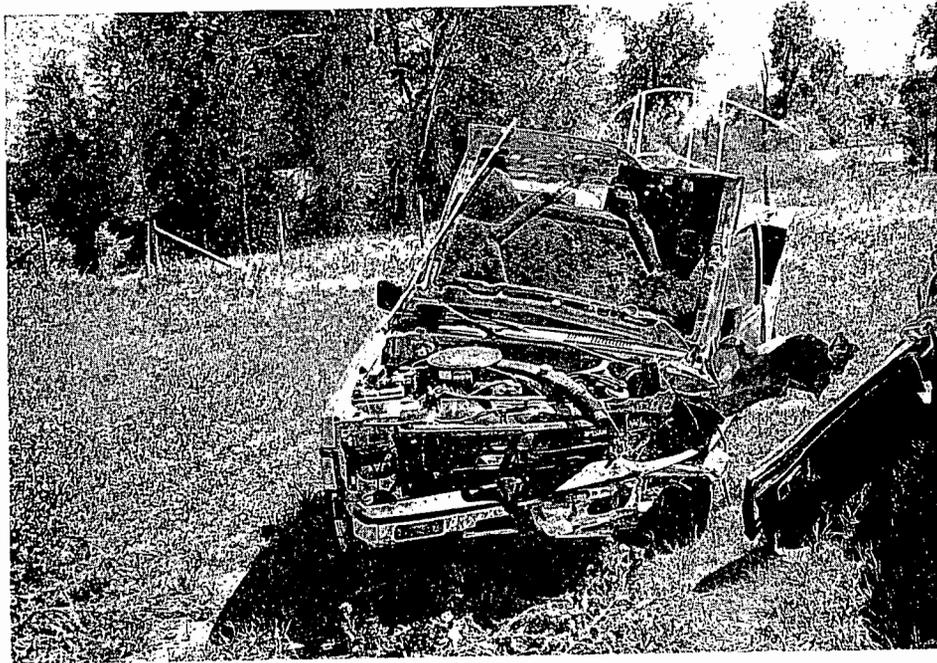
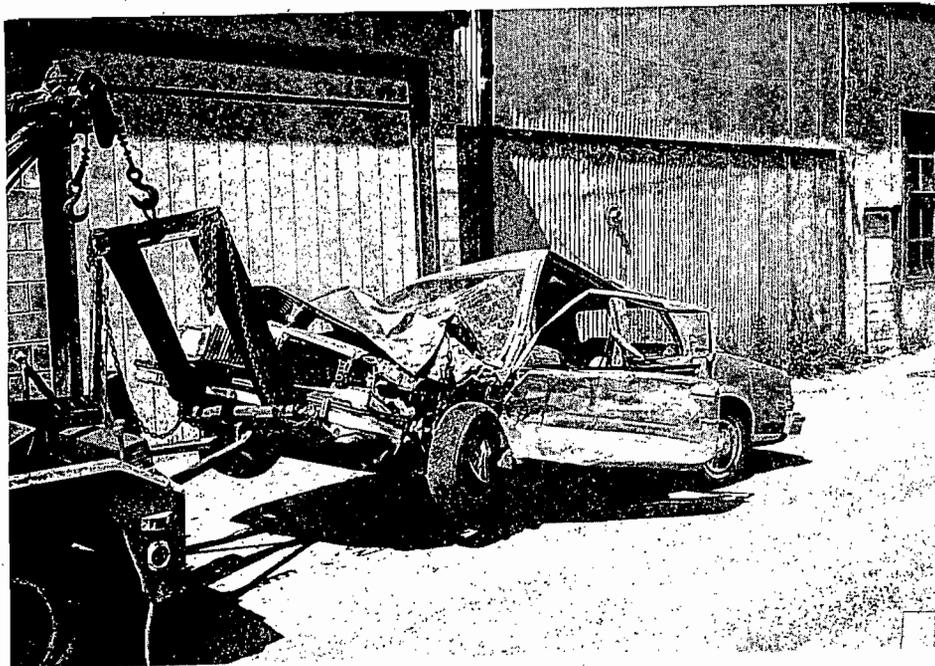
be traveling at the posted speed limit of 55 mph at impact. Both vehicles were extensively damaged (see figure 10). Postaccident toxicological tests were not performed.

Figure 10.--Vehicle damage, Buffalo, Wyoming, July 1989

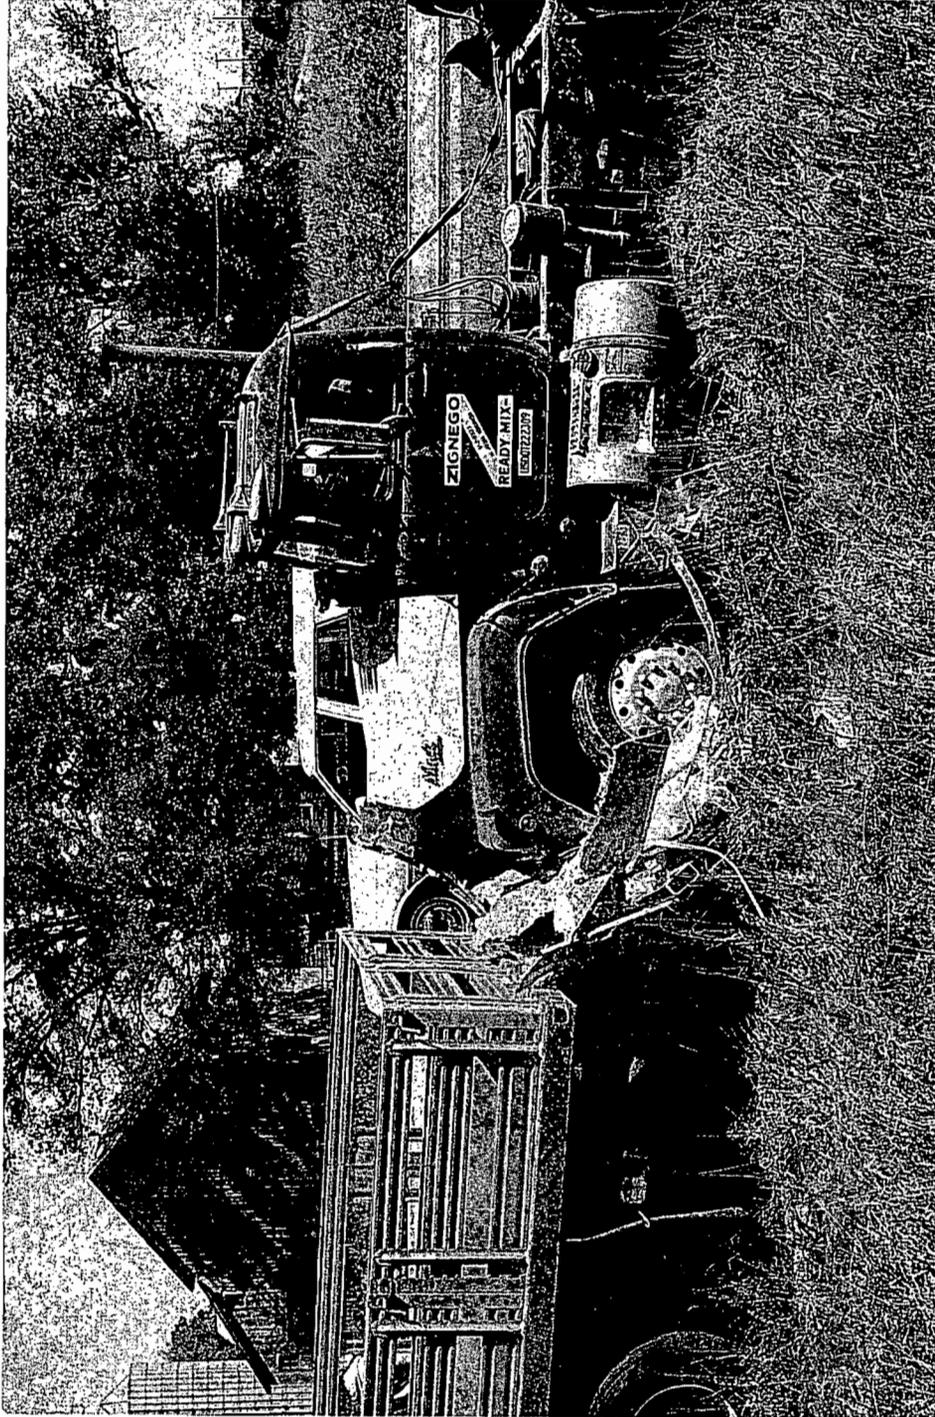
Most likely because the TMA absorbed a substantial amount of the impact forces, the driver of the Mack combination vehicle was not injured. The driver of the Ford truck received minor injuries (cervical neck strain, scalp abrasion, abrasion/contusion on his right calf) and was treated and released from a local hospital.

Figure 11.--Vehicle damage, Ogle County, Illinois, September 1989

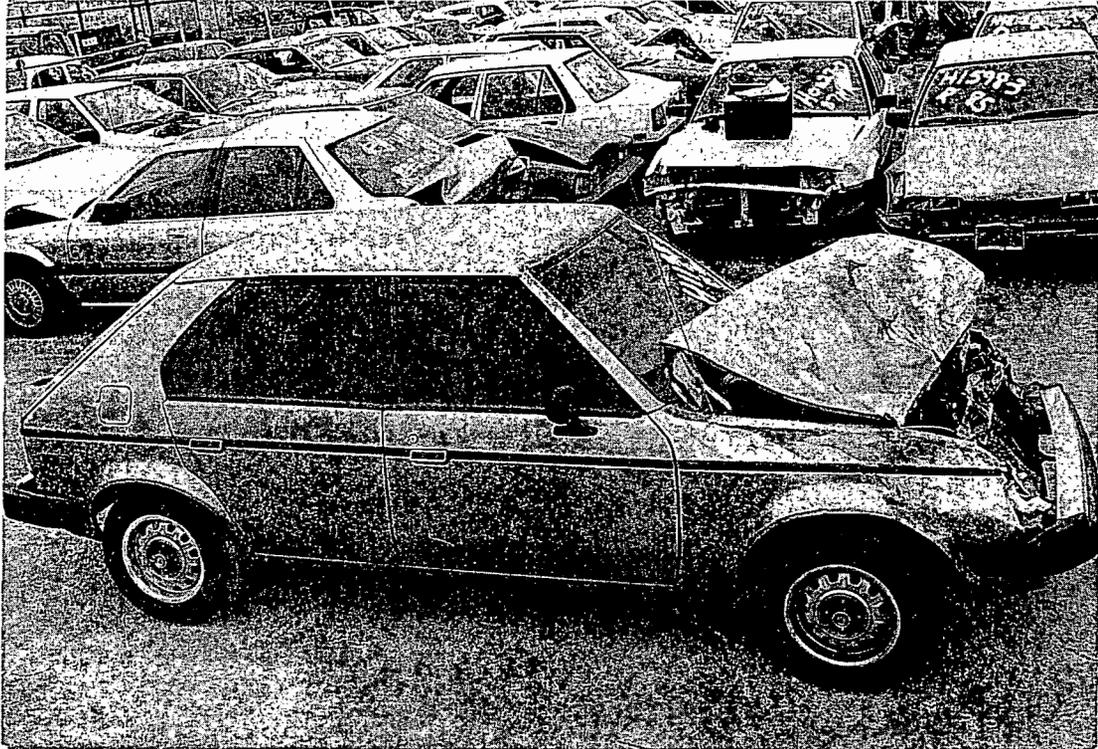
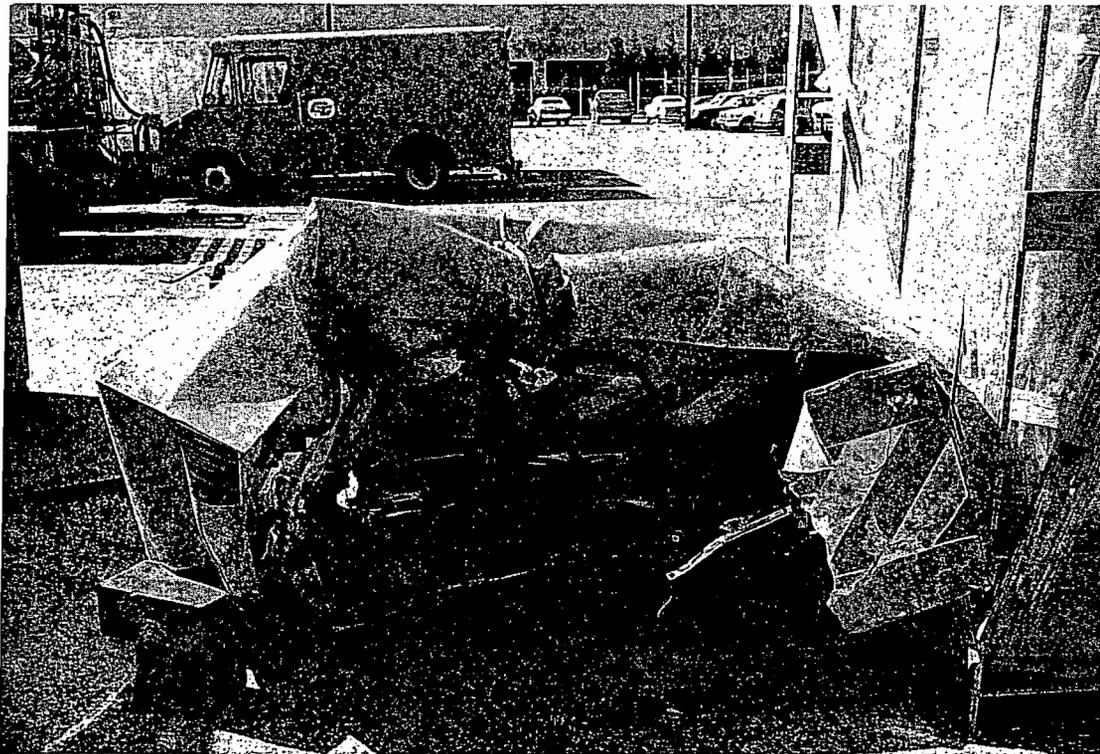
The Dodge Omni sustained crush damage across the front to a maximum depth of 2 feet (see figure 12). The TMA sustained severe crush damage; there was no damage to the shadow truck. Based on the damage to the TMA, the estimated speed of the car at the time it struck the TMA was between 30 and 40 mph.

Figure 12.--Vehicle damage, Downey, California, March 1989

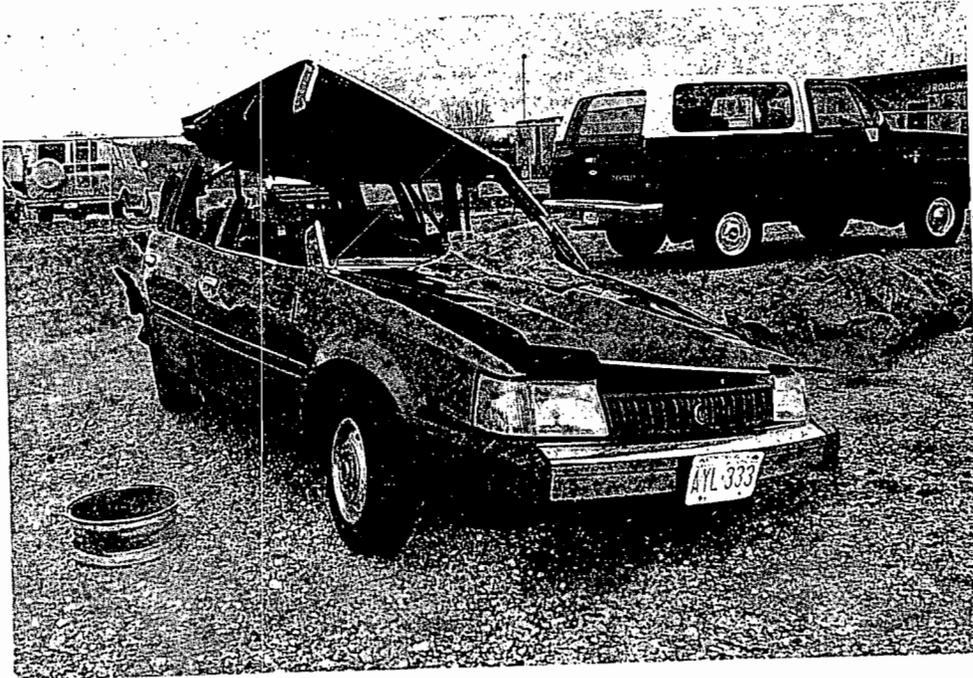
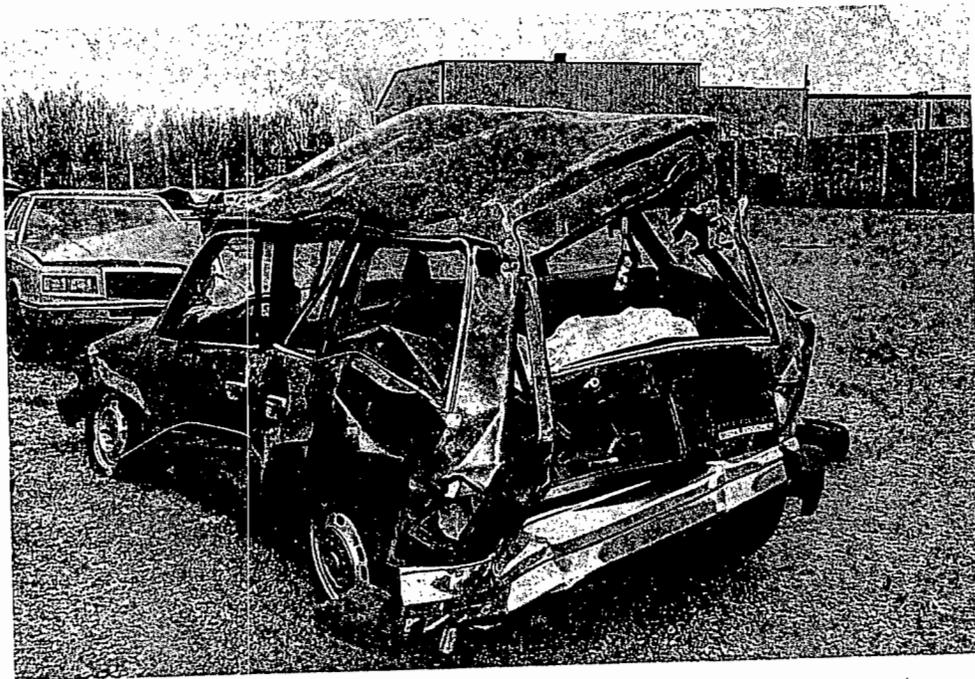
Figure 14.--Vehicle damage, Blooming Grove, Wisconsin, November 1989

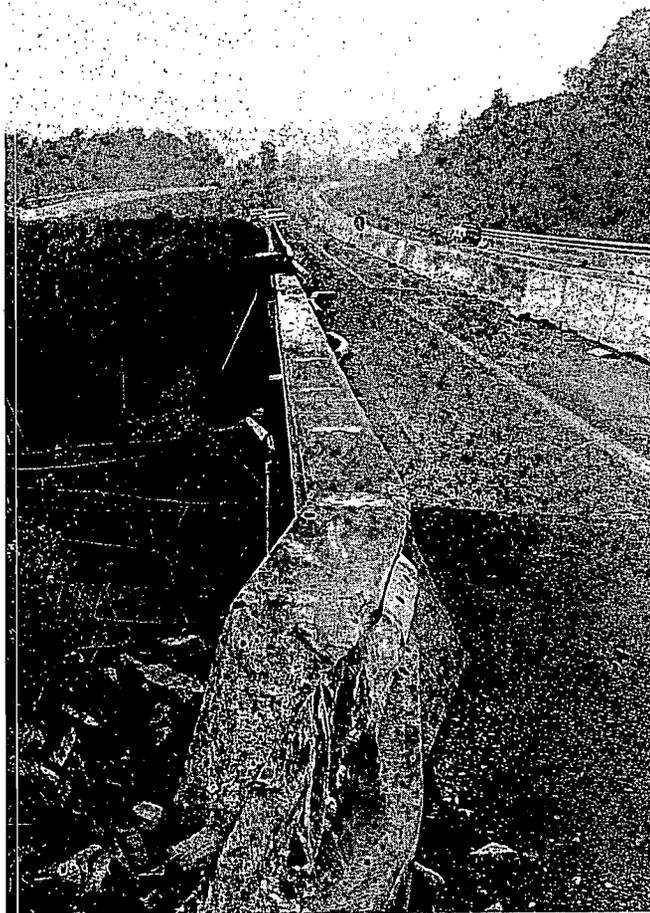
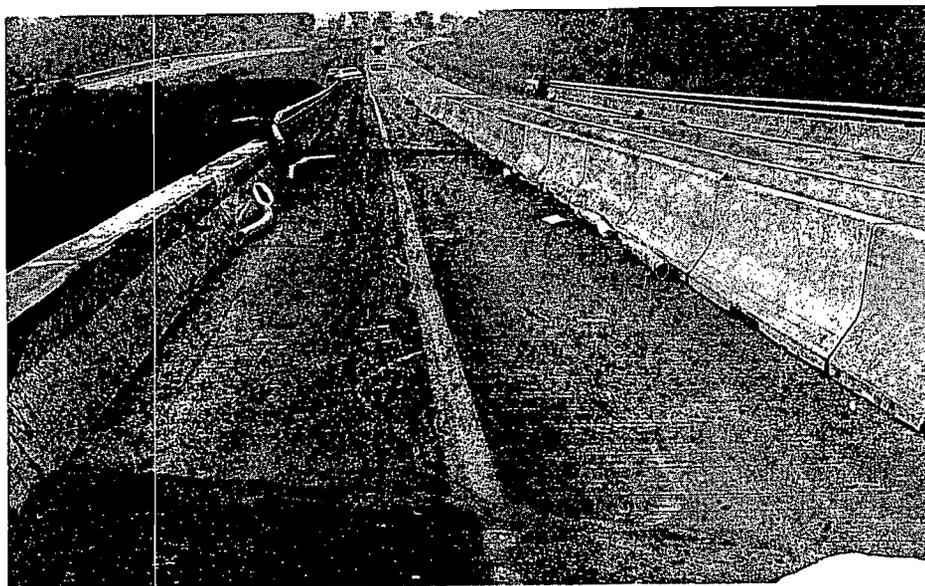
About 4 a.m. on August 14, 1989, a loaded tractor semitrailer was eastbound on I-84 near Sterling, Pennsylvania. The truck was traveling in a 4.7-mile-long construction zone in which the right lane was closed and traffic was channeled to the left lane. At two bridge locations, concrete barriers were used to further reduce the left lane. The barrier extended 5.5 feet into the left lane, reducing the left lane to a width of about 7 feet. Pre-construction pavement markings had not been obliterated. To pass through the work area on the bridge safely, drivers of combination vehicles had to move left and pass through the work area with the left wheels of their vehicles traveling on the 4-foot-wide shoulder between the left edgeline and the bridge parapet wall (see figure 15). As the truck was

Figure 15.--Construction work zone area, near Sterling, Pennsylvania,
August 14, 1989

approaching the second bridge location (about 2.5 miles into the zone), the truck struck the tapered section of the concrete barrier near the centerline, veered left, struck the guardrail, and mounted the bridgerail. After traveling on top of the bridgerail for 96 feet, the truck crossed over the rail and dropped 63 feet to the creek embankment below, landing on its roof. The driver was killed.
