National Transportation Safety Board Safety Study  
Locomotive Fuel Tank Integrity

### **LOCOMOTIVE FUEL TANK INTEGRITY**

Safety Study NTSB/SS-92/04  
Notation 5884

Washington, D.C.  
October 1992

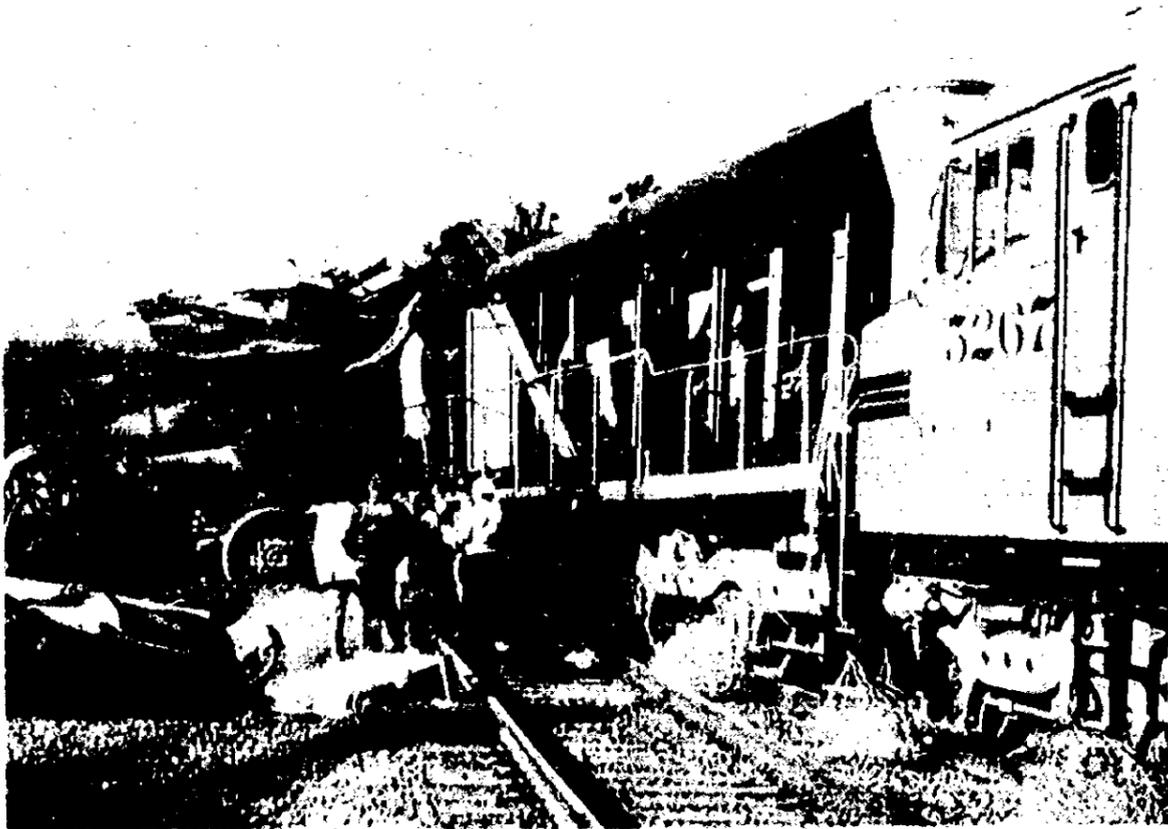
from two ruptured locomotive fuel tanks. The postaccident investigation of this collision revealed that the fuel tanks on both the first and third locomotives of train 891 (fig. 3) were ruptured and their contents released. During the collision, one tank was punctured by a set of wheel trucks, and the other was ruptured either by debris or by the impact of landing on top of the lead locomotive of train 818. Some of the fuel was sprayed into the air, making it highly combustible.

Figure 3.—Damage to fuel tank on third locomotive unit of train 891 at Corona, California.

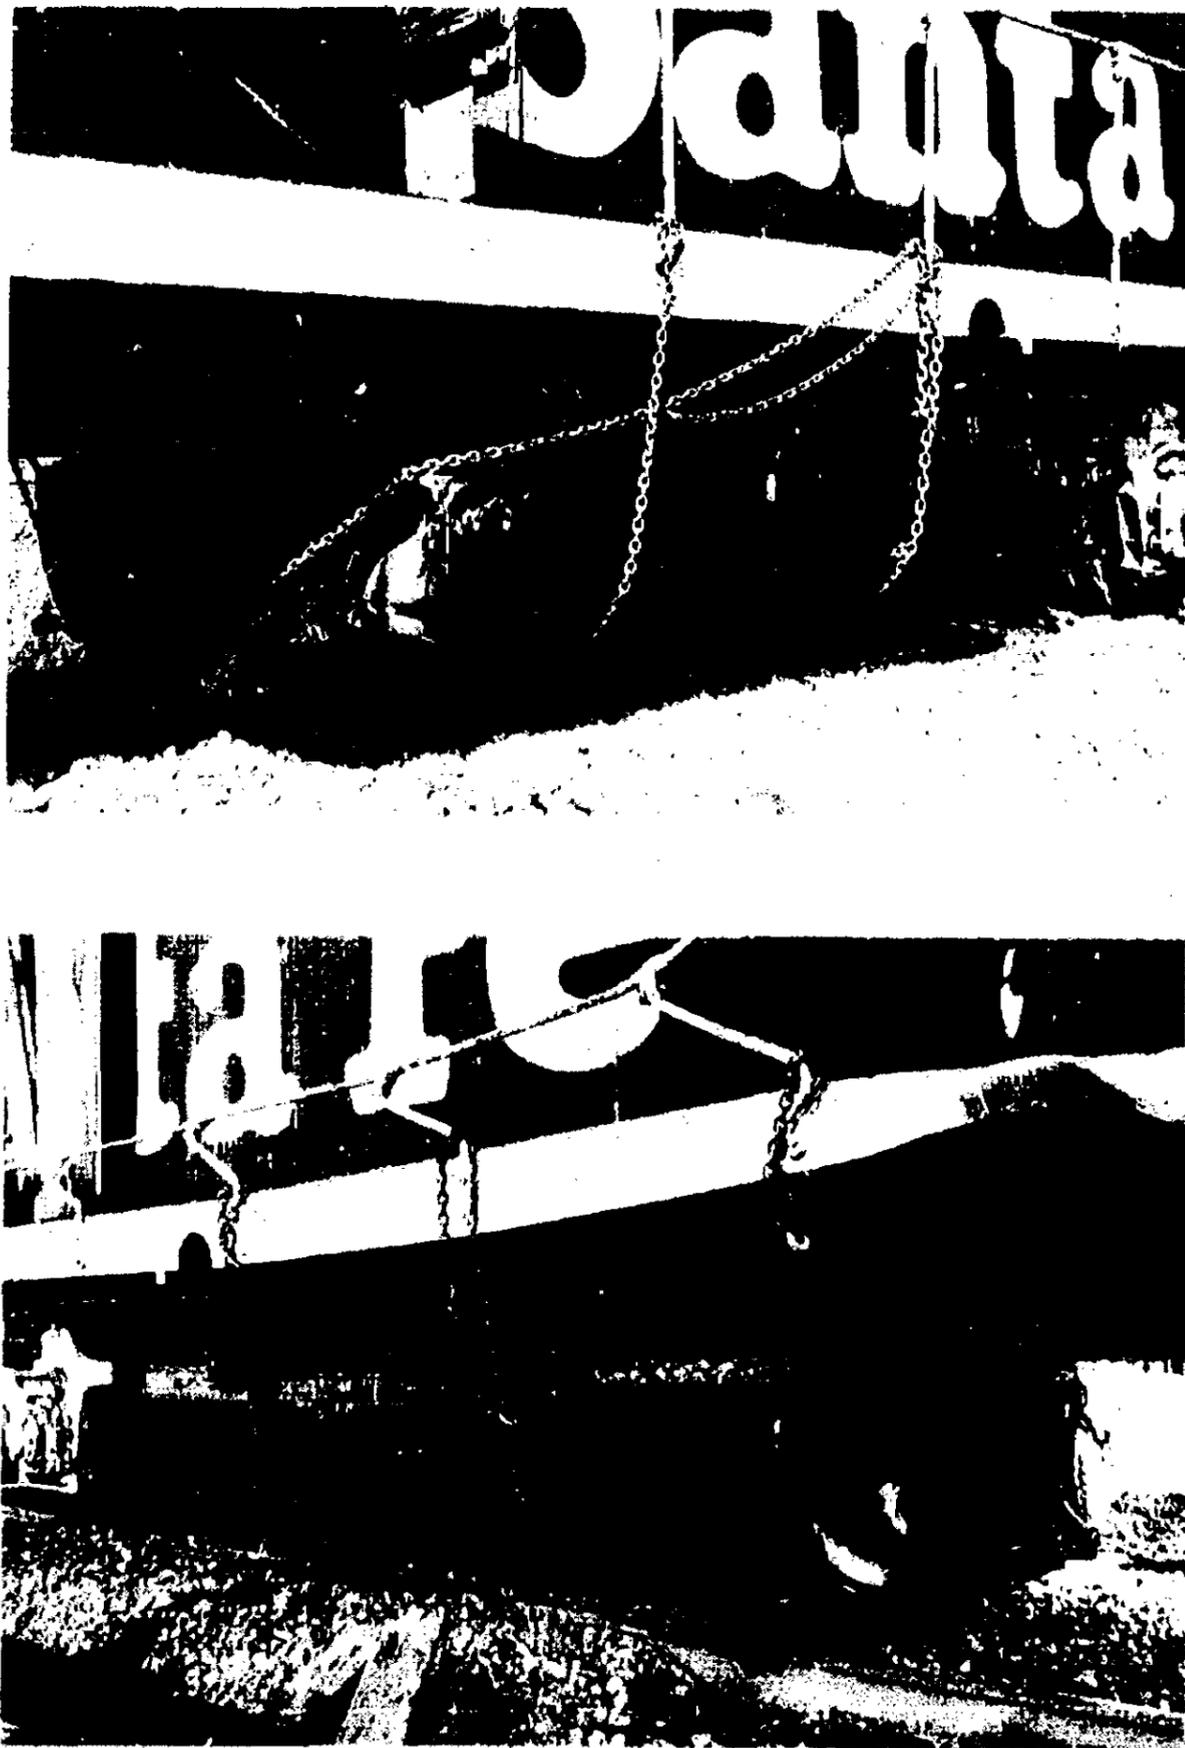
As a result of the collision damage, four of the five fuel tanks involved in the collision were ruptured (the tank on KCS725 was not ruptured), spilling most of the fuel contained therein in the derailment area. No fire occurred. Safety Board investigators examined the traction motor and other electrical cables, some of which were severely damaged and severed. No evidence of arcing at or near the locomotive fuel tanks was observed.

The metallurgical examination revealed no pre-existing corrosion damage. All fractures examined were typical of overstress separations.

Figure 6.—Damage to fuel tank on locomotive unit SP2052 at Kansas City, Missouri.

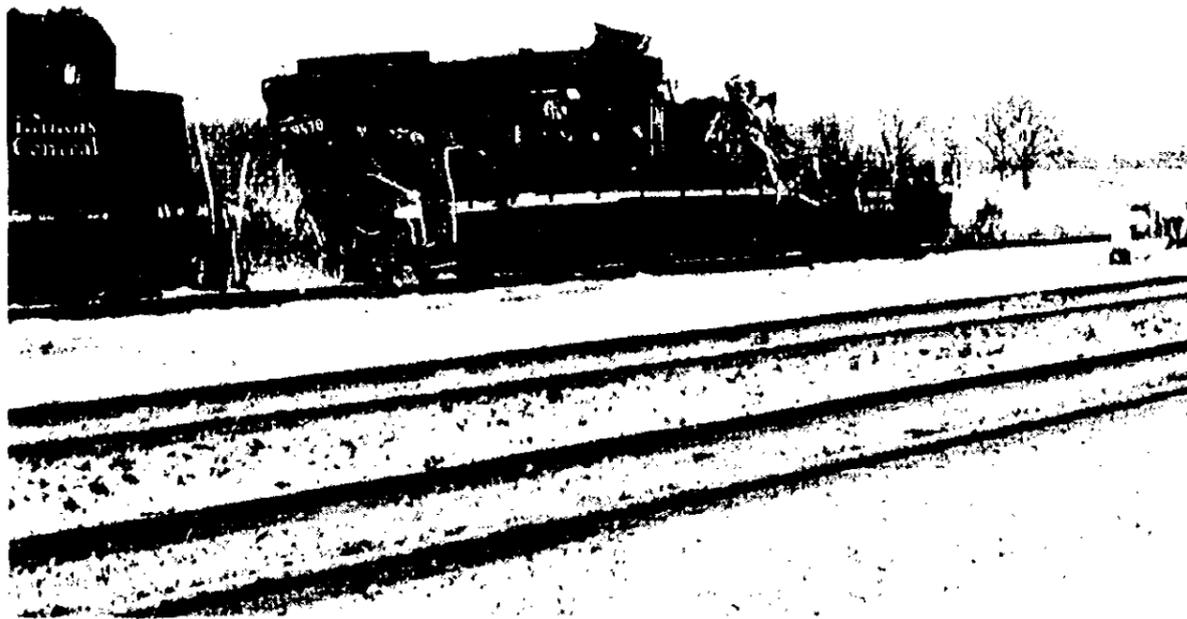
The locomotive units on the southbound train (Extra 3116) struck the opposing consist. The lead locomotive unit of this consist, 3116, overrode locomotive unit 9570 (fig. 8). The fuel tank on the overriding locomotive unit was dented and ruptured (fig. 9). A tear at the tank side and bottom end plate weld occurred. All of the fuel was lost from this tank.

Figure 8.—Damage to overridden locomotive unit 9570 at Fulton, Kentucky.
