Safer Seas 2014

LESSONS LEARNED FROM MARINE
ACCIDENT INVESTIGATIONS

Office of Marine Safety Investigations

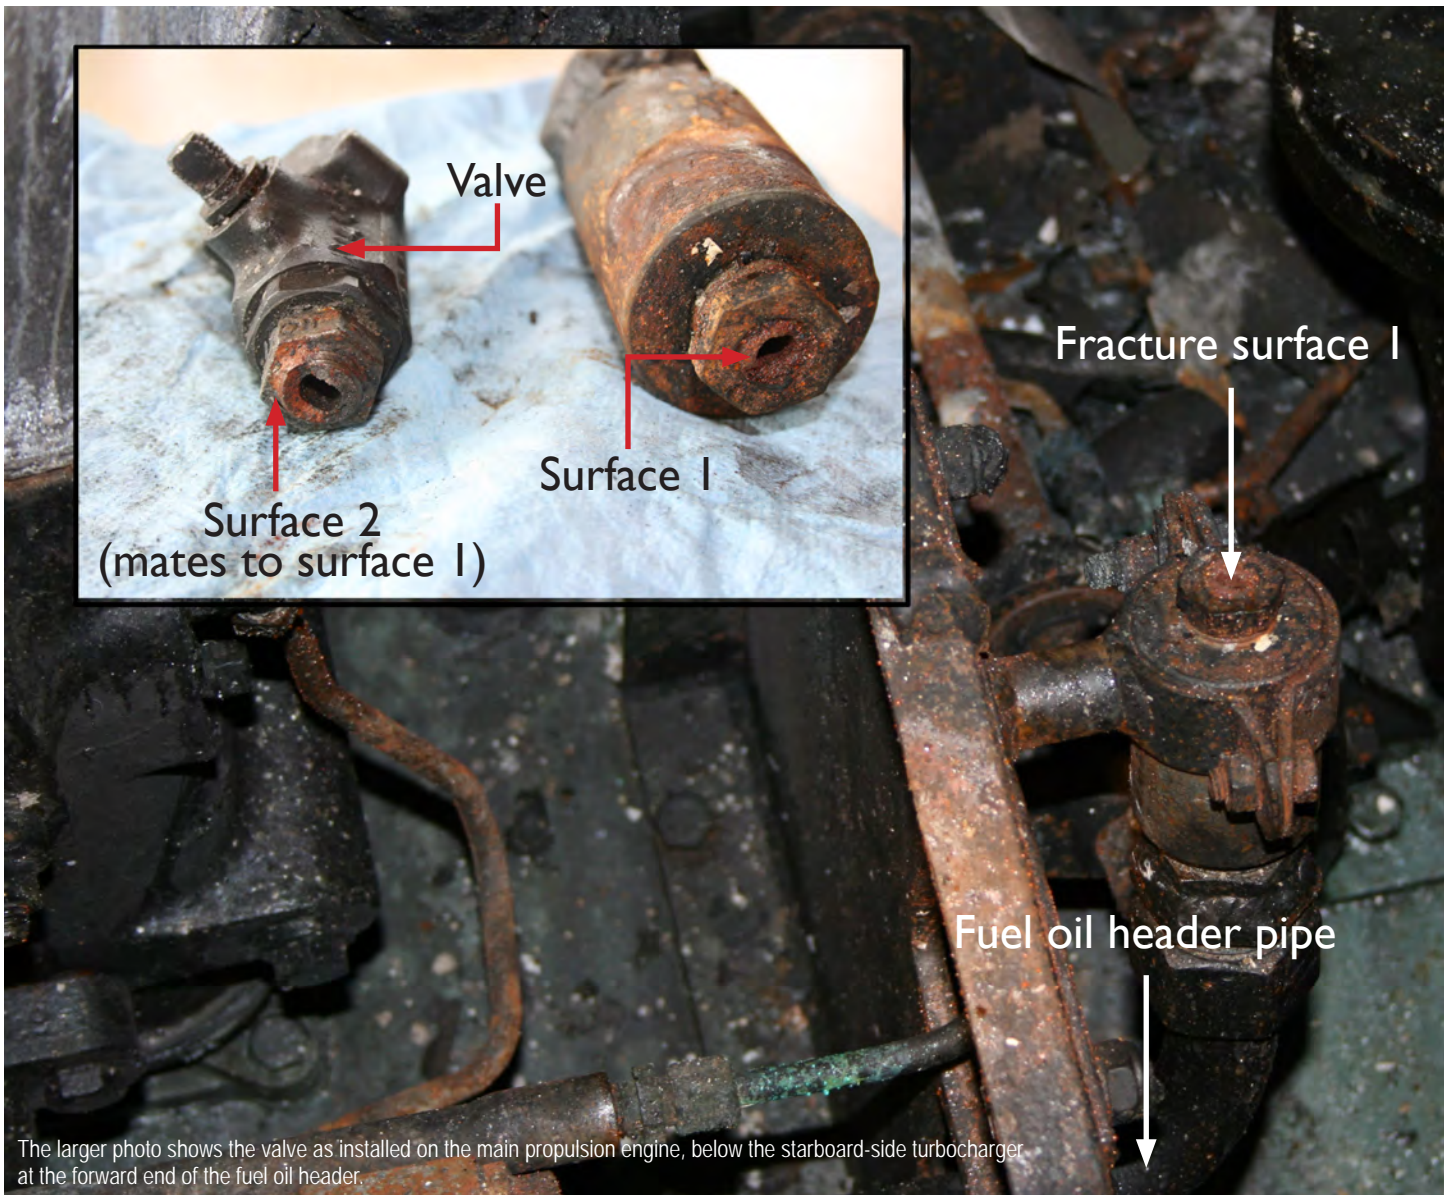
starboard-side fuel oil header near the starboard-side turbocharger. The valve had become detached from the fuel oil piping system as a result of a fracture at its threaded connection fitting. The quarter-inch, 2,000-psi valve had been installed at an elevated position at the forward end of the fuel oil piping system, and it was used to vent air from the system as needed. After the accident, the crew pressure-tested the fuel oil piping system and found no abnormal leaks or openings other than at the vent valve connection.

At the request of the vessel’s insurers, a forensic engineering firm metallurgically examined the fracture surface of the valve fitting. The analysis report indicated

that the fracture resulted from “ductile overload with a torsional component.” The analysis report also found that the appearance of the fracture indicated that “the fitting fractured due to a single load, such as an impact, that caused it to separate.”

The National Transportation Safety Board determines that the probable cause of the fire on board fishing vessel *Arctic Storm* was a fractured fitting on a fuel oil vent valve, located on the main propulsion engine, which resulted in fuel oil spraying onto a hot engine surface and igniting.

The larger photo shows the valve as installed on the main propulsion engine, below the starboard-side turbocharger at the forward end of the fuel oil header.

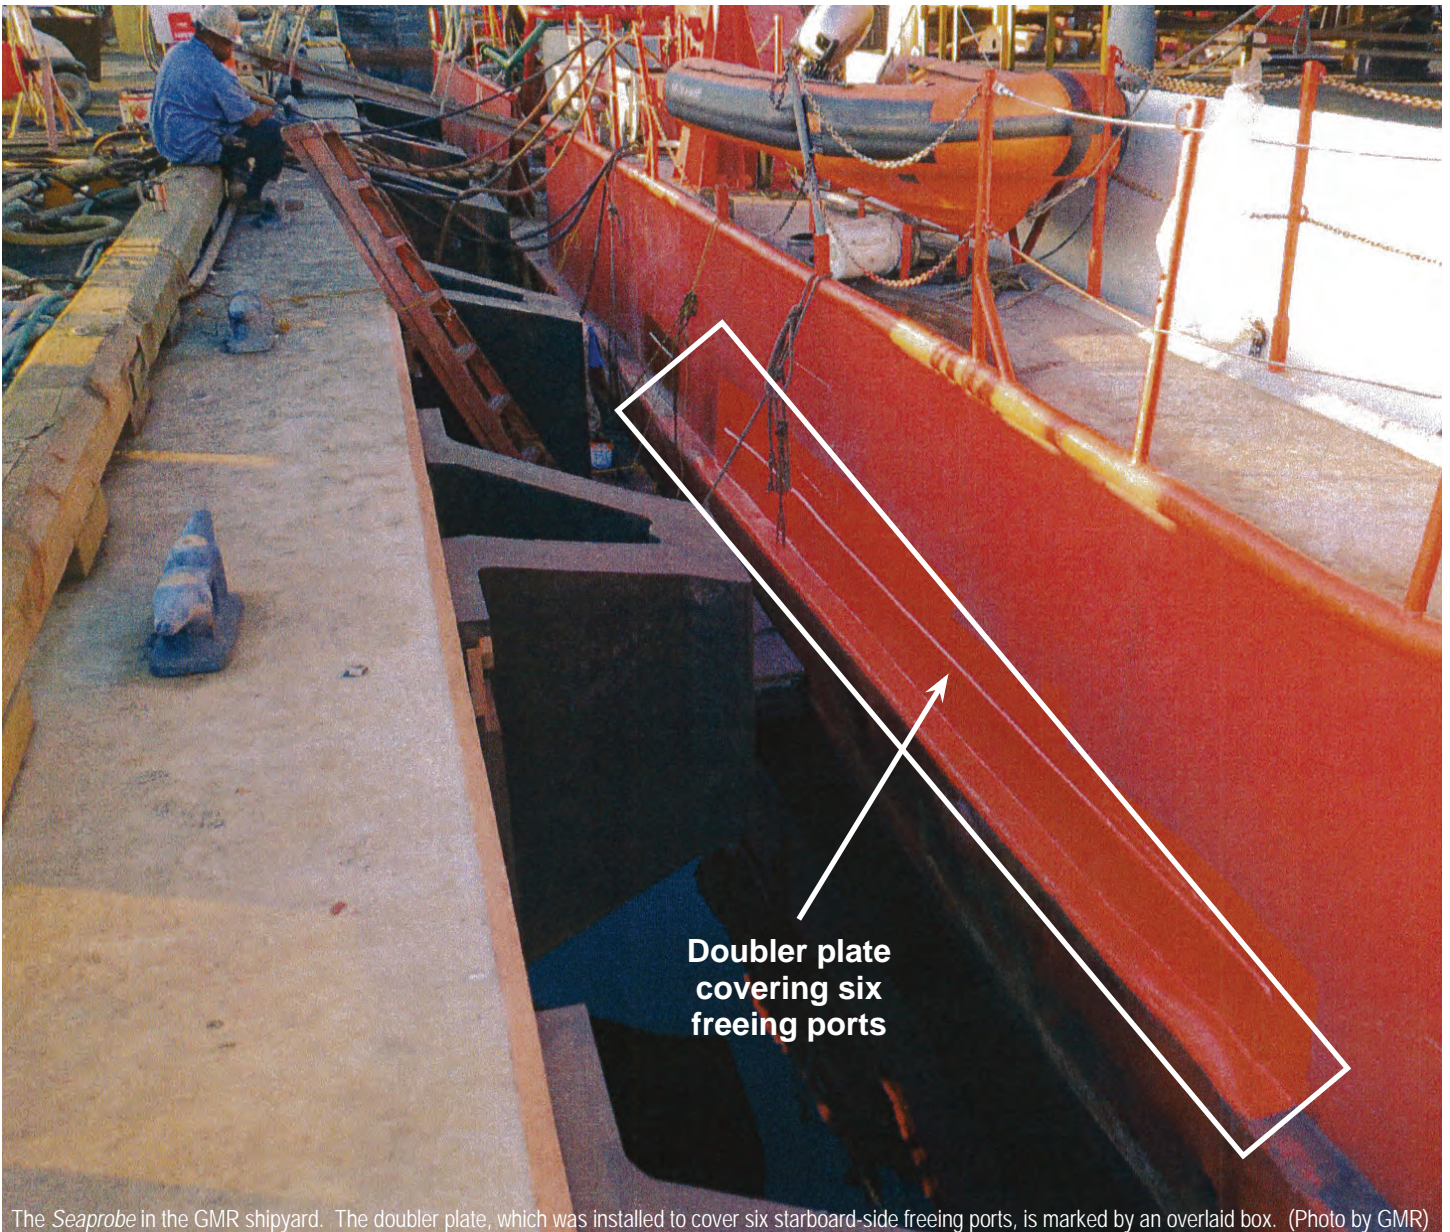
The *Seaprobe* had been conducting work off the coast of South America and was en route to Morgan City, Louisiana, when the crew noted seawater ingress in the vicinity where the starboard engine exhaust pipe exited through the engine room overhead. The crew made temporary repairs including fastening thin sheets of metal to the starboard-side exhaust trunk where the original metal had thinned or disappeared due to corrosion. The exhaust trunk housed exhaust pipes from machinery in the engine room and ran forward horizontally above the deck to the stack.

To better address the flooding, the captain diverted the *Seaprobe* to the Gulf Marine Repair (GMR) shipyard in Tampa, Florida. The GMR shipyard personnel used doubler plates to temporarily repair the starboard engine and generator exhaust pipes housed within the exhaust trunk. The bottom plate of the exhaust trunk was removed to gain access, and the plate was not put back or replaced. The port engineer, who was a representative of the vessel owner and present at the shipyard during the repair work, told investigators that he did not direct the shipyard personnel to replace the bottom plate because he wanted to allow for further examination during the vessel's next scheduled drydock.

The National Transportation Safety Board determines that the probable cause of the flooding and subsequent sinking of the *Seaprobe* was the decision of the vessel

owner to delay making permanent repairs to the starboard-side exhaust trunk and covering six of the vessel's freeing ports, leaving the *Seaprobe* susceptible to downflooding from boarding seas. Contributing to the accident was the owner's failure to comply with the vessel's safety management system and mandatory load line regulations.

The *Seaprobe* in the GMR shipyard. The doubler plate, which was installed to cover six starboard-side freeing ports, is marked by an overlaid box. (Photo by GMR)

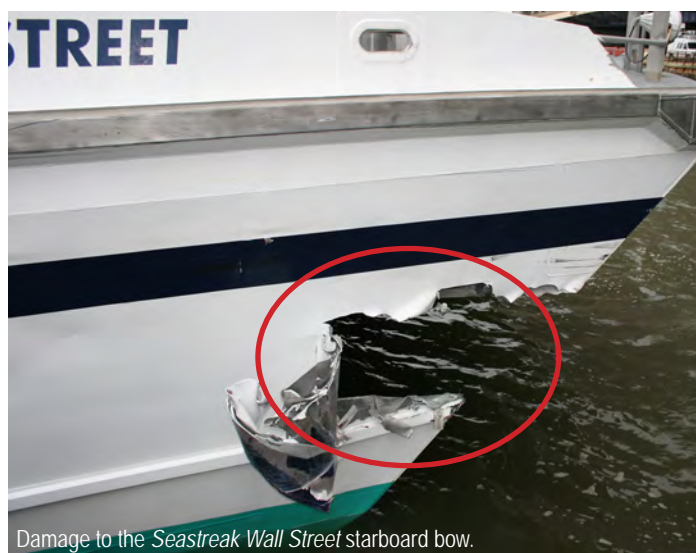
Damage to the *Seastreak Wall Street* starboard bow.

The National Transportation Safety Board determines that the probable cause of the *Seastreak Wall Street's* allision with the pier was the captain's loss of vessel control because he was unaware the propulsion system was in Backup mode. In addition, his usual method of transferring control from one bridge station to another during the approach to the pier did not allow sufficient time and distance to react to the loss of vessel control. Contributing to the accident was Seastreak LLC's ineffective oversight of vessel operations. Contributing to the severity of injuries was Seastreak LLC's lack of procedures to limit passenger access to stairwells on the *Seastreak Wall Street* during potentially high-risk situations such as vessel docking and undocking.

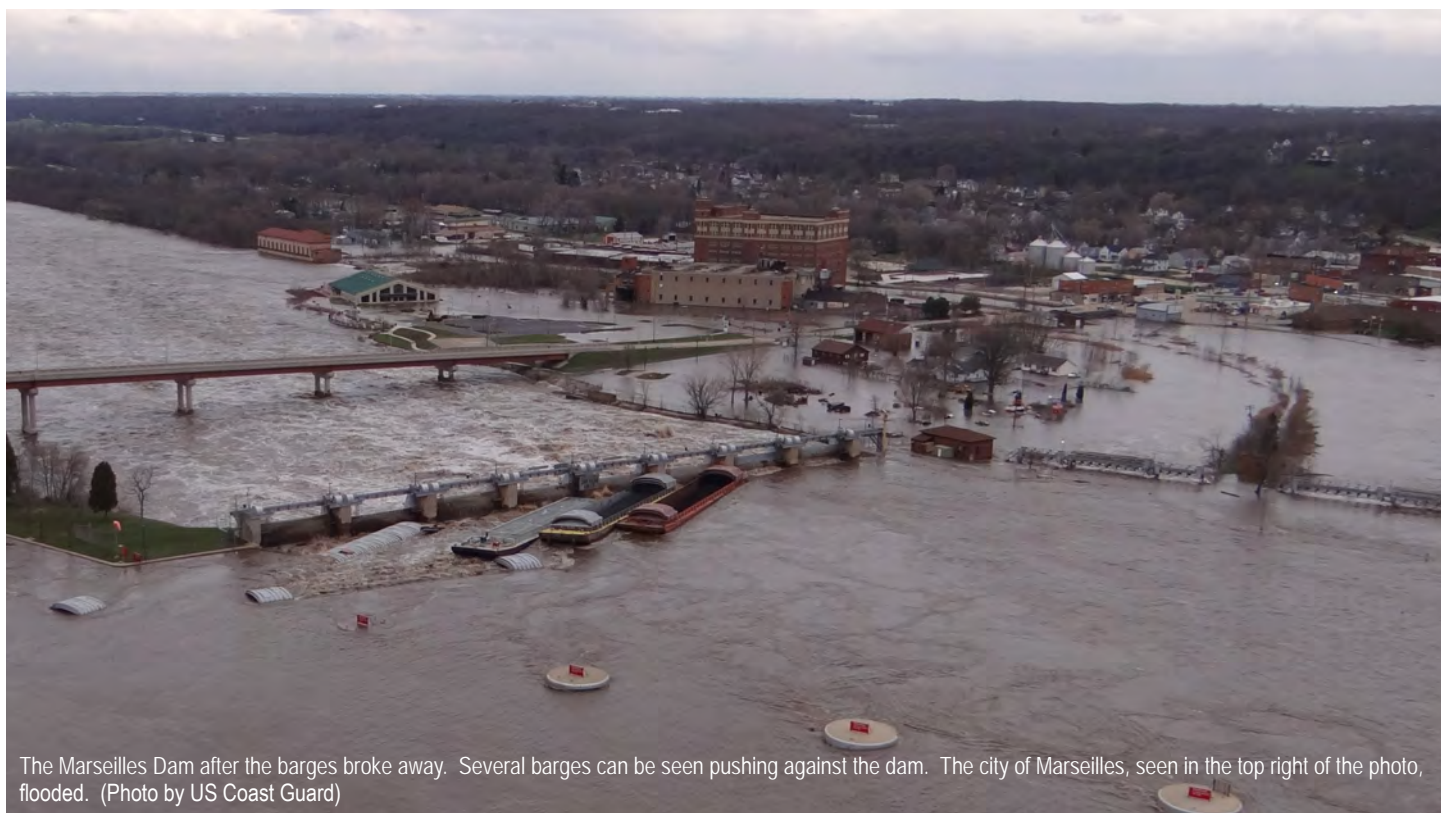
The National Transportation Safety Board determines that the probable cause of the allision of the *Dale A. Heller* tow with the Marseilles Dam was the decision by all involved parties to proceed with the passage of the tow during a period of record high water and significant risk. Contributing to the accident was the failure of the Marseilles Dam lockmaster and the *Dale A. Heller* captain to communicate effectively about the actual positioning of the dam's gates before and during the transit.

The Marseilles Dam after the barges broke away. Several barges can be seen pushing against the dam. The city of Marseilles, seen in the top right of the photo, flooded. (Photo by US Coast Guard)

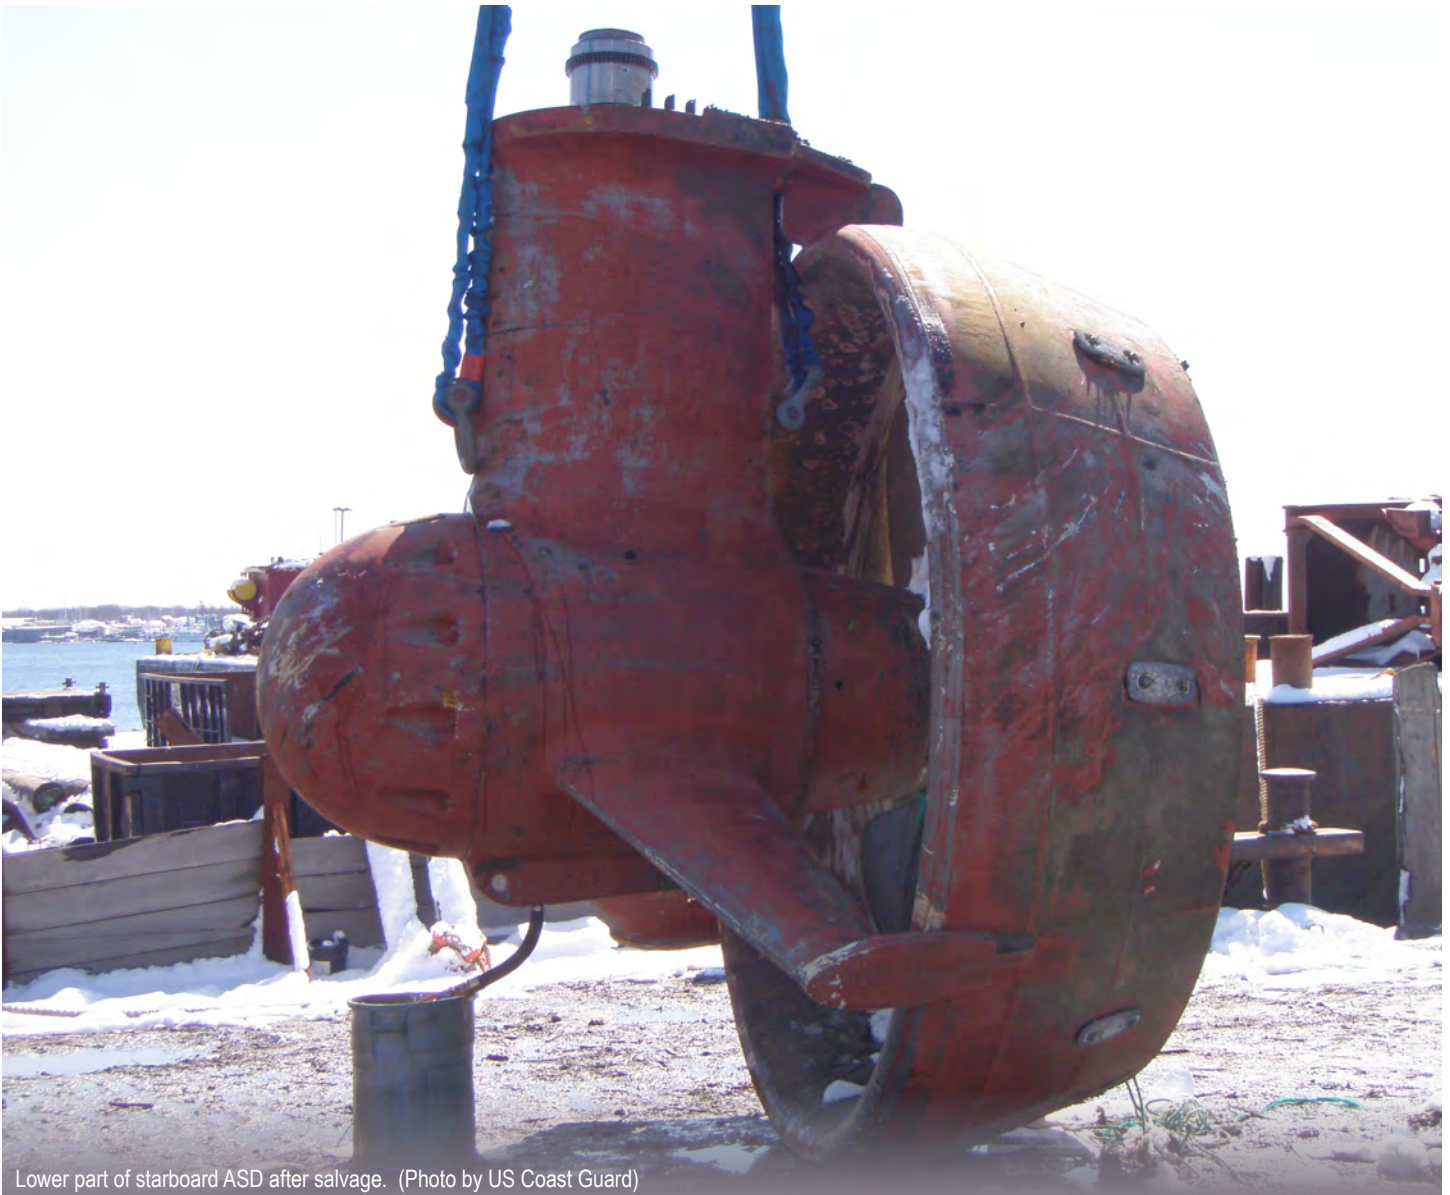
Lower part of starboard ASD after salvage. (Photo by US Coast Guard)

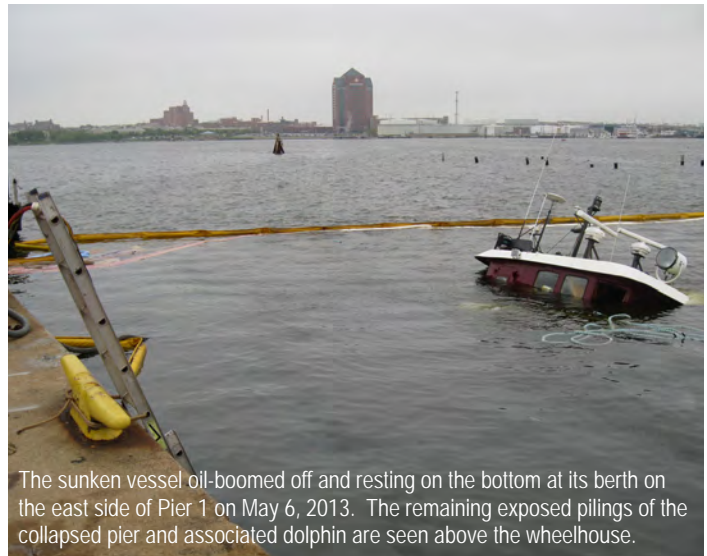
The sunken vessel oil-boomed off and resting on the bottom at its berth on the east side of Pier 1 on May 6, 2013. The remaining exposed pilings of the collapsed pier and associated dolphin are seen above the wheelhouse.

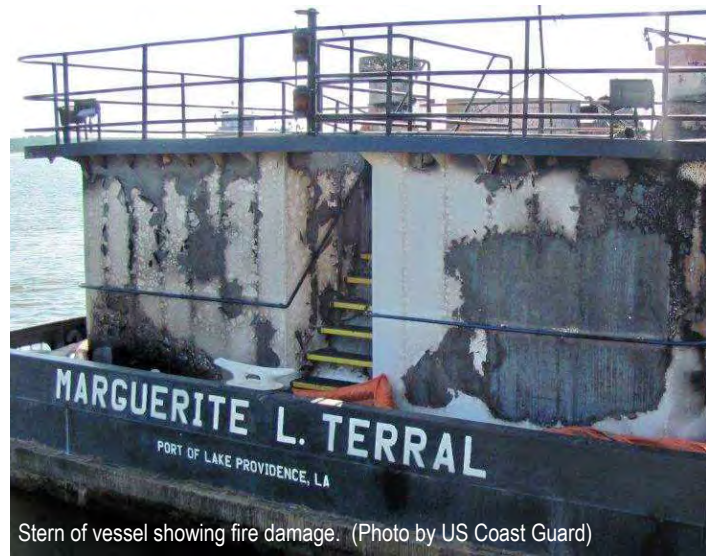
Stern of vessel showing fire damage. (Photo by US Coast Guard)

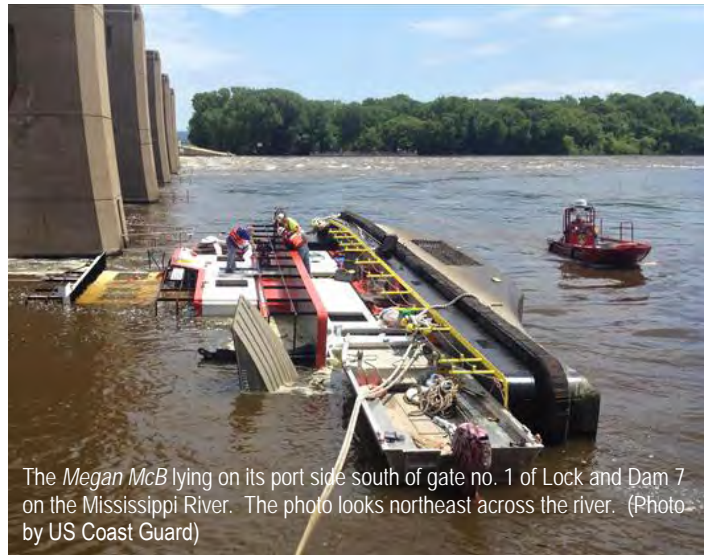
The *Megan McB* lying on its port side south of gate no. 1 of Lock and Dam 7 on the Mississippi River. The photo looks northeast across the river. (Photo by US Coast Guard)

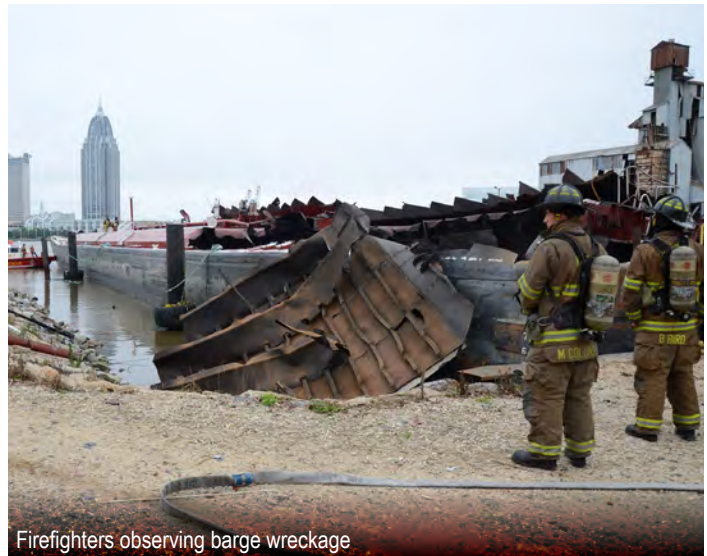
Firefighters observing barge wreckage

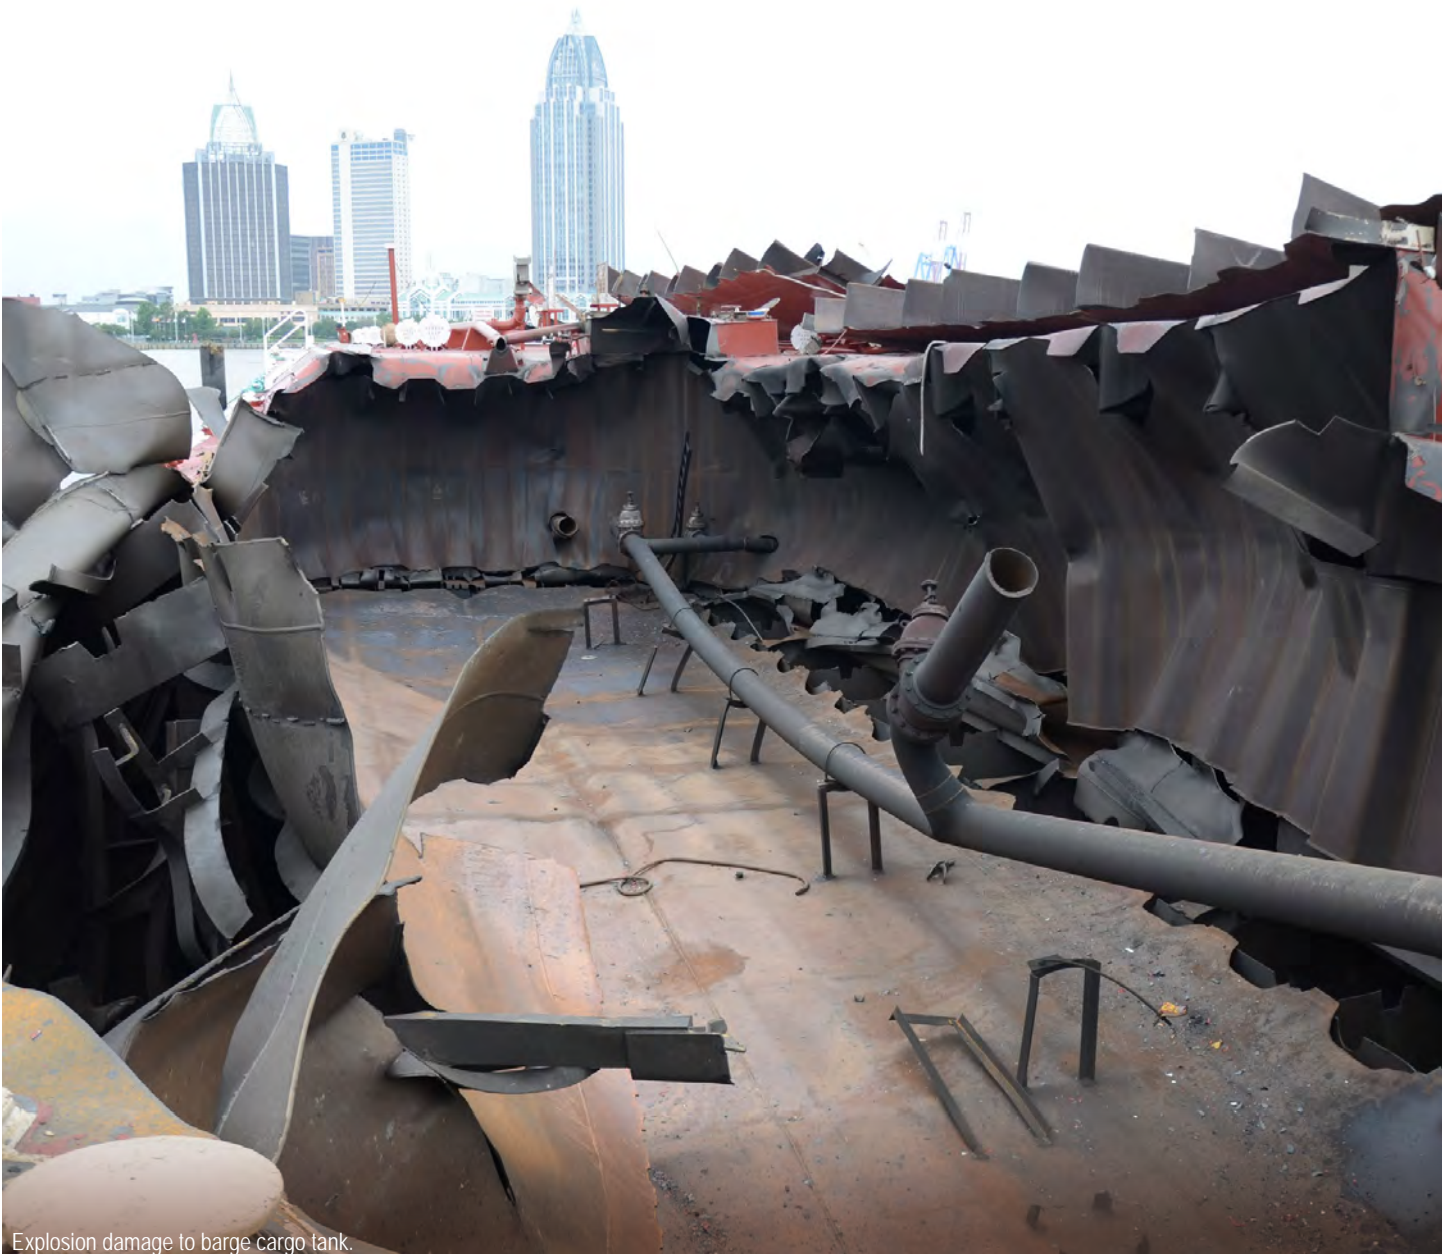
Explosion damage to barge cargo tank.

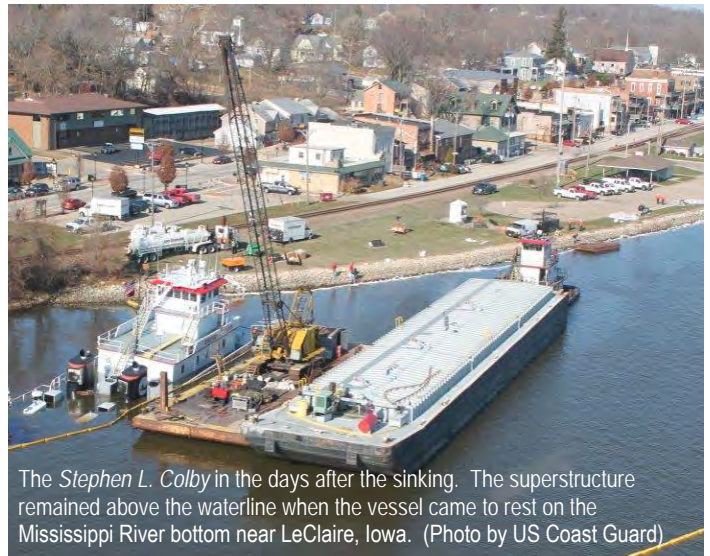
The *Stephen L. Colby* in the days after the sinking. The superstructure remained above the waterline when the vessel came to rest on the Mississippi River bottom near LeClaire, Iowa. (Photo by US Coast Guard)

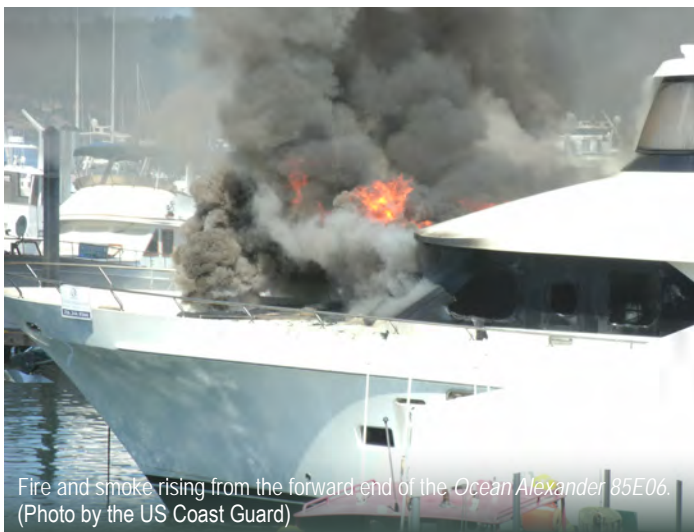
Fire and smoke rising from the forward end of the *Ocean Alexander 85E06*.
(Photo by the US Coast Guard)

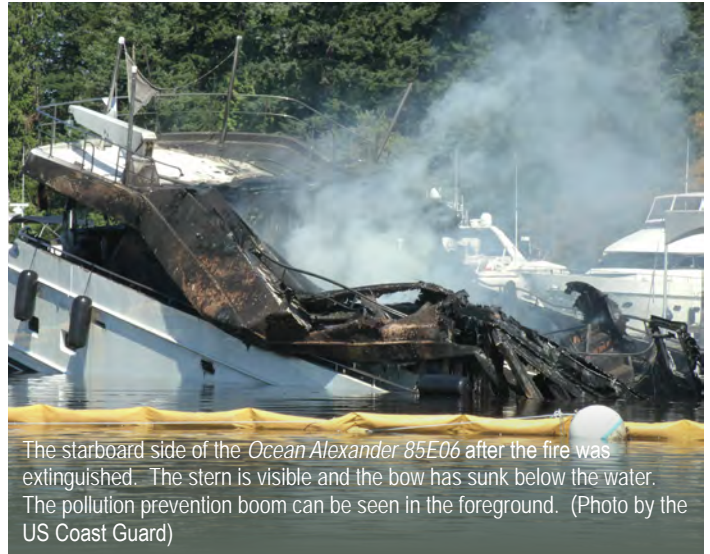
The starboard side of the *Ocean Alexander 85E06* after the fire was extinguished. The stern is visible and the bow has sunk below the water. The pollution prevention boom can be seen in the foreground. (Photo by the US Coast Guard)
