Loss of Control While Maneuvering
Pilatus PC-12/45, N128CM
Butte, Montana
March 22, 2009

Accident Report

NTSB/AAR-11/05
PB2011-910405

**LOSS OF CONTROL WHILE MANEUVERING
PILATUS PC-12/45, N128CM
BUTTE, MONTANA
MARCH 22, 2009**

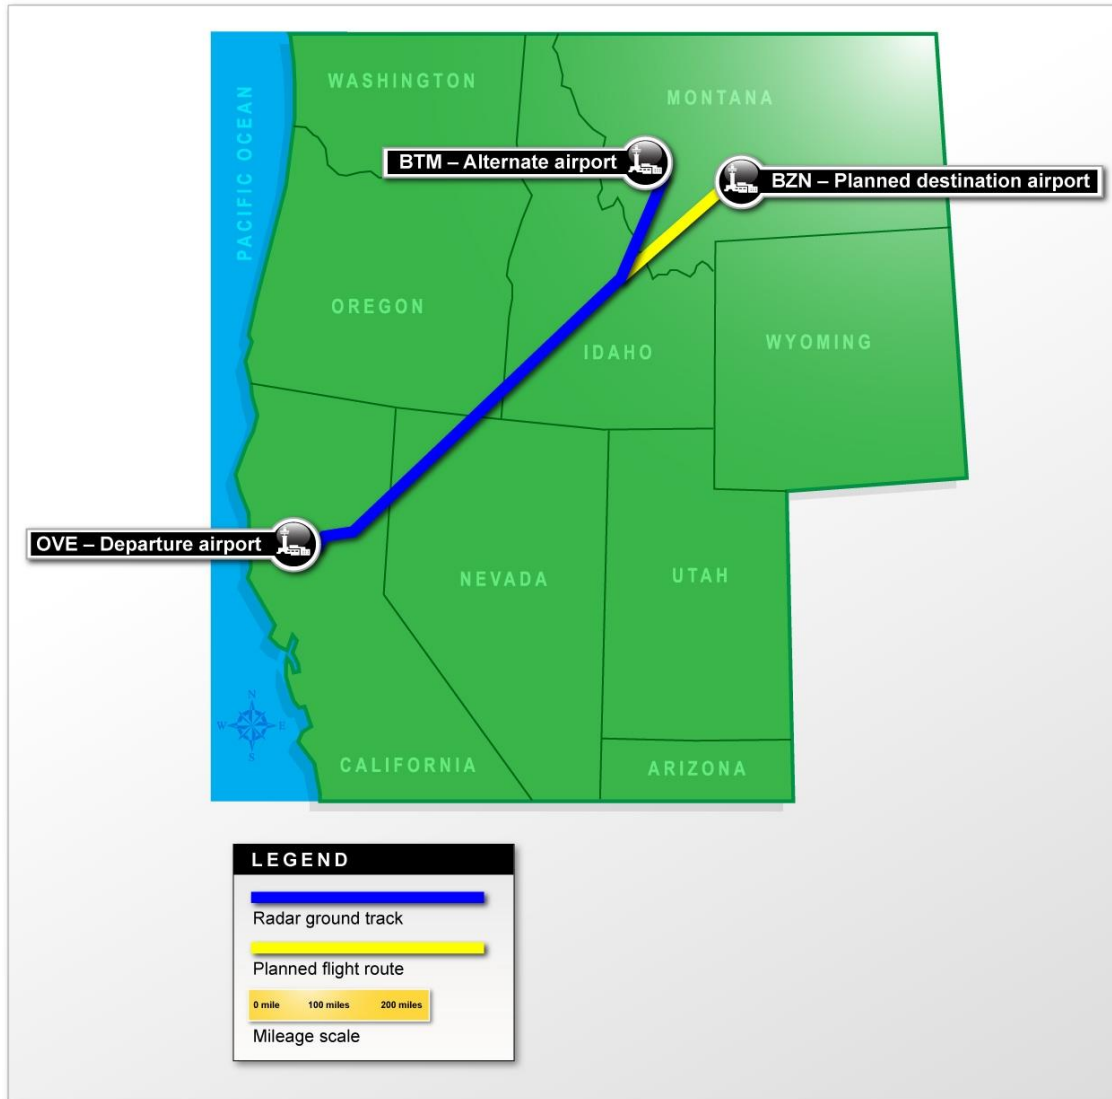
Figure 1. Radar ground track and planned flight route.

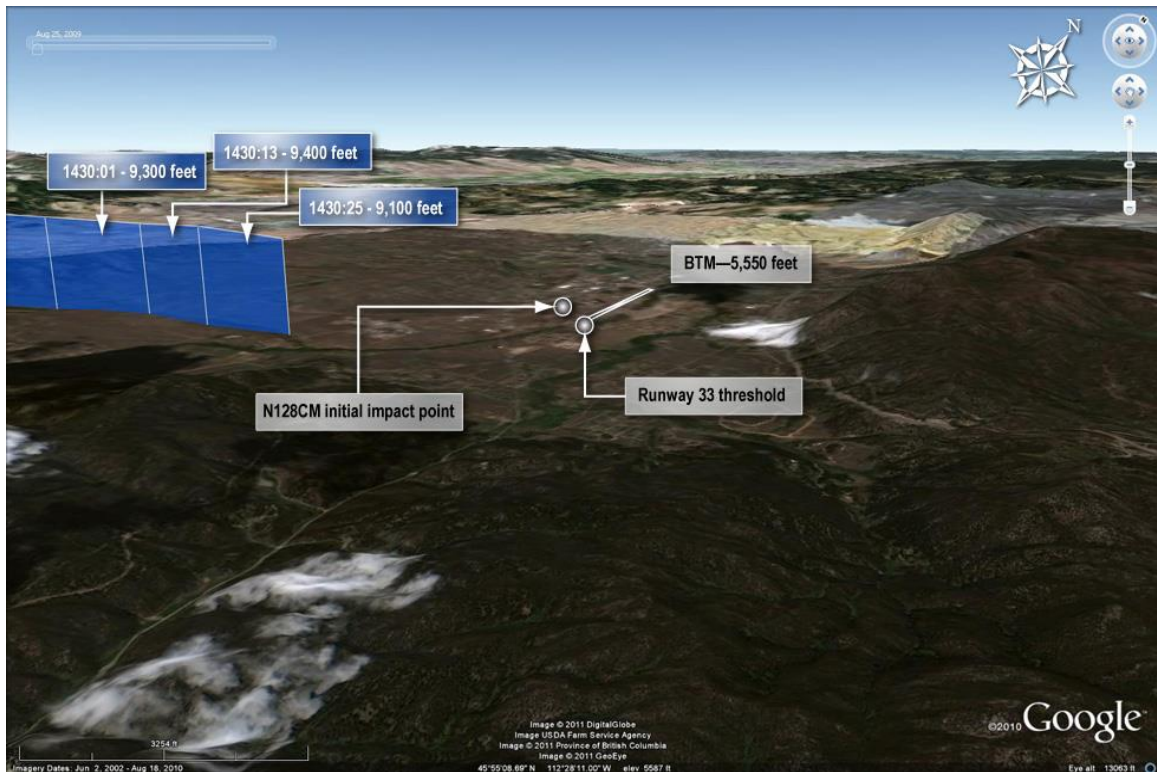
Figure 2. Final radar targets and terrain surrounding Butte, Montana (looking northwest).

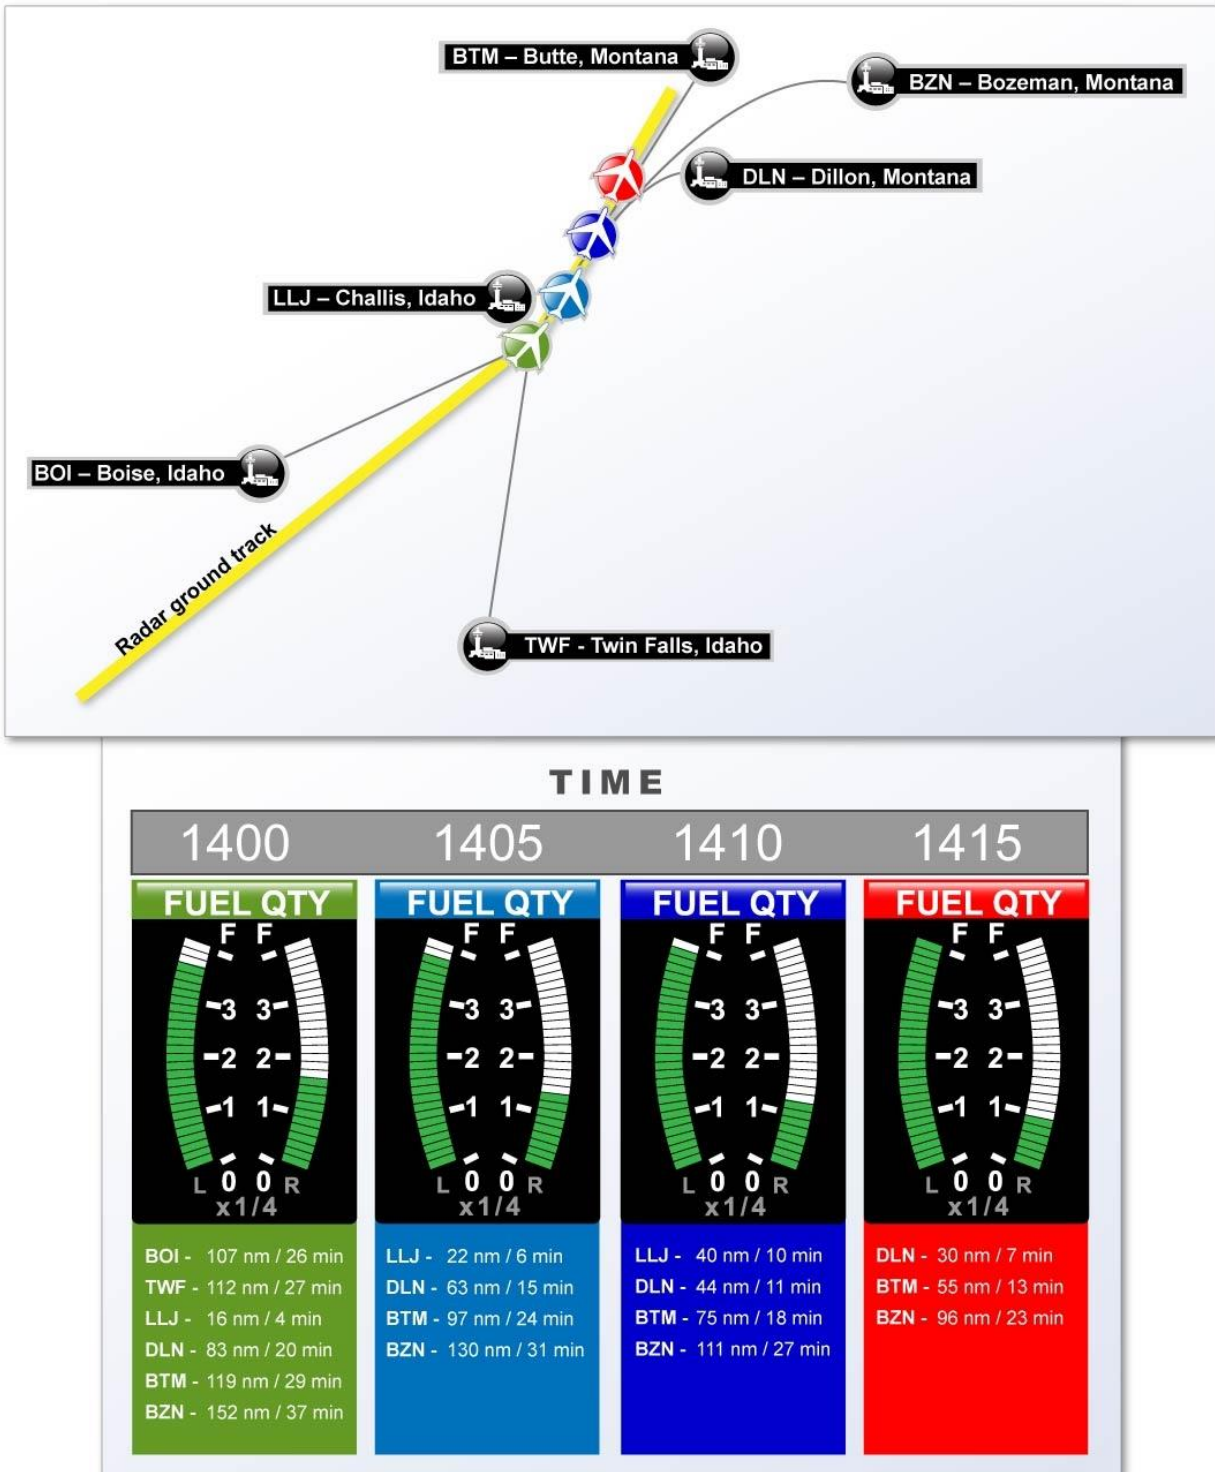
Figure 7. Available airports about the time of the diversion to Butte, Montana.
