Impact with Power Lines
Heart of Texas Hot Air Balloon Rides
Balóny Kubíček BB85Z, N2469L
Lockhart, Texas
July 30, 2016

Accident Report

NTSB/AAR-17/03
PB2018-100161

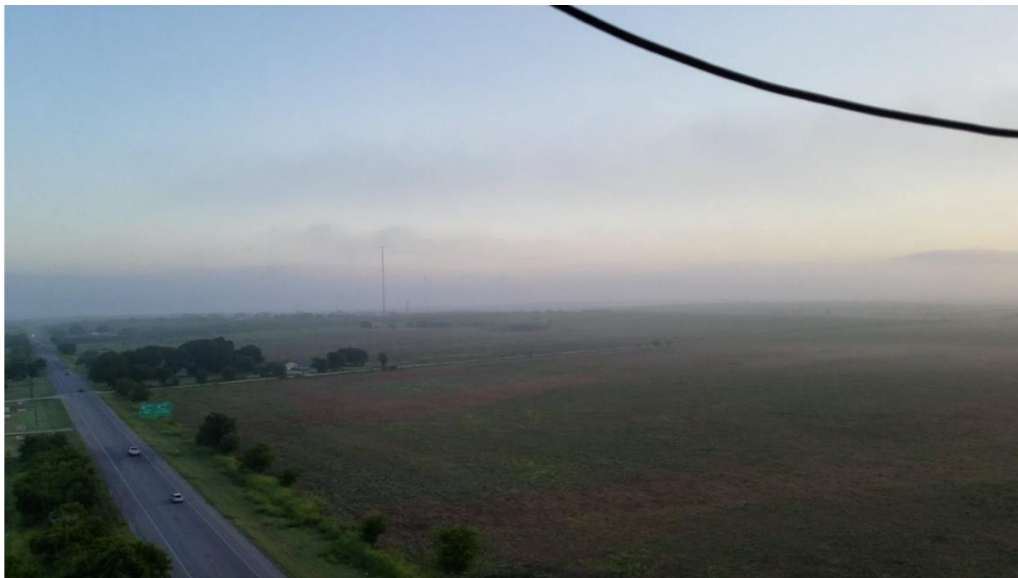
Figure 2. In-flight conditions 2 minutes after launch (about 0700).

Fog and low clouds were visible from the balloon along the flight route within minutes of launch. A passenger photograph taken 2 minutes after launch (about 0700), facing in the direction of travel, showed low clouds and fog (see figure 2). A photograph taken about 0703 showed the balloon much closer to the clouds (see figure 3). The ground crew chief stated that he saw the balloon enter "a little bit of fog" soon after it passed over a tollway (about 1.5 miles north of the launch site) and that the fog became "thicker" until he could only see the basket beneath low clouds; he stated that the basket was just above the treetops at this point. About 0717 (19 minutes after launch), a passenger captured a photograph showing reduced visibility when compared to earlier conditions (see figure 4).

Note: The photograph was taken facing north; fog and low-level clouds can be seen along the route of flight.

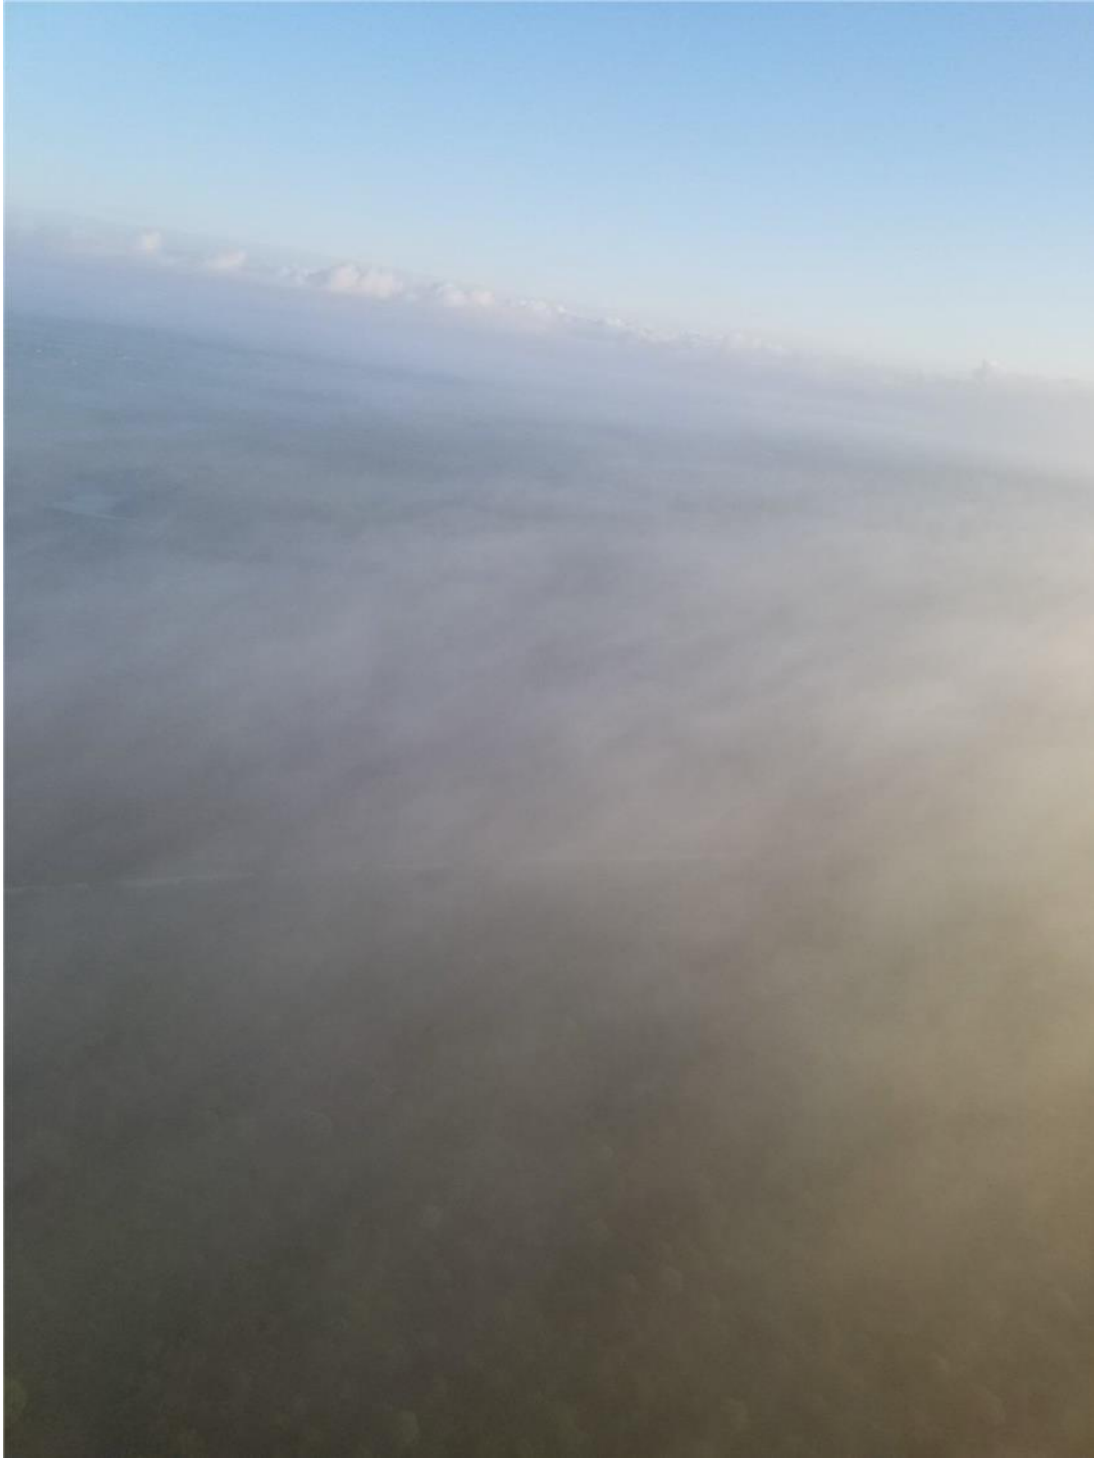
Figure 6. In-flight conditions 26 minutes after launch (about 0724).

Note: The ground is again visible through thin clouds.

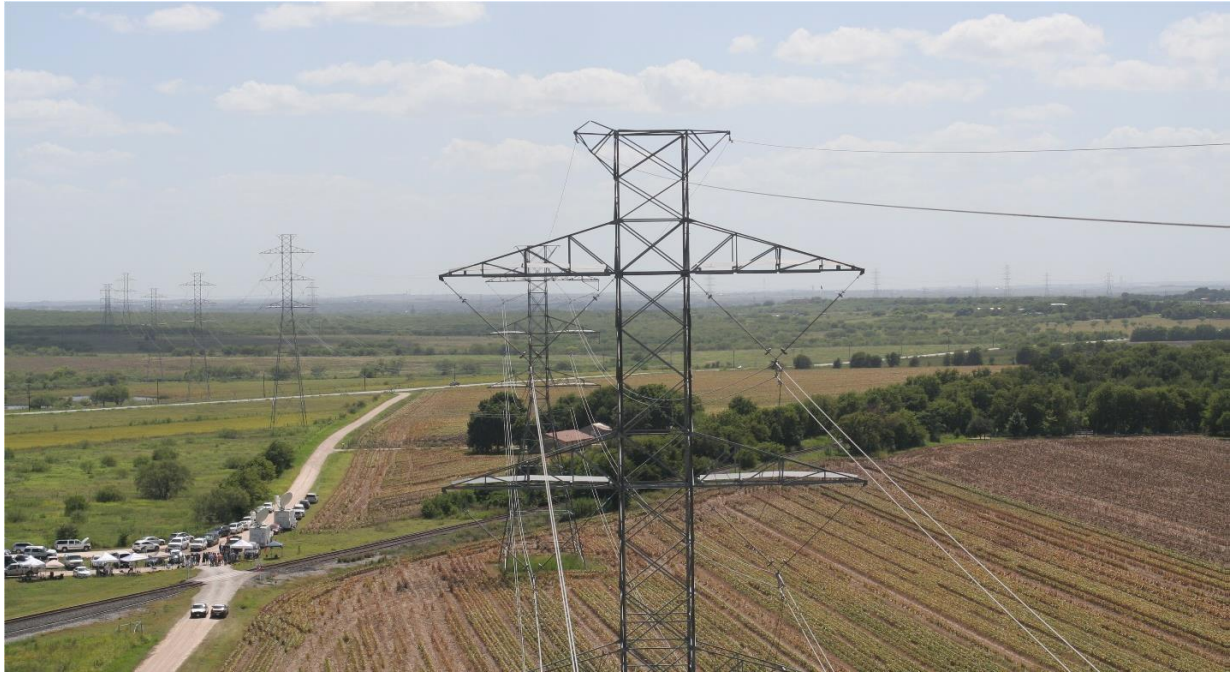
Figure 10. Power lines at the accident site.

The crash site was located about 8 miles north of the launch site in an open field crossed by power lines. The power lines were oriented east/west, nearly perpendicular to the balloon’s flightpath. The lines were configured with a single, noncharged, grounded line on each side at the top with three phased pairs of charged lines below on each side (see figure 10). The balloon’s basket was located beneath the power lines. The balloon’s burner assembly and envelope were located about 0.5 mile downwind (north) of the basket (see section 1.6 for wreckage and impact information).
