# AIRCRAFT ACCIDENT REPORT

LOS ANGELES AIRWAYS, INC.

S-61L HELICOPTER, N300Y

COMPTON, CALIFORNIA

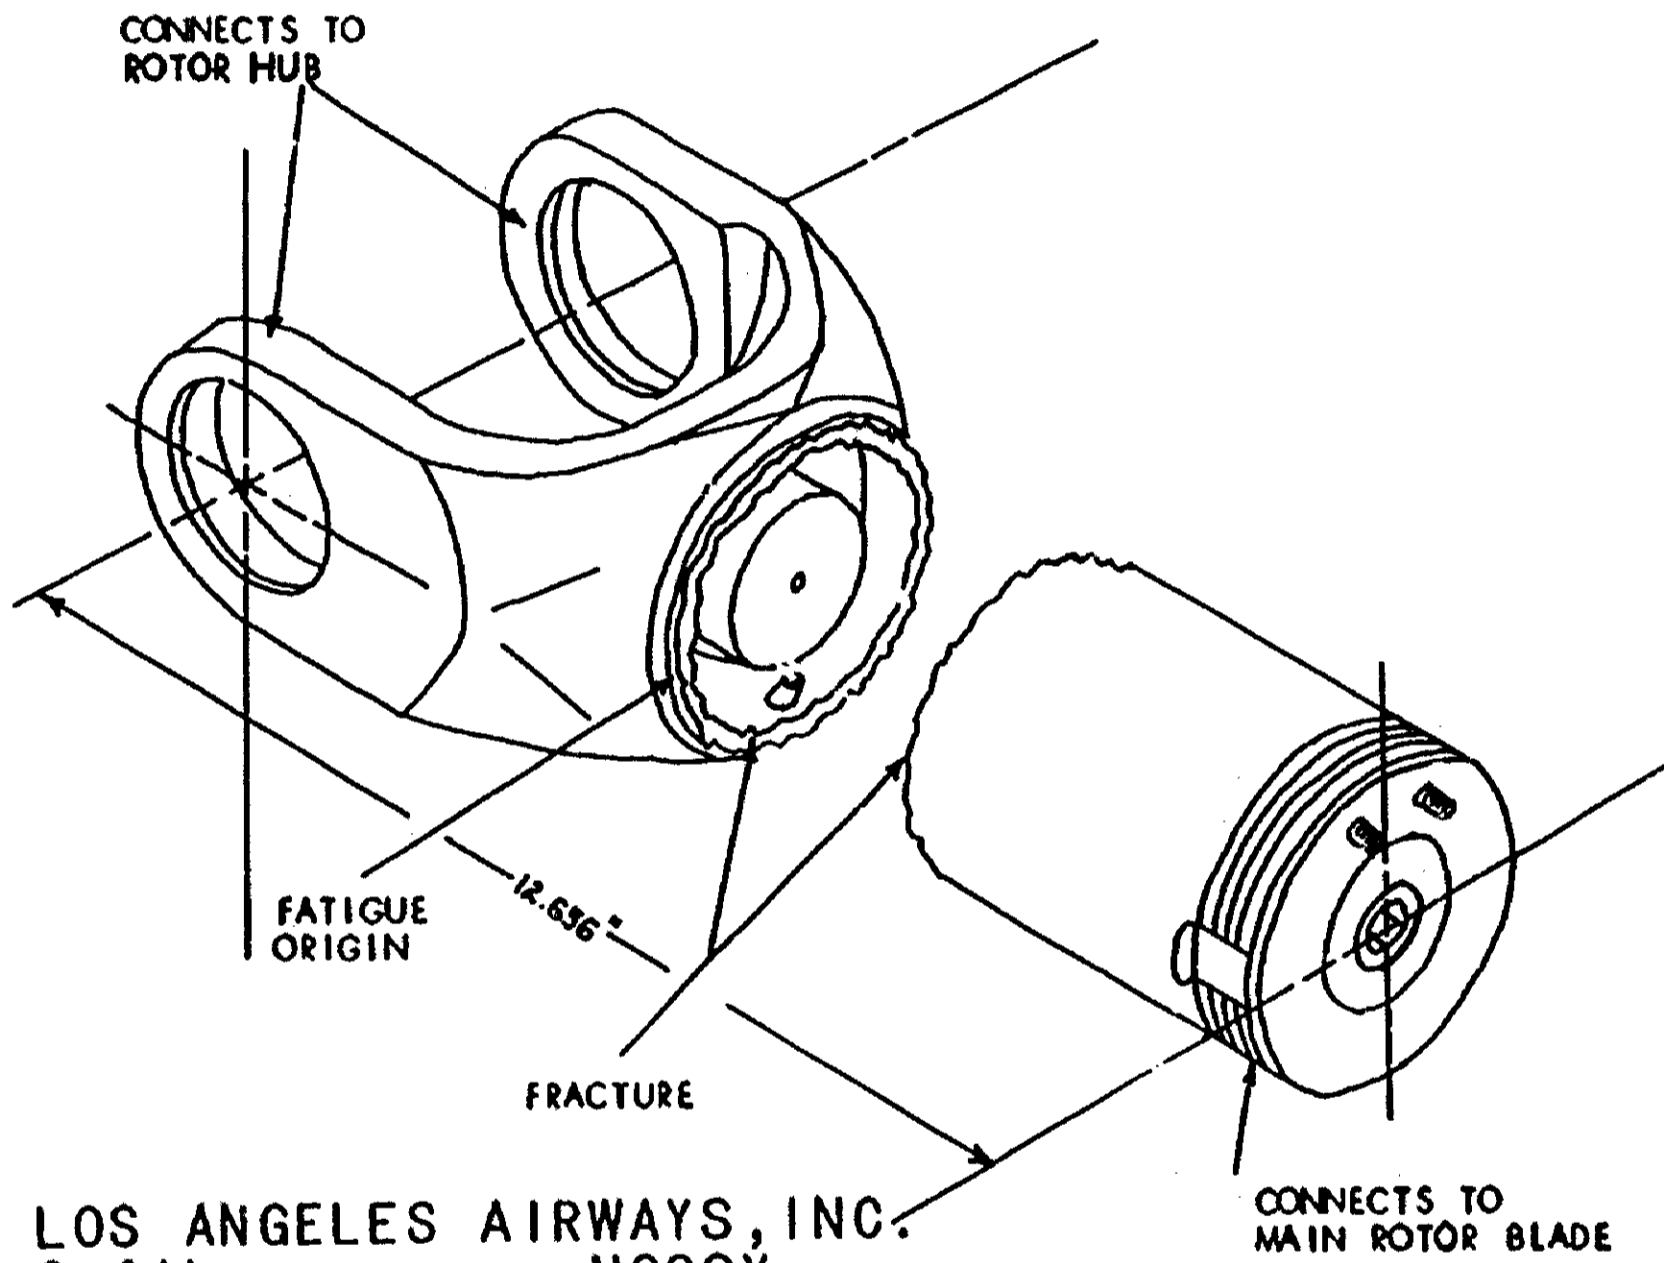
ATTACHMENT I  
MAIN ROTOR SPINDLE  
PART NO. S6110-23325-2B

The Safety Board determines that the probable cause of this accident was the fatigue failure of the yellow main rotor blade spindle, causing separation of the blade which made the aircraft uncontrollable. The fatigue crack originated in an area of substandard hardness and inadequate shot peening.

assembly were located in the main impact area. The fifth main rotor blade (yellow) including the sleeve and part of the spindle, was located approximately one quarter of a mile northwest of the main wreckage site. Minor parts associated with this rotor blade were scattered over a three-block area northwest of the park. Examination of the yellow blade spindle (S/N AJ19) revealed a fatigue fracture in the shank of the spindle adjacent to the shoulder at the inboard end of the shank. (See Attachment 1.)

A stereomicroscope examination of spindle AJ-19 revealed that the nucleus of the fatigue fracture was on the trailing side of the spindle, one-eighth of an inch below the centerline, approximately at the shank tangency point, with the 0.125 inch radius at the shank/fork junction. The crack had originated in the base metal surface at the interface with the nickel plating, and propagated through approximately 72 percent of the shank cross-section prior to the failure. Additional laboratory studies revealed the following factors associated with the development of the fatigue crack:
