NATIONAL
TRANSPORTATION
SAFETY
BOARD

AIRCRAFT ACCIDENT REPORT

DOUGLAS DC-3, N142D

NEW ORLEANS INTERNATIONAL AIRPORT

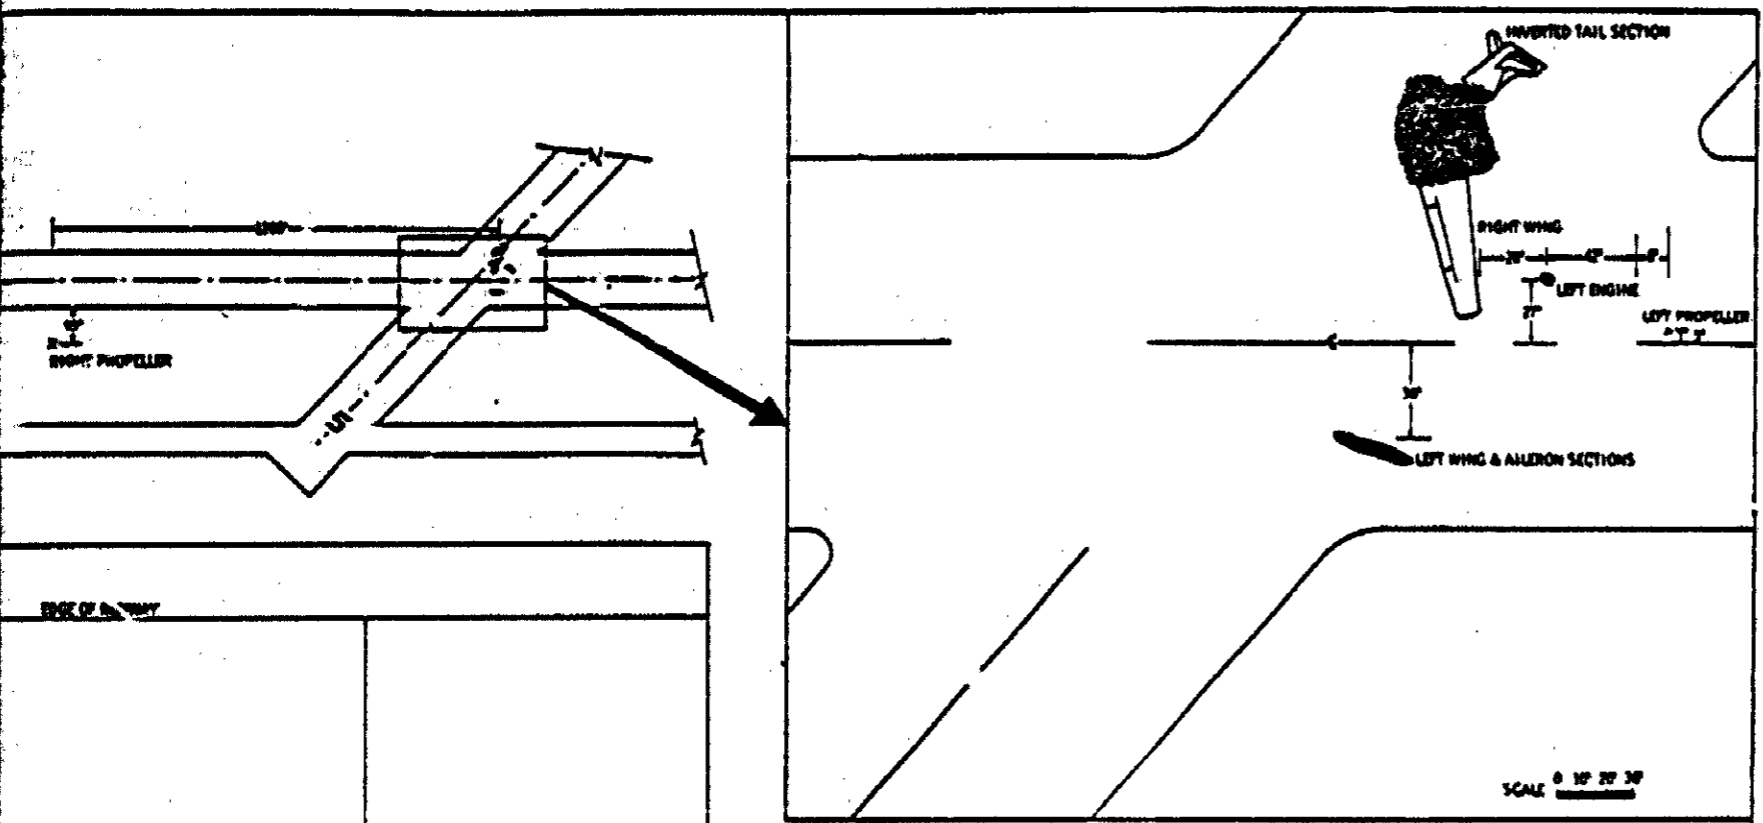
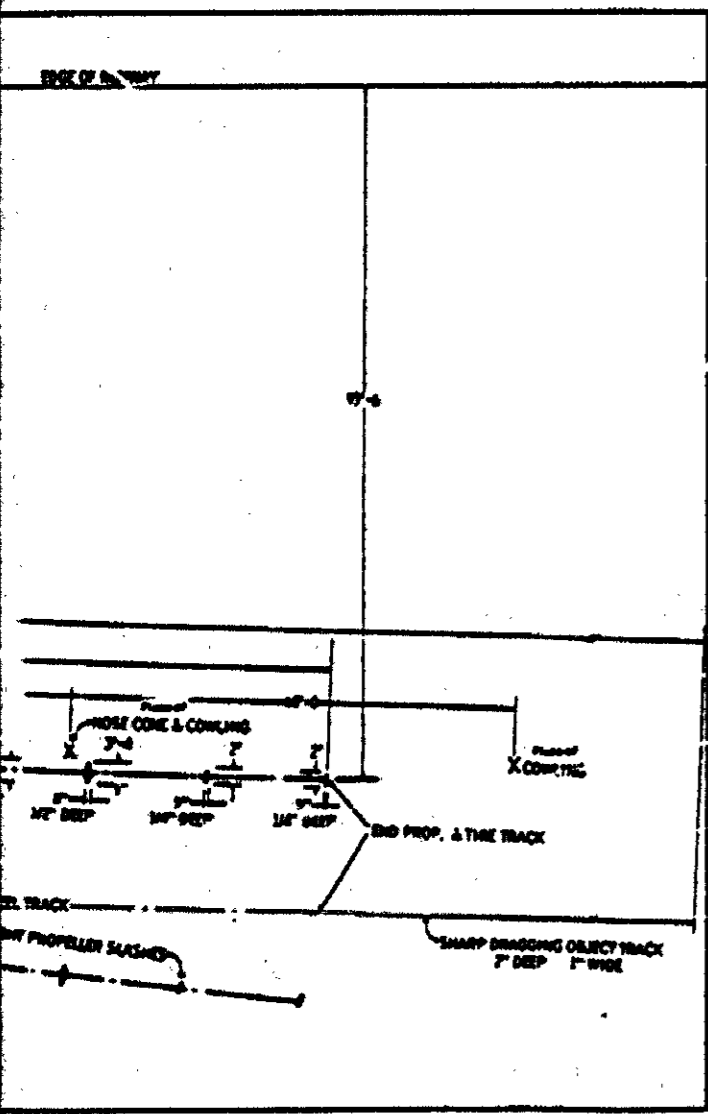
ATTACHMENT NO. 1

The first indication of ground contact was found on Runway 10 at a point 1,198 feet beyond the runway approach end. Two tire scuff marks, 18 feet 8 inches apart, centerline to centerline, were evident. These marks proceeded toward the right side of Runway 10 at an angle of approximately 25°. (See Attachment No. 1, Runway Marks and Wreckage Distribution Chart for details.)

The second indication of ground contact was found 3,100 feet beyond the initial ground contact marks and 87 feet 9 inches right of the right edge of Runway 10. These second marks, consisting of tire scuff marks and propeller slash marks, were found on a taxiway. They began at a point 10 feet 5 inches from the east edge of the north-south oriented taxiway and continued off the taxiway and onto the ground in an eastward direction parallel to Runway 10. The scuff and propeller slash marks proceeded for a distance of 173 feet 9 inches, at which point the tire and propeller slash marks ended. However, a sharply defined groove, 2 inches wide and 1 inch deep, continued in the ground beyond the right landing gear track to a point 259 feet 11 inches from the start of the marks on the taxiway.

The next indication of ground impact was scrape and scuff marks on Runway 10 near the junction of Runways 5 and 10. These marks terminated under the main wreckage, which had come to rest on the north side of the junction. A red glass-like substance was imbedded in one of the scrape marks. This material was similar to the broken red cover from the left wingtip light.
