# AIRCRAFT ACCIDENT REPORT

CAPITOL INTERNATIONAL AIRWAYS, INC.

DC-8-63F, N4909C  
Anchorage, Alaska  
November 27, 1970

REPORT NUMBER: NTSB-AAR-72-12

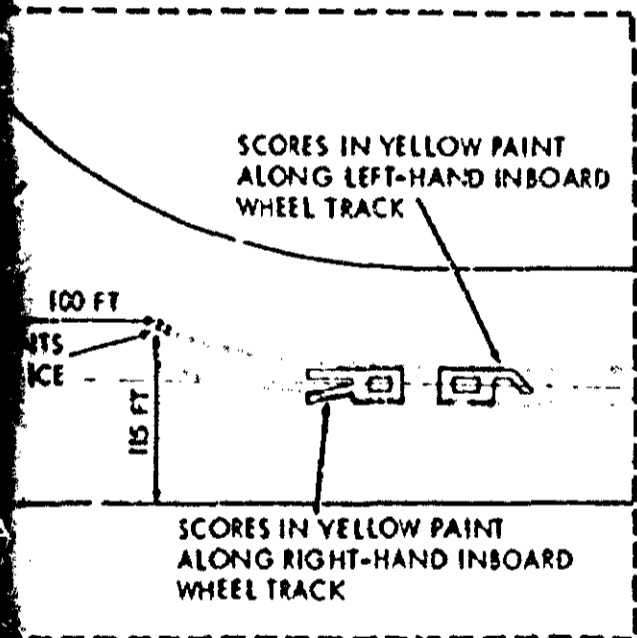
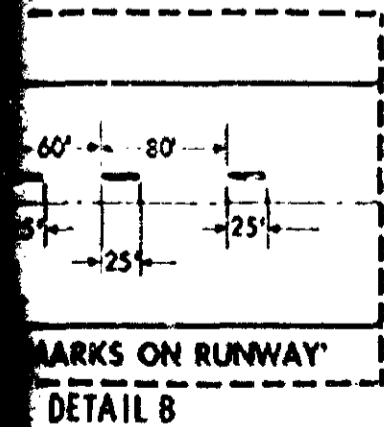
MARKS ON RUNWAY  
DETAIL B

By 4,300 feet, each left-hand track was reduced to two narrow bands (each approximately 2 inches in width) on the outside edges of the track. In this same area were found the first pieces of nonal rubber. Parts of both tire caps and carcasses were identified.

The right-hand tracks were also reduced to narrow bands, similar to those described above, at a point approximately 8,700 feet beyond the static footprint. In that same area, a piece of tire bead from a right-hand inboard tire was found wedged into a centerline runway light.

APPROX. WIDTHS OF TIRE TRACKS

LHOB	LHIB	RHIB	RHOB
LINE-UP	12"	12"	13"	12"
1000 FT.	12"	13"	16"	14 1/2"
3000 FT.	12"	-	18"	14"
4400 FT.	BEAD MARKS	-	-	-
8800 FT.	BEAD MARKS & RIM MARK ON	-	-	-
	☉ LIGHTS
