1. Report No. NTSB-AAR-74-4	2. Government Accession No.	3. Recipient's Catalog No. PB- 232 360	
4. Title and Subtitle Aircraft Accident Report - Texas International Airlines, Inc., CV-600, N94230, Mena, Arkansas, September 27, 1973		5. Report Date April 11, 1974

**TEXAS INTERNATIONAL AIRLINES, INC.
CONVAIR 600, N94230
MENA, ARKANSAS**

SEPTEMBER 27, 1973

**NATIONAL TRANSPORTATION SAFETY BOARD
Washington, D.C. 20591
REPORT NUMBER: NTSB-AAR-74-4**

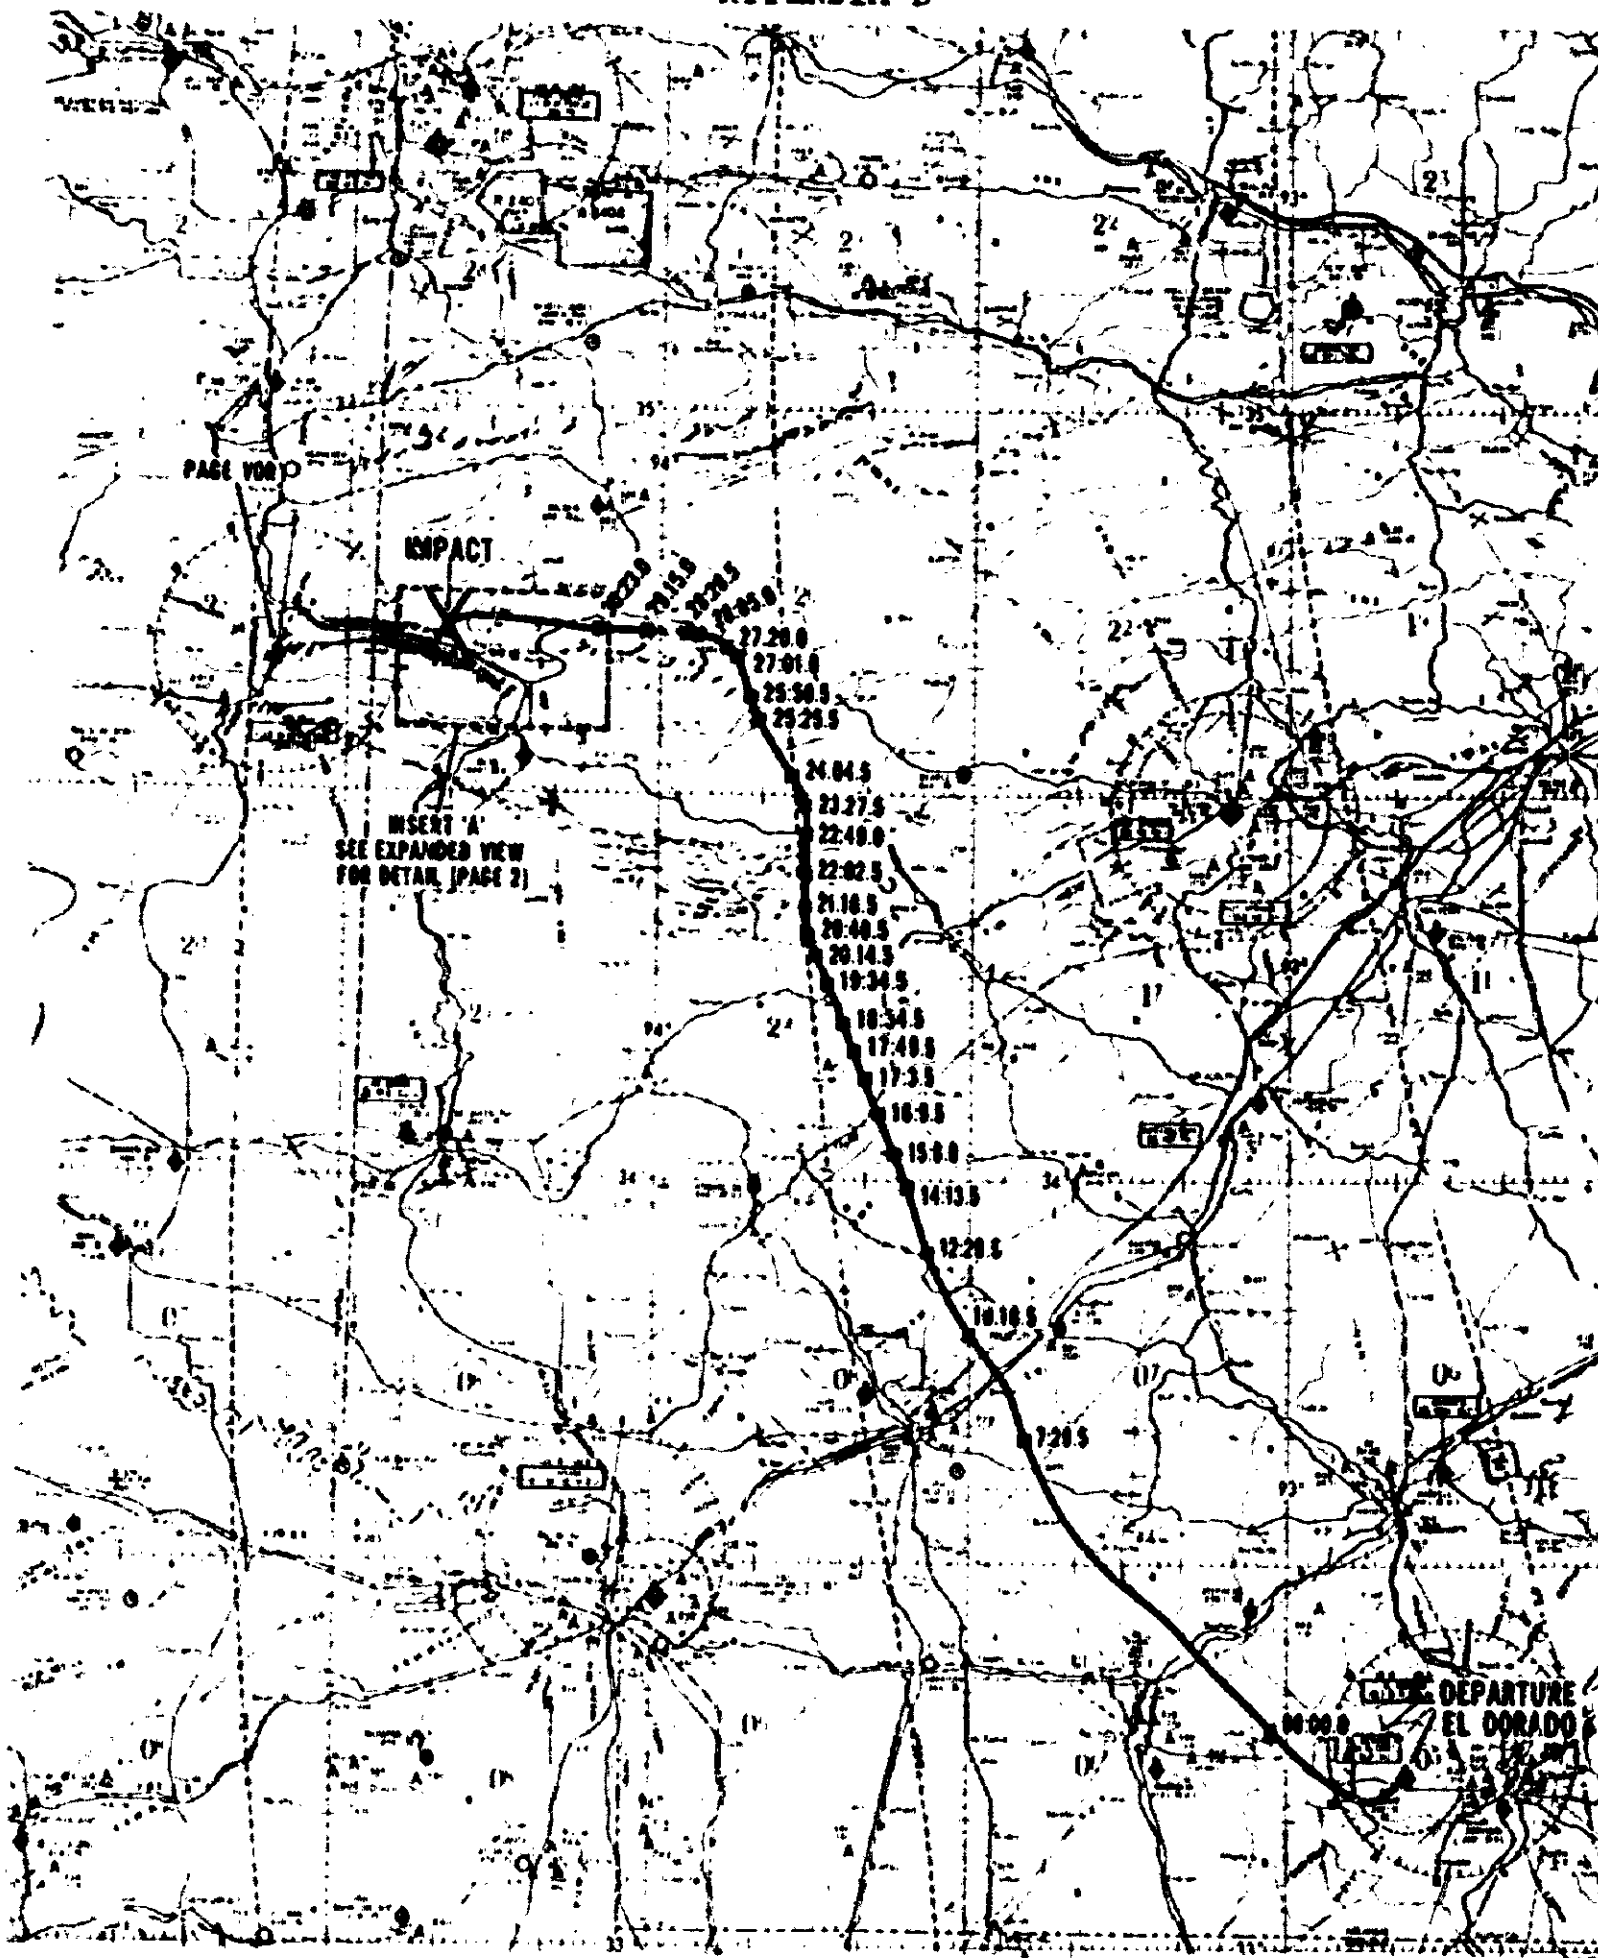
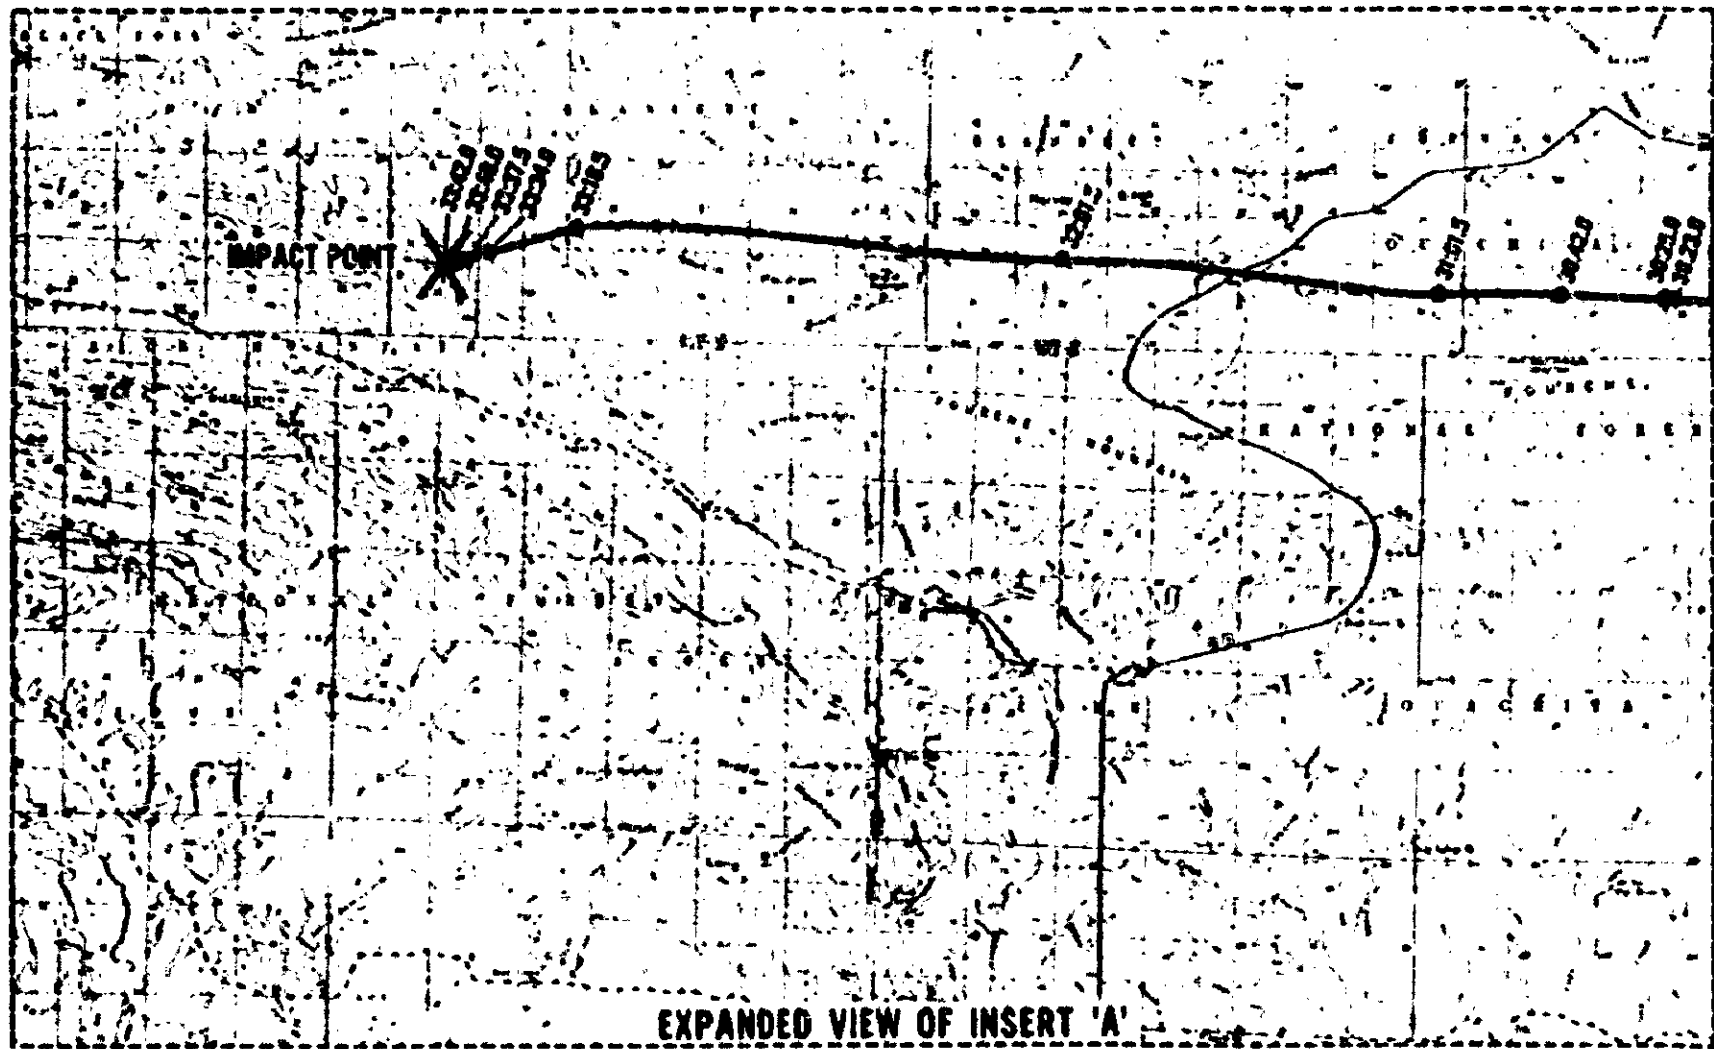
APPENDIX D

FLIGHT TRACK PRESENTATION
TEXAS INTERNATIONAL AIRLINES
CONVAIR CV-600, N94320
FLIGHT NO. 655
MENA, ARKANSAS
September 27, 1973

1. Times shown correspond to those relative times assigned to intra-cockpit conversation transcribed from the Aircraft Cockpit Voice Recorder. Sounds of impact occurred approximately 37 minutes 20 seconds after departure from El Dorado.
2. The Flight Track shown was derived from airspeed and heading data captured by the Aircraft Flight Data Recorder and estimated en route wind information.
