AIRCRAFT ACCIDENT REPORT - WIEN AIR ALASKA, INC.,  
FAIRCHILD F-27B, N4904  
GAMBELL, ST. LAWRENCE ISLAND, ALASKA

Bureau of Aviation Safety  
Washington, D. C.

January 1976

1. Report No. NTSB-AAR-76-1	2. Government Accession No.	3. Recipient's Catalog No.	
4. Title and Subtitle Aircraft Accident Report - Wien Air Alaska, Inc. Fairchild F-27B, N4904 Gambell, St. Lawrence Island, Alaska		5. Report Date January 7, 1976

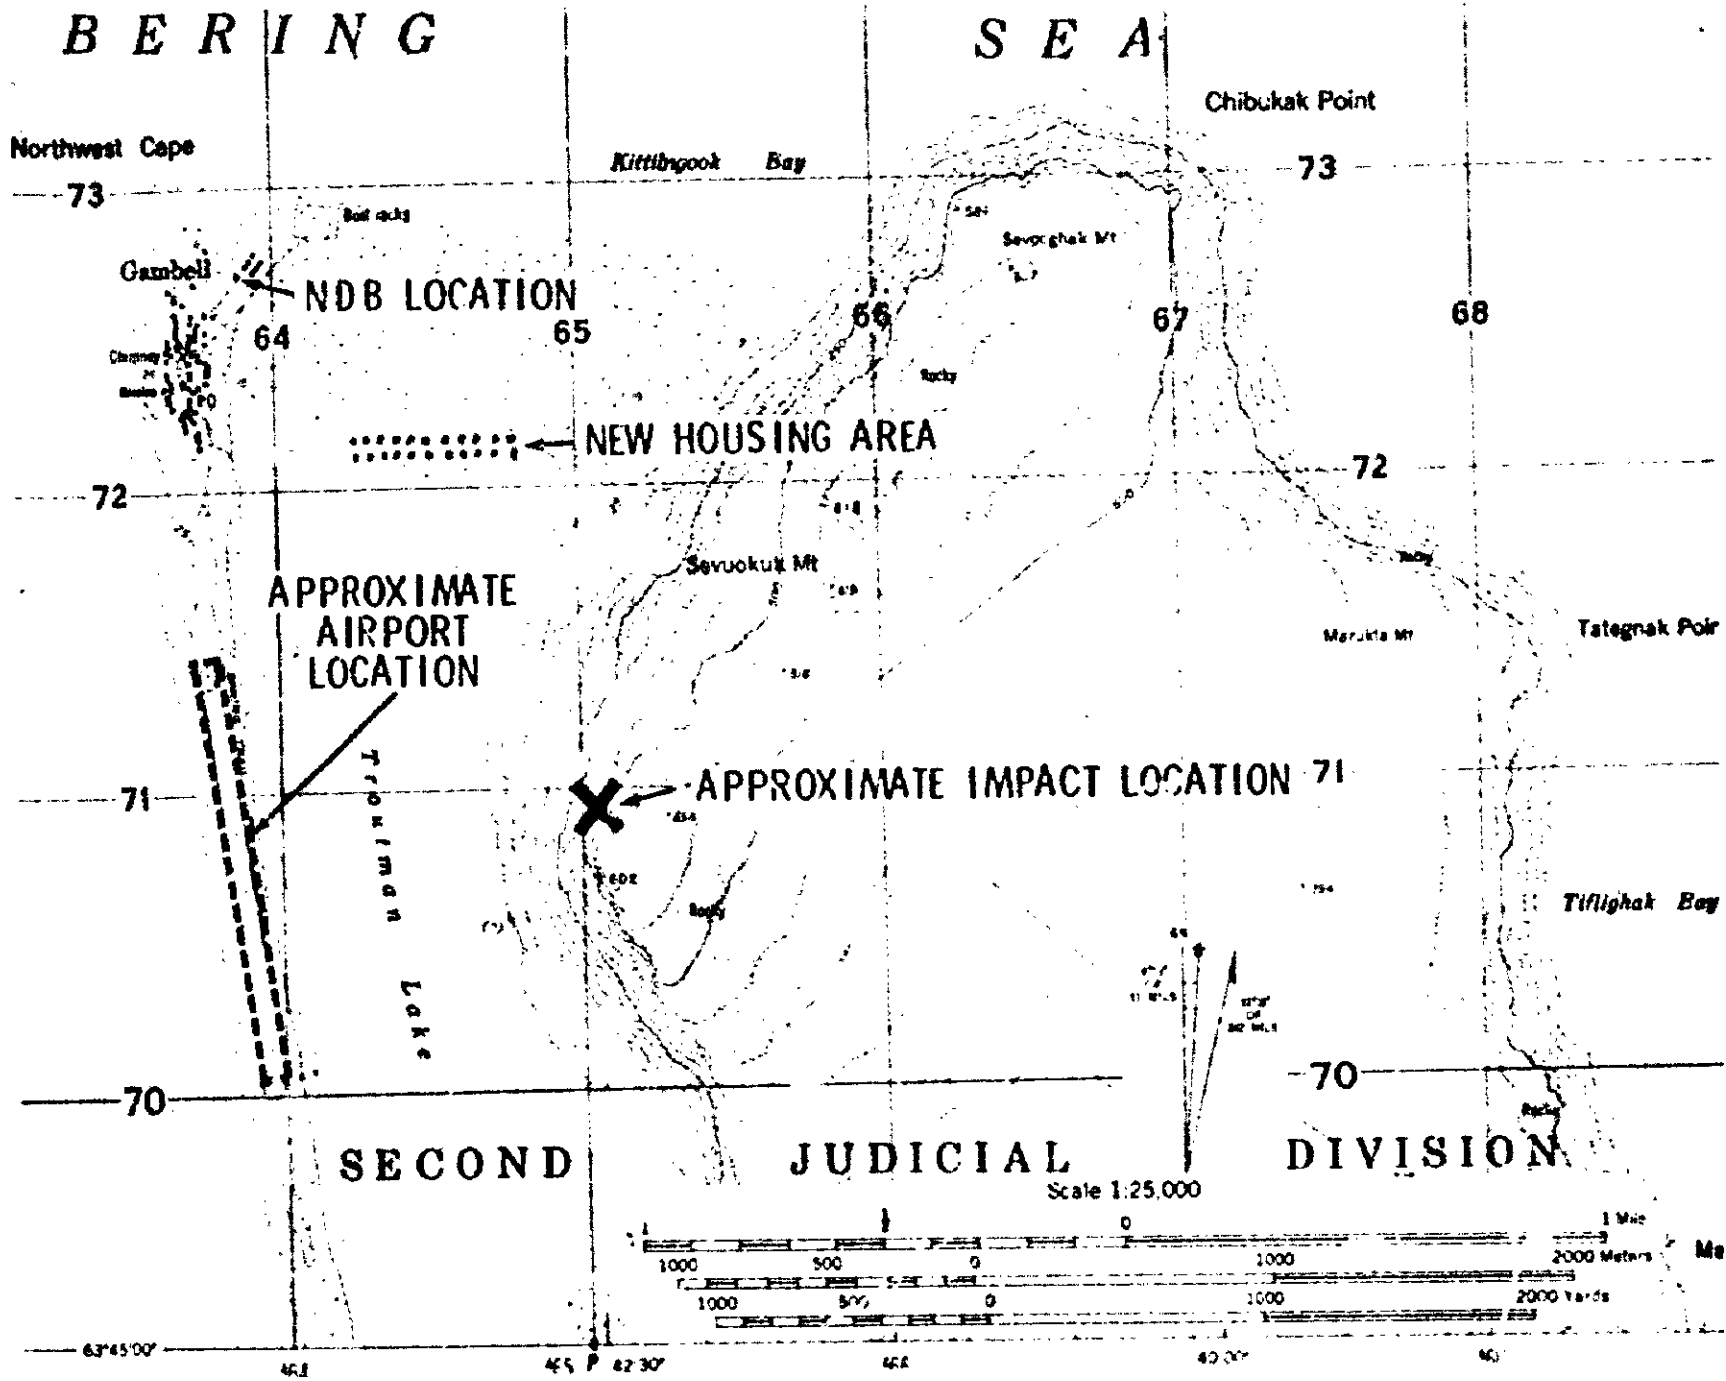
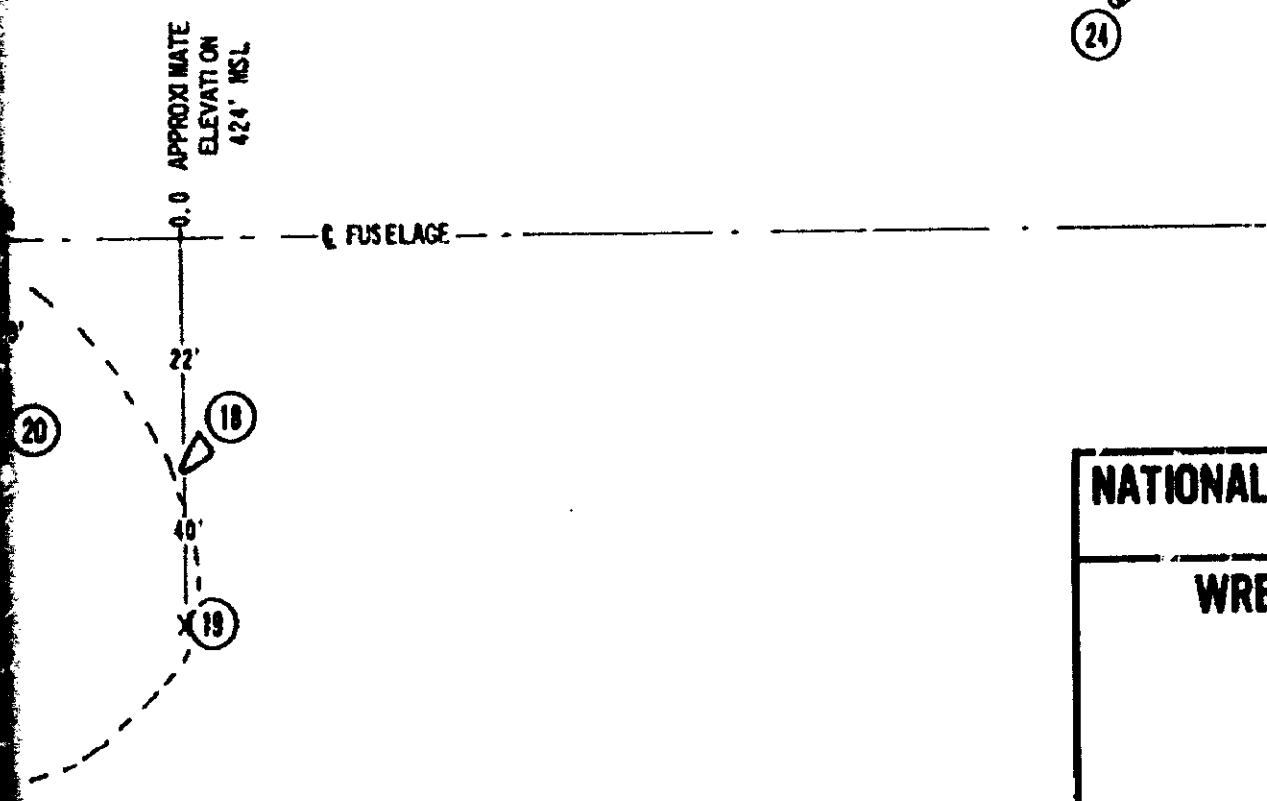
**WRECKAGE DISTRIBUTION CHART**  
**WIEN AIR ALASKA, INC.**  
**FAIRCHILD F-27B, N4904**  
**GAMBELL, ALASKA**  
**AUGUST 30, 1973**

The aircraft crashed into the northwest slope of Sevuokuk Mountain at an altitude of 424 feet. The first impact mark was found 134 feet below a 558-foot ridge. The aircraft overturned during the crash and came to rest inverted and heading opposite the direction of flight. The wreckage was distributed on a magnetic heading of 140°. Except for a part of the left and right main landing gears, the wreckage was confined to an area 248 ft. long and 80 ft. wide. (See Appendix D.)

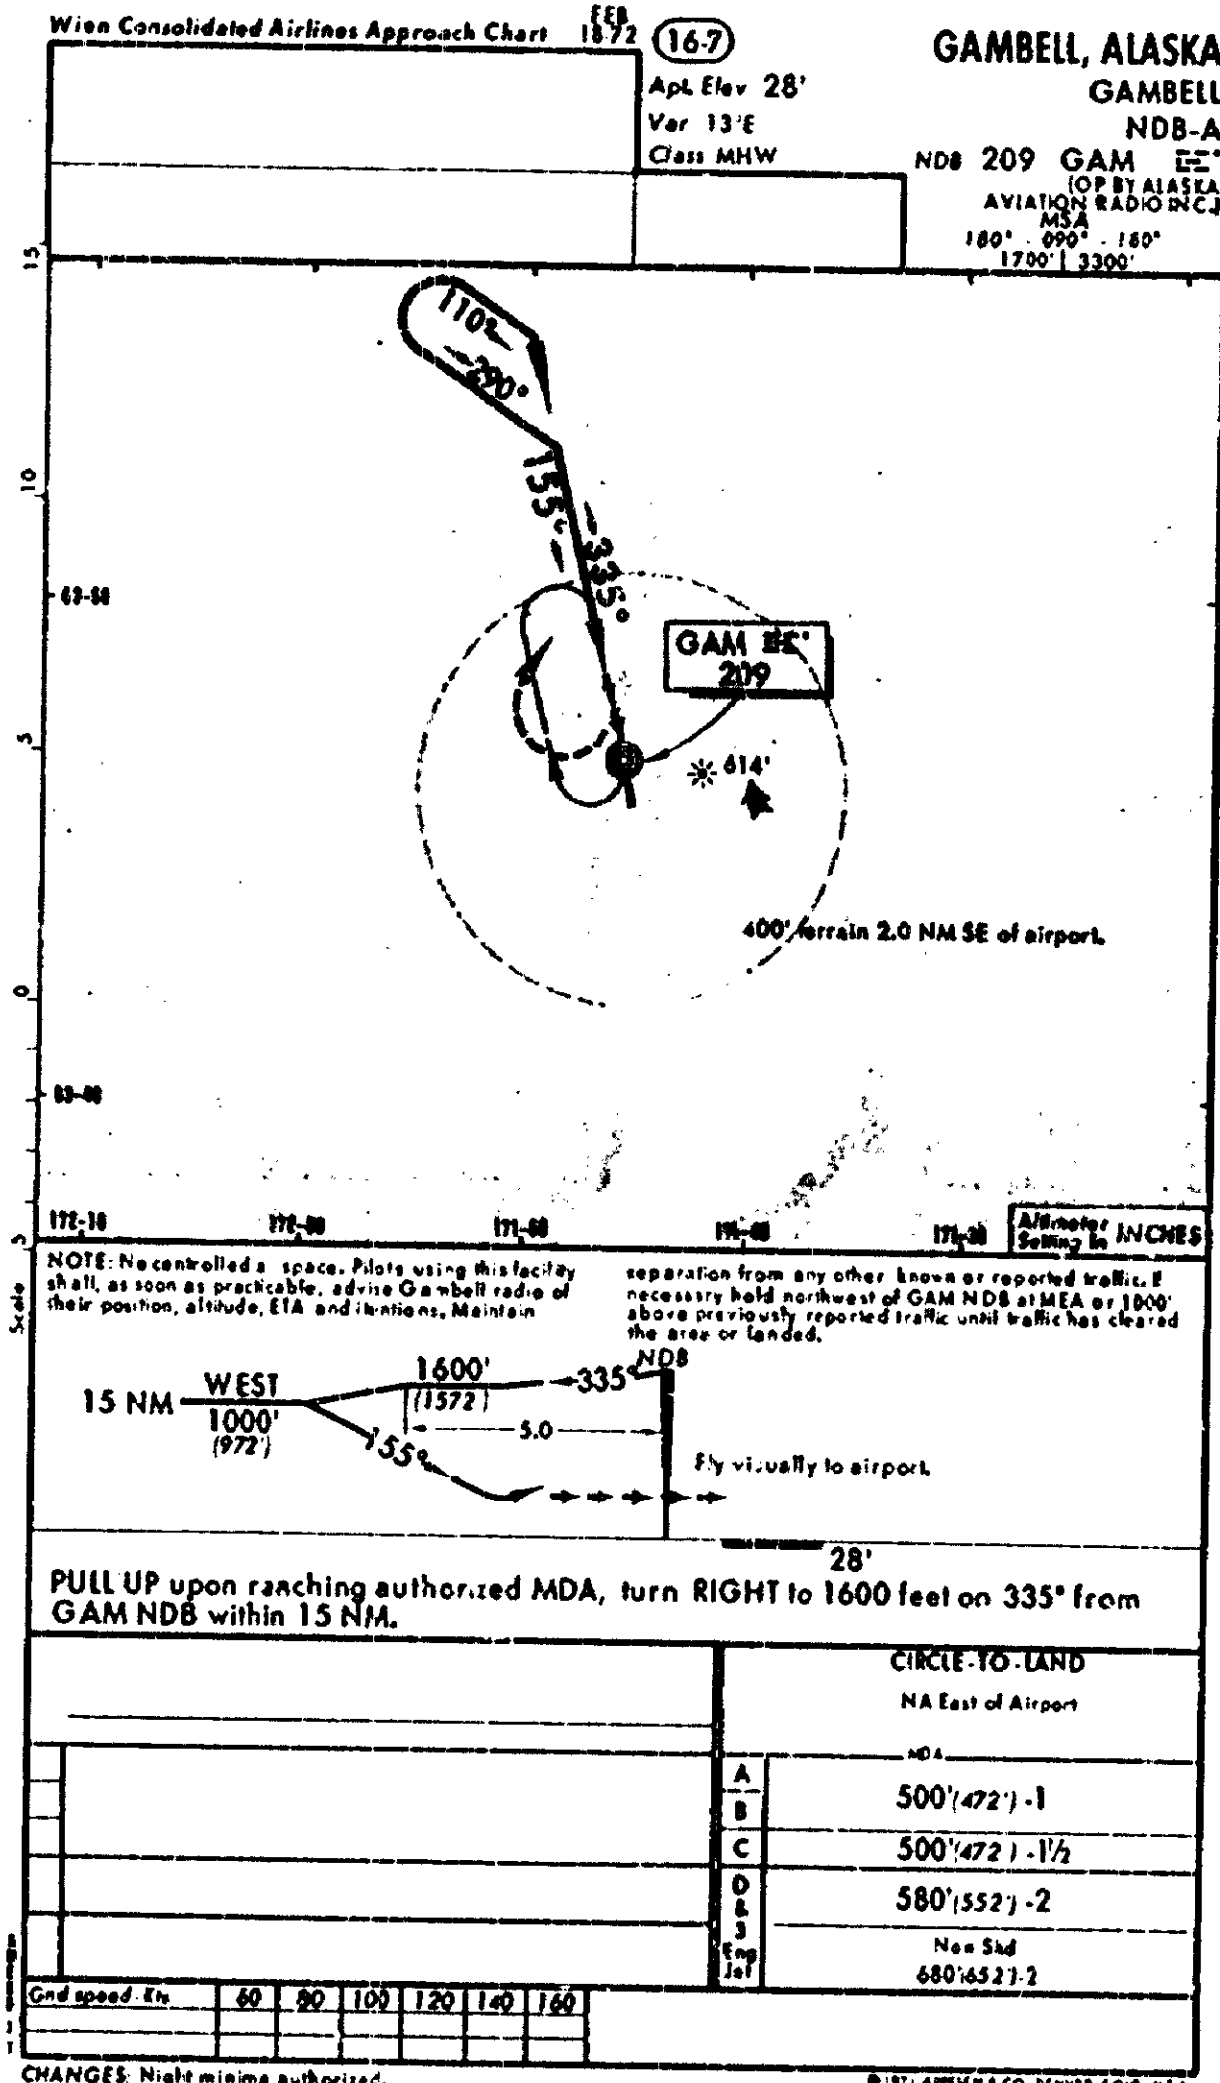
APPENDIX F

The Gambell NDB-A Company approach plate was last revised on February 4, 1972, with an effective date of February 11, 1972. (See Appendix F.) This approach plate depicts the approach to runway 16. After the NDB is intercepted, the plate calls for a heading of 335° and a descent from 1,600 feet to 1,000 feet after the aircraft has proceeded outbound from the NDB for at least 5 miles. The procedure turn is made to the west and within 15 miles of the NDB, after which the plate prescribes descent to the minimum descent altitude (MDA) of 500 feet on a heading of 155°. If visual flight conditions cannot be maintained from the MDA inbound to the NDB and to the airport, a missed approach must be executed. The approach plate depicts the inbound heading of 155° to be along the extended centerline of the runway.

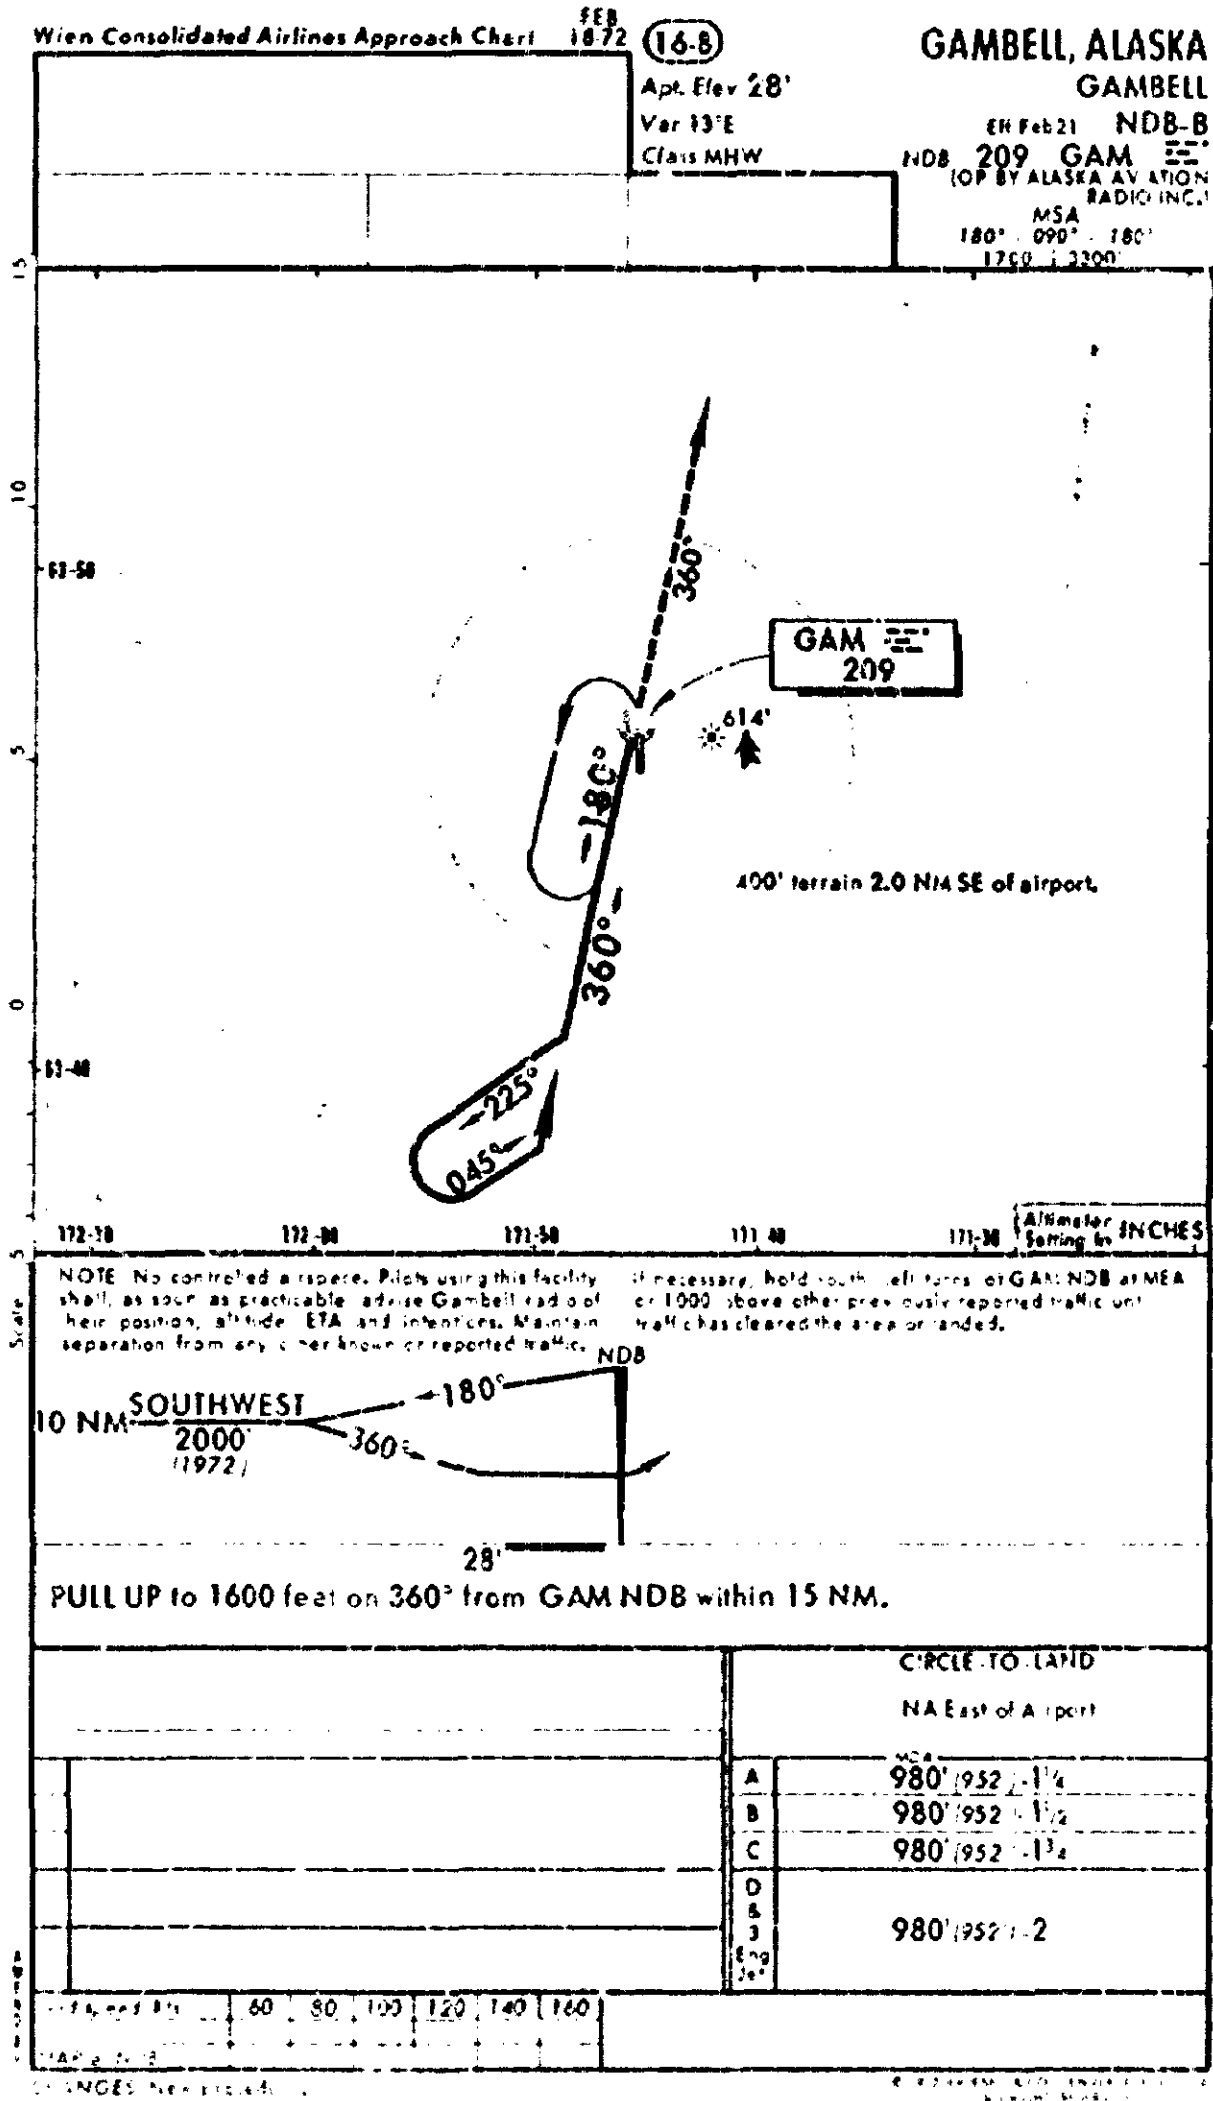
APPENDIX F

The NDB-B approach to runway 34 calls for a MDA of 980 feet to the NDB and, if visual flight cannot be accomplished, a missed approach must be executed to the west. (See Appendix F.)

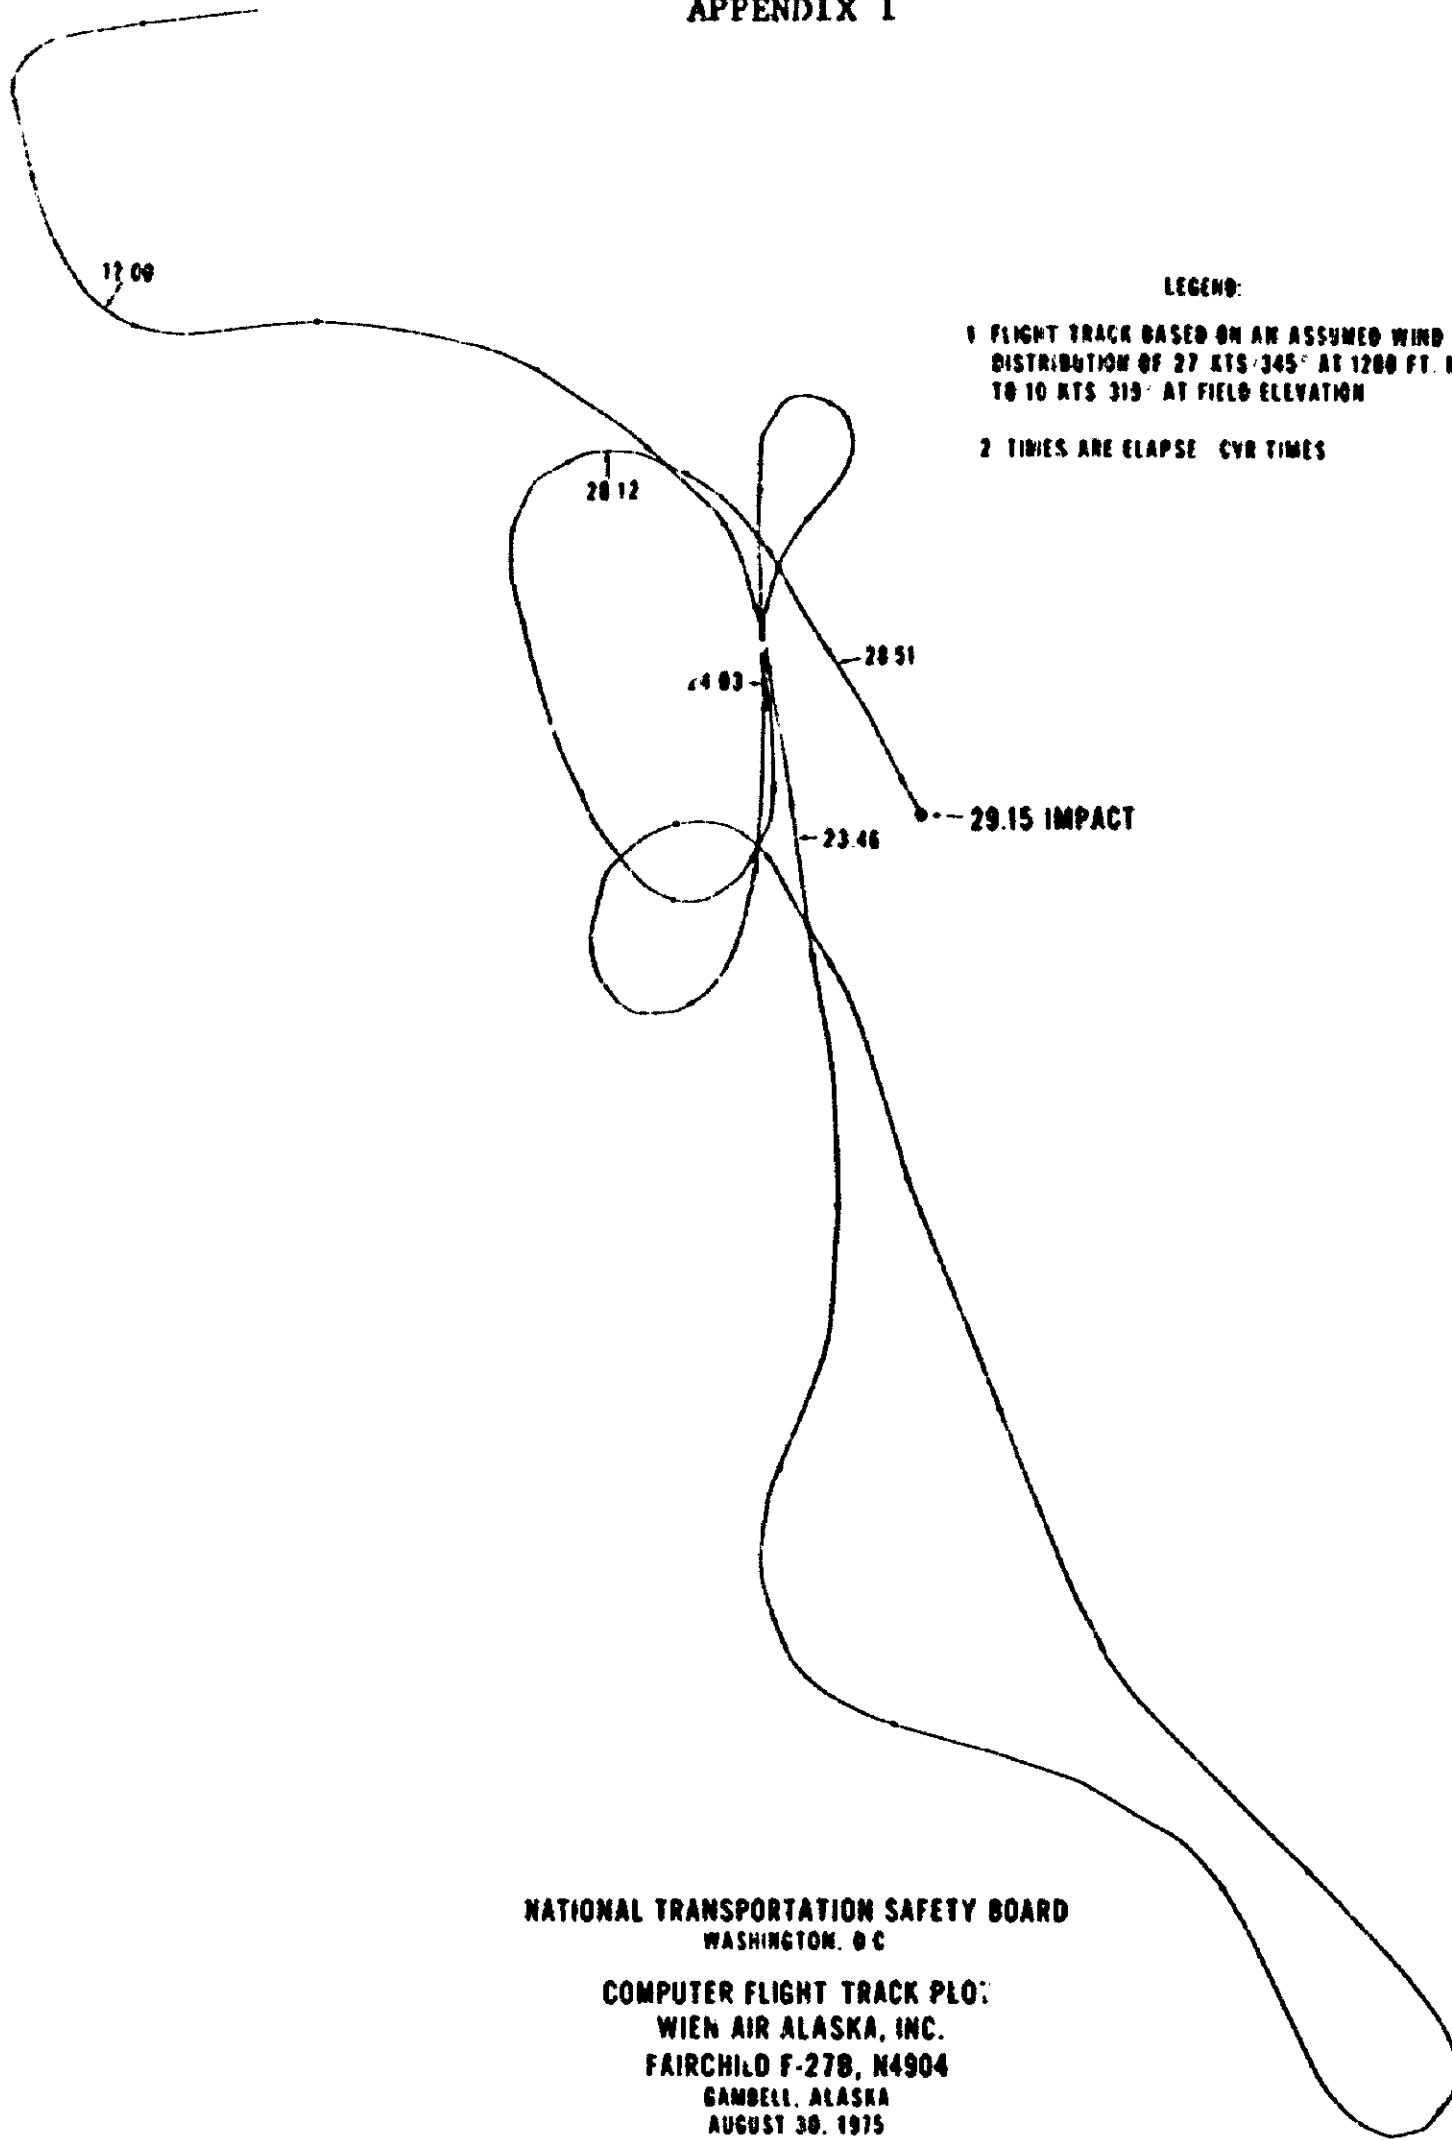
COMPUTER FLIGHT TRACK PLOT  
WIEN AIR ALASKA, INC.  
FAIRCHILD F-27B, N4904  
GAMBELL, ALASKA  
AUGUST 30, 1975

A heading of 140° was maintained for about 28 seconds until the aircraft struck Sevuokuk Mountain at an altitude of 424 feet. Several of the passengers could see the ground and were aware of their position relative to the village of Gambell. Some of them realized that the aircraft was going to hit the mountain and braced themselves.
