Aircraft Accident Report. American  
Airlines, Inc., Boeing 727-95, N1963  
St. Thomas, Virgin Islands, April 27, 1976

National Transportation Safety Board, Washington, D C

1. Report No. NTSB-AAR-77-1	2. Government Accession No.	3. Recipient's Catalog No.	
4. Title and Subtitle Aircraft Accident Report -- American Airlines, Inc., Boeing 727-95, N1963, St. Thomas, Virgin Islands, April 27, 1976		5. Report Date December 16, 1976	6. Performing Organization Code

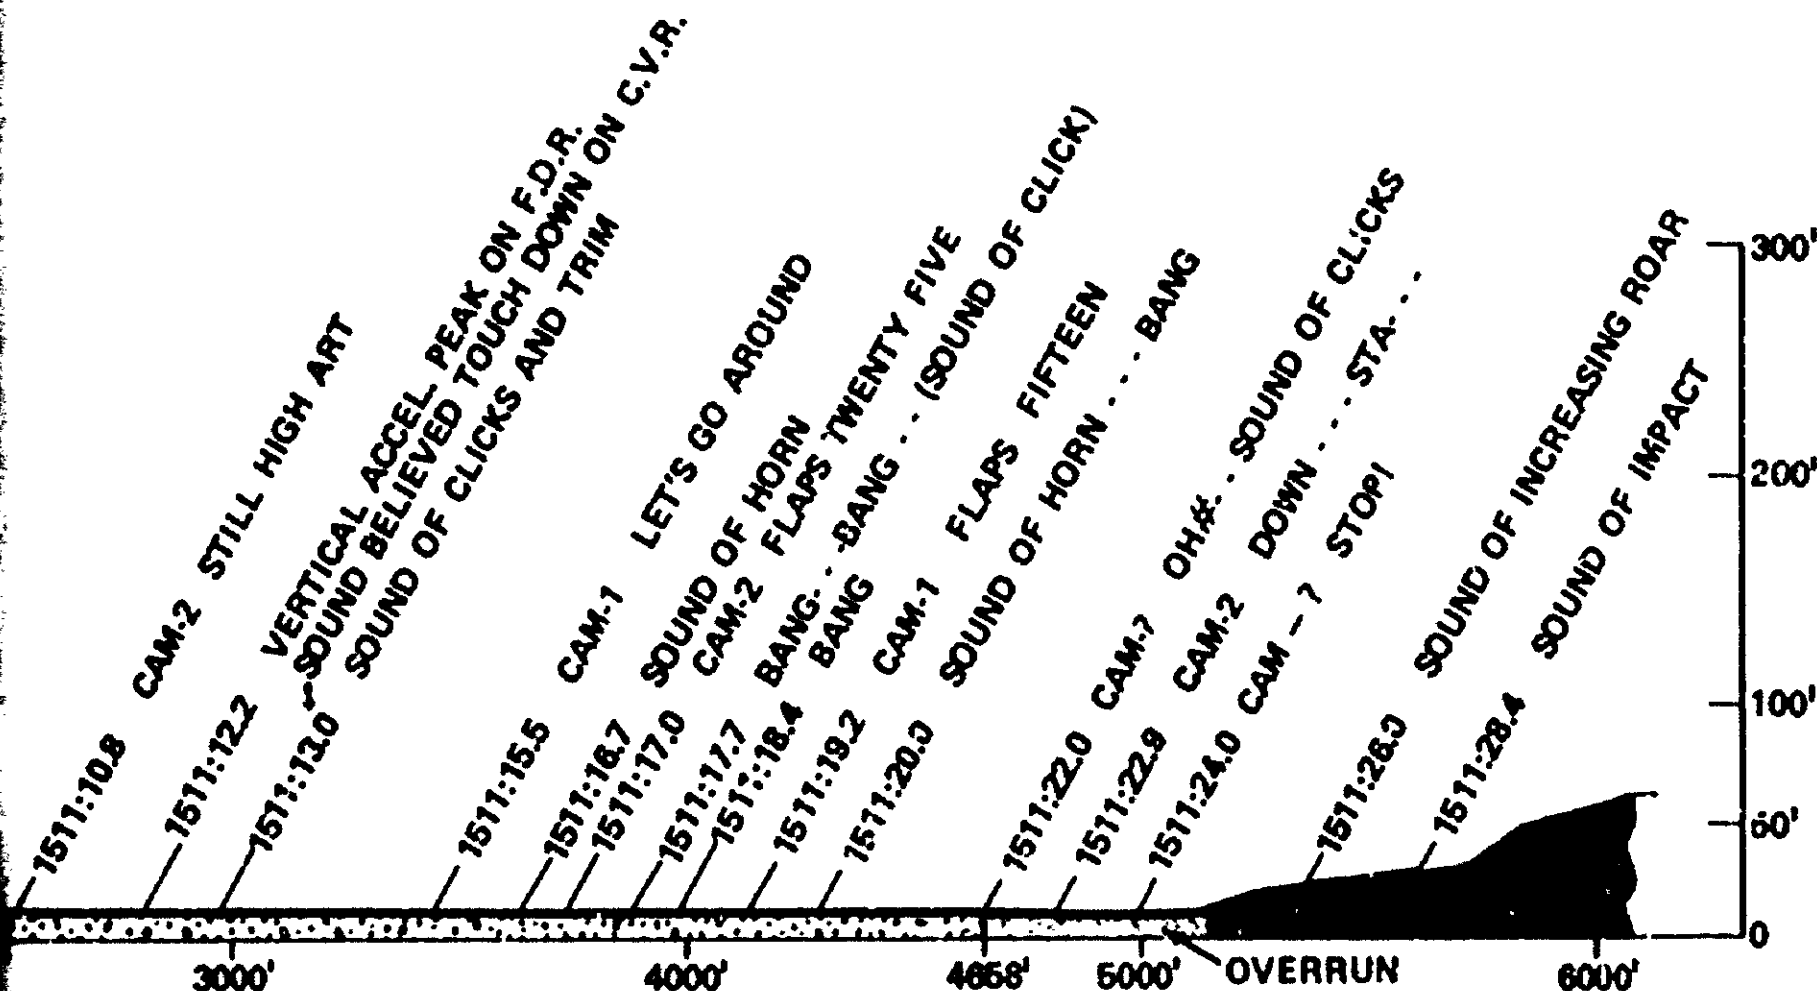
**APPROACH PROFILE**  
**AMERICAN AIRLINES, BOEING 727-95 N1963**  
**HARRY S. TRUMAN AIRPORT, ST. THOMAS, VIRGIN ISLANDS**  
**APRIL 27, 1976**

The profile shown in Appendix D was prepared using assumptions which seemed to be most logical to the investigators. These assumptions are noted thereon. This profile shows that the aircraft crossed the threshold at an airspeed of 131 knots and an altitude of about 80 feet. The touchdown was calculated to be about 2,800 feet beyond the threshold. At touchdown, about 1,850 feet of runway and 500 feet of overrun were available on which to stop the aircraft. When the captain stated "Let's go around," the aircraft was about 3,450 feet beyond the threshold, or 1,200 feet of runway and 500 feet of overrun remained.
