# **NATIONAL TRANSPORTATION SAFETY BOARD**

## **AIRCRAFT ACCIDENT REPORT**

**SCANDINAVIAN AIRLINES SYSTEM  
FLIGHT 901**

**McDONNELL DOUGLAS DC-10-30  
JOHN F. KENNEDY**

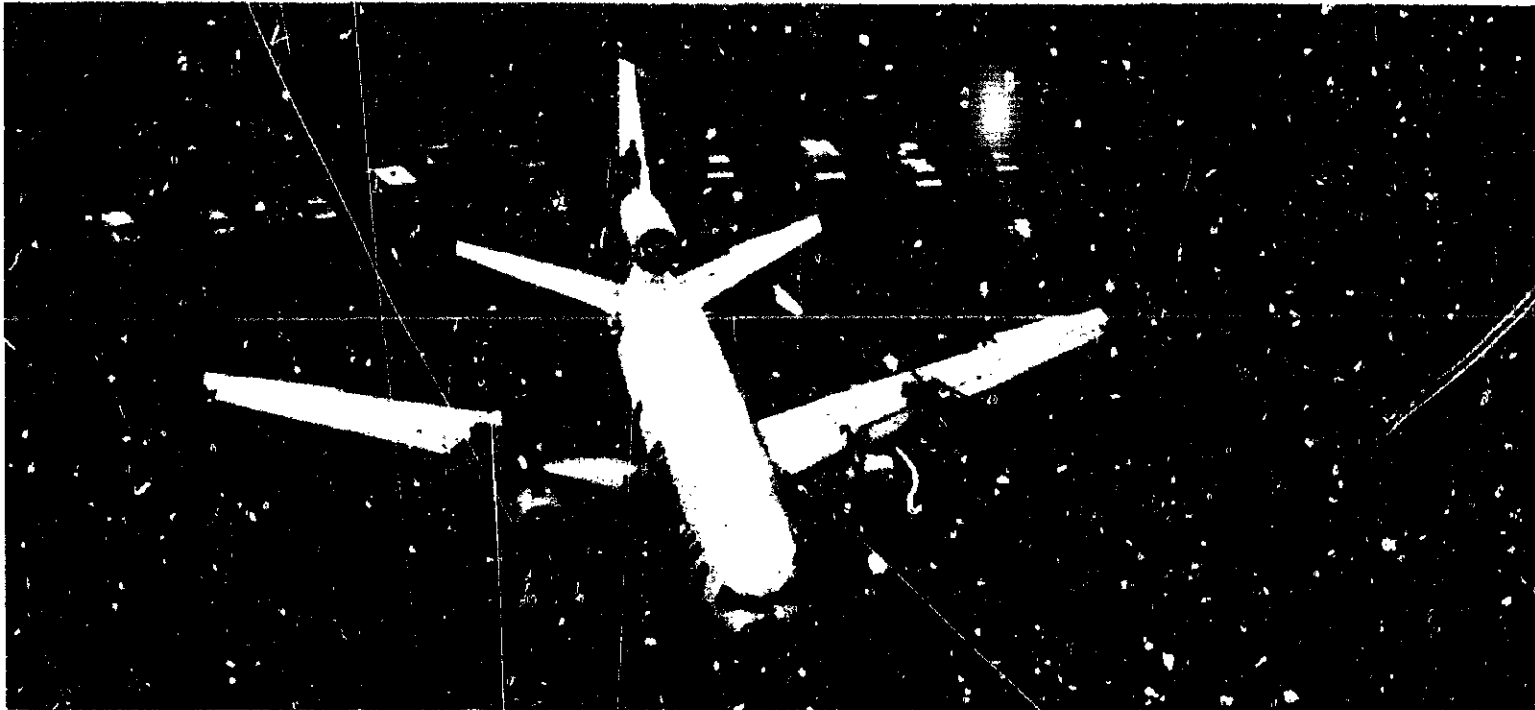
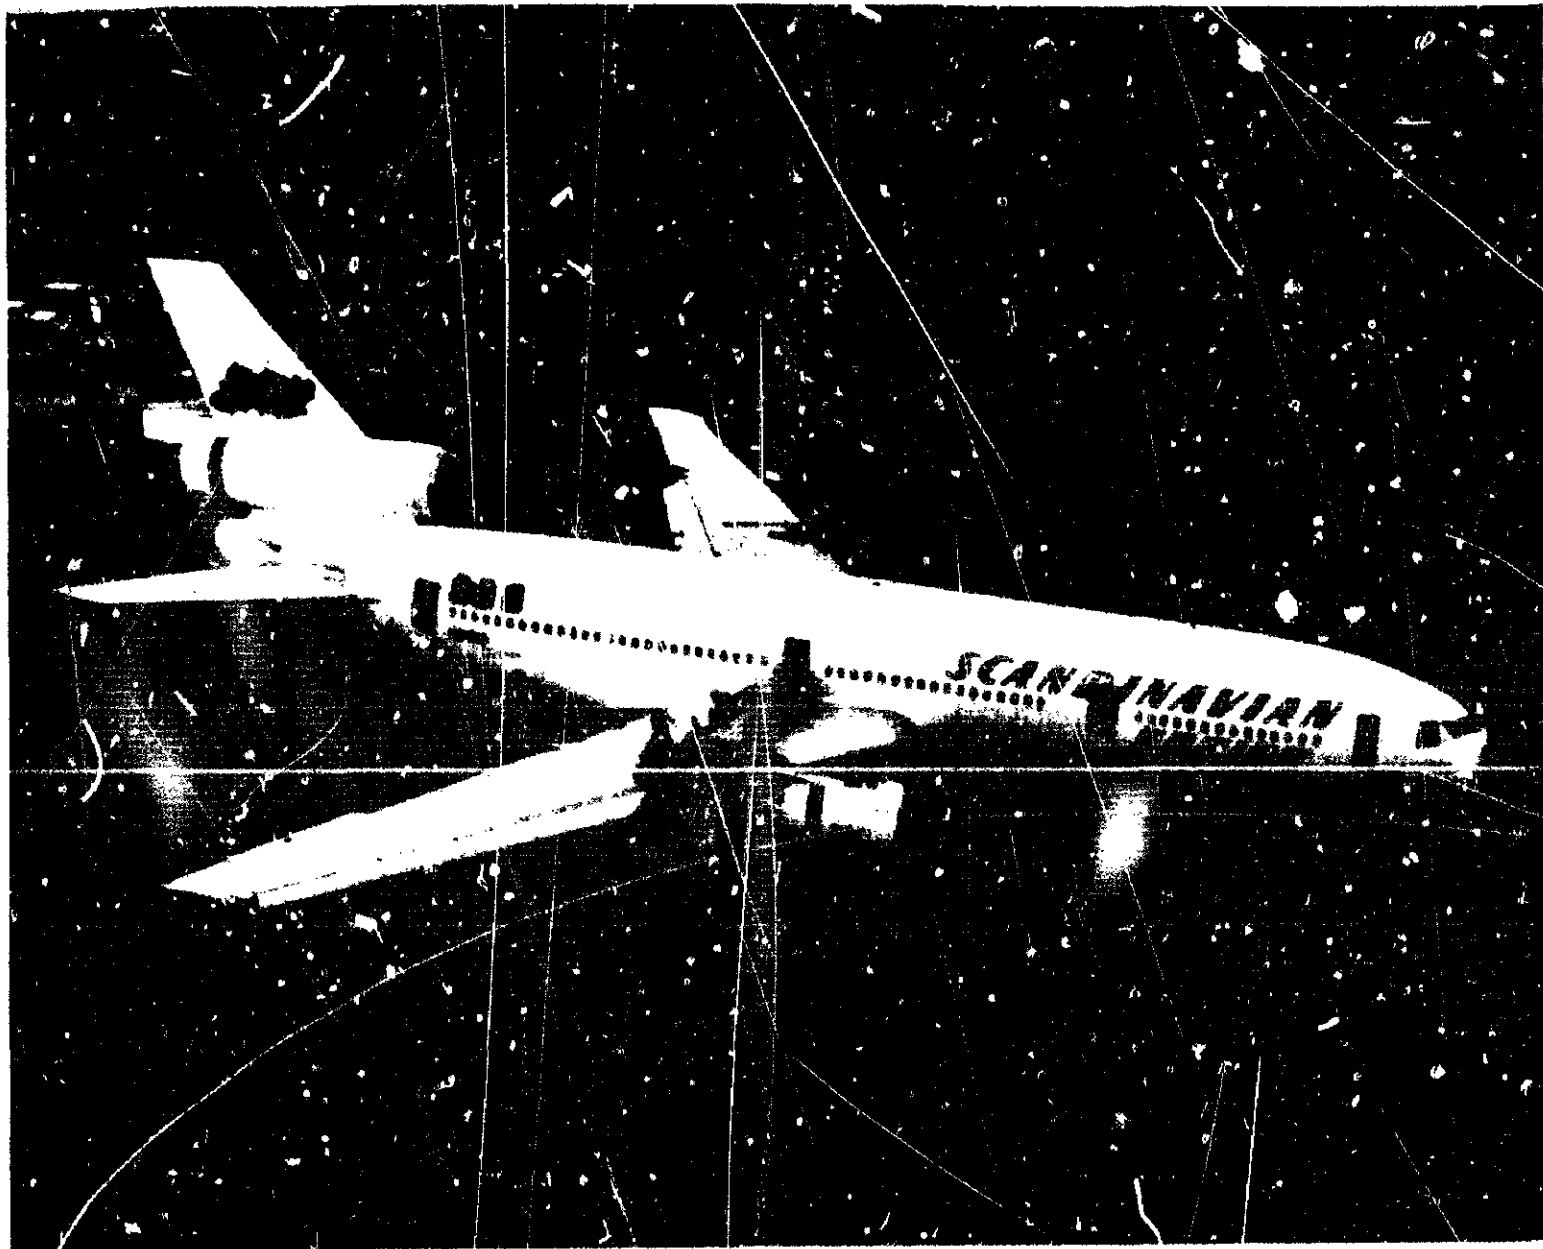
Figure 2.—Flight 901 at rest in Thurston Basin.

The forward section of the airplane fuselage came to rest in Thurston Basin, a tidal waterway about 600 ft (182.88 meters) from the runway 4R departure end. The airplane was damaged substantially. (See figure 2.) The captain immediately began to execute the memory items of the "On-Ground Emergency Check List." However, neither he nor the systems operator could move the engine fire selectors or fuel cutoff levers to their full off positions.

The aft portion of the fuselage remained generally intact. There was major damage at the lower nose area, to the radome, and to the forward pressure bulkhead at fuselage station (FS) 275. The nose landing gear structure had collapsed under the fuselage. The drag braces were fractured and had separated from their attachment fittings. The interior of the forward fuselage area was deformed and exhibited fractures at the flight deck and galley floor locations. Several floor beams below the galley floor were fractured and twisted.
