NATIONAL TRANSPORTATION SAFETY BOARD

AIRCRAFT ACCIDENT REPORT

**PIEDMONT AIRLINES FLIGHT 467
BOEING 737-222, N752N
CHARLOTTE DOUGLAS INTERNATIONAL AIRPORT
CHARLOTTE, NORTH CAROLINA
OCTOBER 26, 1986**

NTSB/AAR-87/08

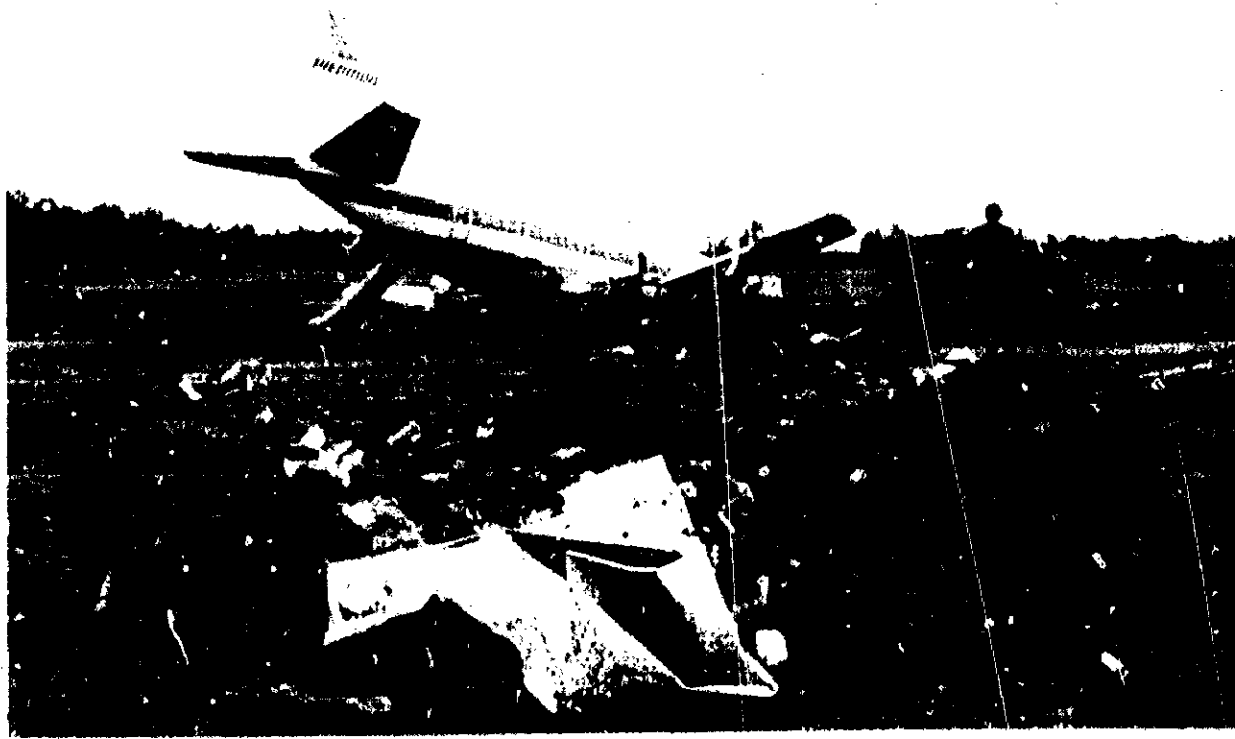
Figure 2.—Concrete culvert area and rear view of airplane.

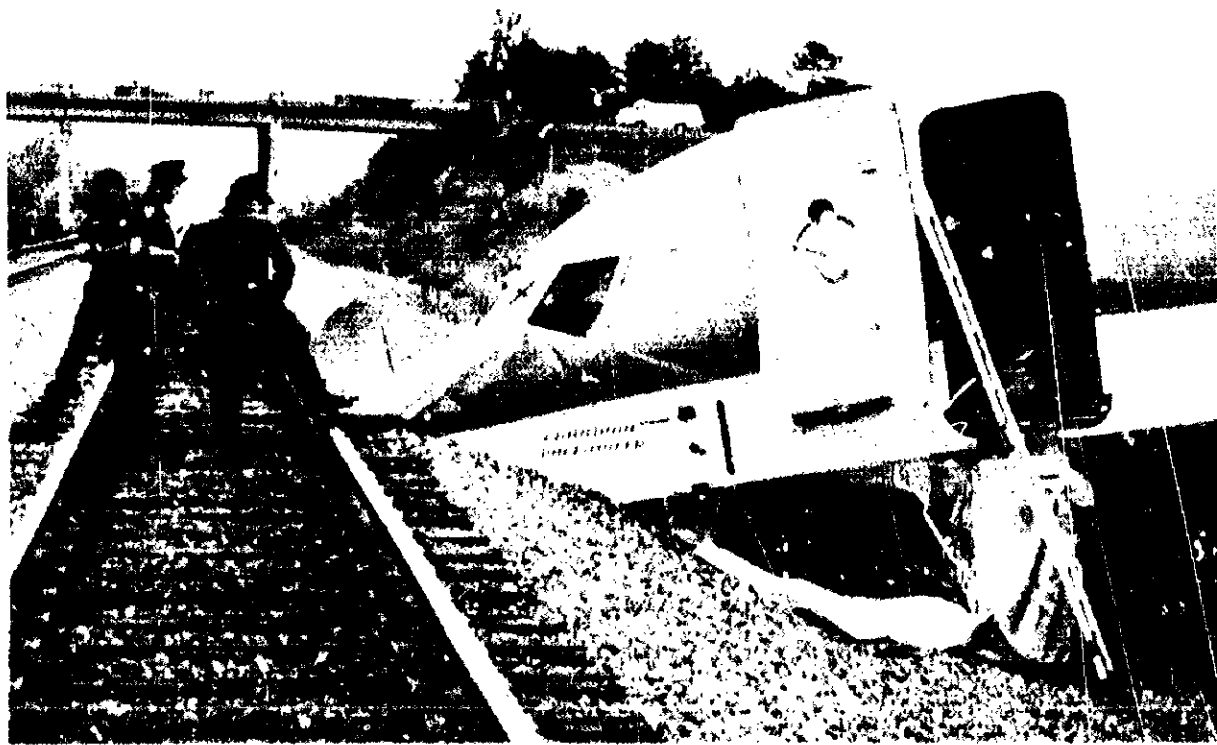
Figure 3.—Left side of airplane nose against railroad track.

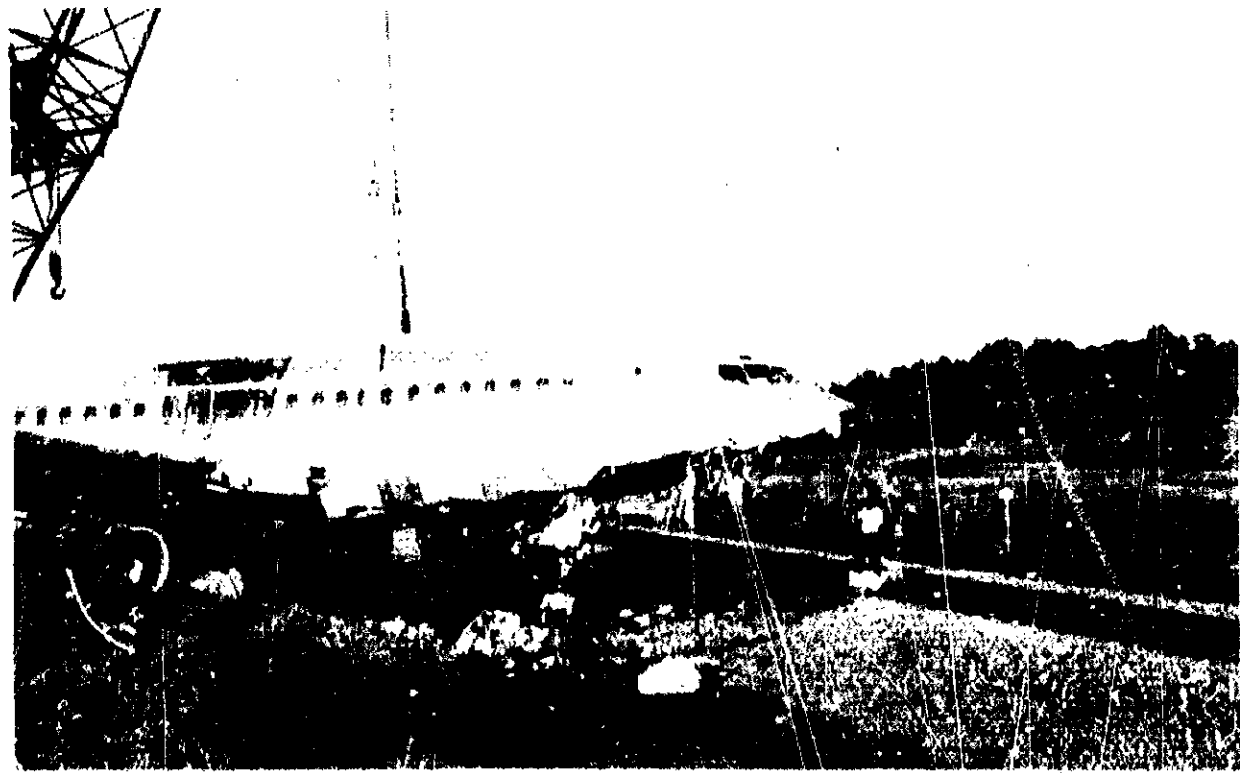
The airplane wreckage was confined to the area between the localizer antenna array, located north of the departure end of runway 36R, and the railroad tracks. Most of the damage to the airplane occurred to its underside, resulting mostly from contact with the concrete culvert located beyond the runway. (See figures 5 and 6.)

Figure 6.—Right side of forward fuselage

trailing edges, suffered decreasing degrees of damage. The keel beam was fractured aft of the wing center, and there was compression buckling of the fuselage skin forward of the aft exit. The empennage was undamaged.
