**NATIONAL
TRANSPORTATION
SAFETY
BOARD**

AIRCRAFT ACCIDENT REPORT

**ATLANTIC SOUTHEAST AIRLINES, INC., FLIGHT 2311
UNCONTROLLED COLLISION WITH TERRAIN
AN EMBRAER EMB-120, N270AS
BRUNSWICK, GEORGIA
APRIL 5, 1991**

**Adopted: April 28, 1992
Notation 5511A**

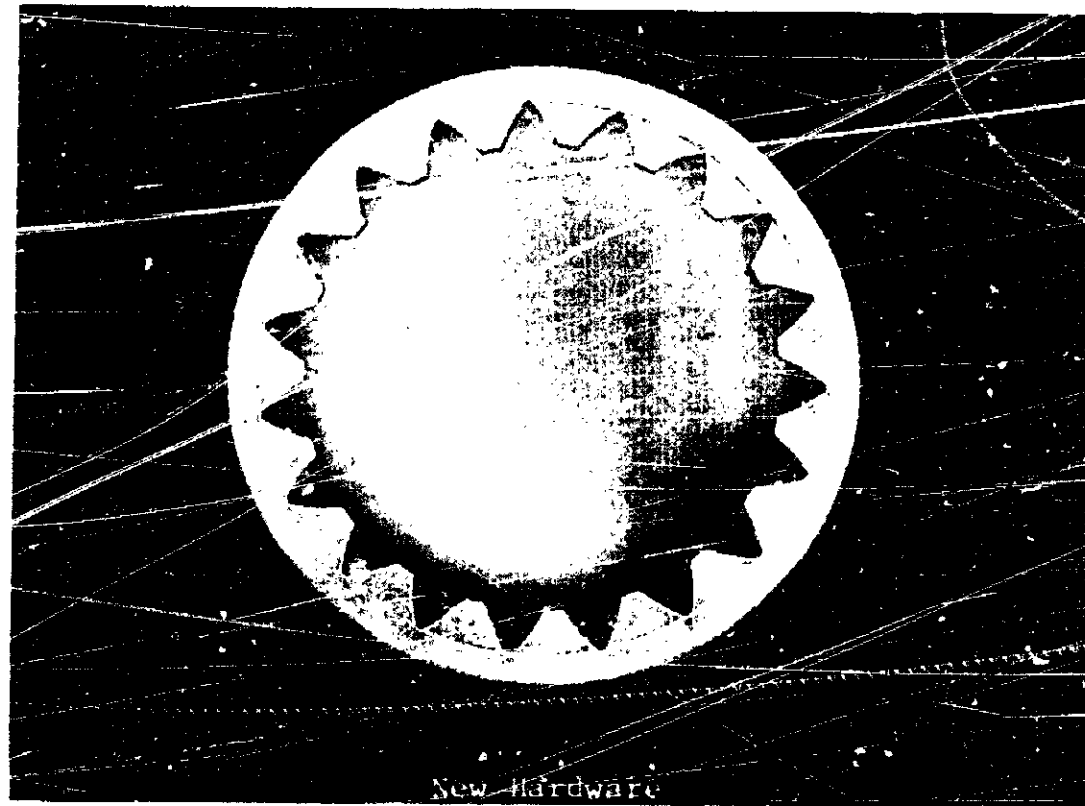
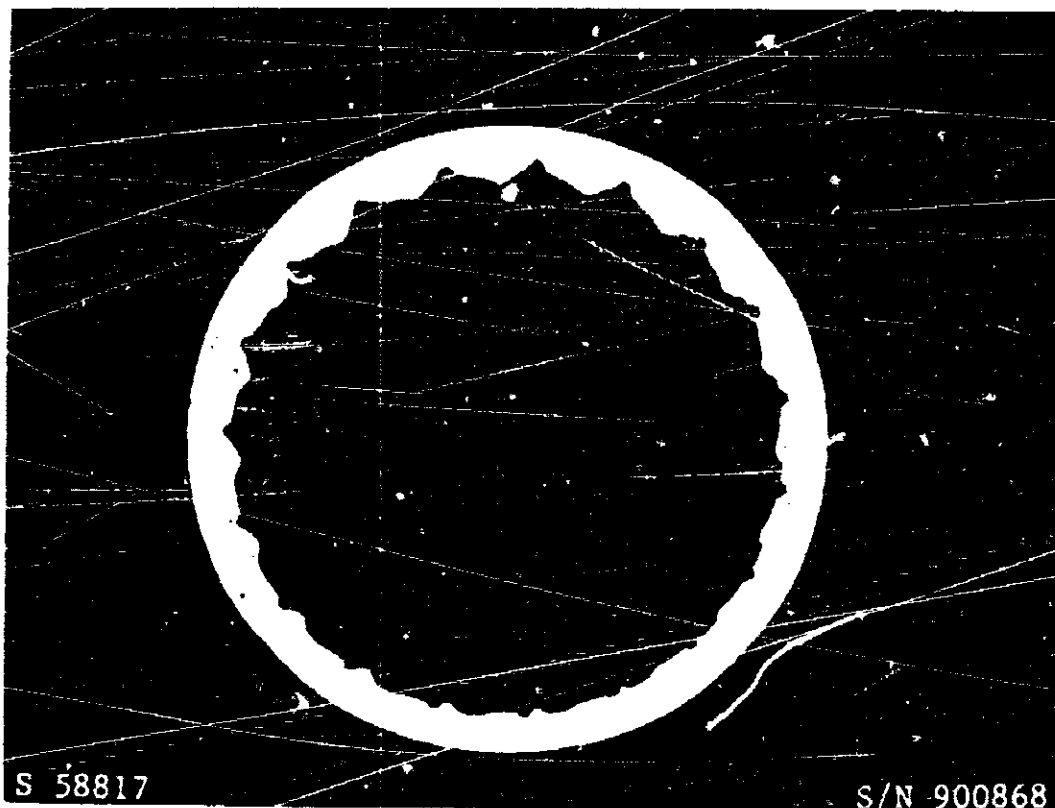
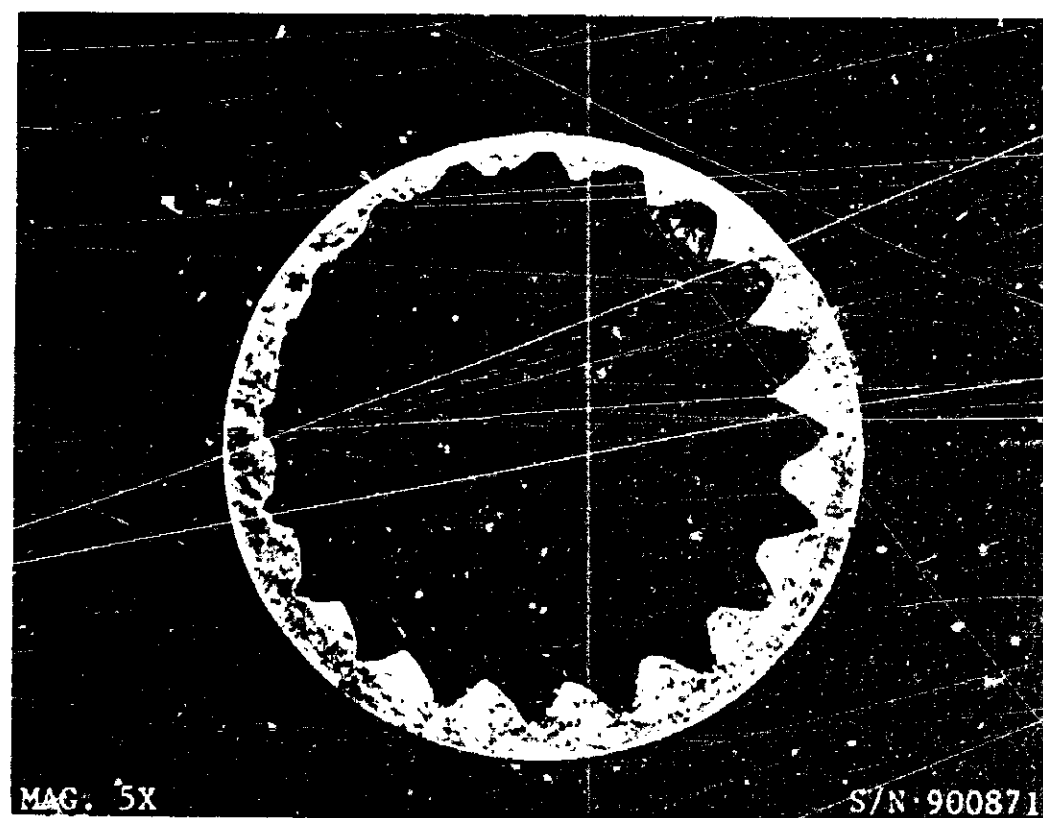
Figure 3.--PCU quill.

The discrepancy in the propeller control unit was found to have been extreme wear on the propeller control unit quill spline teeth which normally engaged the titanium-nitrided splines of the propeller transfer tube. It was found that the titanium-nitrided surface was much harder and rougher than the nitrided surface of the quill. Therefore, the transfer tube splines acted like a file and caused abnormal wear of the gear teeth on the quill. The investigation found that wear of the quill was not considered during the certification of the propeller system.

The ballscrew quills were removed from the PCUs for examination. The quills from both PCUs had severely worn internal splines. (See figure 3). The spline teeth on the left quill were almost entirely worn away, and the wear pattern was slightly off the axial centerline. The right quill spline wear was more eccentric with a heavy wear pattern on one side and relatively little wear on the opposite teeth. The left quill was assembled on the left oil transfer tube for measuring radial displacement of the quill when engaged on the spline teeth of the transfer tube. While thus assembled, the quill would rotate freely about the tube, and the quill teeth were worn to the extent that they did not engage the grooves or teeth on the tube. A similar test accomplished with the right quill indicated that the quill would engage the spline teeth of the transfer tube.

However, based upon the number of worn quills found, including those from the accident airplane, the manufacturer issued Alert Service Bulletin 14RF-9-61-A49 on May 7, 1991, that advised all operators to inspect PCUs for worn quills and began a fleet campaign to remove from service the titanium nitrided transfer tubes and to replace them with the original nitrided tubes. The Alert Service Bulletin defined the manufacturer's recommended inspection intervals and wear limits for the quill.
