PB95-910401  
NTSB/AAR-95/01

## AIRCRAFT ACCIDENT REPORT

RUNWAY OVERRUN FOLLOWING REJECTED TAKEOFF  
CONTINENTAL AIRLINES FLIGHT 795  
McDONNELL DOUGLAS MD-82, N18835  
LaGUARDIA AIRPORT  
FLUSHING, NEW YORK  
MARCH 2, 1994

**Abstract:** This report explains the accident involving Continental Airlines flight 795, an MD-82 airplane, which experienced a runway overrun following a rejected takeoff from runway 13 at LaGuardia Airport, Flushing, New York, on March 2, 1994. Safety issues discussed in the report include the availability of takeoff performance data for flightcrews, the proper functioning of pitot/static heat systems, the duration of cockpit voice recordings, and problems associated with passenger evacuations from airplanes. Safety recommendations concerning these issues were addressed to the Federal Aviation Administration and to Continental Airlines, Inc.

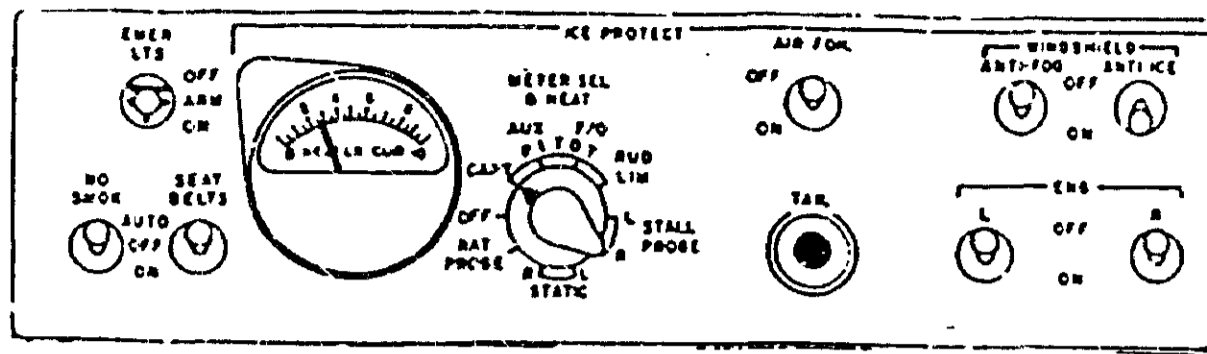
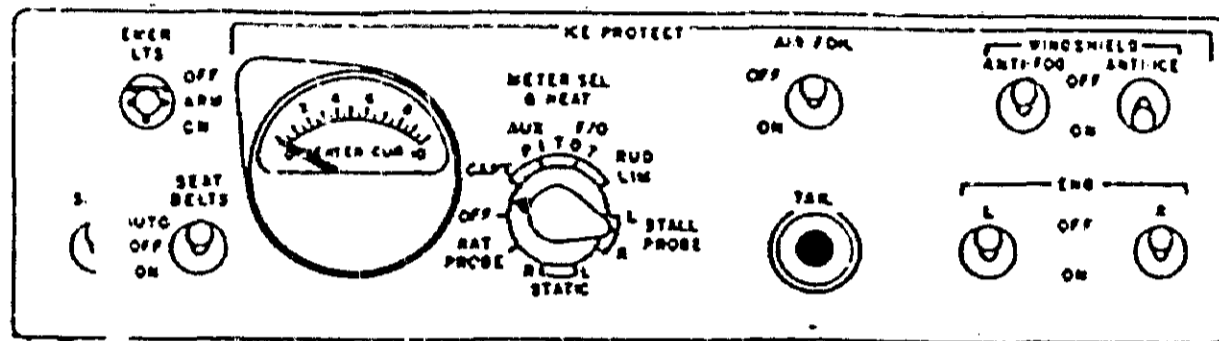
Figure 1.--Pitot/static/stall heater selector switch.

Upper Illustration-Normal position for system ON and reading CAPT Heater current.

Middle Illustration-Approximate alignment of accident airplane's switch in OFF detent.

Bottom Photo-Photo of accident airplane's METER SEL & HEat switch in OFF position. See arrow: ➤

The METER SEL & HEAT, which controls heat to the pitot tubes/static ports, RAT probe, and AOA [angle of attack] was found to be slightly misaligned. When the switch was set to the OFF position, the switch "pointer" indication was approximately 1/3 of the distance toward the CAPT position. The misalignment of the switch existed as it was rotated throughout each position. Each position was clearly identified by a detent. The switch rotated freely without apparent binding or malfunction.

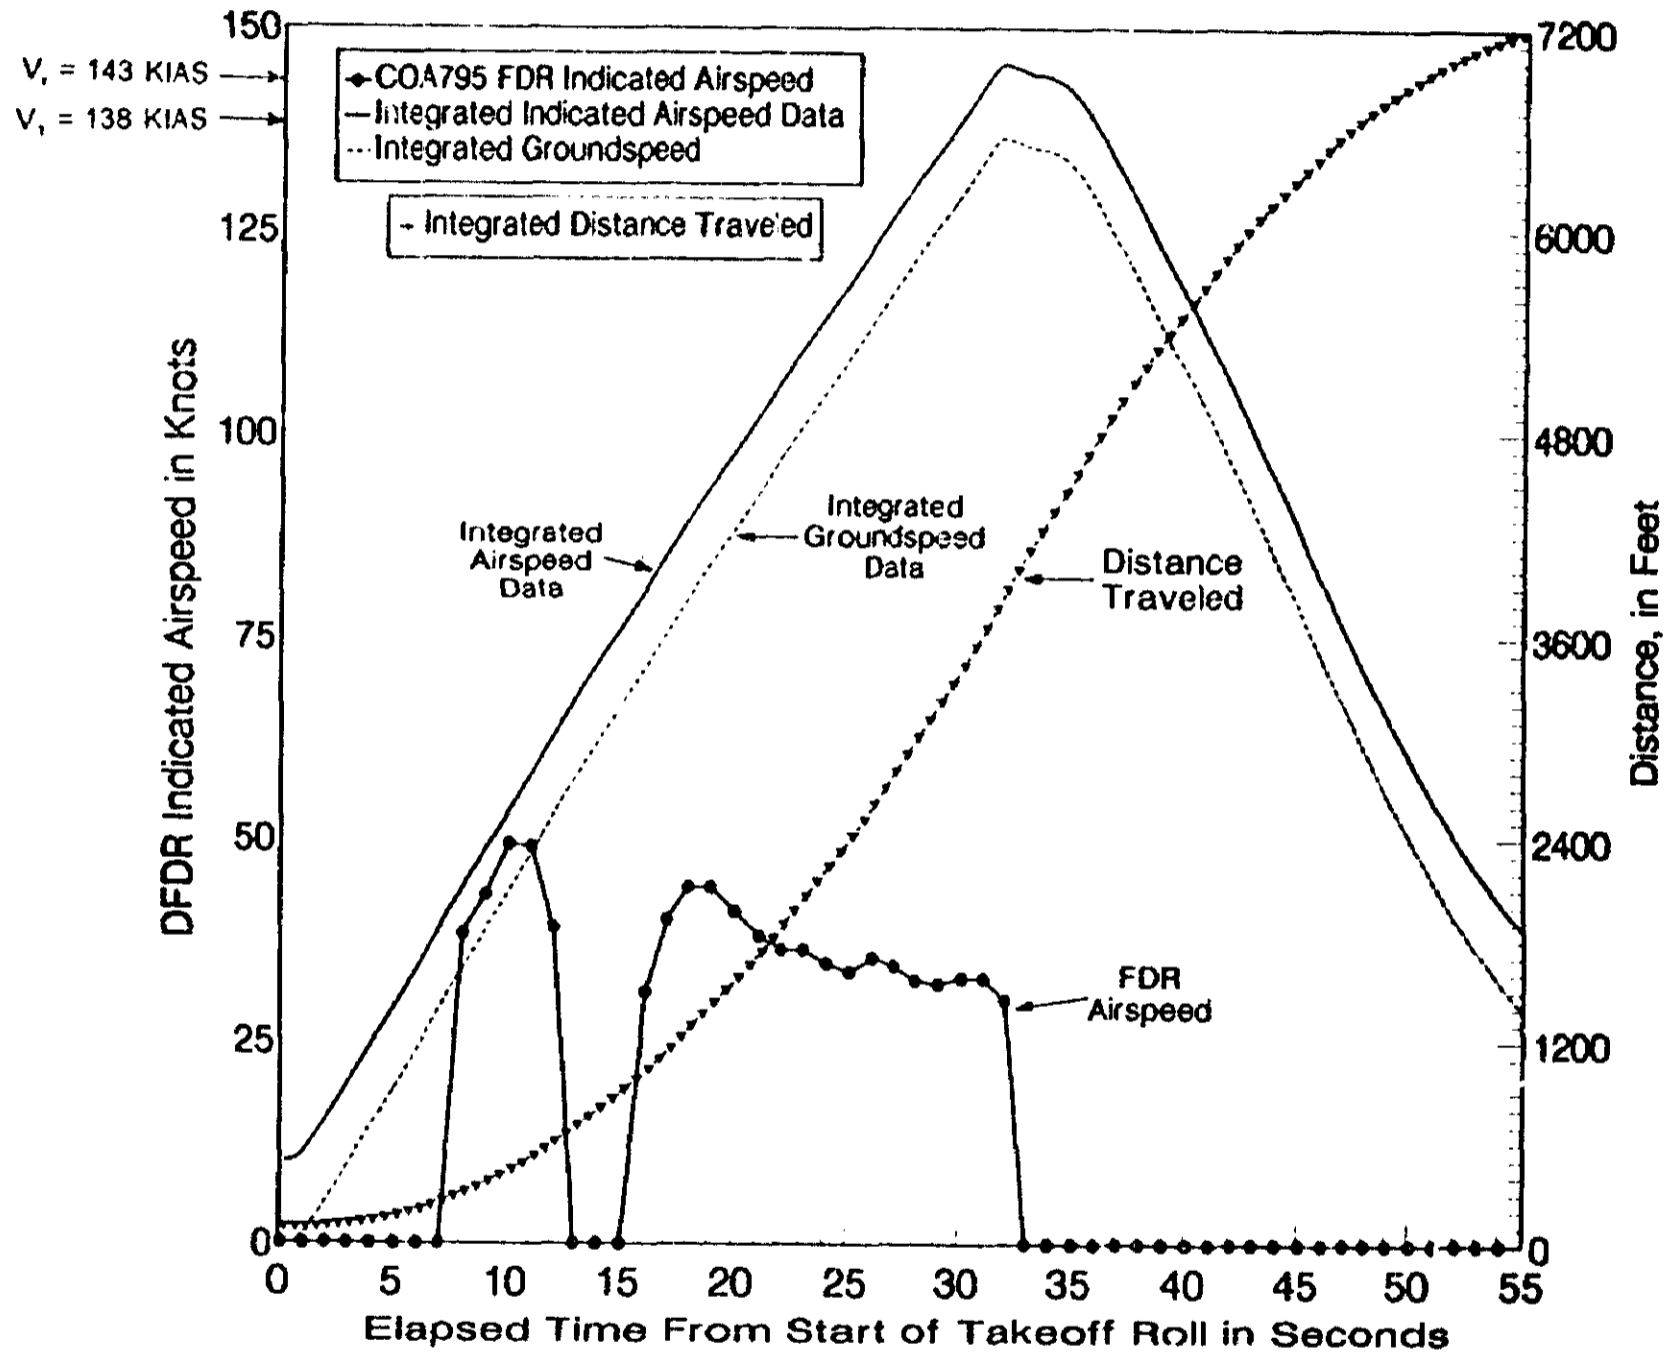
Figure 5.--Comparison of FDR airspeed and integrated airspeed.

1. The accelerations and decelerations were consistent with expected airplane performance for the conditions present.
2. The takeoff was rejected at a computed indicated airspeed of 143 KIAS. (See figure 5).
3. The maximum computed indicated airspeed during the takeoff was 145.5 KIAS.
4. The airplane departed the end of runway 13 at a computed indicated airspeed of 53 KIAS.
5. The airplane struck the dike at a computed 39 KIAS.
6. The time between 60 KIAS and the start of the abort (as determined by the performance evaluation, not the cockpit indicators) was 19.25 seconds.

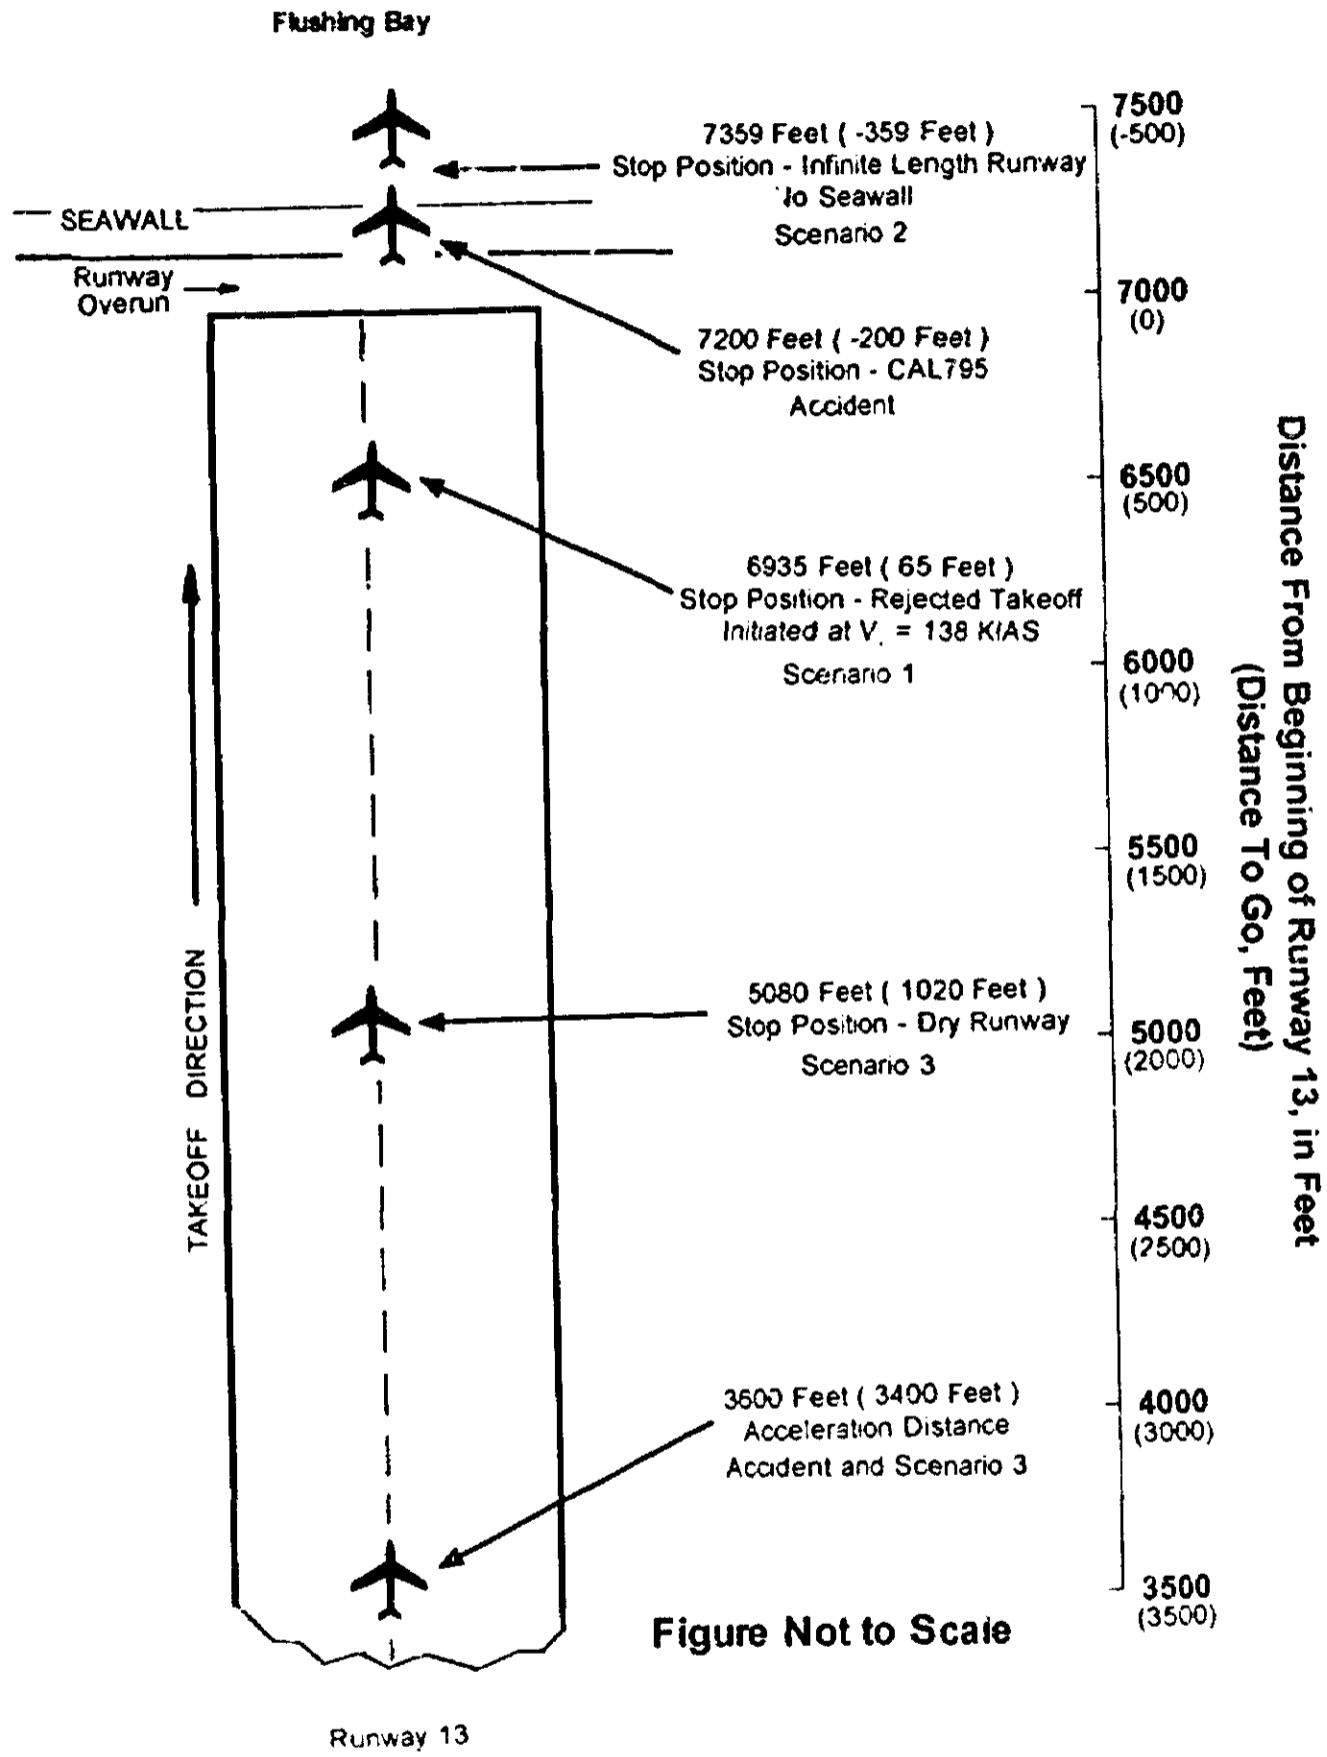
Figure 6.--Results of takeoff/stop scenarios.

The airplane performance study also revealed that the airplane should have been able to stop 1,320 feet from the end of the runway, if the runway surface were dry. (See figure 6, scenario 3). These computations assumed weight, thrust, and environmental conditions for the accident flight. The study also determined that the acceleration of the airplane, as compared to the nominal performance data for the airplane, was consistent with that for an uncontaminated runway, and the deceleration values were consistent with a slippery runway. (A Mu of 0.2 was used in these calculations).
