# National Transportation Safety Board

## Safety Recommendation Report

### Reported Flight Control System Difficulty on Embraer EMB-175

<b>Accident Number:</b>	DCA20IA014
<b>Operator:</b>	Republic Airways
<b>Aircraft:</b>	Embraer-175
<b>Location:</b>	Hartsfield-Jackson Atlanta International Airport, Atlanta, GA
<b>Date:</b>	November 6, 2019

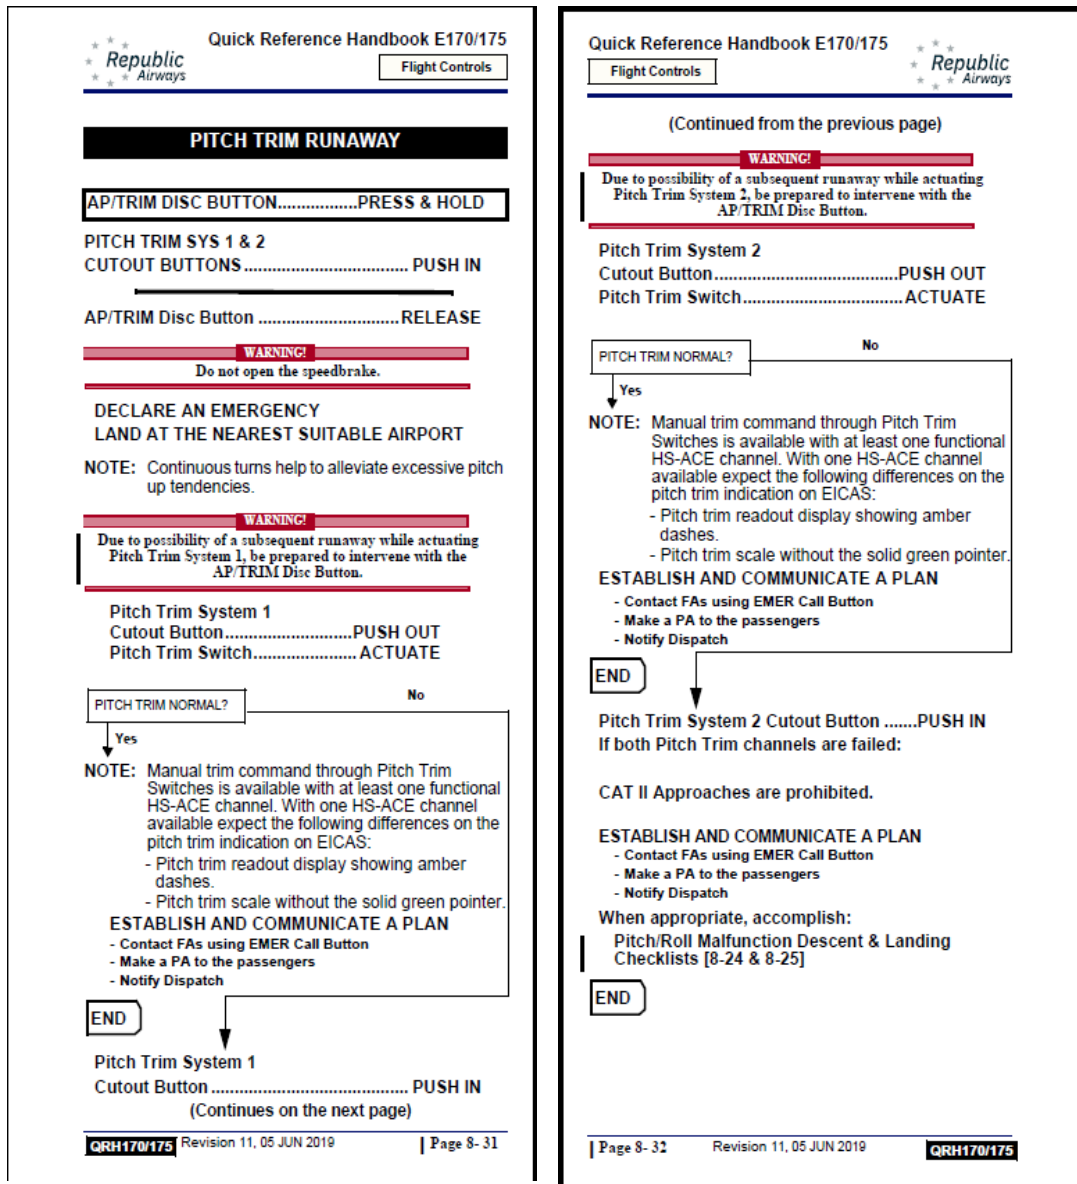
**Figure 1.** Republic Airways Pitch Trim Runaway Checklist.

The NTSB is concerned that, in the event of high control forces resulting from a pitch trim malfunction, flight control failure, or other system anomaly that occurs in a similar phase of flight, other pilots of EMB-170/175/190/195/Lineage 1000 series airplanes may experience difficulty in quickly responding to the problem. In addition, the NTSB notes that Embraer's Pitch Trim Runaway checklist contained a memory item to select both the PITCH TRIM SYS 1 and PITCH TRIM SYS 2 cutout buttons; Republic's checklist did not contain this memory item. During this incident, without access to the checklist or the QRH, the crew only selected the PITCH TRIM SYS 1 cutout button.

Because of the high control forces necessary to maintain control of the airplane, the flight crew in this incident had to rely on the memory item and their understanding of the pitch trim system to resolve the issue by using the first officer's trim switch. Although this memory item was intended to stop a pitch runaway condition, it did not provide information for crews to re-trim the airplane. Thus, it is critical that the memory items are robust enough to protect against incomplete system knowledge and physical limitations preventing access to the QRH so that pilots can quickly trim to regain control of the airplane.

The NTSB concludes that when an unintended pitch trim operation is masked, the crew’s application of the memory item(s) on the EMB-175 Pitch Trim Runaway checklist may not comprehensively address the circumstances of the trim system operation in a timely manner; limitations in the checklist memory item(s) may delay pilots in properly responding to and regaining control of Embraer EMB-170/175/190/195/Lineage 1000 series airplanes. Therefore, the NTSB recommends that ANAC, in coordination with the FAA, Embraer, and US operators, determine if changes to the Embraer EMB-170/175/190/195/Lineage 1000 series airplane Pitch Trim Runaway checklists are required to adequately address all potential trim system failures, and make such changes as necessary. Further, the NTSB recommends that the FAA, in coordination with ANAC, Embraer, and US operators, determine if changes to the Embraer EMB-170/175/190/195/Lineage 1000 series airplane Pitch Trim Runaway checklists are required to adequately address all potential trim system failures, and make such changes as necessary.

In coordination with the Federal Aviation Administration, Embraer, and US operators, determine if changes to the Embraer EMB-170/175/190/195/Lineage 1000 series airplane Pitch Trim Runaway checklists are required to adequately address all potential trim system failures, and make such changes as necessary. (A-20-6)

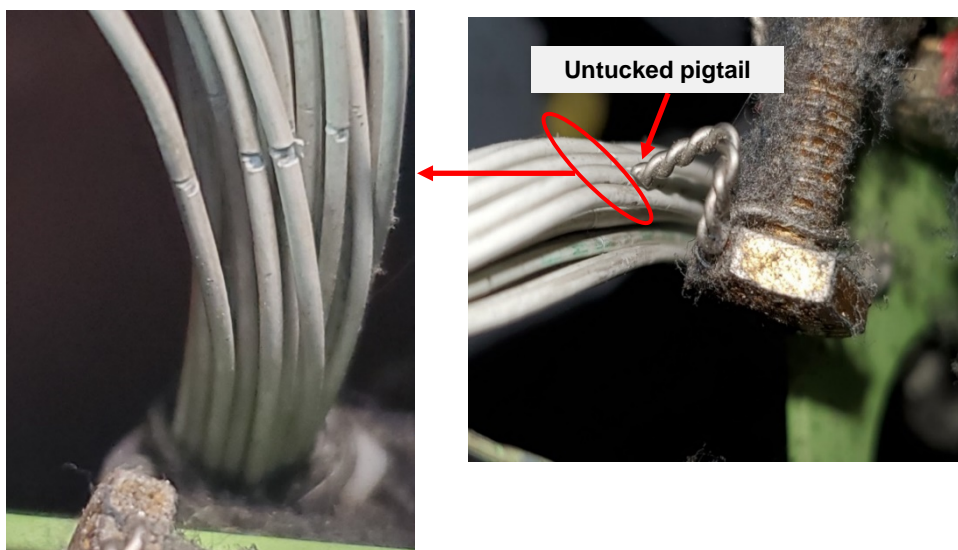
Postincident examination of the airplane (in the area where the captain's control column runs through the flight deck floor) revealed chafed insulation around the wires connecting the horizontal stabilizer actuator control electronics to the captain's pitch trim switch and autopilot/trim disconnect button. The chafing damage was caused by contact with the incorrectly untucked pigtail of the forward mechanical stop bolt safety wire (see figure 2).<sup>3</sup> The maintenance procedures in the EMB-175 airplane maintenance manual (AMM) for adjusting the mechanical stop bolt do not currently draw any specific attention to this critical area.

**Figure 2.** Photographs showing damaged wire (red circle in right photo and enlarged view on the left) of the forward mechanical stop bolt safety wire on incident EMB-175.

Postincident inspections of some EMB-170/175 airplanes have found additional airplanes with damaged wiring in the same area adjacent to the forward mechanical stop bolt. After chafed wires were found on the incident airplane, Republic voluntarily inspected the rest of its fleet and found nine airplanes with chafed wiring. Other operators have also voluntarily inspected their airplanes; thus far, one additional airplane has been found with damaged wiring. The NTSB concludes that damaged wiring could be present on other Embraer EMB-170/175 airplanes—as well as EMB-190/195/Lineage 1000 series airplanes, which have a similar control column

<sup>3</sup> The safety wire is required hardware that retains the control column mechanical stop bolt.

Therefore, the NTSB recommends that ANAC require Embraer to develop instructions for operators of Embraer EMB-170/175/190/195/Lineage 1000 series airplanes to inspect the wiring in the captain’s and first officer’s control columns for damage, replace where needed, and ensure proper clearance from adjacent components, including the forward mechanical stop bolt and its safety wire. The NTSB also recommends that, once Embraer develops inspection instructions for the wiring in the captain’s and first officer’s control columns as requested in Safety Recommendation A-20-1, ANAC and the FAA require operators of Embraer EMB-170/175/190/195/Lineage 1000 series airplanes to inspect that wiring for damage, in compliance with Embraer’s instructions, replace where needed, and ensure proper clearance from adjacent components, including the forward mechanical stop bolt and its safety wire.

Require Embraer to develop instructions for operators of Embraer EMB-170/175/190/195/Lineage 1000 series airplanes to inspect the wiring in the captain’s and first officer’s control columns for damage, replace where needed, and ensure proper clearance from adjacent components, including the forward mechanical stop bolt and its safety wire. (A-20-1)

Once Embraer develops inspection instructions for the wiring in the captain’s and first officer’s control columns as requested in Safety Recommendation A-20-1, require operators of Embraer EMB-170/175/190/195/Lineage 1000 series airplanes to inspect that wiring for damage, in compliance with Embraer’s instructions, replace where needed, and ensure proper clearance from adjacent components, including the forward mechanical stop bolt and its safety wire. (A-20-2)
