# **National Transportation Safety Board**

## **Highway Accident Brief**

Fatal Pedestrian Collision with Sport Utility Vehicle Upper Marlboro, Maryland, June 24, 2016

Accident Number:	HWY16SH016
Accident Type:	Fatal pedestrian collision with sport utility vehicle
Location:	Watkins Park Drive (State Route 193) at Chesterton Drive, Upper Marlboro, Maryland
Date and Time:	June 24, 2016, about 12:30 p.m. eastern daylight time
Vehicle:	2010 Cadillac Escalade
Driver:	69-year-old male
Pedestrian:	76-year-old male
Fatalities:	1

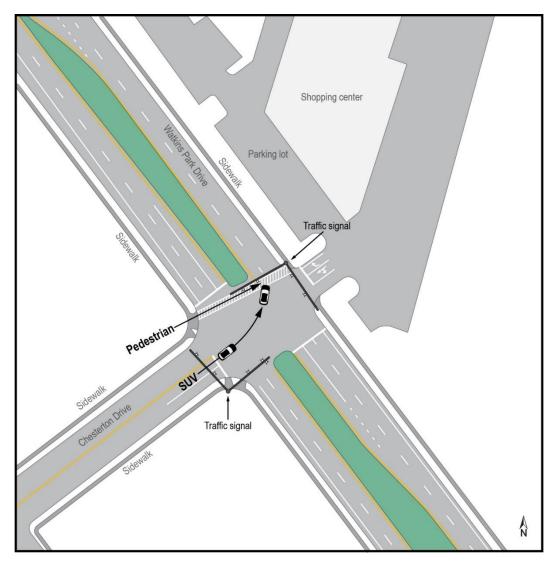
About 12:30 p.m. on Friday, June 24, 2016, a 2010 Cadillac Escalade sport utility vehicle (SUV) operated by a 69-year-old male was stopped for a red traffic signal in the northeastbound travel lane of Chesterton Drive at Watkins Park Drive (State Route 193) in Upper Marlboro, Prince George's County, Maryland. Meanwhile, a 76-year-old male pedestrian was standing on the opposite side of Chesterton Drive, near a pedestrian crosswalk, waiting to cross Watkins Park Drive. When the traffic signal on Chesterton Drive cycled to green and the pedestrian signal cycled to WALK, the driver entered the intersection and the pedestrian entered the crosswalk (figure 1). As the driver made a left turn into the left northwestbound lane of Watkins Park Drive and the pedestrian reached the same lane, the SUV struck the pedestrian while he was in the crosswalk, causing him to fall to the roadway. On colliding with the pedestrian, the driver sharply applied the brakes, stopping the SUV in the left northwestbound lane.

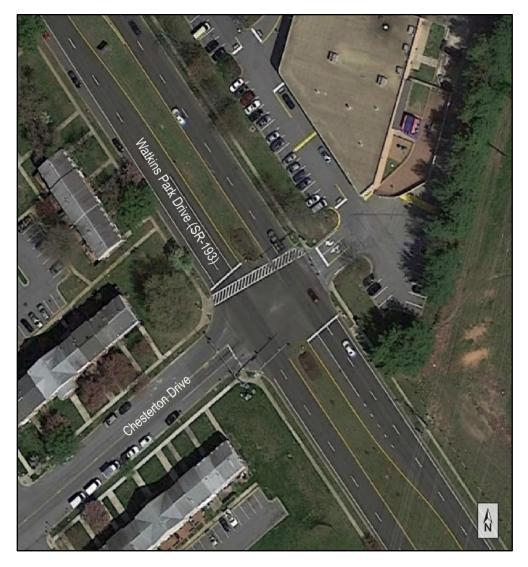
The crash occurred on Watkins Park Drive at its intersection with Chesterton Drive, near the exit from a parking lot (figure 2). Watkins Park Drive is a main traffic artery in the suburban unincorporated community of Upper Marlboro. The area near the crash is mostly residential. The roadway is asphalt and consists of two northwestbound and two southeastbound through lanes. Each through lane is about 11 feet wide. The through lanes in both directions have a left-turn lane

**Figure 2.** Aerial view of intersection of Watkins Park Drive and Chesterton Drive in Upper Marlboro, also showing parking lot and exit (upper right) near crash site. (Base photo by Google Earth)

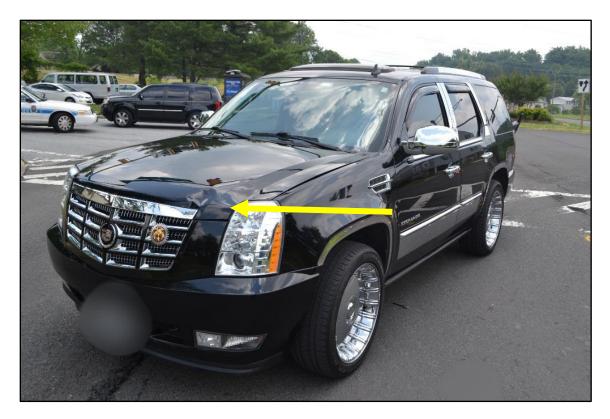
The SUV was examined at the crash scene. It had contact damage on the left leading edge of the hood (figure 3). The grill was cracked, and ornamental trim around the wheel well on the front left fender was bent. No other crash-related damage was noted.
