Highway Accident Brief

Fatal Pedestrian Collision with Minivan Thief River Falls, Minnesota, October 6, 2016

Accident Number:	HWY17SH002
Accident Type:	Fatal pedestrian collision with minivan
Location:	State Highway 59, Thief River Falls, Minnesota
Date and Time:	October 6, 2016, about 7:00 a.m. central daylight time
Vehicle:	2005 Chrysler Town and Country
Driver:	69-year-old female
Pedestrian:	7-year-old male
Fatalities:	1

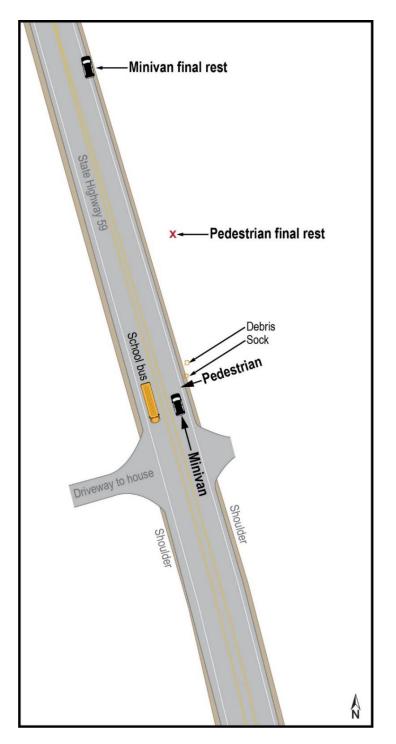
Figure 1. Diagram of crash scene showing location of school bus, path of minivan, point of impact with pedestrian, and final rest positions of pedestrian and minivan. Bus stopped across highway from where pedestrian was waiting, near driveway to his house.

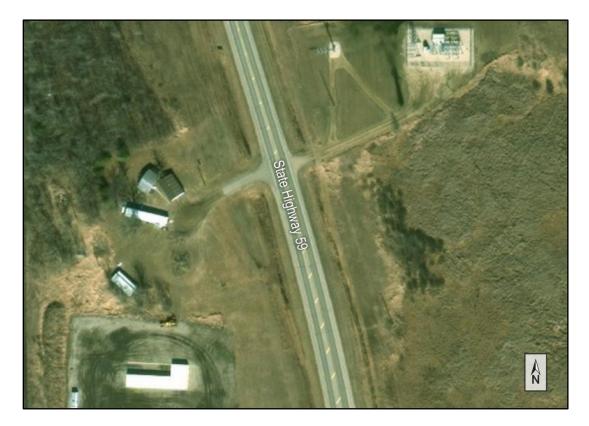
The crash occurred in a rural area, where fields and farms dominate the landscape (figure 2). State Highway 59 is a north/south, two-lane asphalt road that runs northwest to southeast in the area of the crash. The highway has a single lane in each direction, with a double yellow line separating the lanes and a white line separating the northbound lane from the shoulder. The area has no crosswalks, pedestrian control signals, or overhead street lights. Ambient lighting is limited to one lamppost on private property (where the pedestrian lived) across the street from the school bus pickup site. Investigators could not determine whether the light was on at the time of the crash.³ The posted speed limit is 60 mph.

Figure 2. Aerial view of crash location. Pedestrian was waiting with siblings on east side of highway, across road from driveway to his house, shown on left. (Base photo by DigitalGlobe)

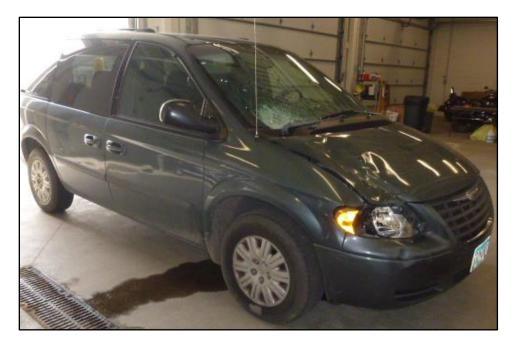
The crash vehicle was a 2005 Chrysler Town and Country minivan. The driver reported that the minivan was in working order before the crash. Damage to the minivan included dents on the right front bumper, headlight assembly, and hood (figure 3). A swipe mark (disturbance of dust and dirt) on the hood went up toward the windshield. The windshield was cracked on the lower right side. No blood or skin was observed in the fragments of windshield glass.

Figure 3. Photograph of minivan showing damage to right bumper, headlight assembly, hood, and windshield.
