National Transportation Safety Board

Highway Accident Brief

Multivehicle Work Zone Crash on Interstate 84, Boise, Idaho, June 16, 2018

Accident Number:	HWY18FH015
Accident Type:	Multivehicle collision in work zone
Location:	Interstate 84, near milepost 47, Boise, Idaho
Date and Time:	June 16, 2018; about 11:32 p.m., mountain daylight time
Vehicle 1:	2019 Volvo truck-tractor in combination with 2015 Great Dane refrigerated semitrailer
Vehicle 2:	2008 Jeep Wrangler
Vehicle 3:	2003 Volvo truck-tractor in combination with 2008 Great Dane refrigerated semitrailer
Vehicles 4–7:	2006 Ford Fusion, 2014 Ford F-150, 2015 Ford Escape, 2010 Ford Focus
Fatalities:	4
Injuries:	4 (minor)

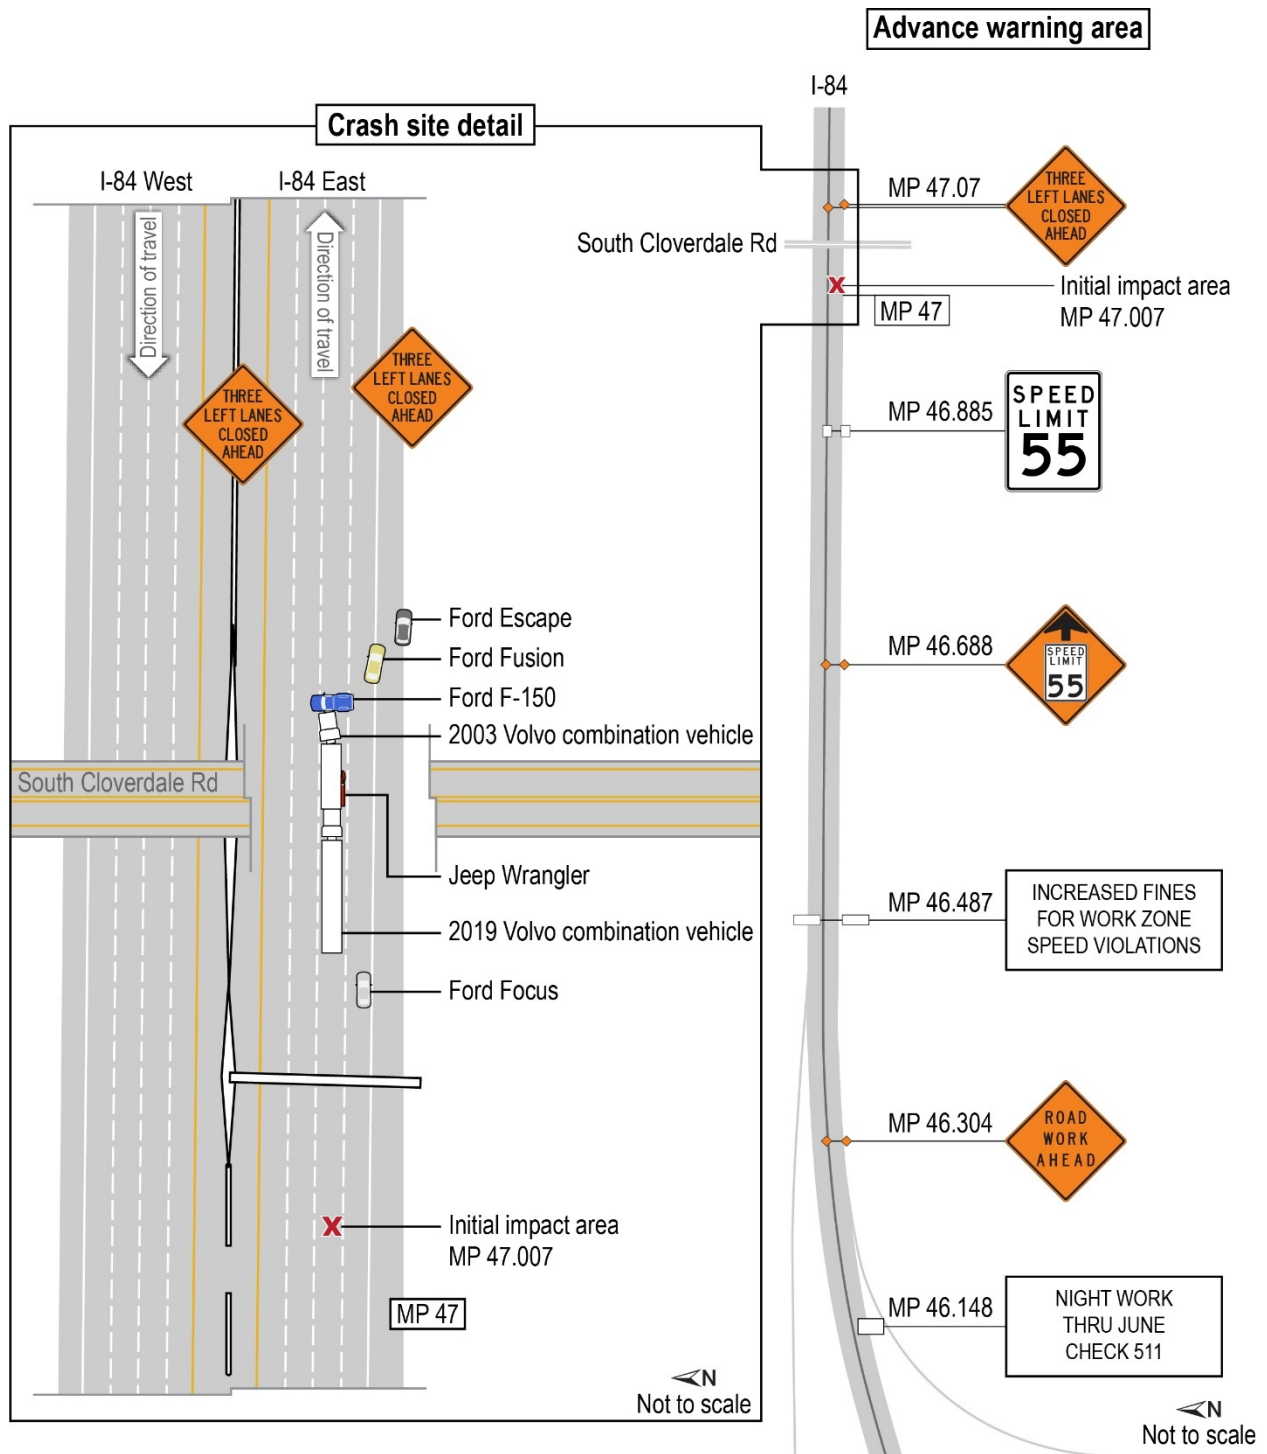
Figure 2. Diagram of crash area on I-84. The right side of the figure shows part of the advance warning area for the work zone and the locations of the signage on I-84 between MP 46.148 and slightly beyond MP 47.07. The left side of the figure is an expanded view of the immediate crash area, which is represented from MP 47 to just beyond MP 47.07.

Despite the construction staging and traffic control plan requiring that two lanes remain open at all times during construction, lanes 1, 2, and 3 in the eastbound direction were all closed; only lane 4 (the far right lane) was open.¹⁴ Data recorded by the ITD automatic traffic recorders that were positioned in the transition area for this work zone indicated that, before the crash, the traffic speed had slowed to about 18 mph and had resulted in a lengthy queue forming, due to the vehicle stop-and-go situation. The ITD work zone inspectors noted the lane closures in their traffic control maintenance diaries, but they did not take any action to address the fact that the lane closures exceeded those permitted by the traffic control plan or to resolve the resulting hazards associated with the traffic queue.¹⁵

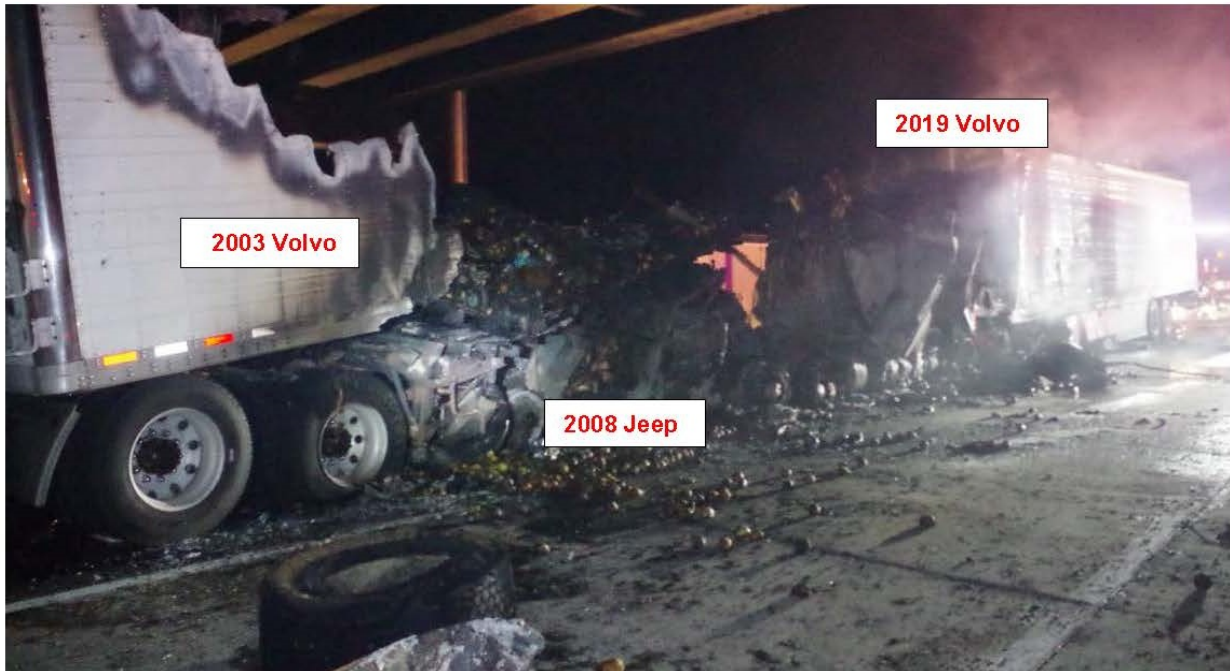
After being struck by the 2019 Volvo truck, the Jeep was pushed forward so that it underrode the trailer of a 2003 Volvo truck-tractor in combination with a 2008 Great Dane refrigerated semitrailer in the same lane. The 2003 Volvo combination vehicle moved forward and collided with the rear of a 2006 Ford Fusion, pushing it into the rear of a 2014 Ford F-150 and sideswiping a 2015 Ford Escape. Debris from the collision also damaged a 2010 Ford Focus. A postcrash fire ensued that consumed the Jeep, most of the 2003 Volvo combination vehicle's semitrailer, and a portion of the 2019 Volvo truck's cab and semitrailer, as well as severely damaging the Cloverdale Road overpass.⁴ Figure 2 shows a diagram of the crash area and the locations of the vehicles at final rest, and figure 3 shows the postcrash condition of the two combination vehicles and the Jeep.

Figure 3. Postcrash photograph of vehicles under Cloverdale Road overpass; view is looking west, toward the 2019 Volvo truck that began the crash sequence. (Source: Idaho State Police)

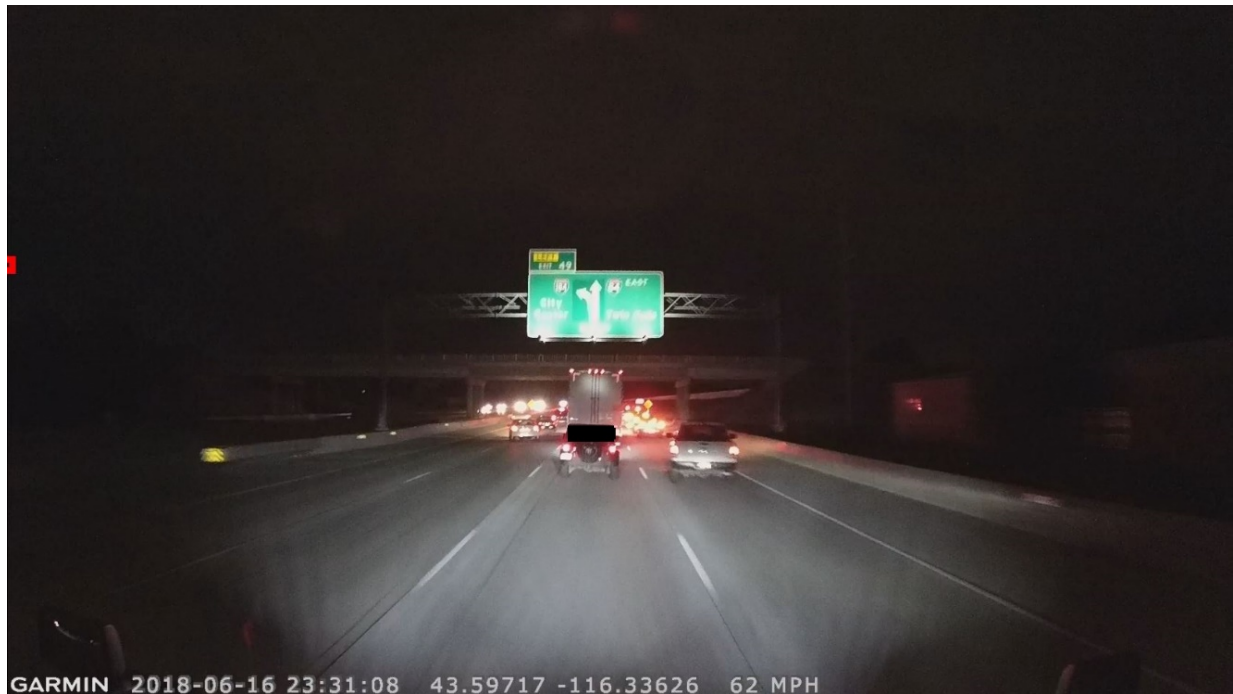
The 2019 Volvo truck-tractor was equipped with an aftermarket onboard Garmin camera system. This system recorded vehicle speed, interior audio, and forward-facing video when triggered.⁵ An image taken by the onboard camera system shows the position of the Jeep 1.3 seconds before the crash impact (see figure 4). Taken from the perspective of the 2019 Volvo truck driver, the image shows the end of the traffic queue, with the Jeep in lane 3 immediately

Figure 4. Screenshot from Garmin forward-facing video camera on 2019 Volvo truck-tractor taken shortly before crash. (Source: Garmin Dash Cam)

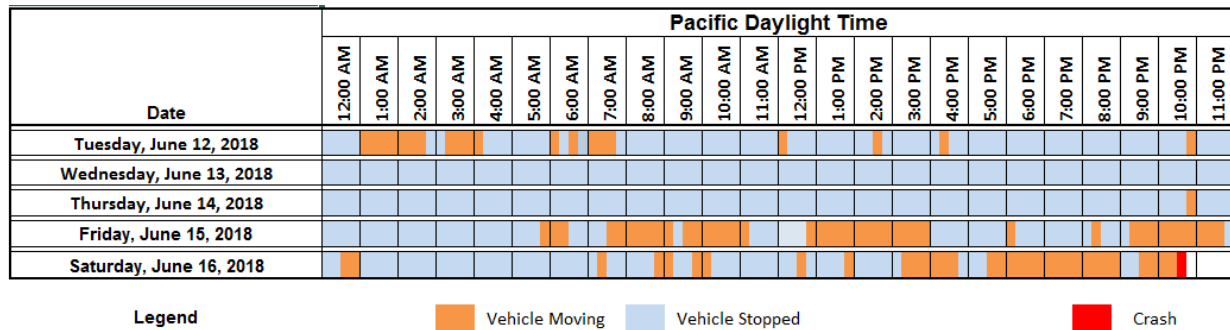
According to the ELD data, on June 15, the day before the crash, the driver began driving at 5:54 a.m. and drove for various intervals of time until 1:00 a.m. on June 16. The ELD data showed that the vehicle was stationary from 1:00 a.m. until 7:15 a.m. on June 16. According to the ELD data and bills of lading, after having the truck loaded with apples in Yakima, Washington, the driver began his eastbound trip at 7:15 a.m. on June 16.²⁶ The driver drove a series of relatively short segments (ranging in length from 15 minutes to 3.5 hours) as he headed to Boise, Idaho, on this leg of his cross-country journey to Massachusetts. During the trip on June 16, the driver stopped the vehicle several times, with the ELD recording non-moving periods that were 2.5 hours long or less, and he continued driving until the crash at 10:32 p.m.²⁷ The distance from where the truck was loaded to the crash scene was about 360 miles. Figure 5 shows the ELD data, indicating when the 2019 Volvo truck was moving and when it was stopped.

Figure 5. ELD data for the 5 days preceding the crash, showing when the 2019 Volvo truck was moving and stopped. (Note: The trip began in Yakima, Washington, which is in the Pacific time zone, but the crash occurred in Boise, Idaho, which is in the mountain time zone. The crash time of 10:32 p.m. Pacific daylight time used in figure 5 corresponds to the crash time of 11:32 p.m. mountain daylight time.)

Based on the ELD recording of the movements of the 2019 Volvo truck, the driver had limited chances for rest preceding the crash. His lengthy on-duty hours in the 2 days before the crash, and the relatively short windows of opportunity for sleep, indicate that he most likely did not obtain adequate sleep during this period. The crash occurred at night when people are more disposed to exhibit fatigue.³¹ Moreover, the driver's inability to maintain his vehicle's lane position, as well as his complete lack of response to the traffic queue as he came upon it, are consistent with a fatigue-related lapse in vigilance.³²
