Motorcoach Collision With Combination Vehicle
After Traffic Break on Interstate 10
Palm Springs, California
October 23, 2016

Accident Report

NTSB/HAR-17/04
PB2018-100195

National
Transportation
Safety Board

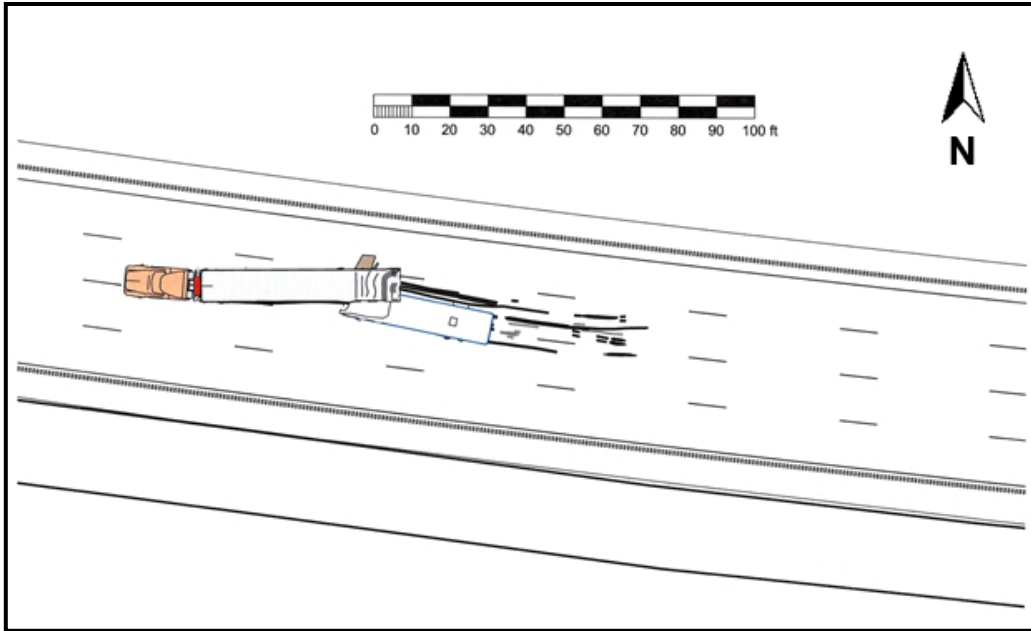
Figure 2. Postimpact positions of the combination vehicle and the bus, and the road friction marks created by the truck-tractor as it was being pushed by the bus.

Investigators found no precollision tire friction marks from the bus that could indicate an evasive braking maneuver. The impact by the bus moved the truck-tractor about 71 feet west, with friction marks terminating at the truck-tractor's drive axle. At rest, both vehicles partially occupied the left-center and right-center travel lanes (see figure 3).

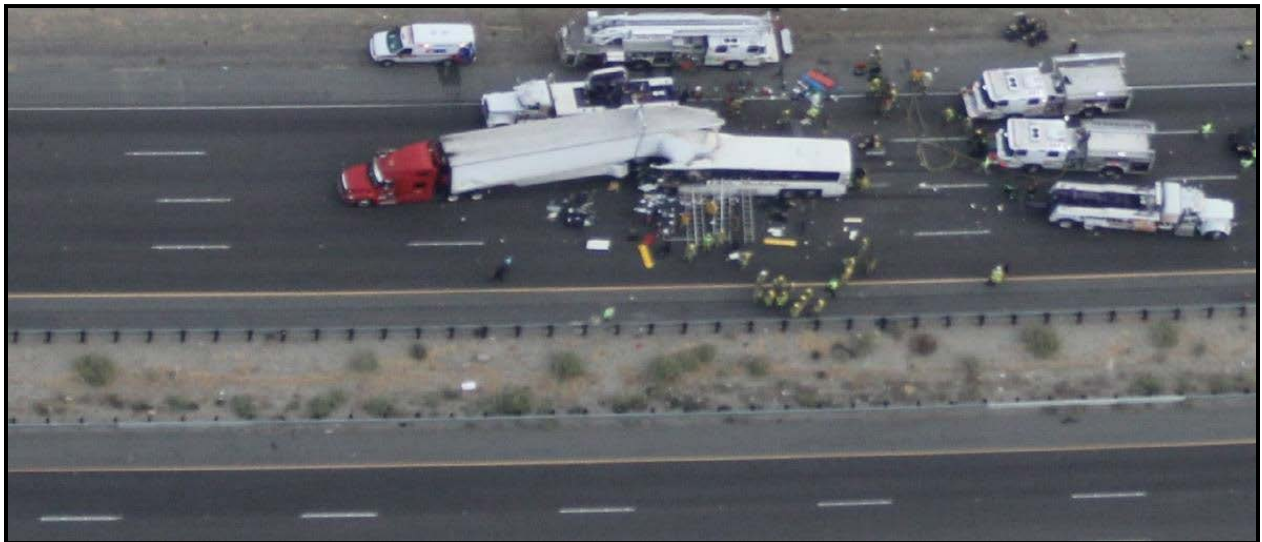
Figure 3. Combination vehicle and bus at rest. (Source: California Highway Patrol)

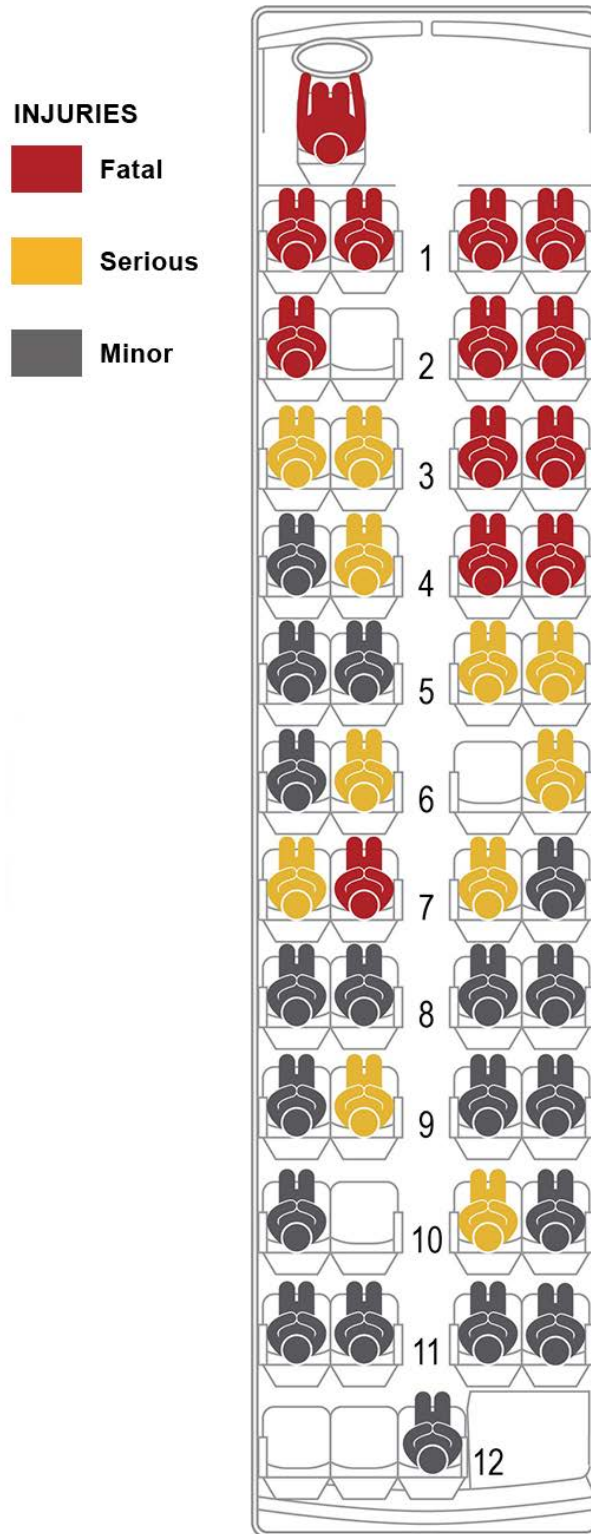
The distribution of injury severity shows that nearly all the bus passengers—9 of 11—who sustained serious injuries were seated in rows 3–7. Only two passengers in the rear half of the bus—those in rows 8–12—sustained serious injuries; the rest of those seated in the rear received minor injuries. Based on interviews with the surviving passengers, NTSB investigators determined the seating positions for all 42 passengers. Figure 4 shows the seating locations and injury classifications for the bus occupants.

Figure 4. Bus seating chart, showing the injury classifications for the driver and 42 bus passengers.

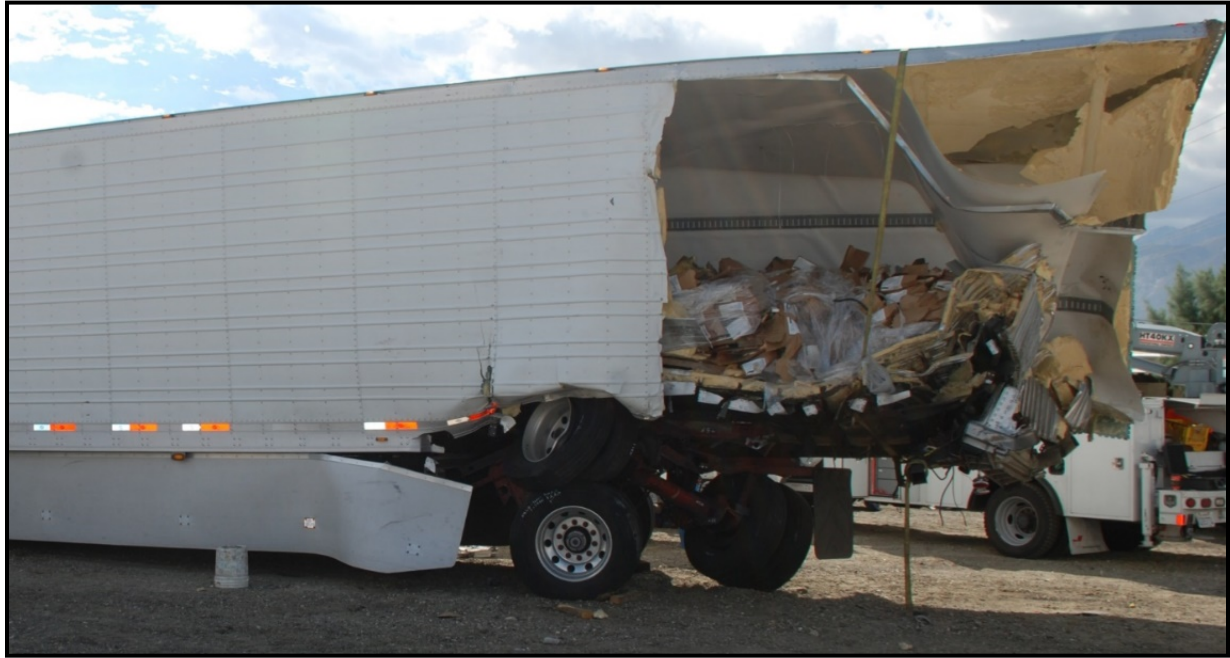
1.5.1.2 Damage. The truck-tractor did not sustain any external damage during the crash. Although the truck-tractor's tires were not damaged, the tires on axles 2 and 3 had longitudinal scuffing and abrasions. The semitrailer, which was 53 feet long, sustained extensive damage to the rear. With their steel frame, the rear doors were displaced and found in debris at the inspection location. The rear bumper and rear impact guard were rolled downward and forward, and they ended below the floor of the semitrailer (see figure 7). The flooring was buckled upward, and crossmembers under the floor were displaced forward, farther on the left, and separated from their mounting positions. Portions of the rear sidewalls were displaced and found in debris. The ceiling on the rear of the semitrailer had collapsed.

The front of the bus underrode the semitrailer up to the semitrailer's rear axles, about 13.4 feet—the maximum forward distance that showed evidence of contact damage. The rear

axle—axle 5—was displaced forward, farther on the left, with the left tires and wheels resting on top of the left tires and wheel of axle 4.

Figure 7. Semitrailer postcrash, showing extensive rear damage. (Source: California Highway Patrol)

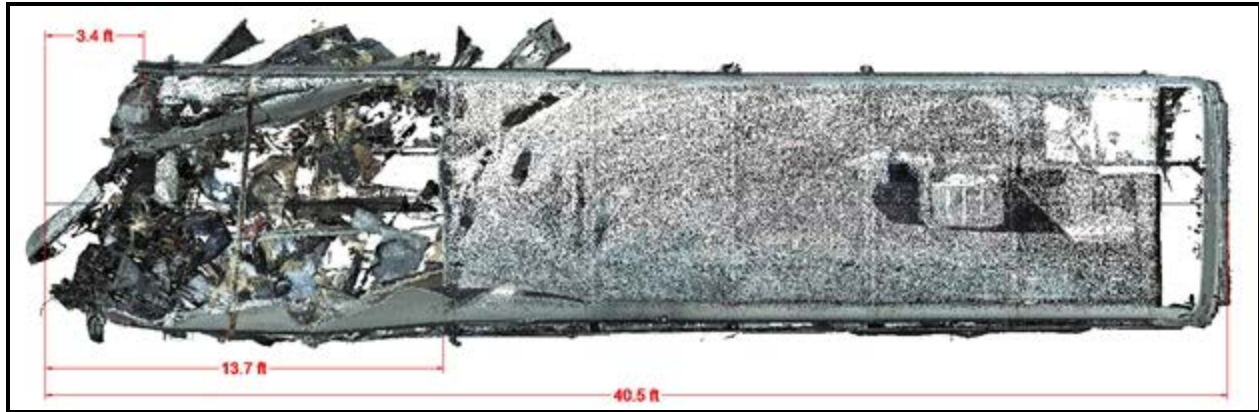
The impact damage was offset toward the right side of the bus; the right front end was displaced rearward 3.4 feet (see figure 9). First responders had cut away a section of the sidewall from the front of the bus to the first two windows on the left side. The sidewall on the right side was also cut away at several locations, including a section from the front of the bus to below window 3, a section below window 5, and just forward of the rear wheels. The passenger entrance stepwell was crushed rearward, and the loading door was displaced and found in debris. The right side of axle 1 was crushed and displaced rearward by about 7 inches, trapping the tire and wheel inside the right-side wheel well.

The semitrailer's left sidewall had intruded into the bus and sheared about 13.7 feet from the roof panel along the left side of the bus, extending from the front of the bus to the second passenger windows and the fourth row of passenger seats.

Figure 9. 3D point cloud image of the bus showing the extent of frontal displacement and roof intrusion in comparison to original dimensions. (Source: California Highway Patrol)
