School Bus Run-Off-Road and Fire
Oakland, Iowa
December 12, 2017

Highway Accident Report

NTSB/HAR-19/01
PB2019-100808

NTSB/HAR-19/01
PB2019-100808
Notation 58678
Adopted June 18, 2019

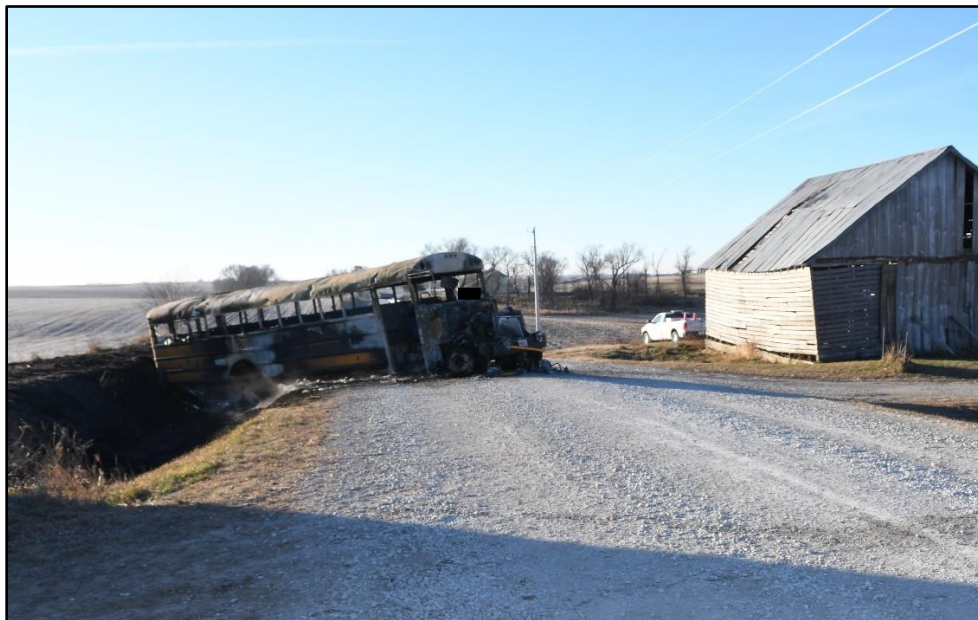
driver used the bus radio to call the RCSD bus maintenance facility. He reported that he was stuck in a ditch at his first pickup location and that there was a fire. The fire spread into and through the bus's passenger compartment, destroying the interior and much of the exterior (figure 3).

Figure 3. Burned school bus (right side) at final rest in ditch next to 480th Street, looking south. (Source: Pottawattamie County Sheriff's Office)

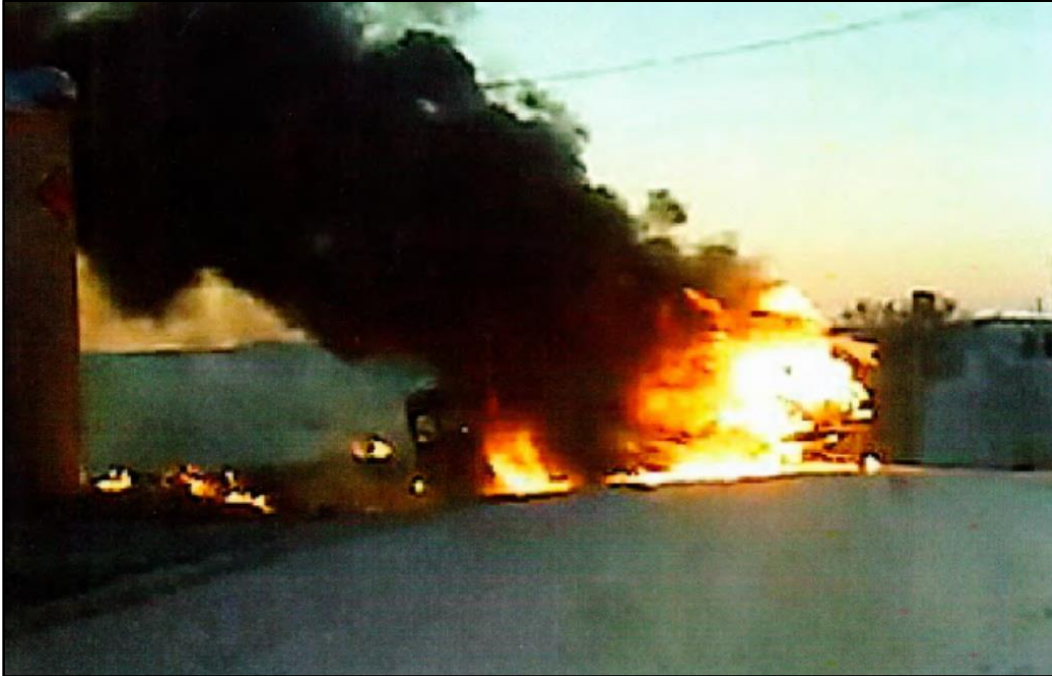
Figure 4. Burning school bus (right side) in still photograph captured from body camera video. (Source: Pottawattamie County Sheriff's Office)

The first county sheriff's deputy to arrive stated that the school bus was fully engulfed in fire when he arrived on scene (refer to figure 4). The deputy applied the fire extinguisher issued by the sheriff's department to the back of the bus, but it had no effect on the fire. He then tried to enter the school bus through the rear emergency exit door, but the flames and fire temperature stopped him. Members of the first fire department unit to arrive reported that when they approached the scene, the bus was on fire from front to rear. They immediately began fire suppression and extinguished the fire. The postcrash fire destroyed much of the school bus (figure 5).

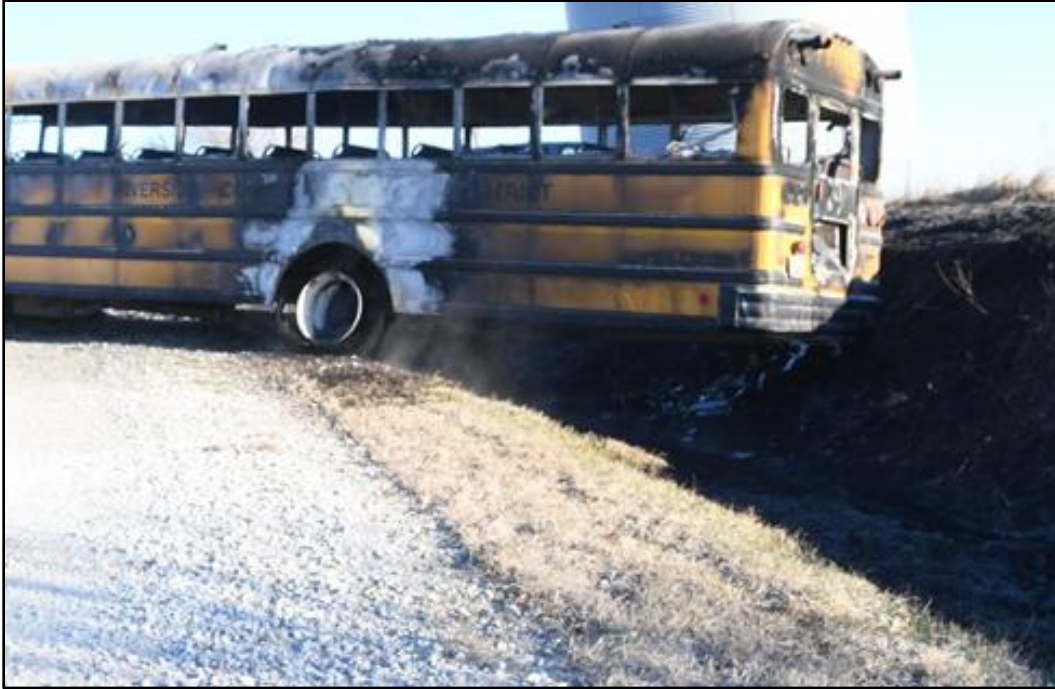
Figure 5. Burned school bus (left rear) at final rest in ditch. (Source: Pottawattamie County Sheriff's Office)

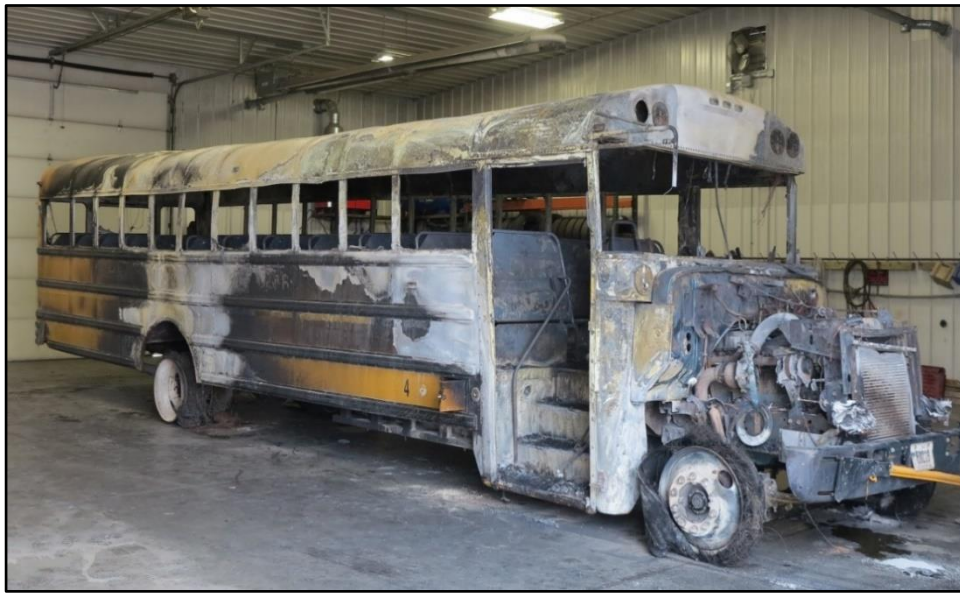
The fuel tank cap was in place, and no damage to the fuel tank was noted.³⁵ Because of the extent of the fire, all tires were destroyed except those on the left steer axle (front axle). The destruction of the tires caused the bus to lower onto the roadway near the front loading door (before being damaged by the fire, the inflated tires would have elevated the loading door above the roadway). No other obstructions to the front door were found; the driver had used the door to load the passenger just minutes before the crash. Only the steel wires from the bead and body plies remained on the other tires, and no reliable tread depth measurements were possible.³⁶ NTSB investigators visually examined the tire rims and found no defects that were not related to the crash. Damage to the front and right side of the bus is shown in figure 6.

Figure 6. Fire damage to bus's front and right side, including loading door, windows, roof, and engine (photographed after bus was removed to garage).

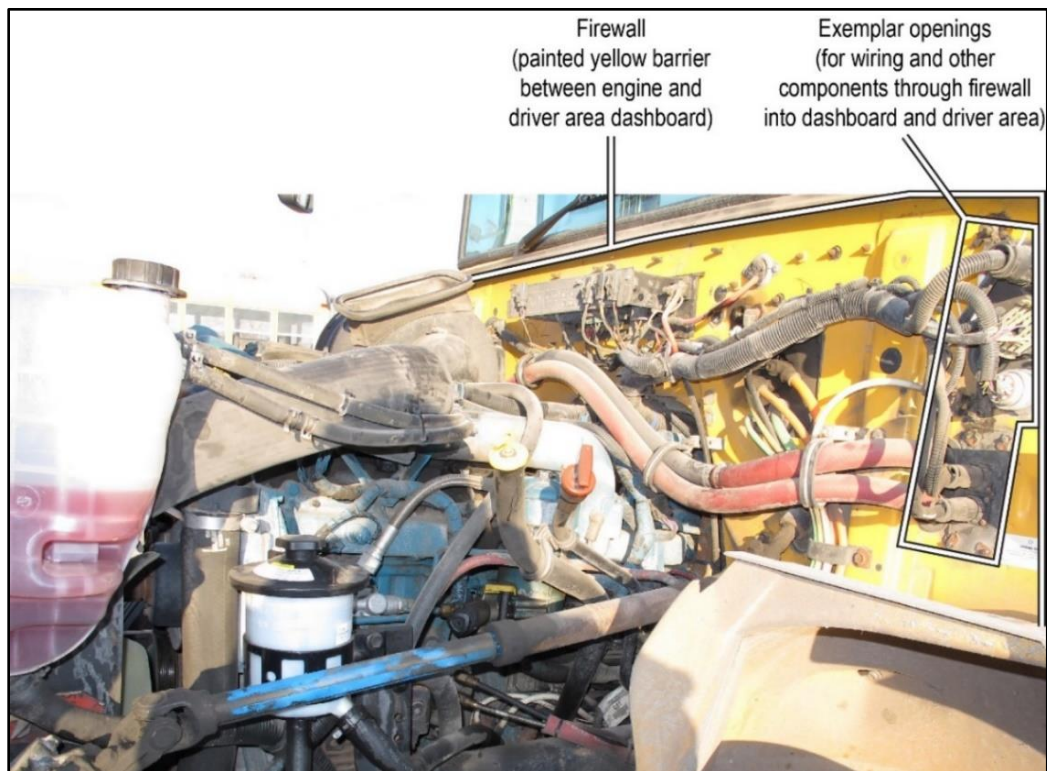
The engine block extended beyond the firewall into the driver area of the bus interior. The area was covered with a fiberglass cowling that was heavily damaged by the fire. Glass fibers were present, but a large amount of resin had burned out of the fiberglass. A hole was found on the upper right corner of the cowling. The engine block and components below the turbocharger and engine control board (forward from the firewall toward the front bumper) were intact and relatively undamaged. The blue paint on the lower part of the engine block was intact; the oil filter was also intact.⁴⁰ Between the engine block and the interior driver's area were several firewall penetrations for components such as wiring (figure 8). Components in the openings to the right of the vehicle's midline were destroyed by the fire. Electrical wiring was still present in the openings to the left of the midline, but the material used to seal the wiring inside the openings was missing and had most likely been destroyed by the fire.⁴¹

Figure 8. Engine compartment of exemplar bus showing firewall and openings into driver's area.

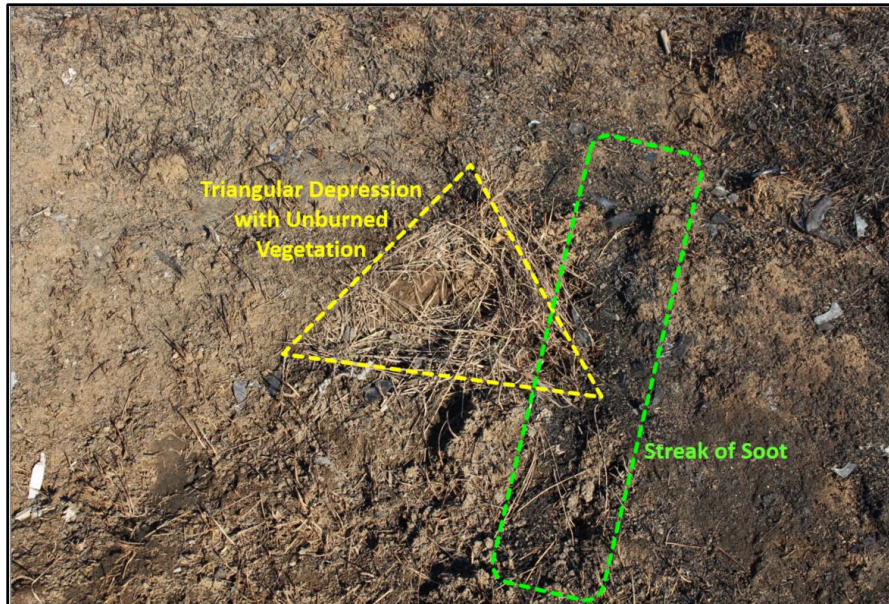
Figure 10. Streak consistent with soot deposit on drainage ditch backslope next to depression containing unburned vegetation.

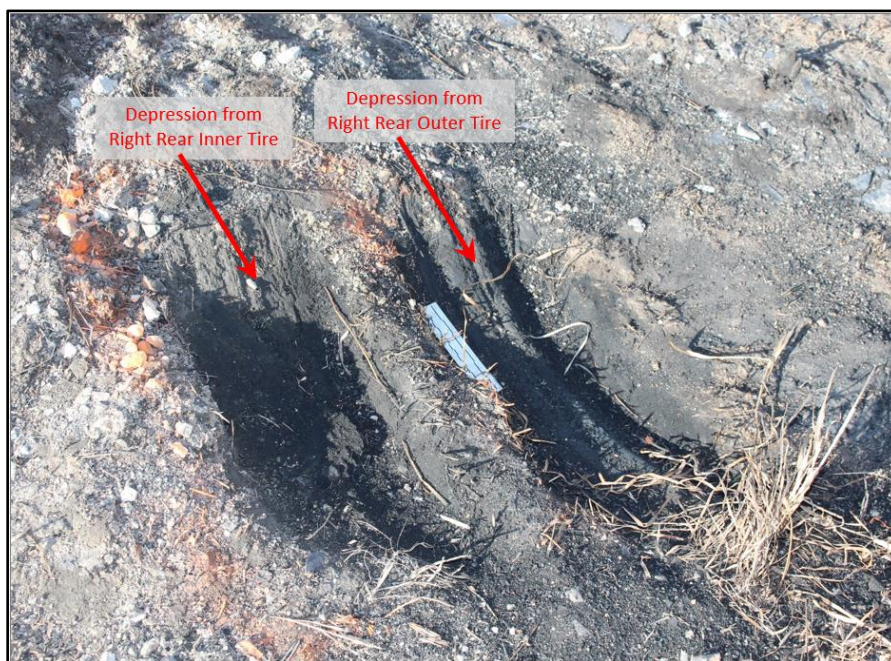
Two distinct depressions, consistent with impressions from the bus's right rear tires, were found in the soil near the bottom of the ditch foreslope. When investigators removed the fire debris, tire imprints in the depressions were exposed (figure 11). One imprint measured about 24 inches long, 9 inches wide, and 2 inches deep and was consistent with being formed by the right rear inner tire. The imprint formed by the right rear outer tire was about 27 inches long, 9 inches wide, and 2 inches deep. Large portions of partially burned and melted tire treads were found lining the bottoms of the depressions.

Figure 11. Soil depressions from rear tires on foreslope near ditch bottom.

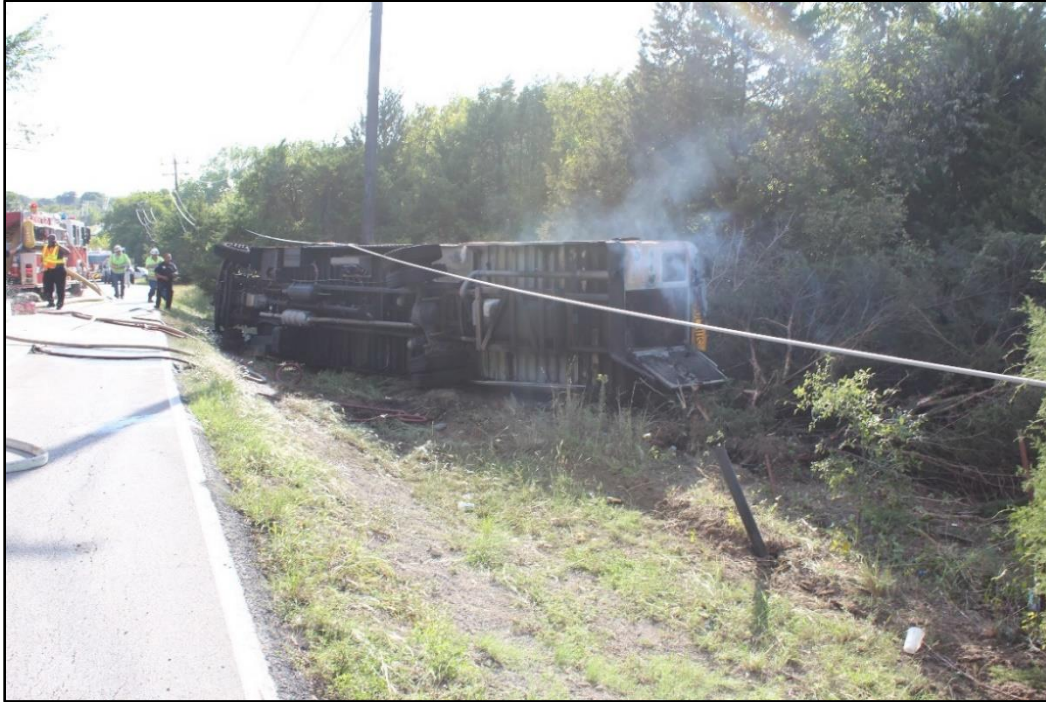
Figure 18. School bus at final rest after crash and fire in Mesquite, Texas. (Source: MPD)

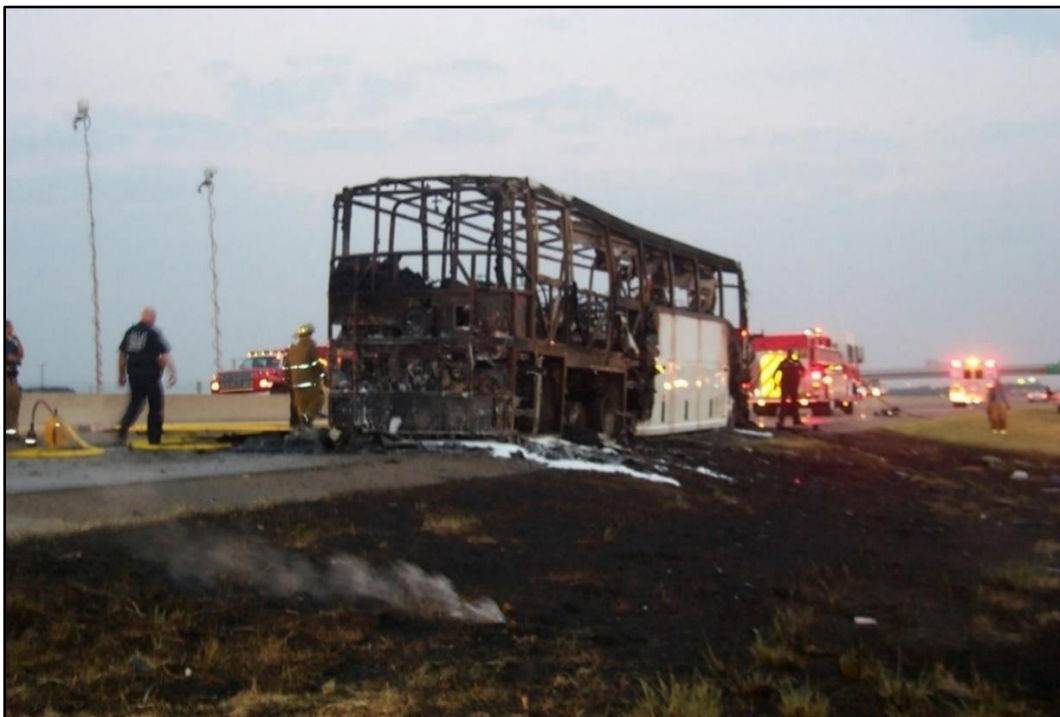
Figure 20. Damaged motorcoach on I-45 after fire near Wilmer, Texas. (Source: Dallas County Sheriff's Office)
