NTSB/HIR-22/01

Multivehicle Crash Near Mt. Pleasant Township, Pennsylvania

January 5, 2020

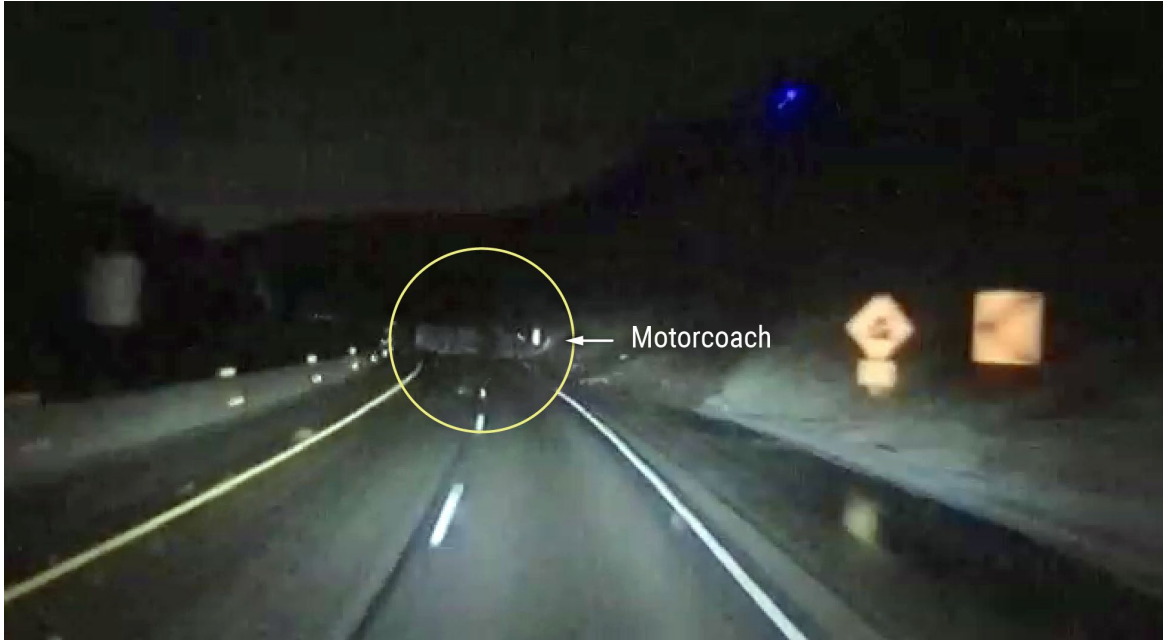
Figure 3. Image from FedEx video showing motorcoach lying across roadway.

Shortly after the motorcoach came to rest across the highway, the FedEx truck collided with it. The truck, occupied by a 35-year-old male driver and a 35-year-old male codriver, was traveling in the right lane. It had entered the curve at 53 mph. As recorded by the truck's inward-facing camera and as stated in his interview with the NTSB, the driver maneuvered left in an attempt to avoid the motorcoach wreckage (see further discussion about inward-facing vehicle cameras in section 2.5). He said that the motorcoach looked like "a black wall." The FedEx truck crashed into the motorcoach at a speed of about 21 mph and came to rest blocking the left lane and median shoulder.

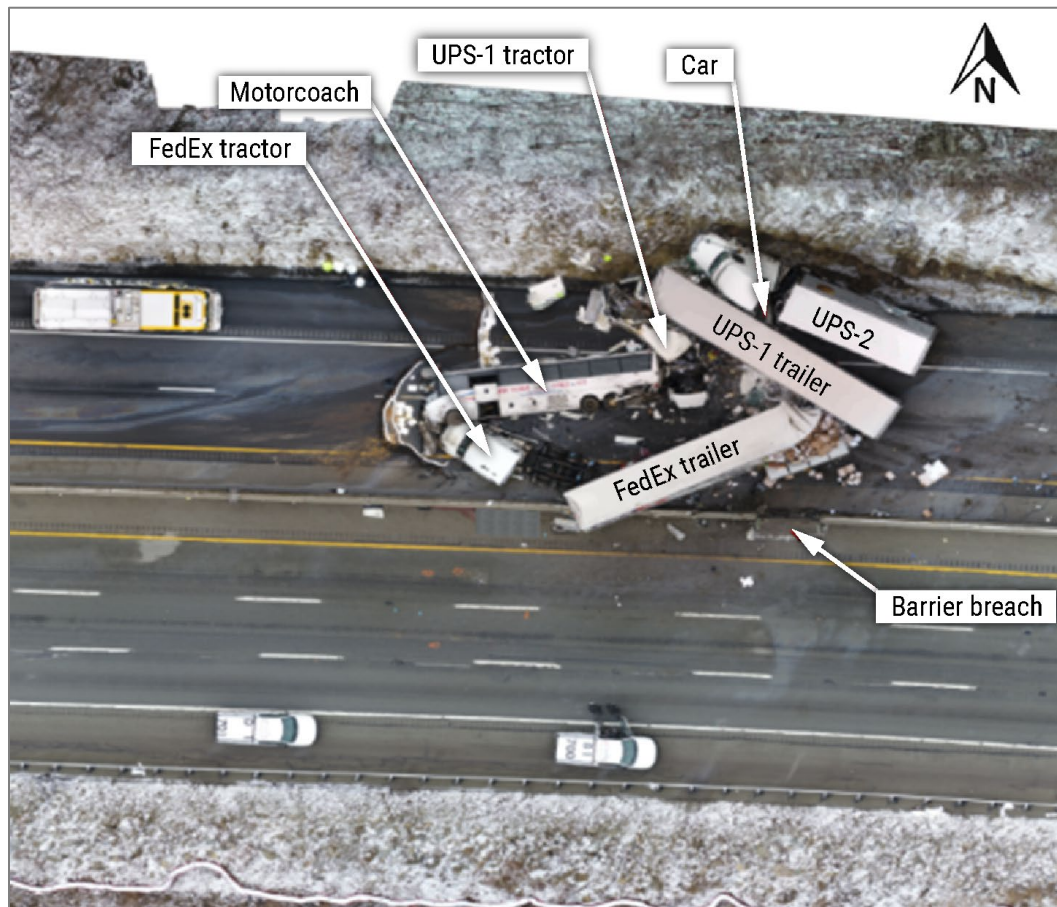
Figure 4. Final rest positions of all vehicles involved in crash. (Source: Pennsylvania State Police image with NTSB overlay)

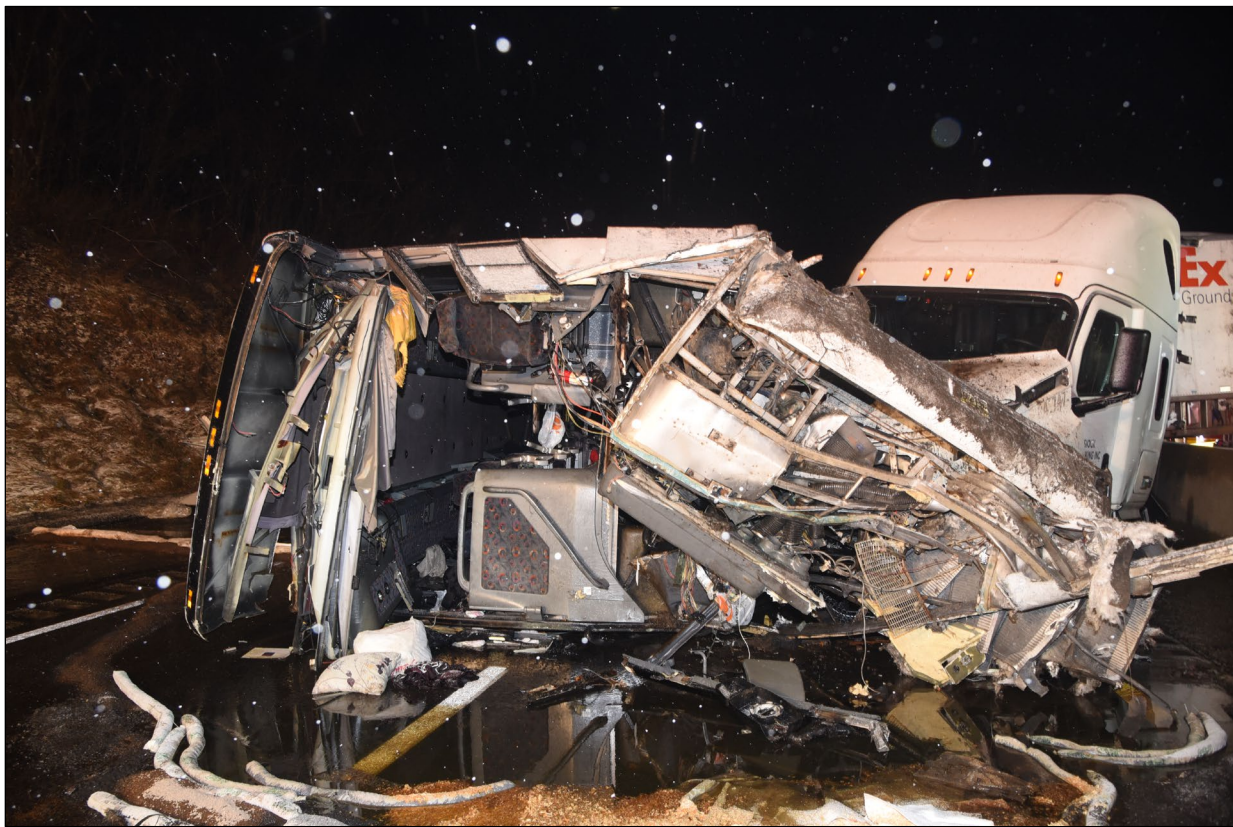
Photographs taken at the scene show the motorcoach's front structure twisted and entangled with the front of the FedEx truck (see figure 7). A point cloud image of the postcrash motorcoach was rendered from three-dimensional scans (see figure 8).³⁰

Figure 7. Photograph of collision scene showing front of motorcoach rolled onto its right side and entangled with front of FedEx truck. (Source: Pennsylvania State Police)

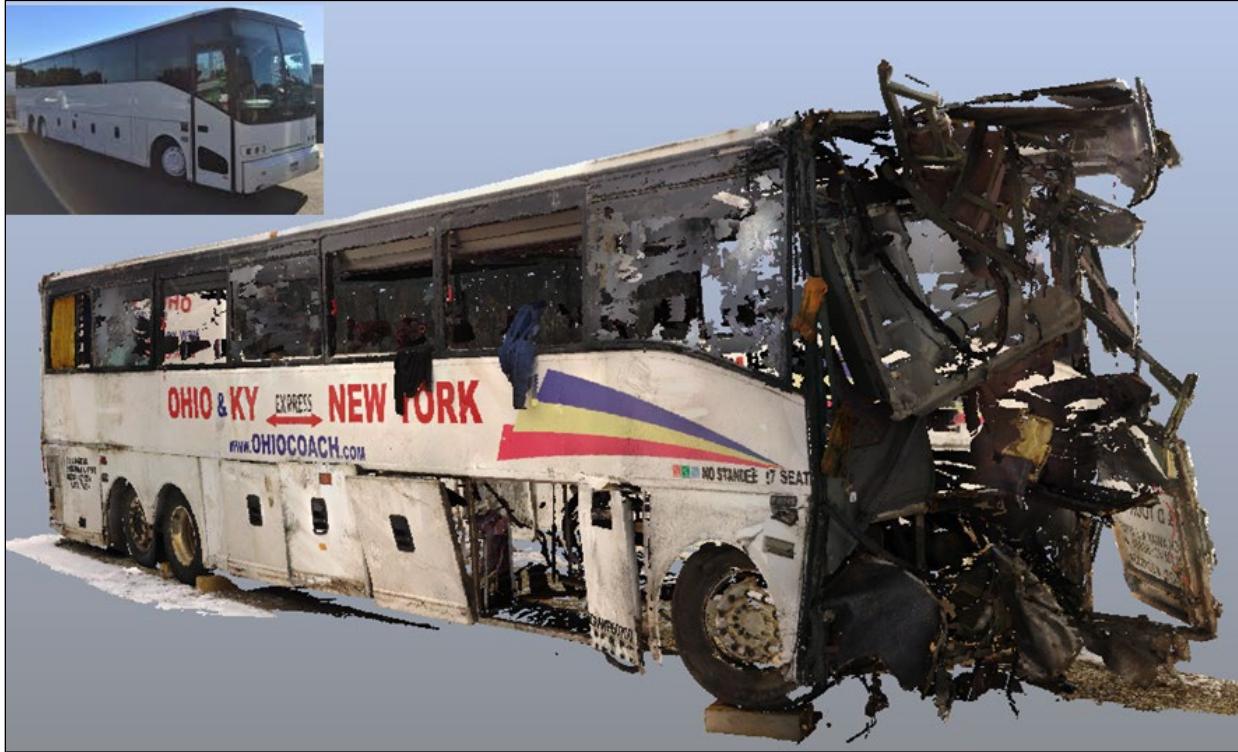
Figure 8. Point-cloud image of motorcoach postcrash, with inset photo of intact motorcoach of same model.

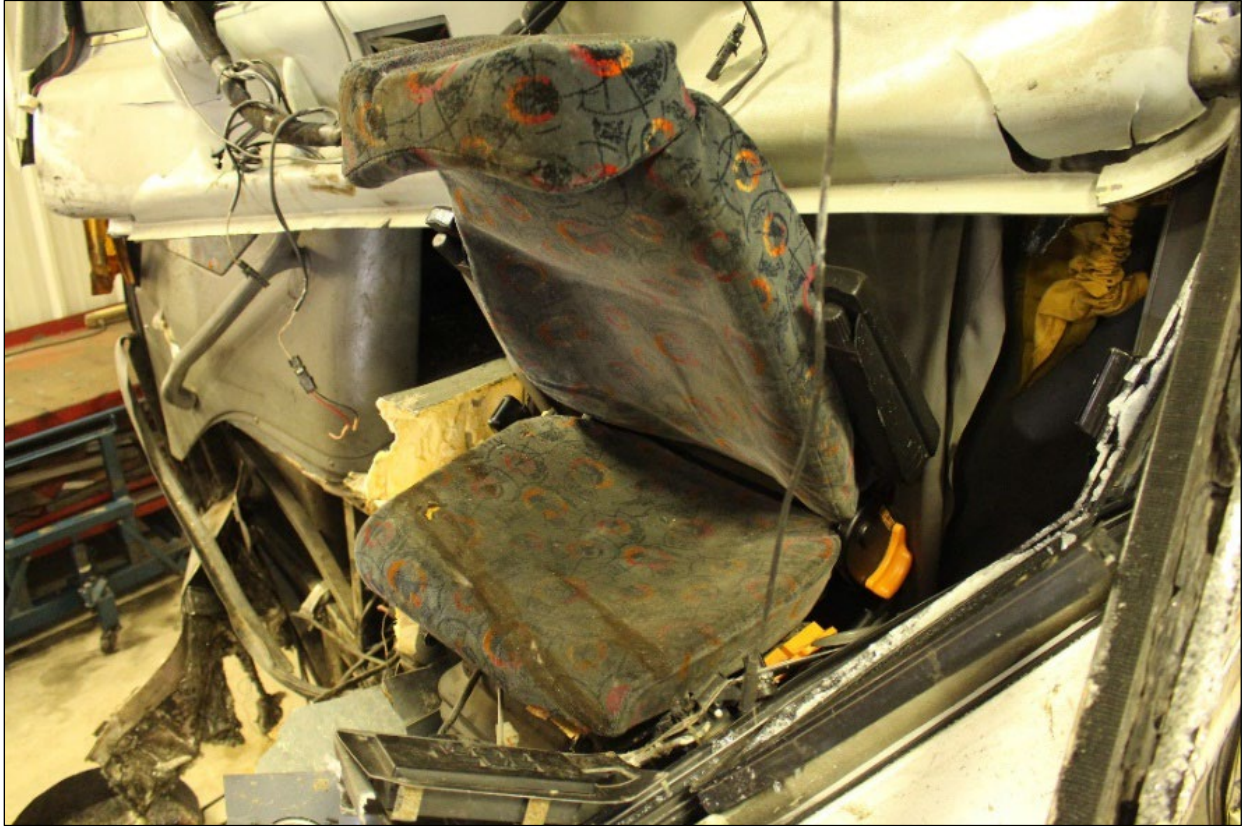
Interior Damage. The driver's seat at the front of the motorcoach was separated from the passenger seats by a privacy panel. The seat was air-suspended and equipped with a lap belt. The crash exposed the front of the motorcoach forward of the privacy panel on the passenger side and the driver's seat, which was still attached to the floor (see figure 9). The lap belt was unbuckled and undamaged.

Figure 9. Driver seat displaced and exposed at front of motorcoach. (Photo was taken at storage facility after vehicle was uprighted and moved from crash scene.)

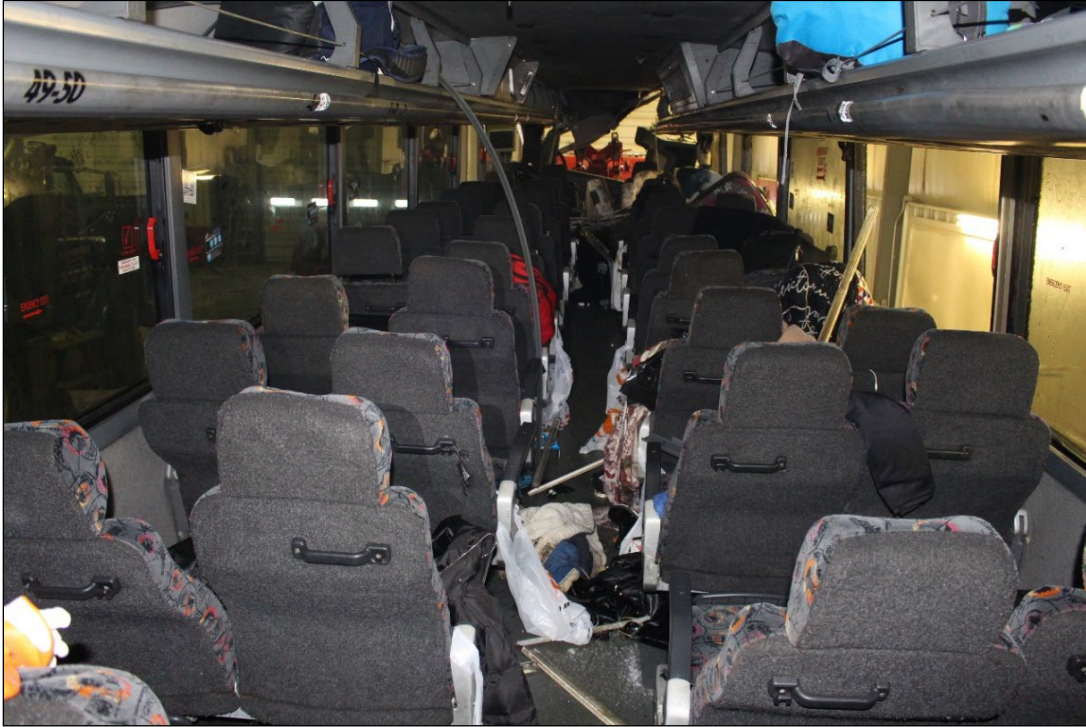
The motorcoach was configured with 14 rows of double passenger seats on the left (driver's) side and 13 rows of double passenger seats on the right (see figure 10). The back of the motorcoach had a row of triple passenger seats on the left and a restroom on the right. Damage to passenger seats included displaced seatbacks or headrests and displaced, deformed, or broken armrests. All the seats were attached to the motorcoach floor postcrash. Although the luggage racks above the seats on the driver and passenger sides were damaged in the crash, they remained attached and did not intrude into the occupant space.

Figure 10. Motorcoach interior viewed from back toward front. Passenger belongings were put inside the vehicle after emergency crews found them strewn on highway after crash. (Photo was taken at storage facility after vehicle was uprighted and removed from crash scene.)

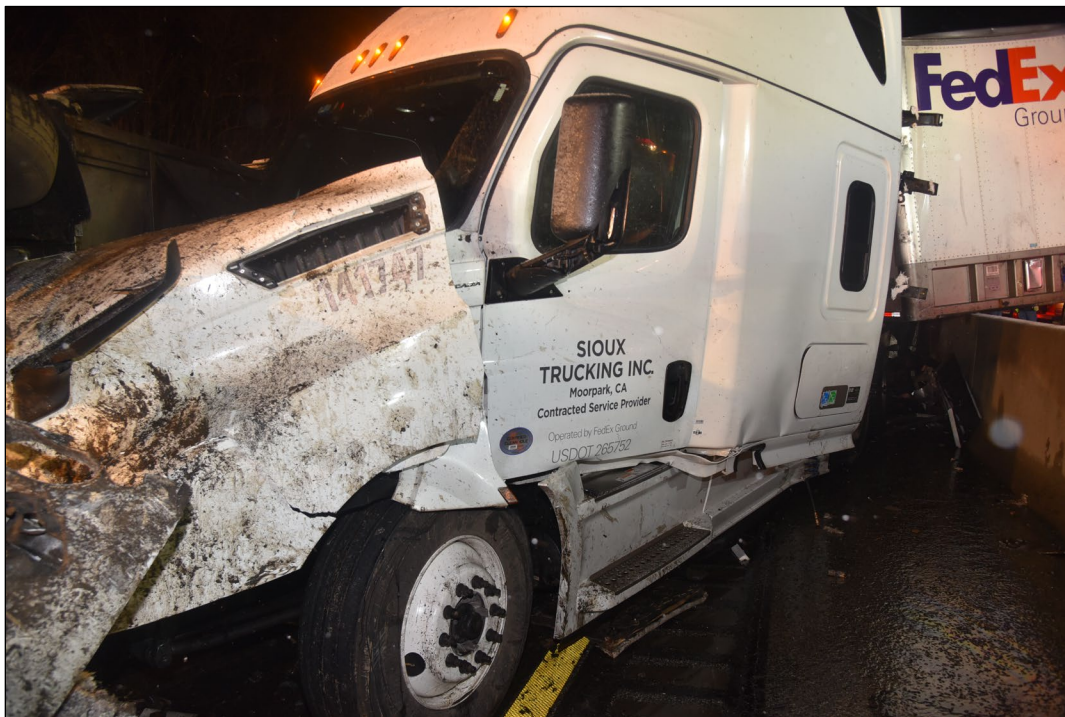
Damage. Photographs taken at the scene show that the semitrailer had separated from the truck-tractor during the crash (see figure 11). At final rest, the trailer was on the median barrier and the truck-tractor was several feet west of the trailer, on the left shoulder and in the left travel lane.

Figure 11. Photograph taken at scene showing damage to FedEx truck. (Source: Pennsylvania State Police)

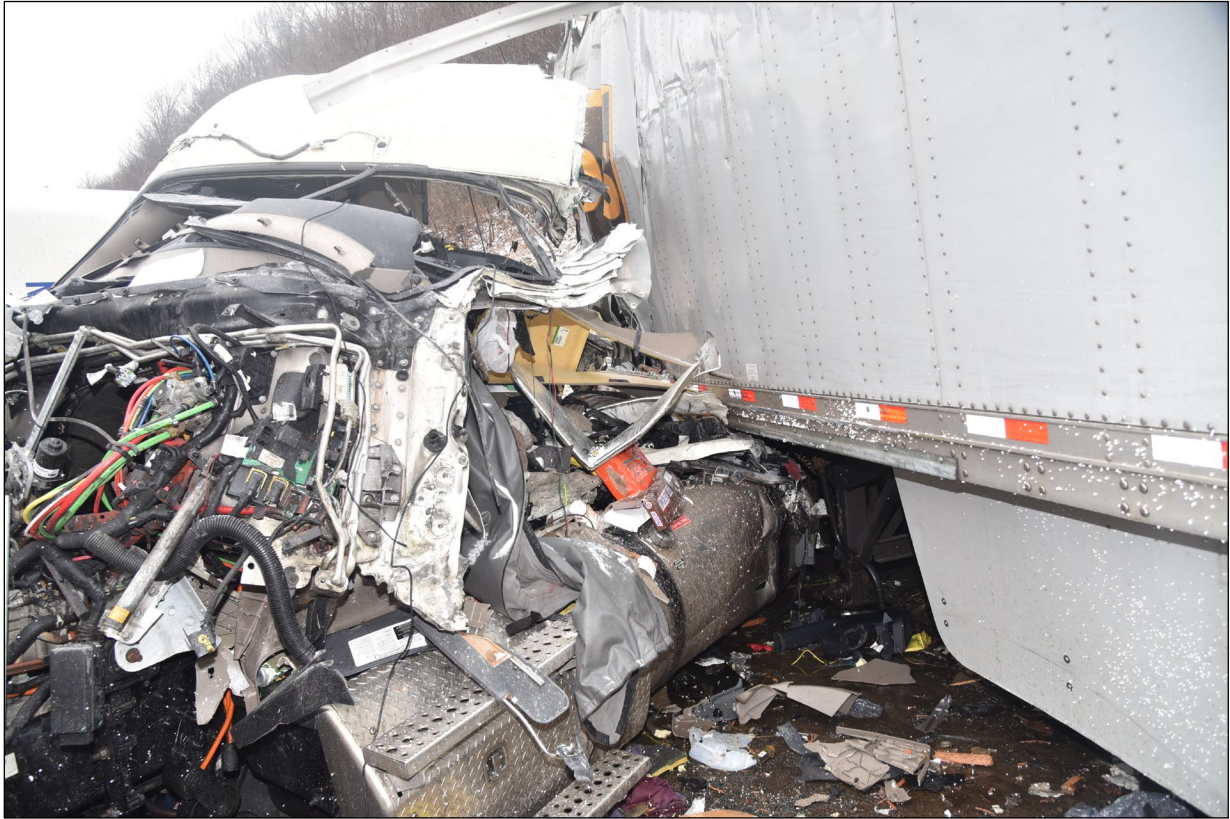
Damage. The truck-tractor sustained catastrophic damage (see figure 12) from striking the FedEx trailer and from its own trailer striking the back of the cab. The left side of the cab and sleeper berth were torn open, and the remaining cab shell skewed toward the right. At final rest, the trailer was “jackknifed” into the sleeper berth.

Figure 12. Photograph taken at scene showing damage to UPS-1 cab.(Source: Pennsylvania State Police)

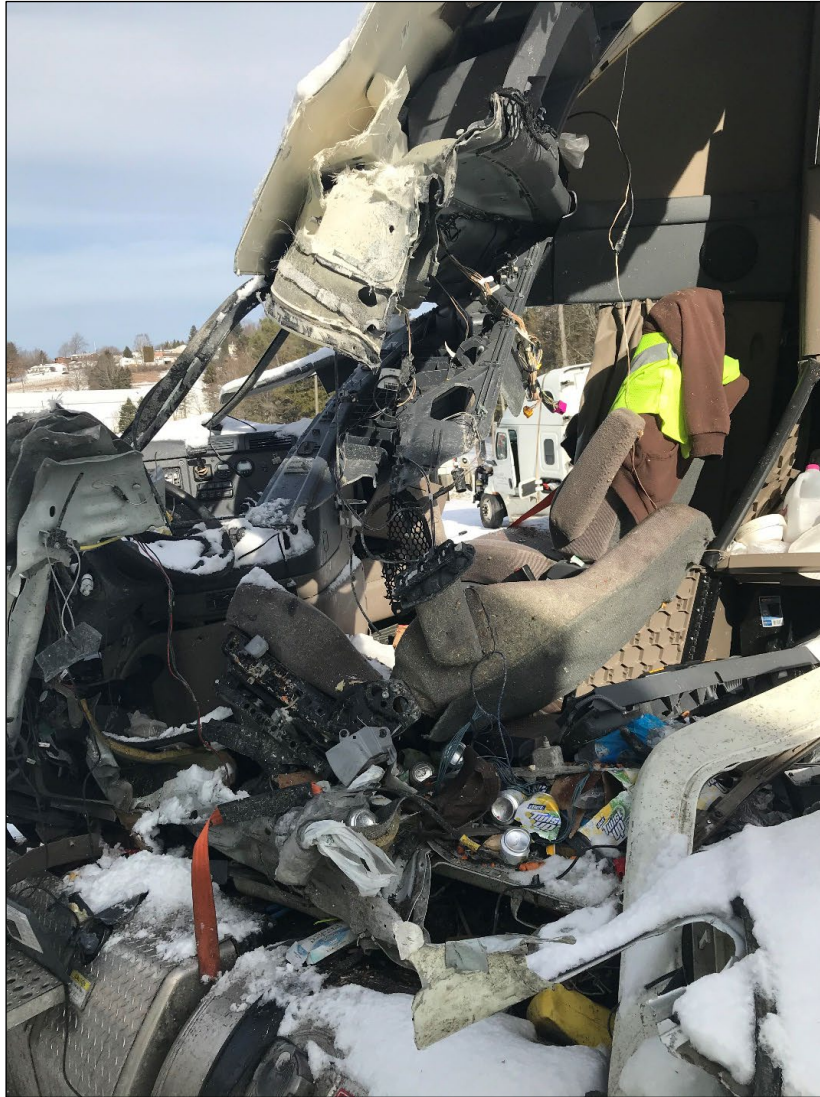
The NTSB examined the wreckage at the tow yard where it was taken after the crash. The A-pillar of the cab was displaced, with damage extending along the left fuel tank and wheel assemblies.³⁷ The entire left side of the cab and sleeper berth was torn open. The driver’s seat was displaced to the right, and all interior driver controls were damaged or missing (see figure 13).

Figure 13. Damage to interior of UPS-1 cab, showing position of driver's seat and destruction to controls.

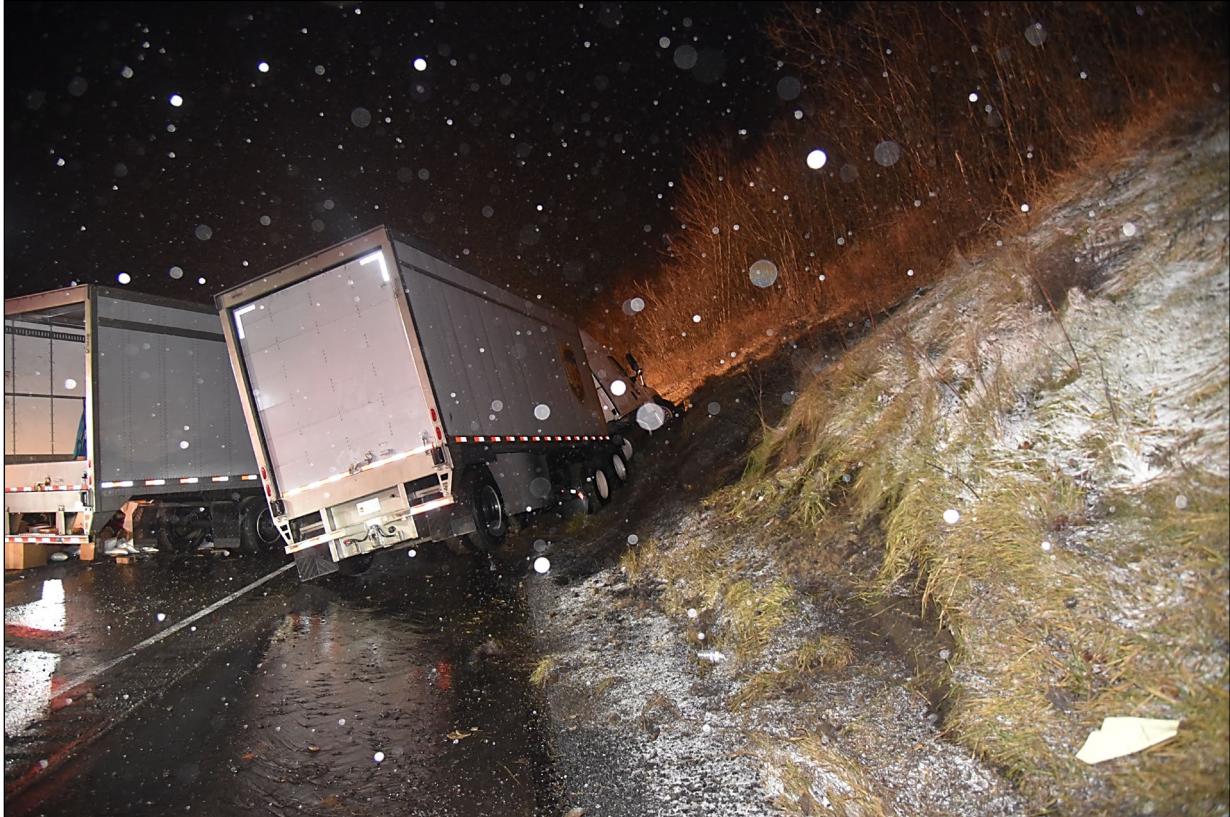
Damage. At final rest, UPS-2 was angled off the roadway and positioned on the right shoulder against the embankment (see figure 14). The unit remained coupled. The truck-tractor and semitrailer were examined at the tow yard after the crash. Damage was limited to the front and left side of the truck. Dirt and debris were found on the front axle, scrapes and gouges were noted on the driver's side. The left fuel tank was dented but not otherwise damaged. The top mount for the shock absorber at the right rear of the cab was broken. No other damage was identified.

Figure 14. UPS-2 run up against embankment, with UPS-1 on left. (Source: Pennsylvania State Police)

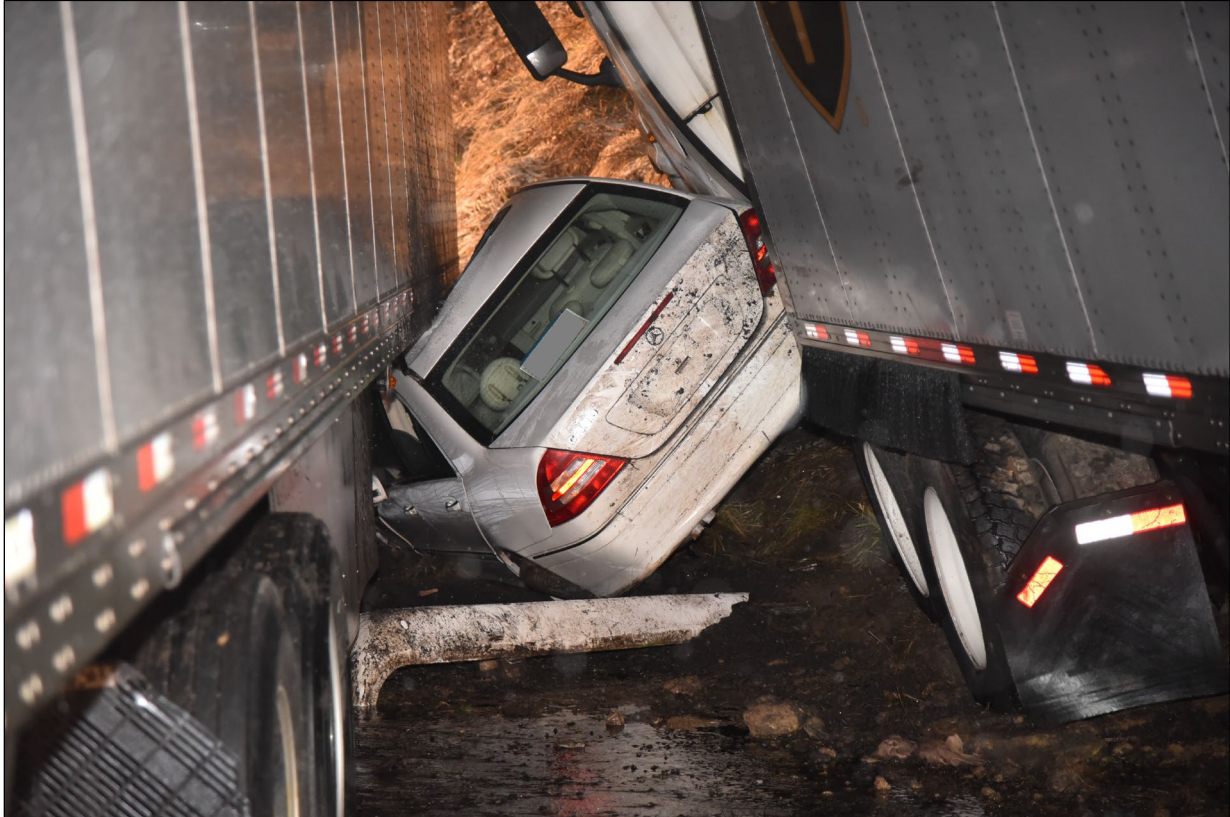
The four-door Mercedes-Benz model C280W4 car was manufactured in 2007. Its curb weight was 3,460 pounds. At final rest, the car was wedged between the right side of the UPS-1 trailer and the left fuel tank and cab of UPS-2 (see figure 15). When examined at the lot where it was taken after the crash, the car exhibited minor-to-moderate damage and deformation.

Figure 15. Final rest position of car wedged between UPS-1 (left) and UPS-2 (right). (Source: Pennsylvania State Police)

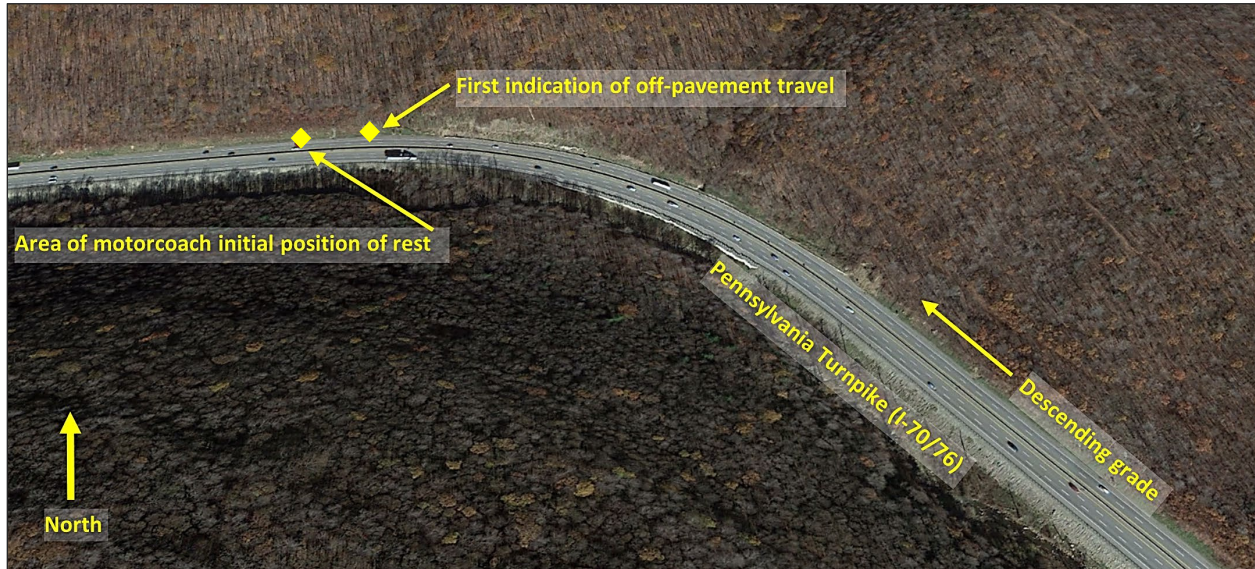
end struck and dislodged a 12-foot-long segment of the median barrier. The motorcoach came to rest approximately perpendicular to the travel lanes, with its undercarriage facing east (refer to figure 3 in section 1.1).⁶¹ The motorcoach's initial position of rest was 162 feet west of the point where it departed the roadway (see figure 17).⁶²

Figure 17. Motorcoach departure point from pavement and initial position of rest. (Source: Google Earth image with NTSB overlay)

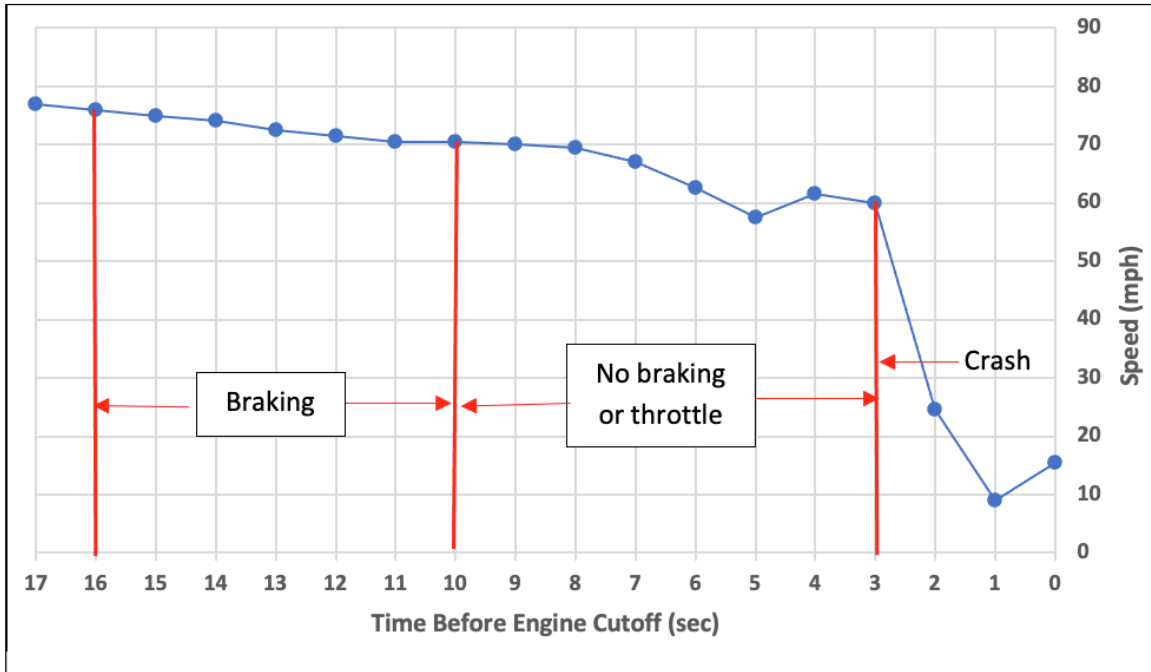
between 10 and 3 seconds before the motorcoach's engine shut off. As shown in figure 18, ECM data indicate that the driver did not engage the service brakes or the throttle during that time.

Figure 18. Speed data from motorcoach's ECM.
