Report Date: May 31, 2022

HIR-22/04

Multivehicle Crash on the Don N. Holt Bridge, Interstate 526

North Charleston, South Carolina
July 1, 2020

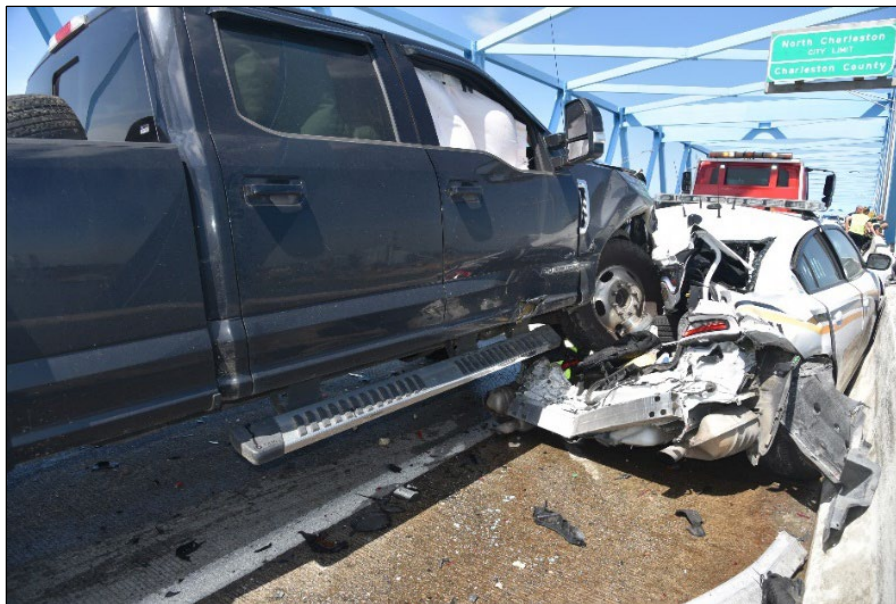
Figure 1. Pickup truck at final rest, with the patrol car and rear of tow truck. (Source: Charleston County Sheriff's Office)

About 9:50 a.m., the 2018 Ford F350 pickup truck with an attached unladen trailer was traveling west in the right lane of I-526. The pickup truck struck the rear of the parked patrol car, pushing it into the deputy. The patrol car continued forward into the rear of the disabled SUV. The SUV was pushed forward and across all three travel lanes, coming to rest on the left shoulder next to the center barrier. The driver of the SUV, who had re-entered his vehicle before the collision, was uninjured. The pickup truck continued to push the patrol car forward, eventually striking the tow truck driver standing on the right shoulder, who was thrown off the bridge and into the river below. The patrol

car struck the rear of the parked tow truck before coming to final rest. The sheriff's deputy sustained serious injuries and the tow truck driver was fatally injured. The driver of the pickup truck was uninjured.

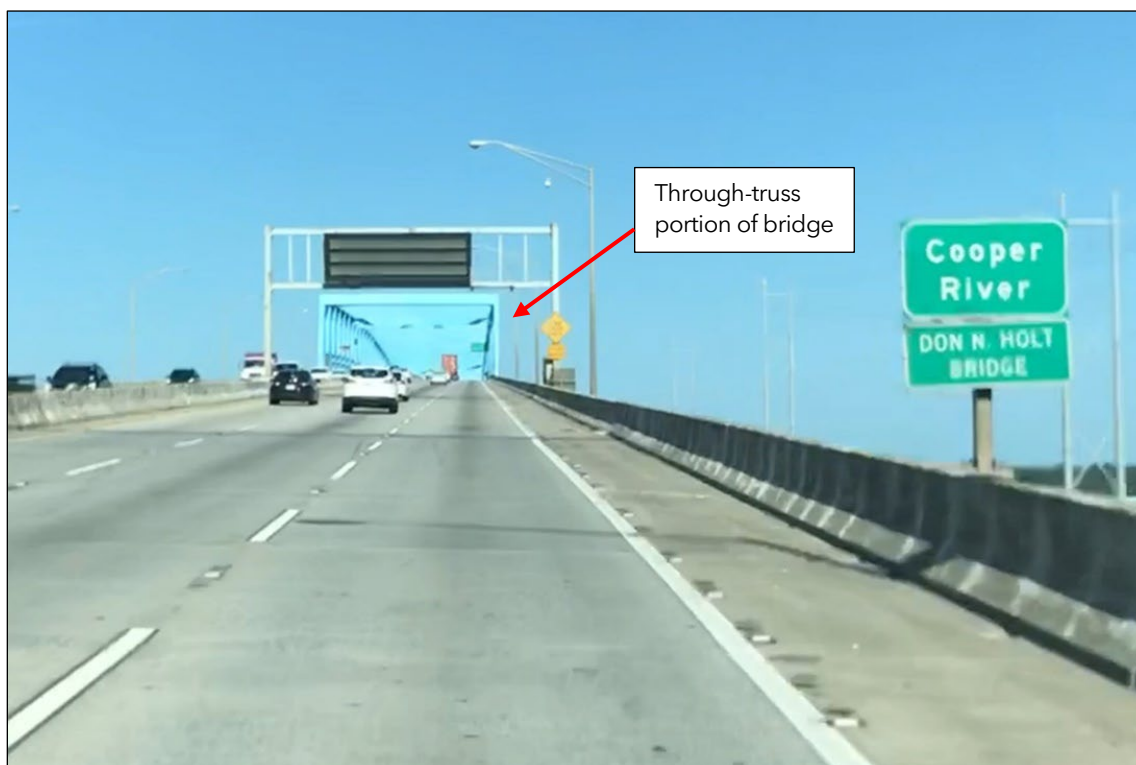
Figure 3. Westbound view from the right travel lane on I-526 approaching the through-truss portion of the bridge deck that spans the Cooper River. The dynamic message sign is located 1,497 feet, or about a quarter mile, east of the crash location.

⁵ Other witnesses also said that they observed the electronic warning sign before the crash. SCDOT told the National Transportation Safety Board that the overhead message sign (shown in figure 3), located about a quarter mile east of the stopped car, was illuminated before the crash.

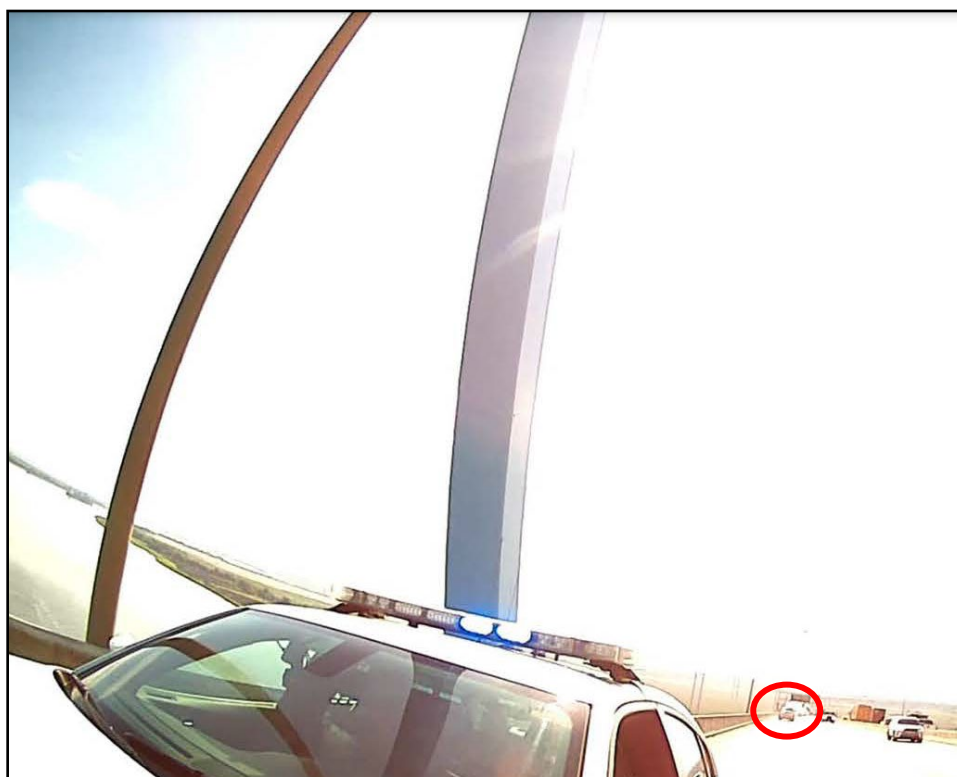
According to the South Carolina Highway Patrol, the pickup truck was traveling at 49 mph at the time of the collision with the patrol car. There was no evidence that the driver applied the brake. The driver told police that he observed an electronic sign that said that a lane was blocked ahead.⁵ He stated he was following a white car that suddenly swerved to the left, revealing the stopped patrol car, and he did not have time to brake. A witness stated that the pickup driver said he was looking at the ships loading and unloading and suddenly a little white car changed lanes in front of him and the patrol car was right in front of him. Figure 4 is a snapshot taken from the body-worn camera of the deputy as he walked back toward his patrol car after speaking with the driver of the disabled vehicle. The red circle highlights the image of the approaching pickup truck captured by the camera. As shown in the snapshot, there are no obstructions present that prevented the driver of the pickup truck from seeing the stopped patrol car with the warning lights activated.

Figure 4. Image from deputy's body-worn camera shows the approaching pickup truck (indicated by the red circle) in the right lane in the background. (Source: Charleston County Sheriff's Office)
