HIR-23-03

Electric Vehicle Run-Off-Road Crash and Postcrash Fire

Coral Gables, Florida
September 13, 2021

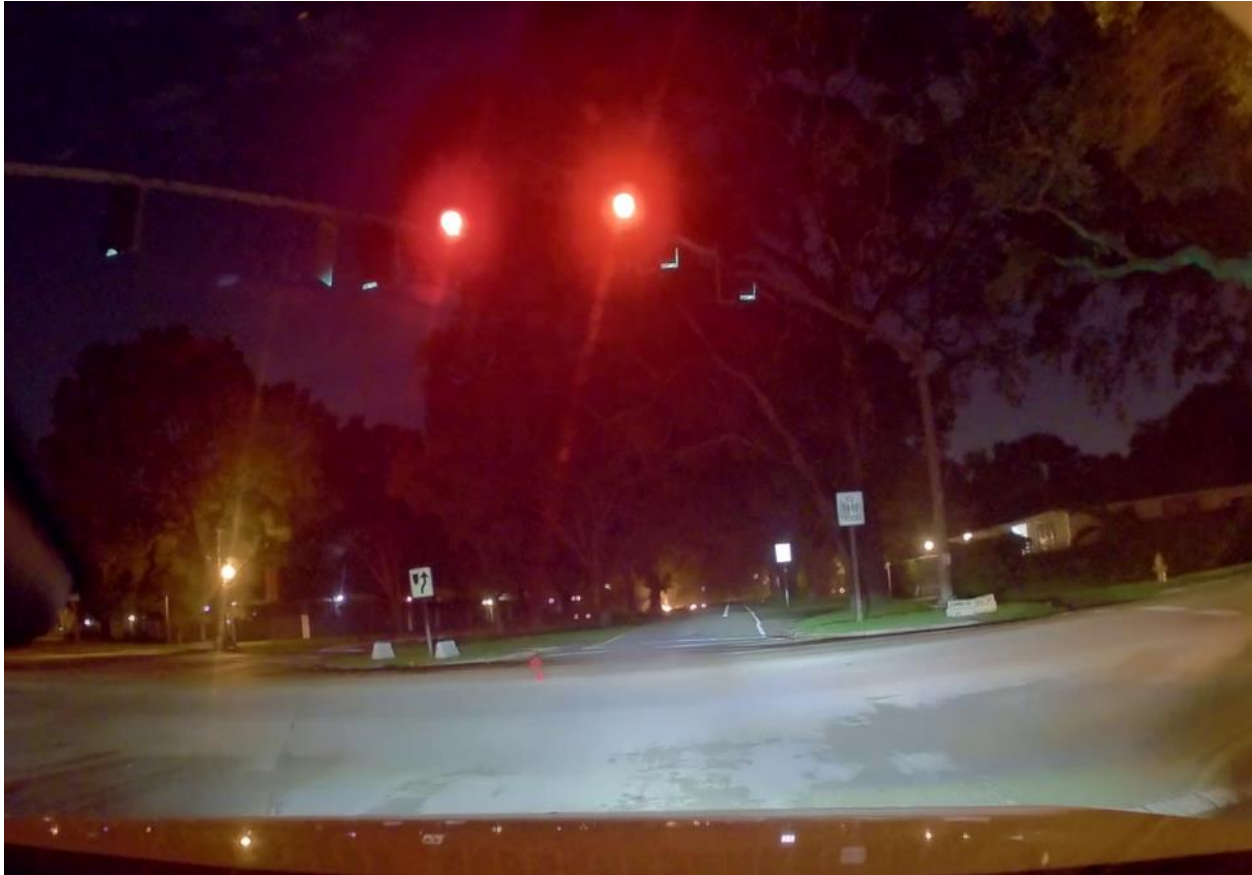
Figure 1. Still image of forward-facing video from witness vehicle at intersection of Alhambra Circle and Coral Way.² The witness vehicle was stopped at the red light. The postcrash fire is visible in the distance.

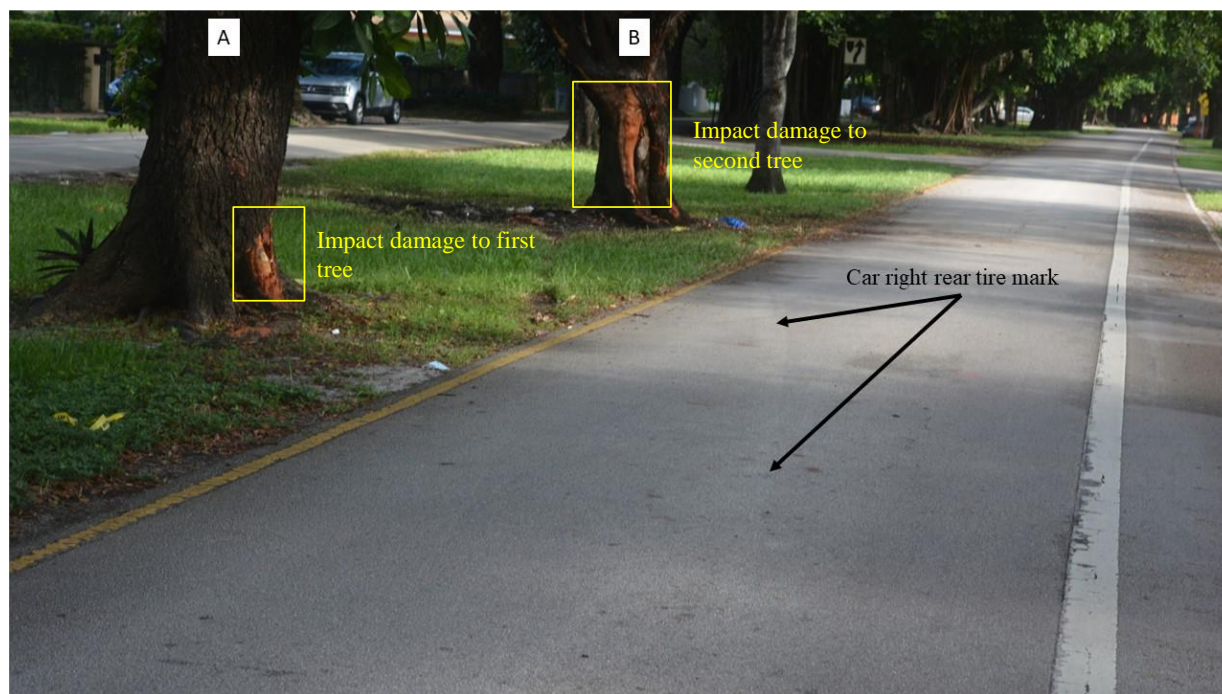
the car struck a tree (labeled as A in figure 3; damage to the first tree is outlined in yellow), after which it continued to yaw counterclockwise. Tire marks were observed on the road surface heading toward a second tree located 42 feet farther north, with which the passenger side of the car collided (labeled as B in figure 3; impact damage to this tree is also outlined in yellow). The car was traveling at approximately 81 mph immediately prior to impact with the second tree. The driver did not apply braking at any point during the approximately 5 seconds prior to the crash with the second tree.⁶ The car struck the tree at the middle right (passenger) side, in between the A and B pillars.⁷ The car rotated around the second tree due to the force at impact and came to rest on the north side of the second tree, as shown in the crash diagram (figure 4).⁸

Figure 3. Alhambra Circle looking north from Coral Way intersection, with two trees struck by car visible on left. (Source: Coral Gables Police Department)

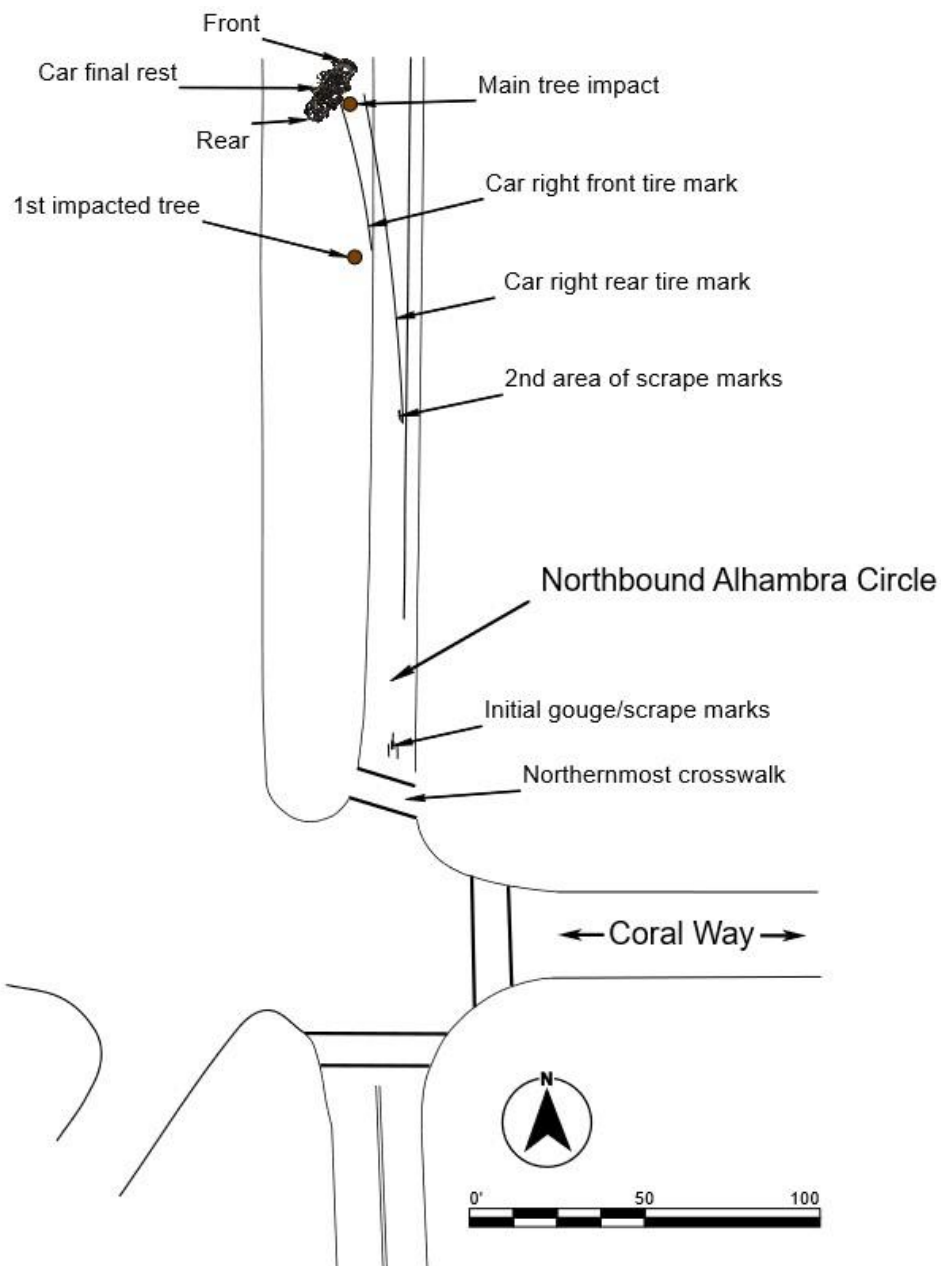
Figure 4. Crash scene diagram.

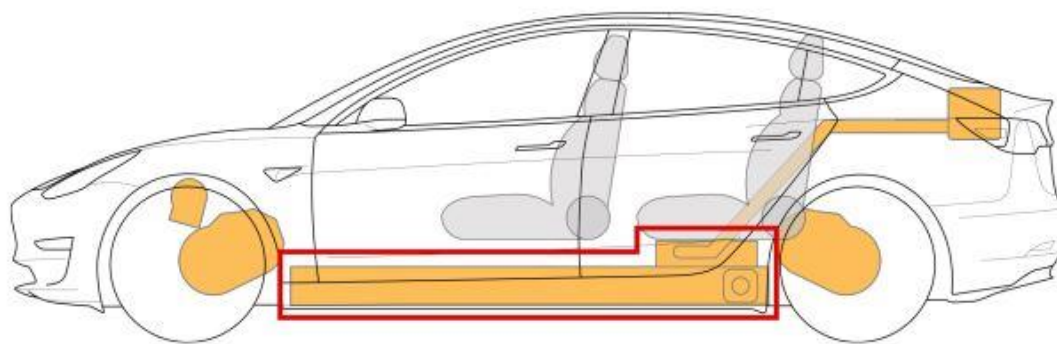
The car's battery compartment was located underneath the vehicle cabin area, as shown in figure 5. The car impacted the second tree on the passenger side, just forward of the B pillar (figure 6, left), and the intrusion reached the battery compartment.

Figure 5. Diagram of Tesla Model 3 powertrain components shown in yellow, with battery location outlined in red. (Source: Tesla)

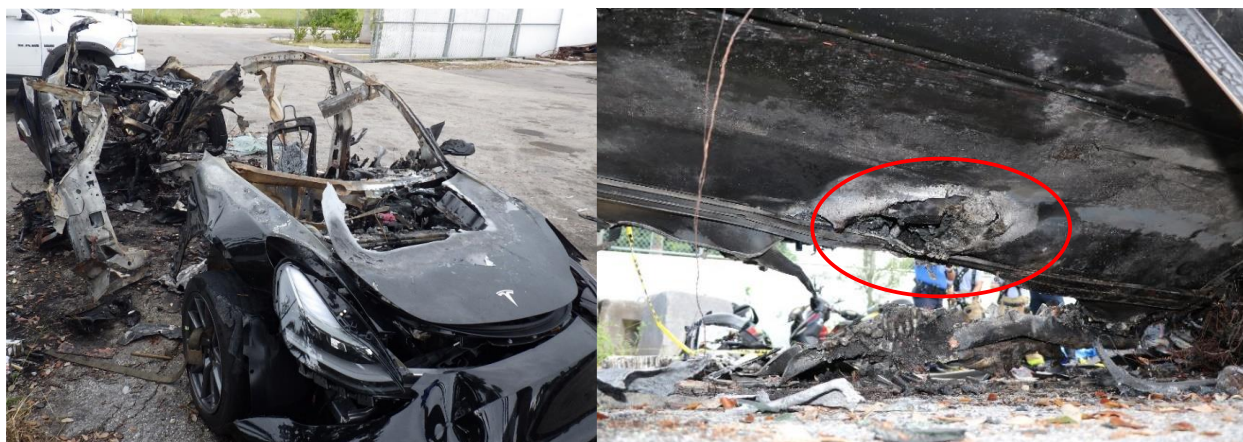
The impact to the car's right side between the A and B pillars caused significant intrusion into the passenger compartment as well as into the high-voltage lithium-ion battery case and enclosed battery modules. Damage to these battery modules resulted in a postcrash fire. The NTSB analysis of the witness vehicle's forward-facing camera video and witness statements indicated that the car was engulfed in fire within seconds after the crash. The car sustained severe thermal damage to the interior, roof, and both sides.

The car's high-voltage lithium-ion battery sustained severe damage to the entire right side, which caused a breach of the exterior battery case. The damage extended into the battery modules within, exposing portions of battery modules and dislodging individual battery cells.¹³ Hundreds of battery cells were displaced and scattered in the wreckage and on the ground. The postcrash fire resulting from these damaged battery modules and individual cells destroyed much of the car's interior and burned through the battery casing on the underside of the car (figure 6, right).

Figure 6. Impact damage to passenger side and fire damage to car (left), with burn hole in battery case circled in red (right).

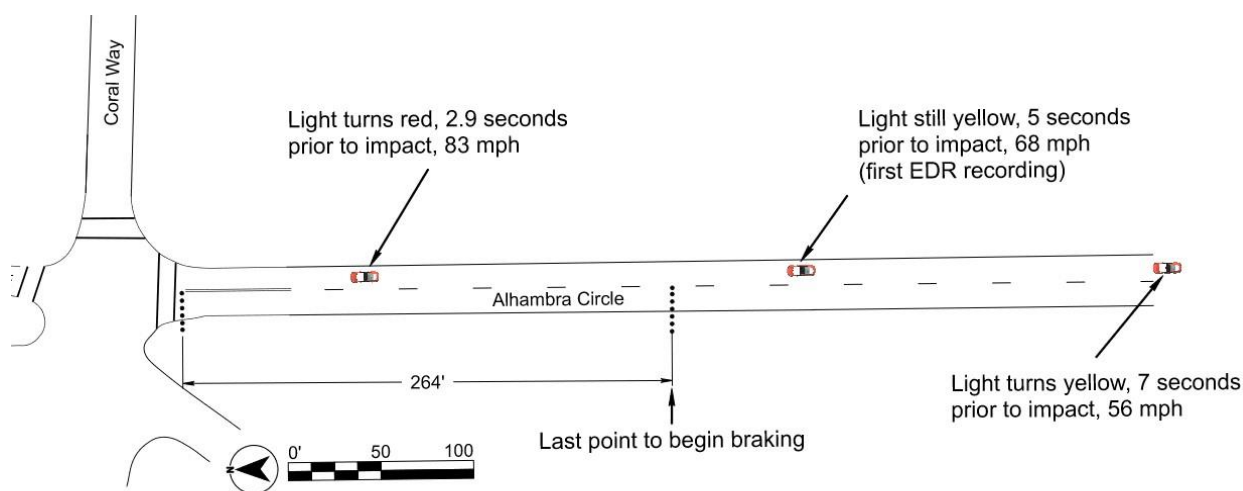
The driver was already speeding prior to the onset of the yellow traffic light, and his decision to continue to accelerate rather than stop at the light was likely an attempt, although unsuccessful, to clear the intersection before the light turned red. Researchers have explored how drivers decide to respond to a yellow light (for example, Gazis and others 1960; see Papaioannou and others 2021 for a current overview). When a signal changes from green to yellow, the factors of vehicle speed, distance to the intersection, roadway conditions, and braking capability of the vehicle are all parameters that specify a range within which the driver has the option to stop at the yellow light or proceed through the intersection before the light turns red. Based on the EDR-recorded speed of 68 mph 5 seconds prior to the second tree impact, as well as the forward-facing video from the witness vehicle, the car could have stopped at the red light had the driver initiated braking within 264 feet of the intersection (see figure 7). Instead, the driver continued to accelerate until the light turned red, at which point he stopped accelerating but did not initiate any braking. The driver's choice to accelerate to a speed of 90 mph through the red light at the intersection with Coral Way led to his loss of control of the car and subsequent impact with two trees.

Figure 7. Calculated minimum stopping distance to traffic signal. The car positions are included for when the signal light turns yellow, the first EDR-recorded position, and when the signal light turns red, along with the time before impact with the second tree at each of these positions.

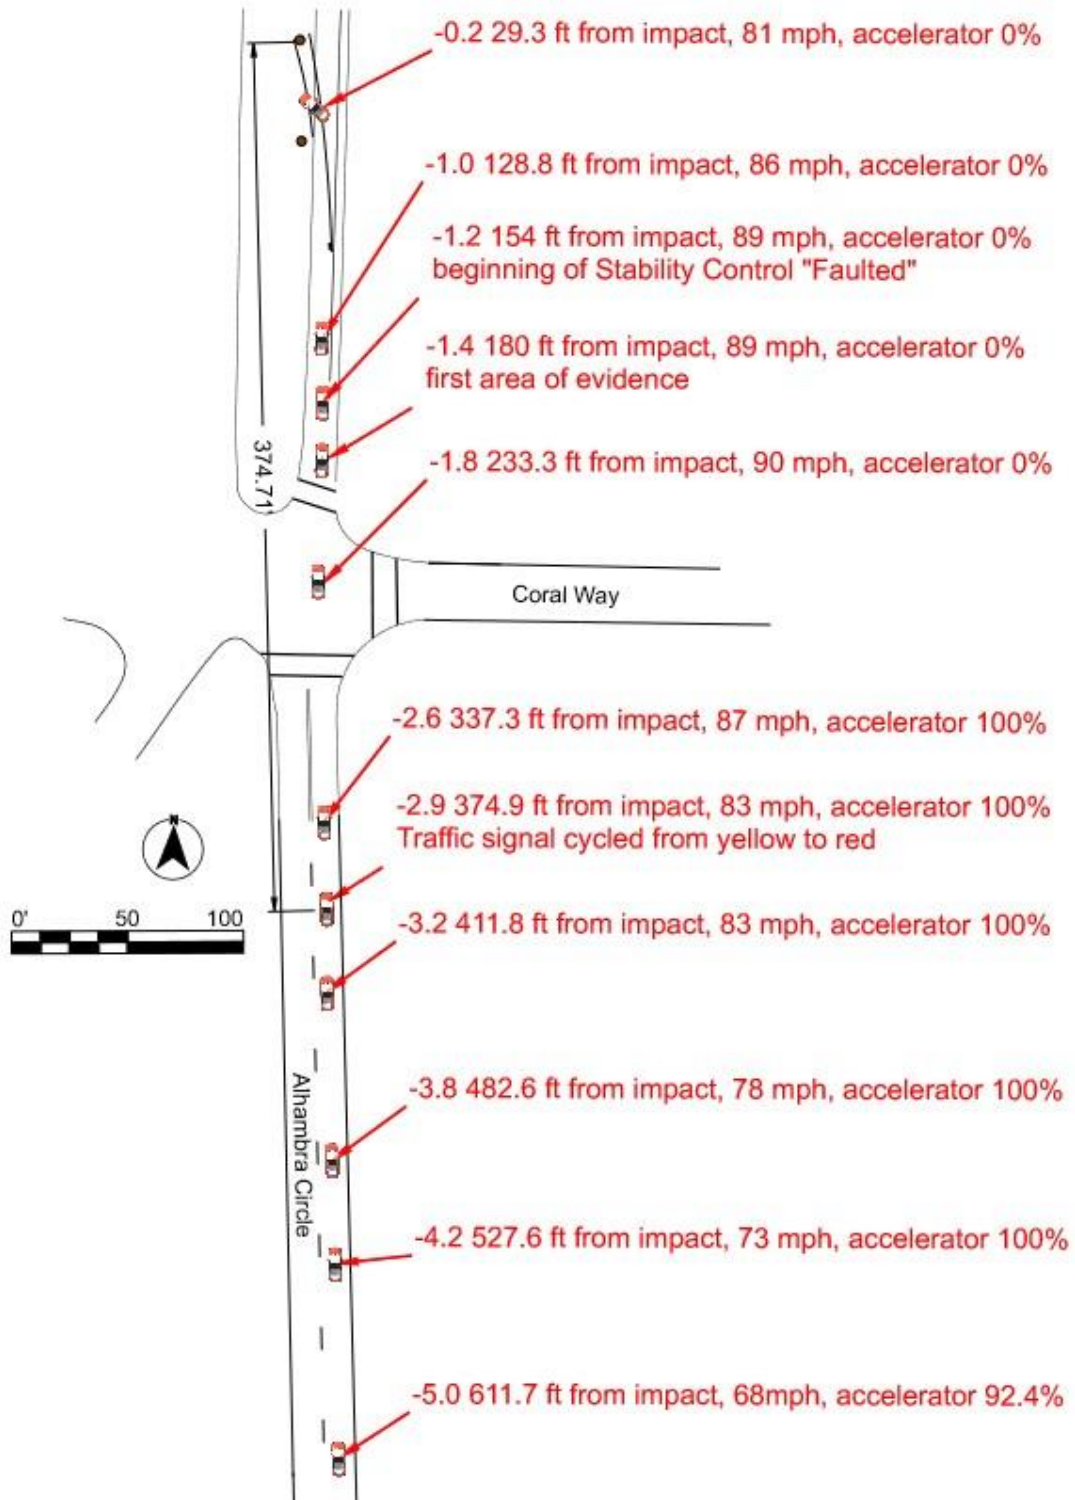
In this crash, the 20-year-old driver accelerated to pass a vehicle, and once back in the northbound lane, continued to accelerate, likely to avoid stopping at the red light. Ultimately, the driver was traveling at three times the posted 30-mph speed limit. Figure 8 includes a diagram of the car's positions in the 5 seconds leading up to the crash, with speed, time, and distance annotated. Evidence obtained from the EDR showed that the car was traveling at 90 mph as it exited the intersection of Alhambra Circle and Coral Way.¹⁵ As the car continued north and traversed the pedestrian crossing, its suspension became fully compressed due to the vertical grade change, and the speed of the car caused its undercarriage to engage the roadway surface, leaving gouge marks north of the crosswalk. When this evidence was aligned with the EDR data, investigators were able to determine that the undercarriage struck the roadway surface about 1.4 seconds prior to the crash with the second tree. The next recorded timestamp in the EDR data (1.2 seconds before the crash) showed that the ESC changed from inactive to a fault state.¹⁶ Given these conditions, the driver had very little time to recover before crashing into the second tree, and the lack of ESC may have further contributed to the loss of control.

Figure 8. Approximate locations of car approaching area of impact, as interpolated from EDR data combined with roadway evidence. The light had already cycled to yellow prior to the first position plotted here. The service brake was off for the full duration.

After contact with the pavement, the car's suspension became unweighted, likely reducing lateral friction. The loss of friction in conjunction with the high speed caused the car to begin a counterclockwise yaw indicating loss of driver control. Although the EDR recorded changes in steering angle, it is unclear if these were the result of driver input or the car's motion itself. The car ultimately exited the roadway into the median, with its left front striking the first tree (tree bark was found embedded in the left front wheel of the vehicle) before it crashed into the second tree. EDR data showed a speed of 81 mph about 0.2 seconds prior to impact with the second tree; this was determined to be the most accurate speed at impact due to the lateral motion of the car.¹⁷ The driver did not apply braking during the 5 seconds leading up to the crash.
