Highway Investigation Report HIR-23/04

# Multivehicle Collision Involving a Milk Tank Combination Vehicle and Stopped Traffic Queue

Phoenix, Arizona  
June 9, 2021

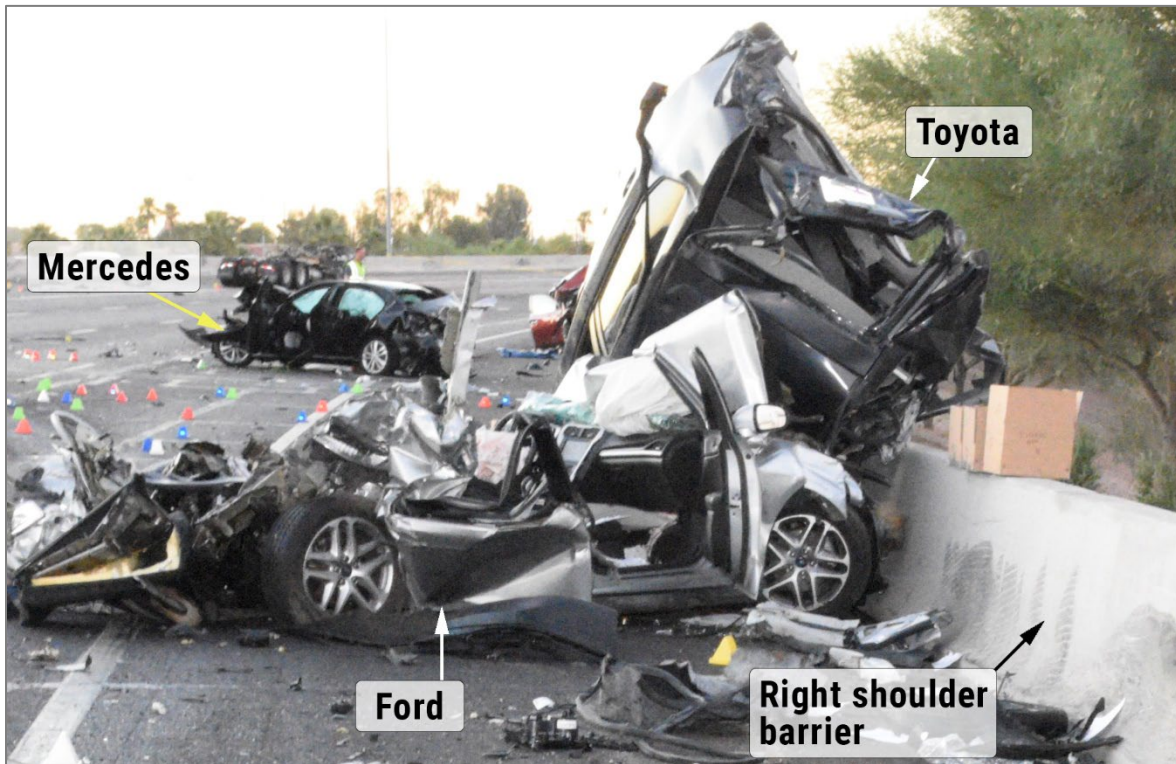
**Figure 2.** Eastbound view of at-rest positions of three of the crash-involved vehicles. (Source: Arizona Department of Public Safety [AZDPS] with annotations by the NTSB).

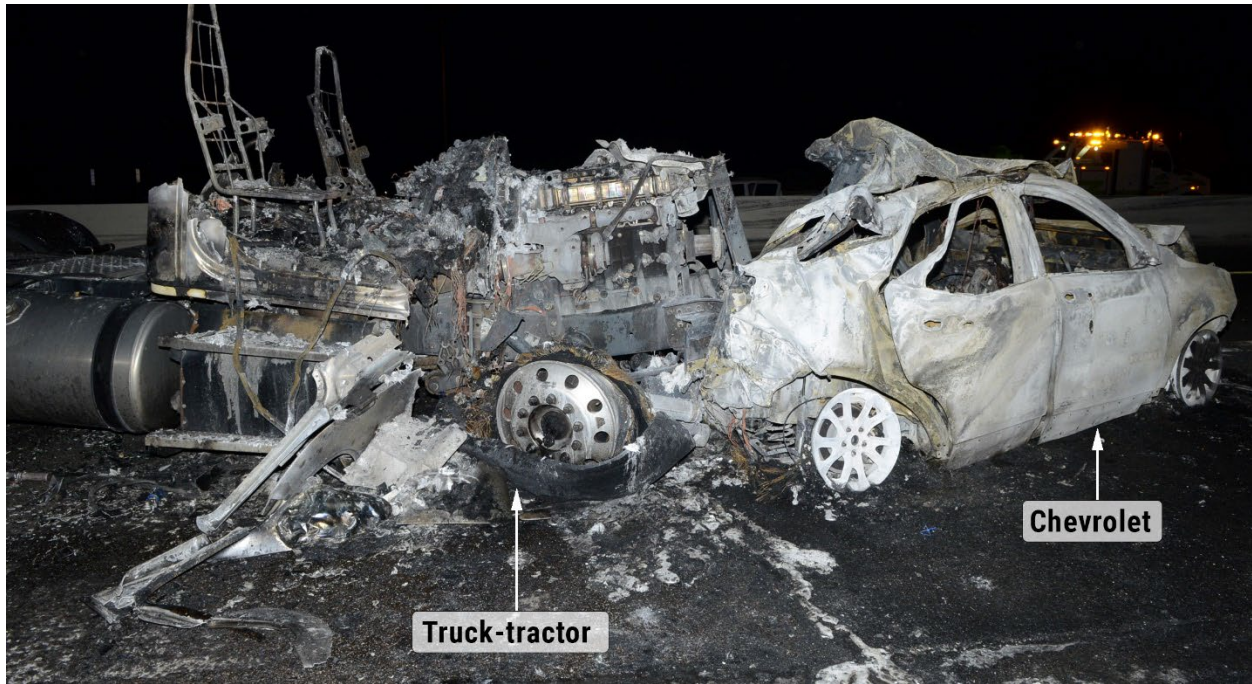
The truck-tractor along with the Chevrolet came to rest in the left eastbound lane, where they were consumed by a postcrash fire (see figure 3). As shown inset in figure 1, in addition to the combination vehicle and the vehicles listed above, four other passenger vehicles, positioned in front of the traffic queue, were involved in the crash. The additional passenger vehicles—a 2015 Nissan Altima, a 2015 Dodge Charger, a 2018 Mercedes-Benz C300W, and a 2013 Lexus CT200H—were struck by the vehicles behind them and collided with each other during the crash sequence before coming to rest (the detailed crash sequence is described in section 1.5).

**Figure 3.** At-rest positions of the truck-tractor and Chevrolet. (Source: AZDPS with annotations by the NTSB)

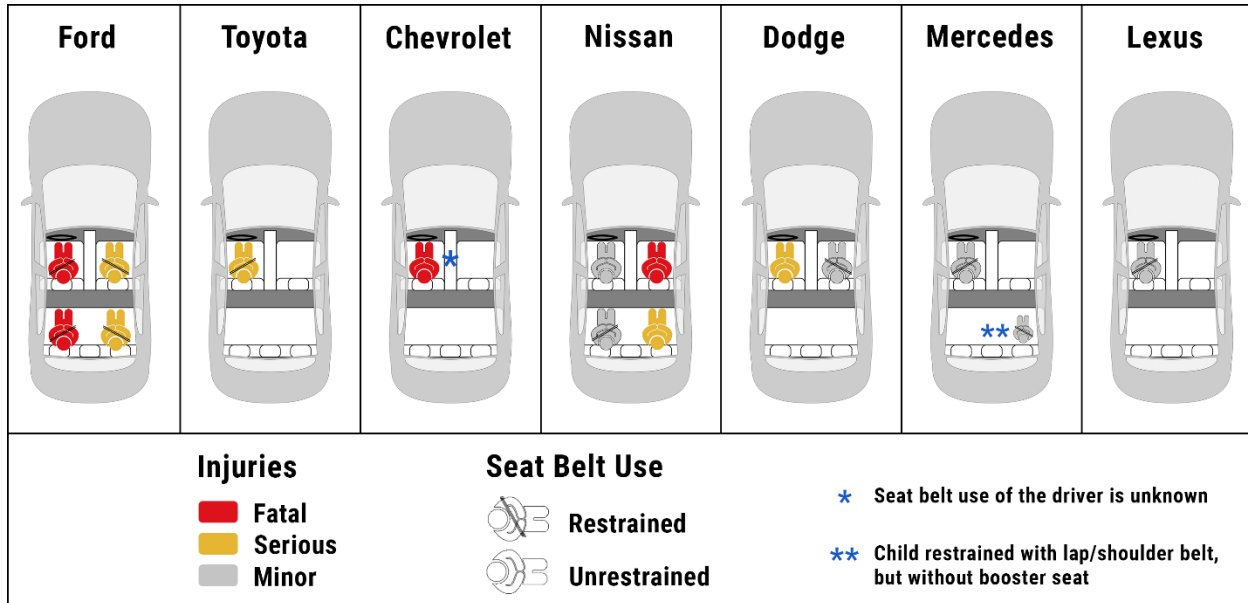
**Figure 4.** Seating positions of passenger vehicle occupants, showing their injury classification and their seat belt use. The vehicles are presented in order of their position in the traffic queue at the time of the initial impact (rear to front).

The front seat passenger of the Nissan, who was ejected and died during the crash sequence, was unbelted. The driver of the Toyota, who sustained serious injuries, was belted but was partially ejected during the crash sequence. The 6-year-old rear passenger of the Mercedes-Benz was restrained with a lap/shoulder belt but was not placed in a child restraint system. Arizona law requires that children between the ages of 5 and 8 who are less than 58 inches tall use a federally approved child restraint system when riding in a vehicle, as specified in 49 *Code of Federal Regulations (CFR)* 571.213.<sup>3</sup> The child in the Mercedes-Benz was less than 58 inches tall. The airbags in all of the passenger vehicles deployed in this crash (see section 1.4.2.2 for airbag control module information).

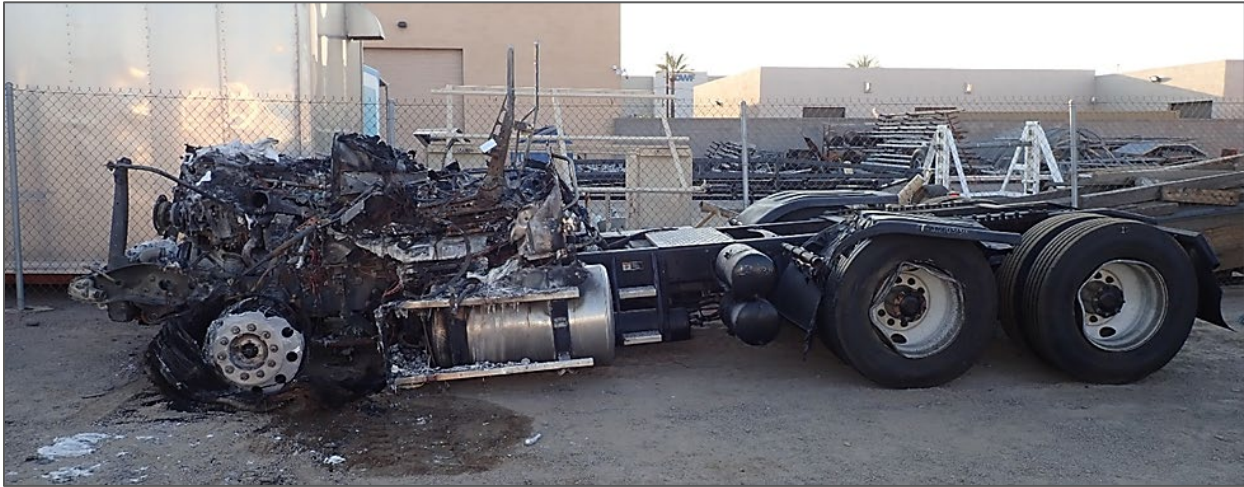
**1.4.1.2 Damage.** The entire cab and engine of the truck-tractor sustained severe fire damage (see figure 6). The truck-tractor's frame rails were displaced outward, and the front frame connector was displaced inward, showing signs of impact with melted remnants of other material. The postcrash fire masked evidence of the truck-tractor's contacts with the passenger vehicles. The rear of the truck-tractor was largely undamaged. The two side saddle fuel tanks were not compromised.

**Figure 6.** View of damage to the left side of truck-tractor.

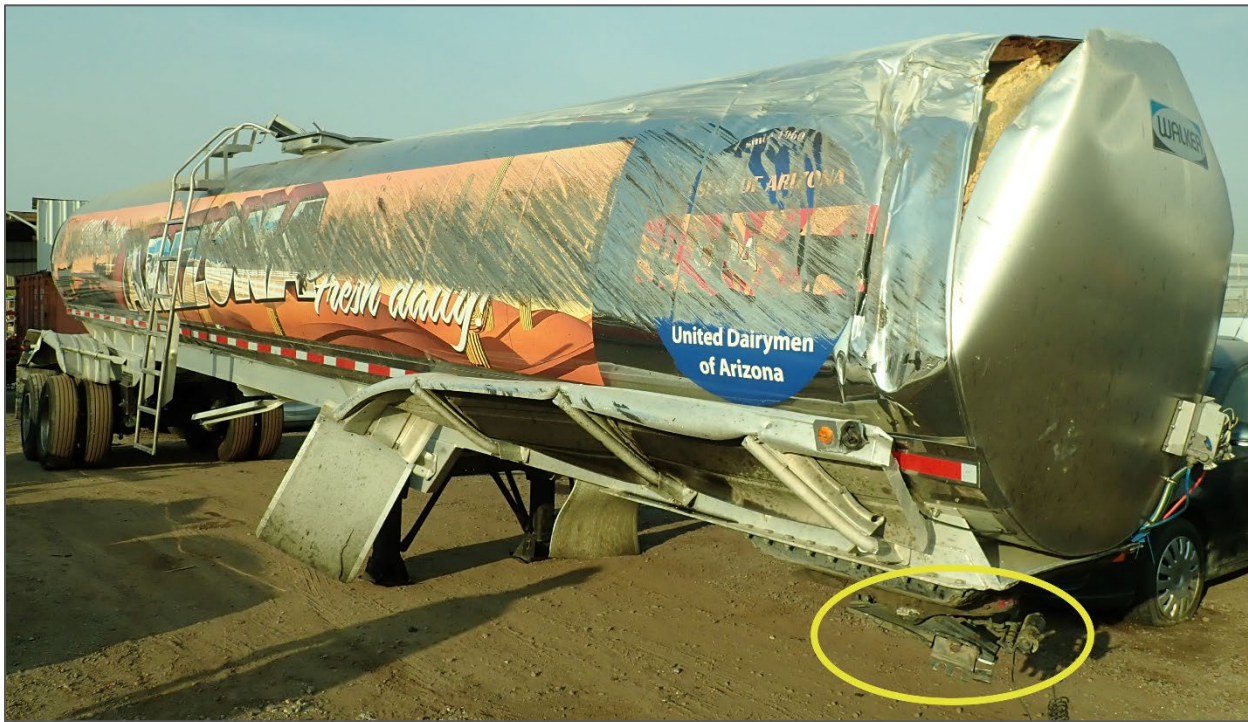
The tank-trailer did not sustain any fire damage. The load of milk spilled onto the roadway through the displaced loading hatch on top of the tank. The kingpin coupler under the front end of the trailer still had the fifth wheel plate from the truck-tractor locked in.<sup>20</sup> The plate was torn away from the sliding fifth wheel assembly on the tractor during the impact with the concrete median barrier. The stainless caps on the front and the end of the tank-trailer were partially detached, exposing the foam insulation (see figure 7). Other damage to the tank-trailer included scuff marks across the entire right side of the trailer and displaced front and rear fenders and their support brackets.

**Figure 7.** View of damage to the front and right side of tank-trailer. The yellow circle highlights the fifth wheel assembly.

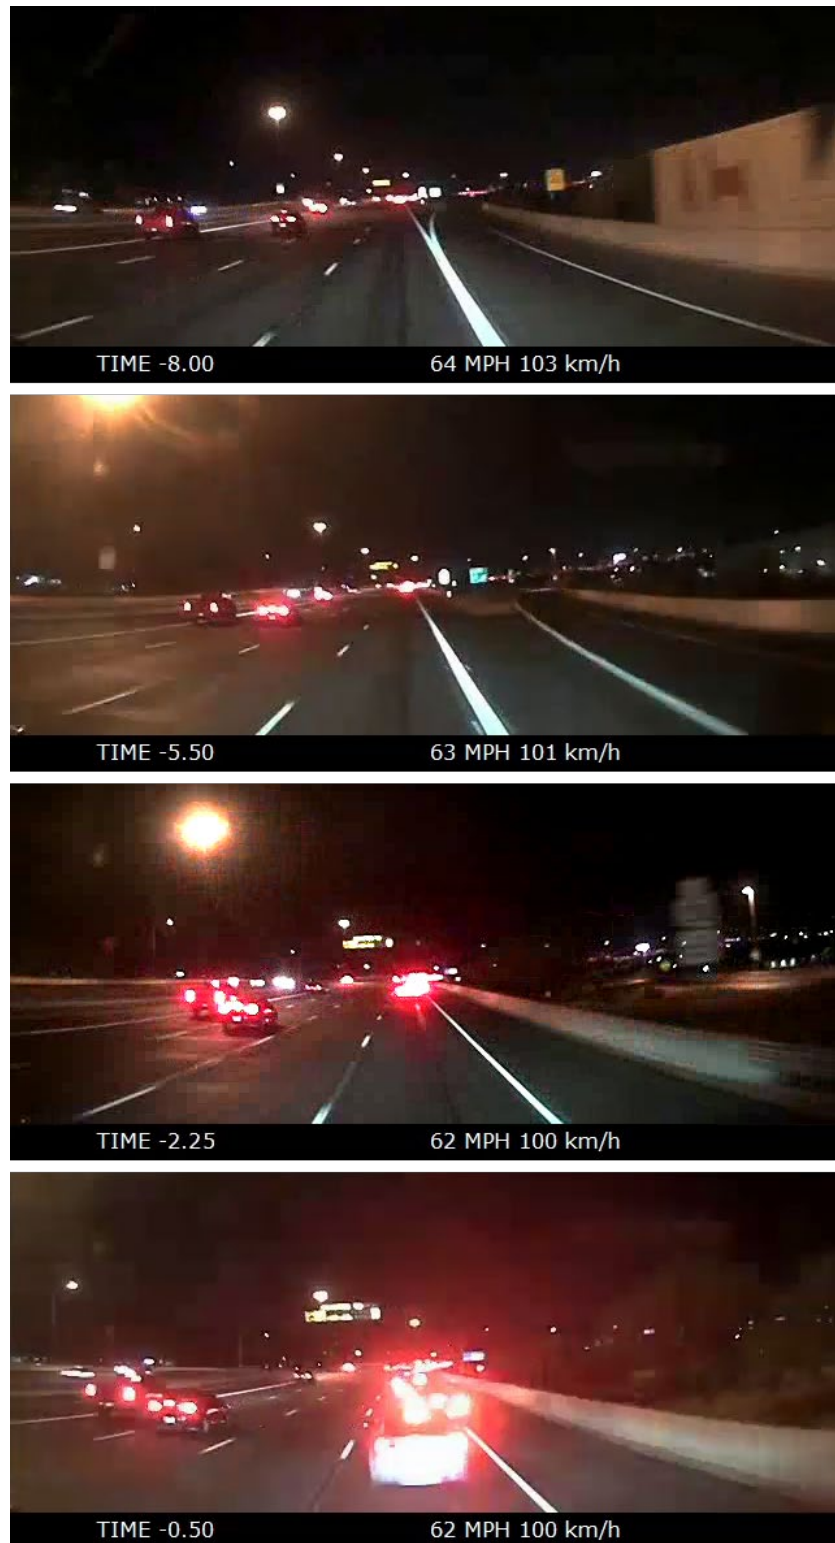
**Figure 8.** Capture of the video from truck-tractor's forward-facing camera at 8 seconds (top image), 5.5 seconds (second image from top), 2.2 seconds (third image), and 0.5 seconds (fourth image) before impact.

The video footage from the system's inward-facing camera shows that 8 seconds before impact, the truck driver was seated upright in the driver's seat, facing forward, wearing an earphone and glasses, and with his left hand on the steering wheel and his right hand resting in his lap.<sup>29</sup> The video shows the driver remaining largely in the same position until 0.25 seconds before impact, when he lifted his right hand from his lap and gripped the steering wheel. Due to the low resolution, it was not possible to determine whether the driver's eyes were open or closed for the duration of the preimpact sequence.

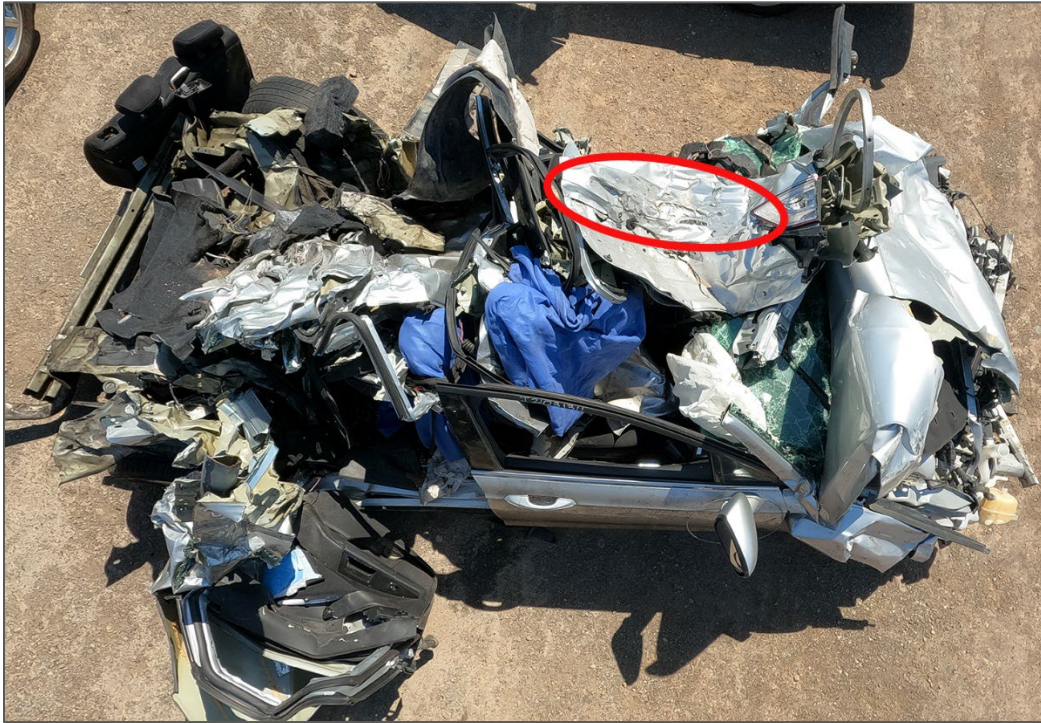
**Figure 9.** Overhead view of damage to Ford. The red circle on the vehicle's roof highlights tire marks made by the truck-tractor.

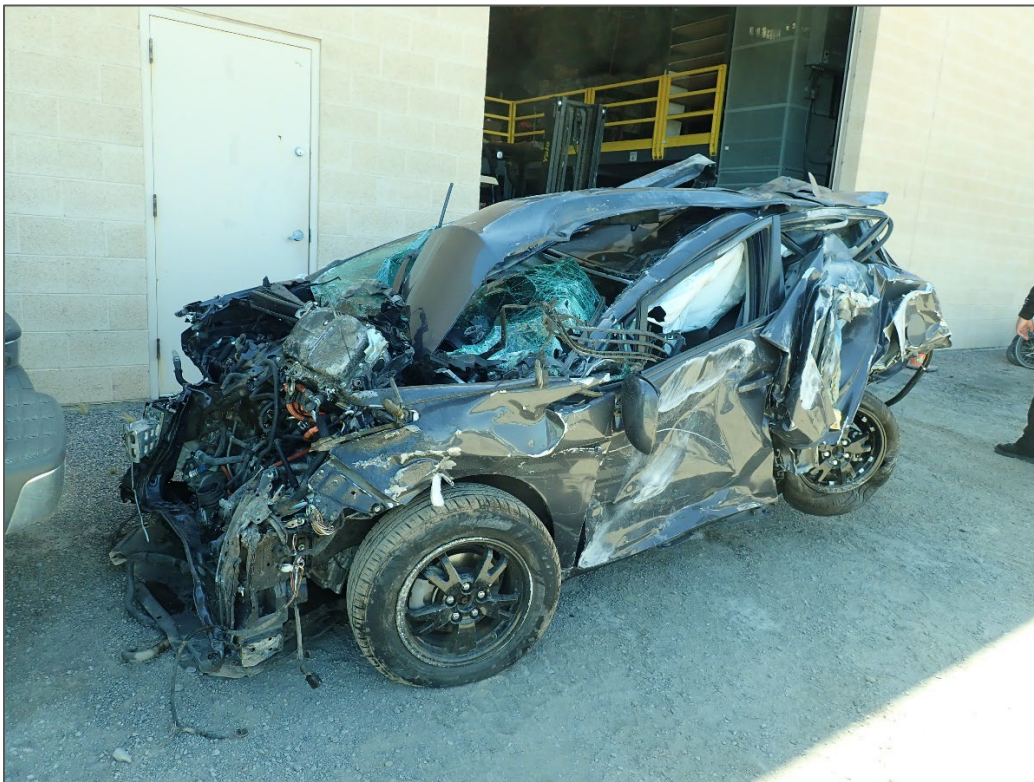
**Figure 10.** Left and front view of damage to Toyota.

<sup>30</sup> The rear bumper of the Toyota was displaced downward, rotated inward and then upward, indicating that the Ford partially intruded underneath the rear of the Toyota.

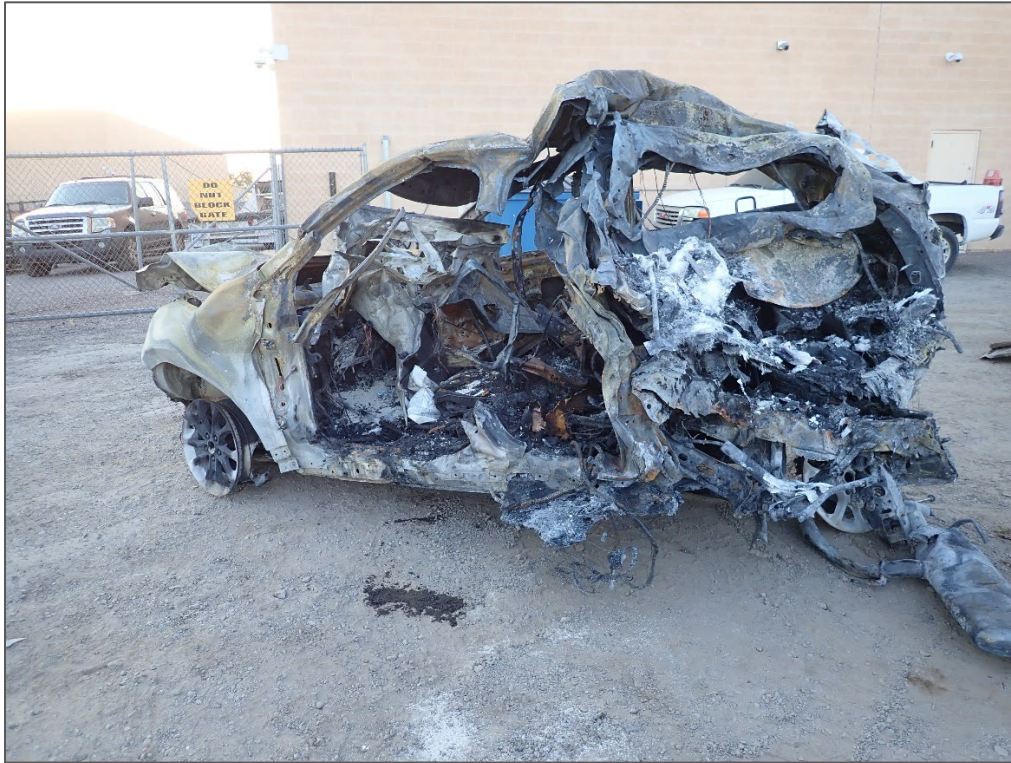
**Figure 11.** Left-side view of damage to Chevrolet.

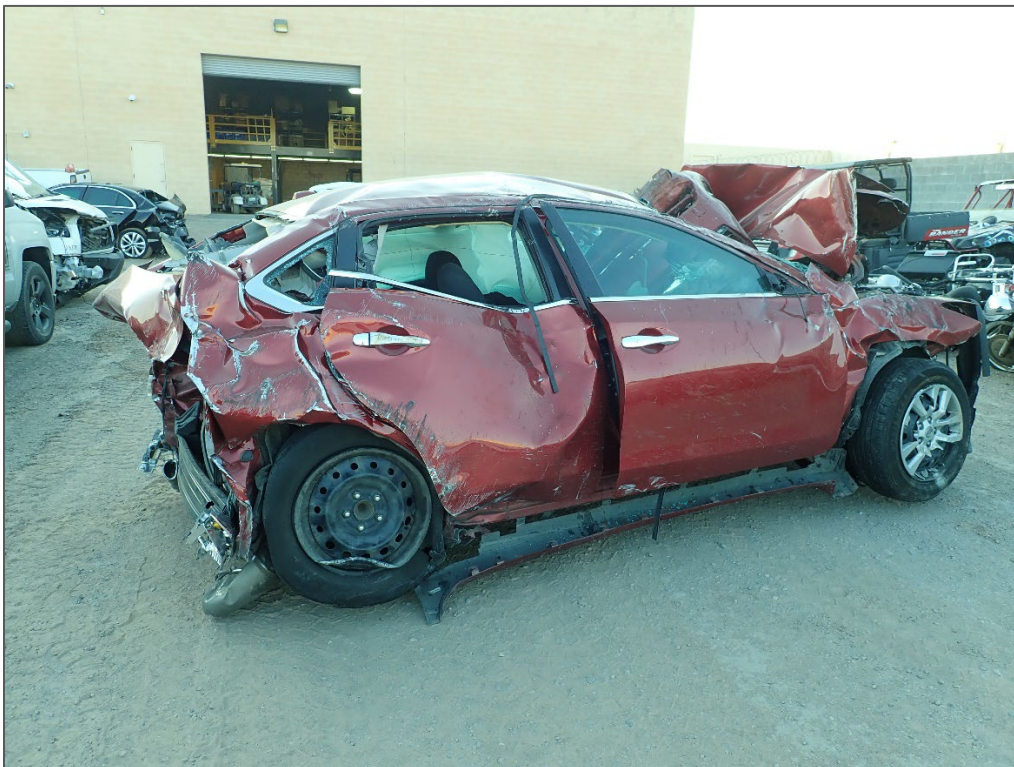
**Figure 12.** Right-side view of damage to Nissan.

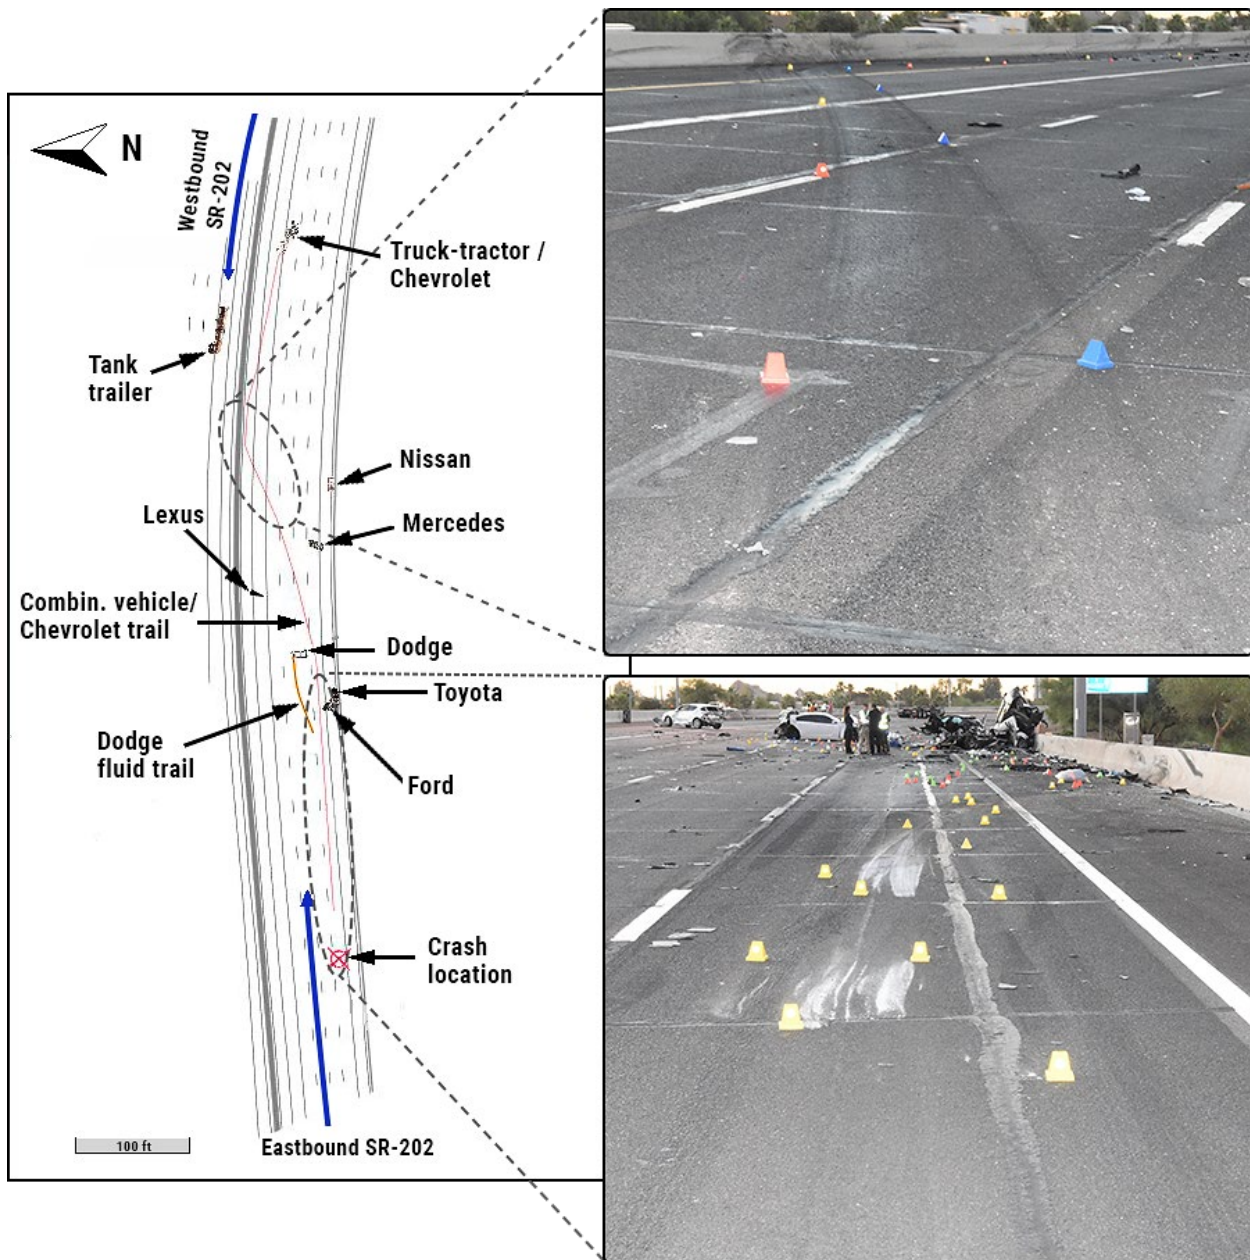
**Figure 13.** Postcrash scene diagram depicting the locations of rest of the truck-tractor, tank-trailer, and the seven passenger vehicles. Two insets show areas of significant roadway evidence leading to the concrete median barrier (upper) and toward the right concrete barrier (lower). (Insets source: AZDPS)

The combination vehicle then struck and partially overrode the rear of the Chevrolet, which became entangled with the front end of the truck-tractor. The combination vehicle together with the entangled Chevrolet struck the rear of the Nissan, which was pushed into the rear of the Dodge, which in turn was pushed into the rear of the Mercedes-Benz. As the combination vehicle with the entangled Chevrolet continued in the northeasterly direction, the Nissan and the Mercedes-
