HIR-23-06

Wrong-Way Driving Crash between Service Truck and Motorcoach on Interstate 20

Big Spring, Texas
November 19, 2021

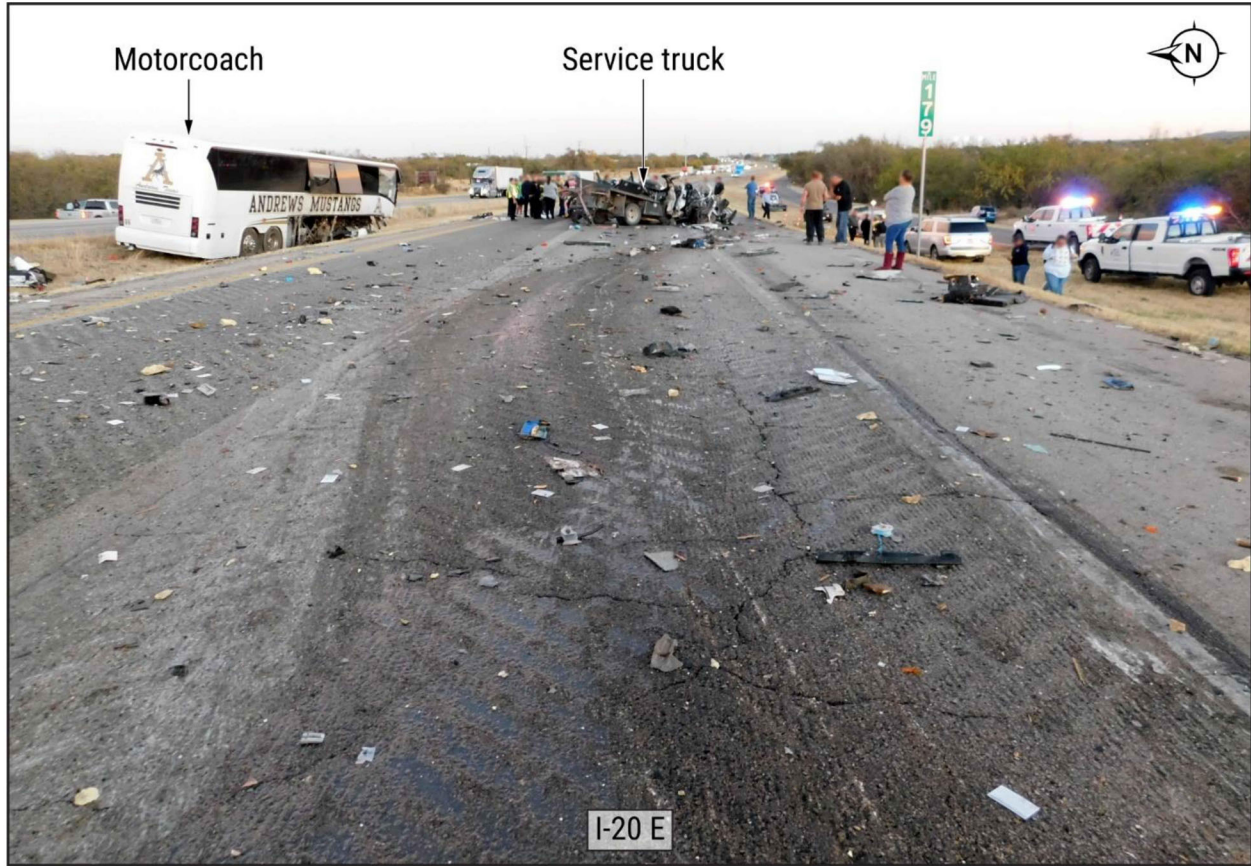
Figure 1. Impact area, with motorcoach in median and service truck in right-hand eastbound traffic lane, both at final rest. Freightliner bus, not pictured, is farther east on the right shoulder of I-20. (Source: Texas Department of Public Safety)

The motorcoach was traveling east in the right lane of I-20 while going around a curve and down a grade when it approached the service truck, which was also in the right lane. The motorcoach began braking and steering to the left.⁶ The service truck and motorcoach collided in the right lane. During the impact, the service truck was pushed backward and subsequently sideswiped by a 2018 Freightliner bus, the second vehicle in the caravan. After the collision with the service truck, the motorcoach traveled into the median and struck the cable barrier before coming to rest. The service truck came to rest in the right lane of eastbound I-20 and was consumed by a postcrash fire. The driver of the sideswiped bus was able to make a controlled stop on the right shoulder of the interstate facing east.

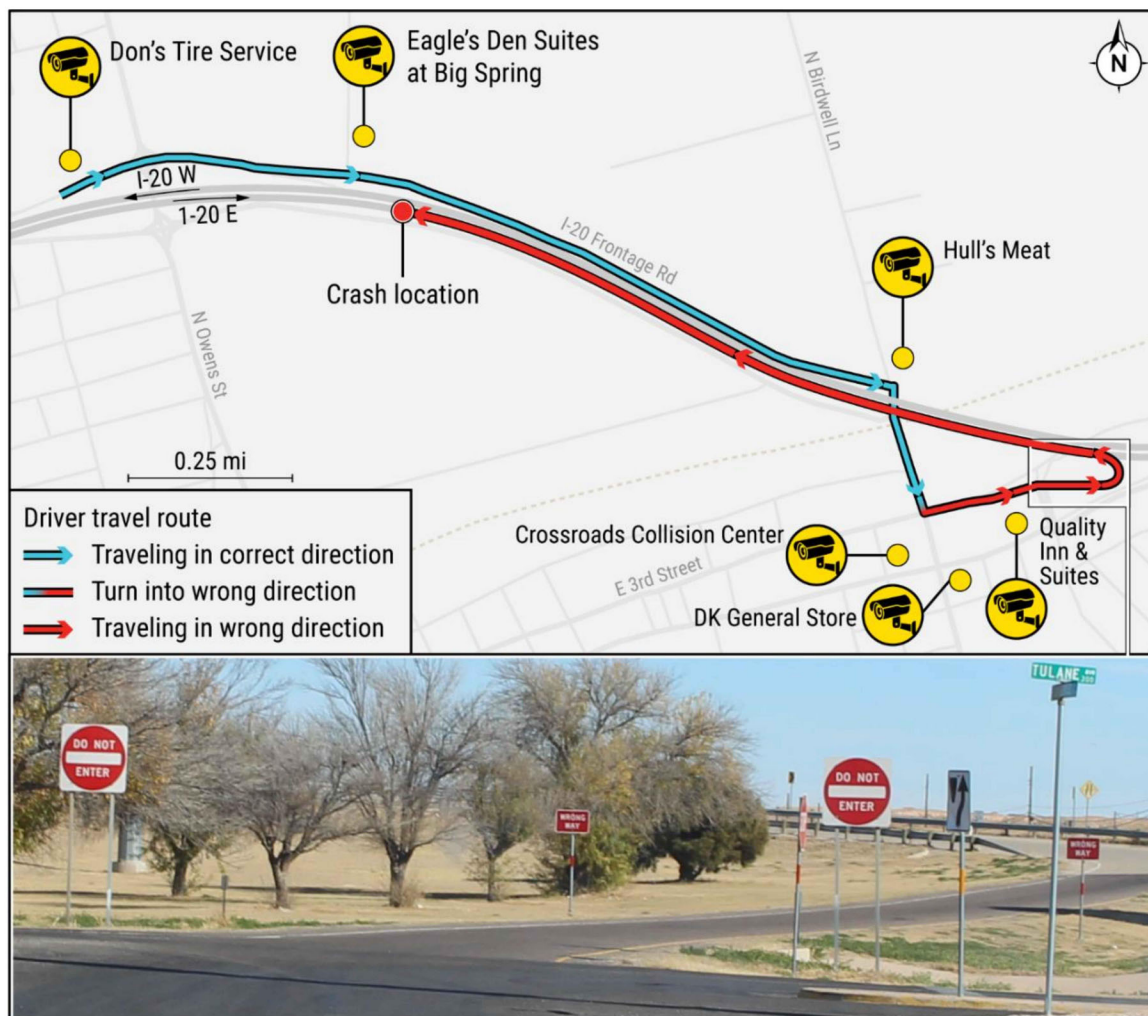
Surveillance videos from six local businesses in Big Spring showed the service truck driver as he traveled east on a frontage road that was just north of and adjacent to westbound I-20. He eventually made a wrong turn that led him to begin traveling west on eastbound I-20 (see figure 3).

Figure 3. Service truck driver's path of travel as determined by surveillance video and witness testimony. Blue arrows show travel in the correct direction, and red arrows show travel in the wrong direction. (Map Source: Google Maps; annotated by NTSB)

Video showed the driver at the signalized intersection of Birdwell Lane and East 3rd Street, which is a one-way street for westbound traffic. The driver made a left turn onto East 3rd Street and began traveling in the eastbound direction. The intersection had a one-way sign posted on the mast arm of the signalized light on East 3rd Street. After turning left, the driver continued for 30 feet and passed a second one-way sign on East 3rd Street indicating that he was traveling in the wrong direction.³ About 90 feet after he passed the second one-way sign, he passed a wrong-way sign on East 3rd Street.⁴

He continued traveling the wrong way on East 3rd Street and entered the exit 179 off-ramp for eastbound I-20 (refer to the lower image in figure 3). Two do-not-enter signs and two wrong-way signs were posted on either side of the ramp's base; the wrong-way signs were located 150 feet behind the do-not-enter signs. In total, from the point of initial wrong-way travel to his entering the exit ramp, the driver passed seven traffic signs indicating that he was traveling in the wrong direction (see figure 4).

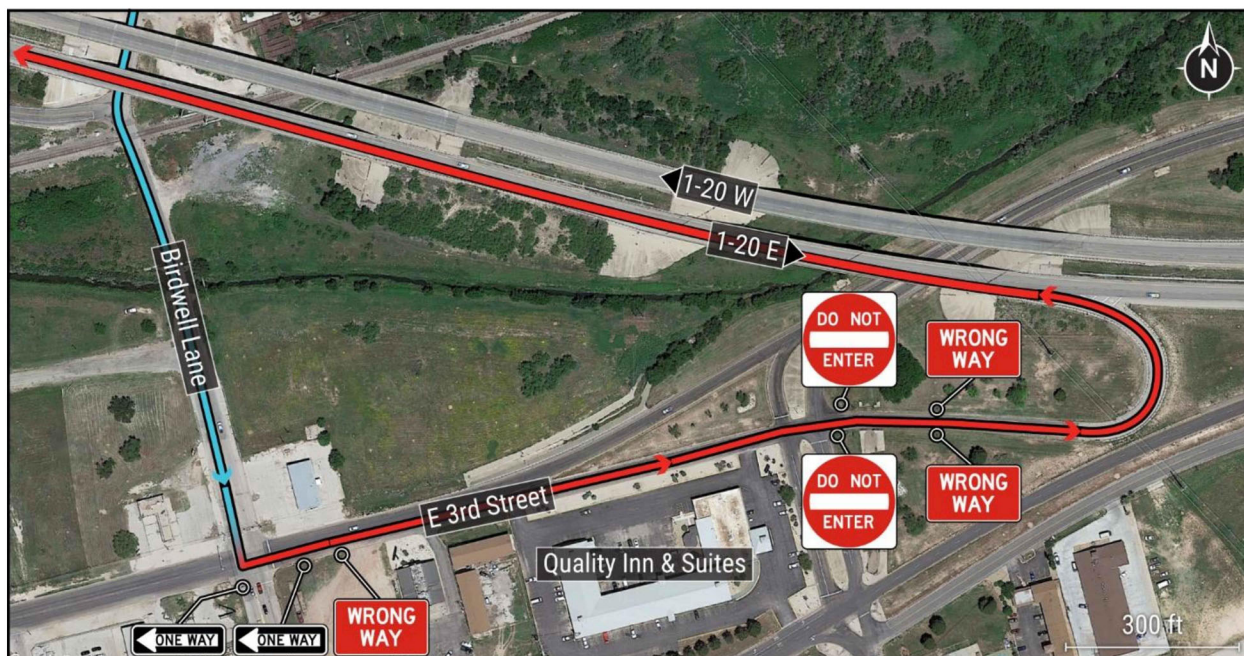
Figure 4. Traffic signs encountered by service truck driver indicating wrong-way travel from Birdwell Lane until he entered the exit ramp onto I-20. (Source: Google Maps; annotated by NTSB).

Traffic signage was not a factor in the service truck driver's error leading to his travel in the wrong direction. He was presented with multiple traffic signs to guide him to travel in the correct direction. From the initial wrong turn onto a one-way street at the intersection of East 3rd Street and Birdwell Lane until the crash event, the driver encountered seven traffic signs indicating wrong-way travel, as follows:

- One-way sign above the signalized traffic light at 3rd Street and Birdwell Lane
- One-way sign on East 3rd Street
- Wrong-way sign on East 3rd Street
- Two do-not-enter signs at the base of the exit ramp
- Two wrong-way signs 150 feet behind the do-not-enter signs at the base of the exit ramp

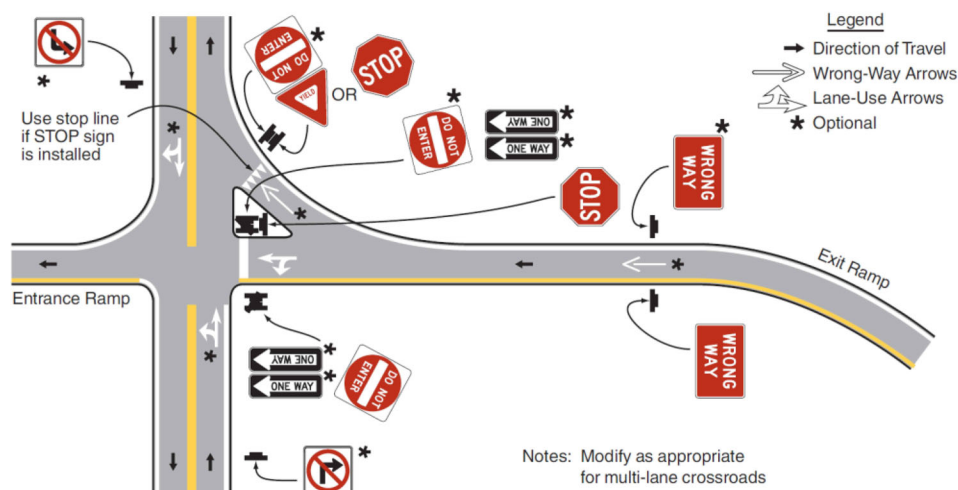
The traffic signs all met *Texas Manual on Uniform Traffic Control Devices (MUTCD)* requirements, which set minimum standards, provide guidance, and ensure uniformity of traffic control devices across Texas (see figure 5). Further, the exit ramp signage exceeded the *Texas MUTCD* requirements by including two do-not-enter signs and two wrong-way signs (posted on both sides of the ramp) rather than one of each sign (posted only on the right side of the ramp), as is required. The Texas Department of Transportation (TxDOT) is taking further actions to address wrong-way driving by updating traffic control devices (including adding raised, retroreflective pavement markers) to deter wrong-way driving at ramp terminations of divided highways. These additional actions also exceed the requirements in the *Texas MUTCD*.

Figure 5. Example application of regulatory signage and pavement markings at an exit ramp termination to deter wrong-way entry. (Source: TxDOT 2014).

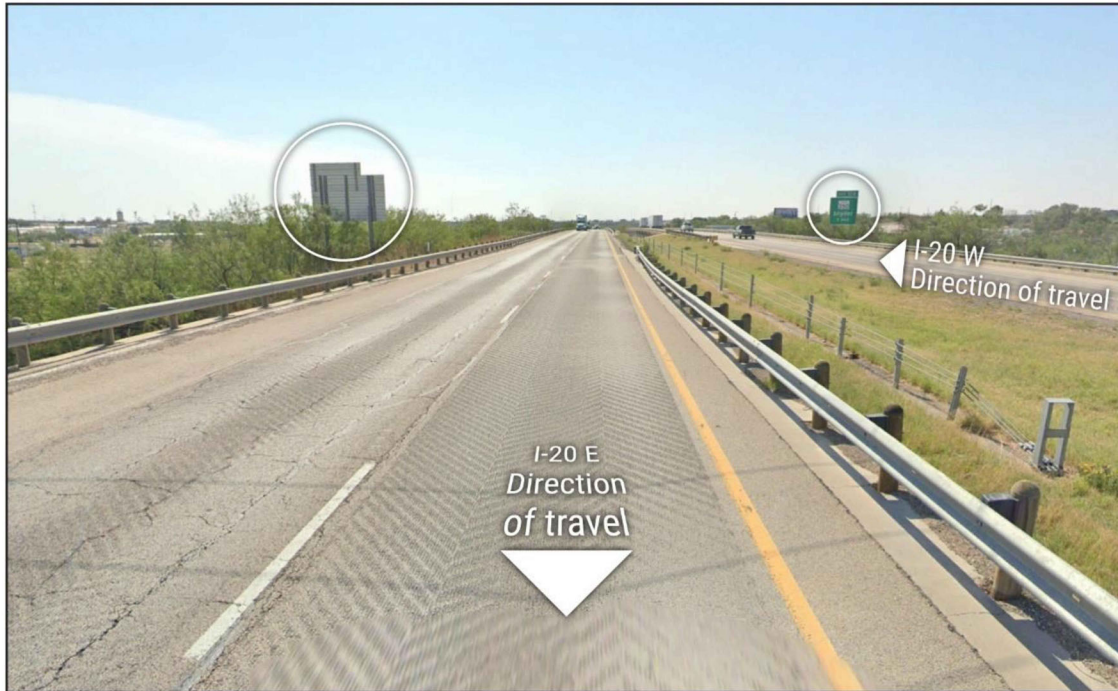
After entering the highway, the driver encountered additional cues indicating that he was driving in the wrong direction (see figure 6). Before the crash, at least four vehicles that were traveling east on eastbound I-20 approached and passed him as he continued to travel west. Further, a driver traveling in the wrong direction would face the backs of highway traffic signs. Although subtle, the white pavement line on a highway is located on a driver's right, and the yellow pavement line is located on the left; for a driver traveling the wrong way, these colored lines would appear on the opposite sides.

Figure 6. Examples of cues indicating wrong-way travel: facing oncoming traffic and the backs of traffic signs and having the yellow pavement line on the right (incorrect) side. (Source: Google Maps; annotated by NTSB)
