HIR-23-10

Grade Crossing Collision Between Commuter Train and Box Truck

Clarendon Hills, Illinois
May 11, 2022

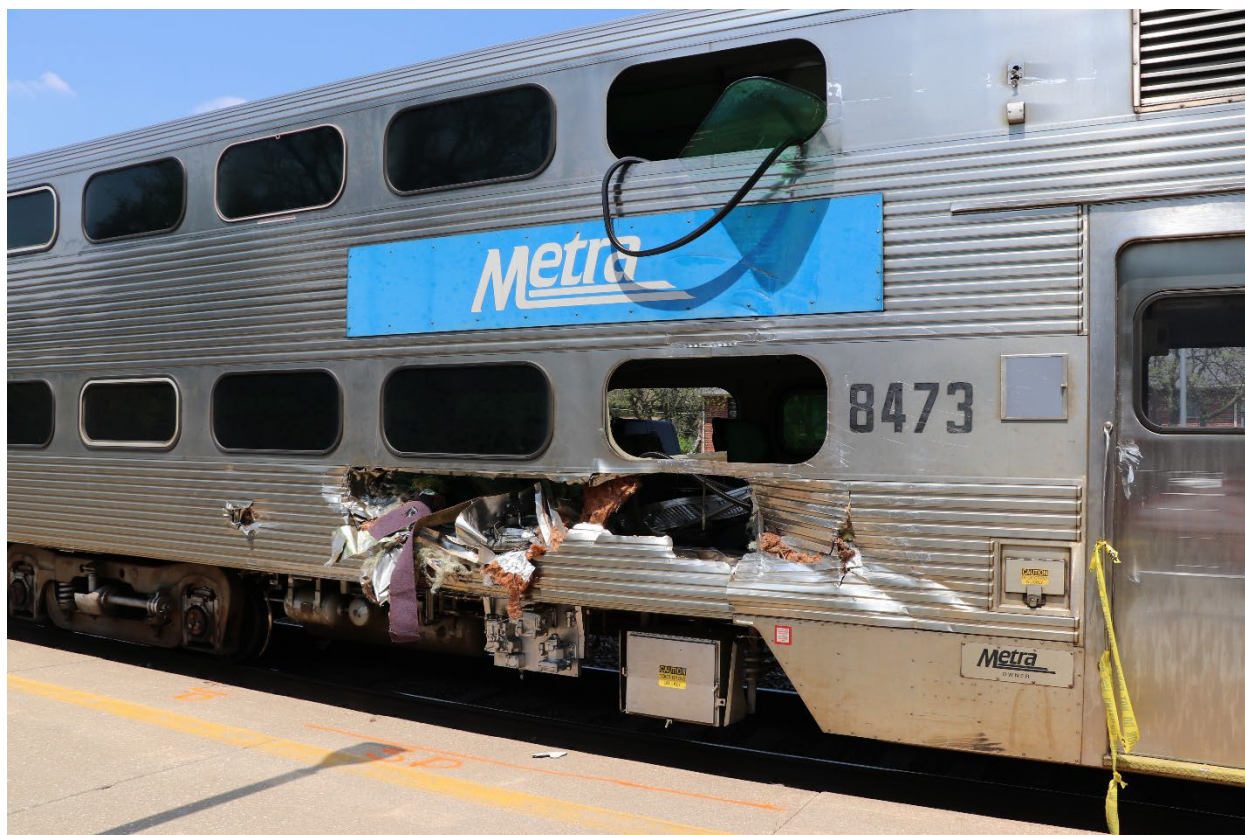
When the commuter train struck the box truck, the truck was pushed against the crossing arm supports, which broke away from the concrete support pedestals on the ground. The truck then rotated clockwise and struck the right side of the train's lead cab car, below the windows. The train did not derail and came to a full stop at 8:16:38, about 1,106 feet east of the crash location. As shown in figure 5, the secondary impact resulted in exterior gouging of the cab car, with intrusion damage to the lower-level seating compartment of the two-level commuter train passenger car, as well as window damage on the upper level.

Figure 5. Exterior damage to the lower-level seating area of the right side of the commuter train's lead cab car. The upper level also sustained window damage.

Window retention was not a factor in the fatal injury sustained by one commuter train passenger. The evidence indicates that the fatal injury was sustained by the impact force of the rear of the box truck with the cab car sidewall near the passenger's seating location, and not as a result of the ejection itself. The impact forces from the box truck likely exceeded the cab car side wall strength requirement in 49 *CFR* 238. The NTSB has previously recommended that the Federal Railroad Administration develop side-impact crashworthiness standards for passenger railcars and then update federal regulations to reflect these new standards. Safety Recommendations [R-12-39](#) and [-40](#) are currently classified Open–Acceptable Response.
