HIR-24/03

# Fire on Battery Electric Transit Bus

Hamden, Connecticut  
July 23, 2022

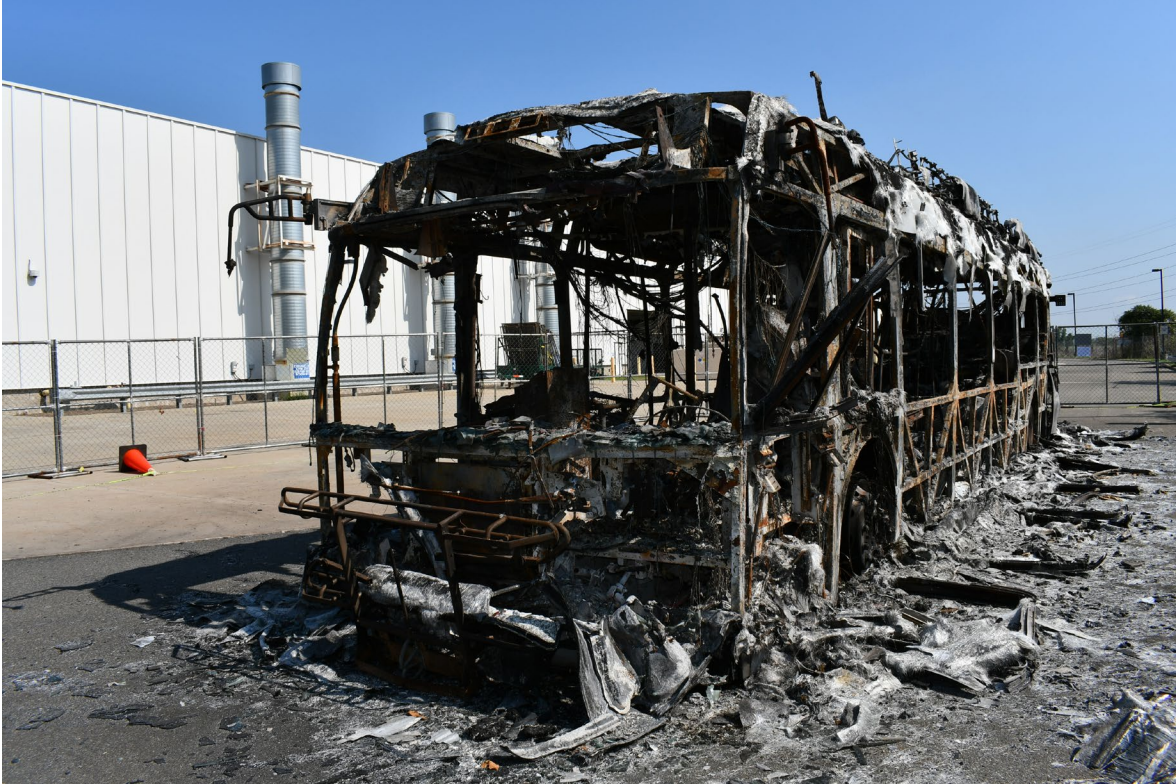
As shown in figures 3 and 4, all areas of the bus sustained severe fire damage. All windows were missing and the fiberglass cladding was consumed, exposing the steel frame of the bus. All tires were consumed, leaving only the wheels. At the rear of the bus, the upper fiberglass door covering the heating, ventilation, and air-conditioning (HVAC) system and the lower door covering the rear high-voltage lithium-ion battery storage area were consumed, exposing the remnants of both the HVAC system and the batteries. Examination of the rear ESS enclosures showed evidence of water or coolant damage to the batteries in one of the ESS enclosures.<sup>5</sup>

**Figure 3.** View from the front driver's side of the battery electric transit bus after the fire.

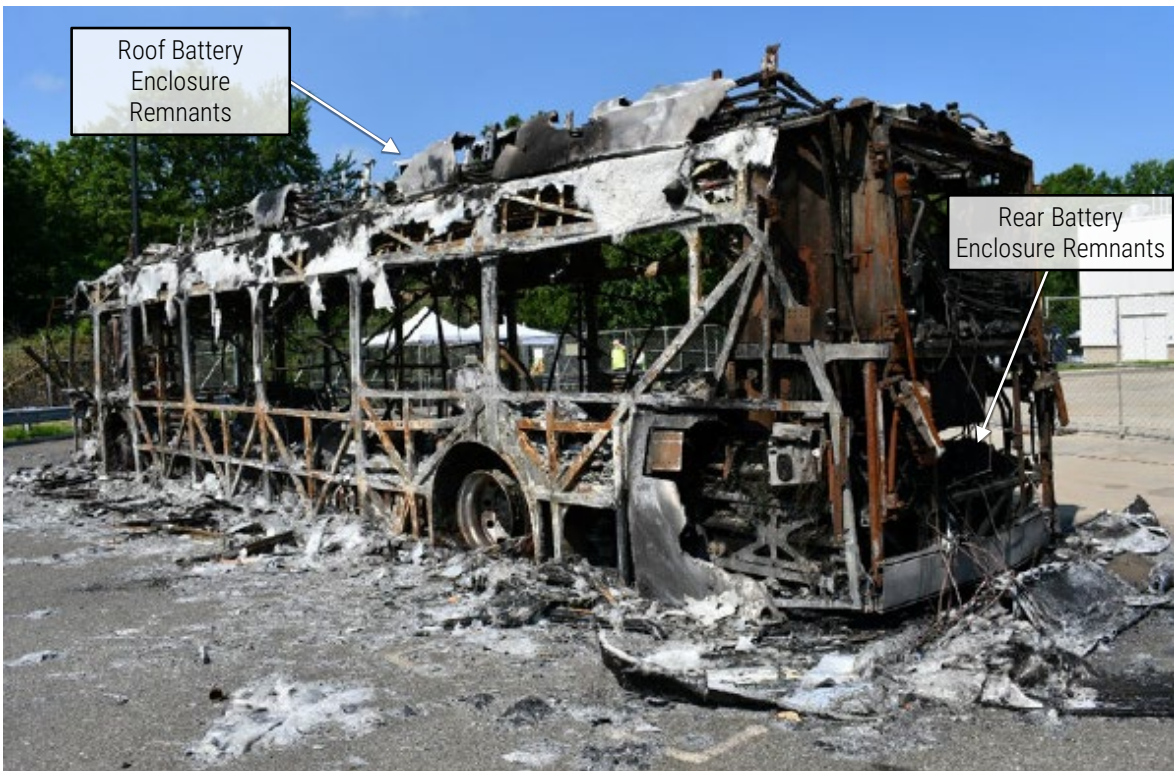
**Figure 4.** View of the burned transit bus from the left rear corner of the bus.
