Cargo Hose Rupture and Release of Anhydrous Ammonia
During Offloading of a Werner Transportation Services
Cargo Tank Motor Vehicle at the Tanner Industries Plant
Swansea, South Carolina
July 15, 2009

Accident Summary Report

NTSB/HZM-12/01/SUM
PB2012-917002

Hazardous Materials Accident Summary Report

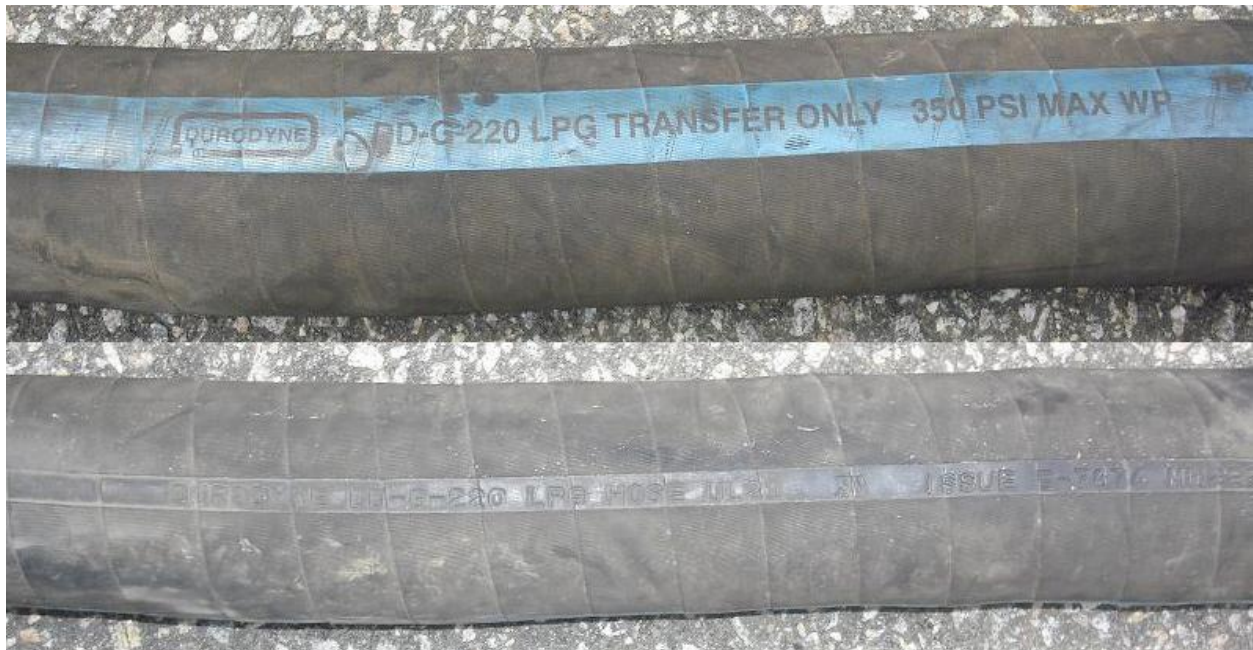
of several different layers of material that are chemically compatible with LPG, but not with anhydrous ammonia. The innermost layer of the hose was made of nitrile rubber, followed by three sequential layers of polyethylene terephthalate (PET) yarn braids encased in chloroprene rubber and an outer layer of neoprene rubber. The PET yarn braids are used to mechanically reinforce the hose, and they provide the hose with the majority of its strength. The hose had a nominal inner diameter of 2 inches, an outer diameter of 2 3/4 inches, and a bend radius of 14 inches. It was rated for use between -40° F and 180° F. The hose had been approved by Underwriters Laboratories Incorporated (UL) and met the UL 21⁶ standard for LPG hose. The maximum allowable working pressure of the hose assembly was 350 pounds per square inch, gauge (psig), and the minimum specified hydrostatic burst strength was 1750 psig, in accordance with UL 21.

The hose was imprinted with text. One side of the black neoprene cover of the hose featured a blue Mylar stripe extending along the length of the hose with the Durodyne logo and “DD-G-220 LPG TRANSFER ONLY 350 PSI MAX WP” printed in black. The phrases “To prevent serious injury or property damage use for intended purpose only,” “Warning: Use of damaged hose could be hazardous; inspect hose and couplings prior to each use,” and “Textile reinforcements meet UL21” were also embossed along the imprinted blue Mylar stripe. The opposite side of the hose had “DURODYNE DD-G-220 LPG HOSE UL21 ISSUE E-7874 MH29239 SPEC DD-G-220 TEXTILE BRAID WP 350 PSIG 4Q05 INSPECT HOSE BEFORE USE” embossed on an imprinted stripe extending the length of the hose. (See figure 1.)

Figure 1. Blue Mylar and imprinted stripes on accident hose.

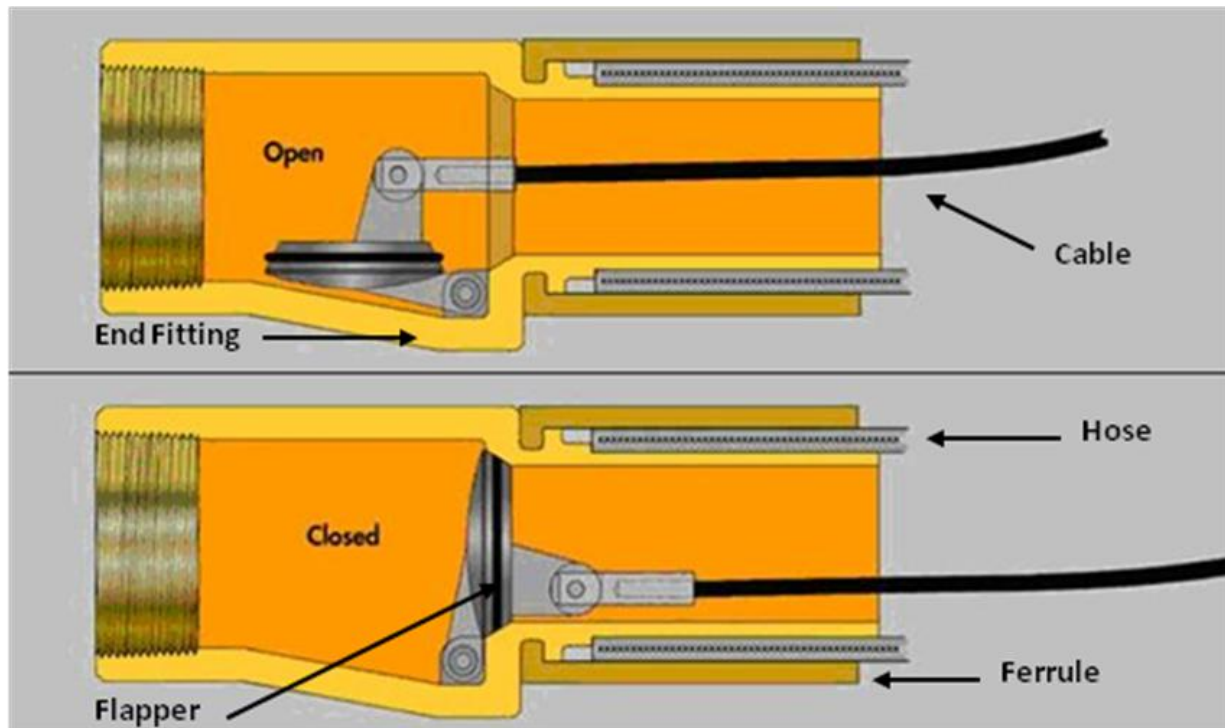
Smart-Hose Technologies of Philadelphia, Pennsylvania, purchased the LPG transfer hose from Durodyne and installed the Smart-Hose safety system to fabricate the complete accident hose assembly as a Lifeline III LPG Transfer Hose. The Smart-Hose safety system consists of an internal cable running through the bore of the hose connected to specially designed unseated flapper valves located on each end of the cable. In the event of hose or coupling separation, catastrophic hose rupture, or excessive hose stretching, the system is designed to shut off the flow of LPG in both directions as the flapper valves release and instantly seat. (See figure 2.)

Figure 2. Schematic depicting Smart-Hose safety system.

Amend the provisions of Title 49 *Code of Federal Regulations* 173.315(n)(2) to require that passive emergency shutdown control systems for highway cargo tanks activate in the event of a partial or complete failure of a cargo hose assembly. (H-12-4)

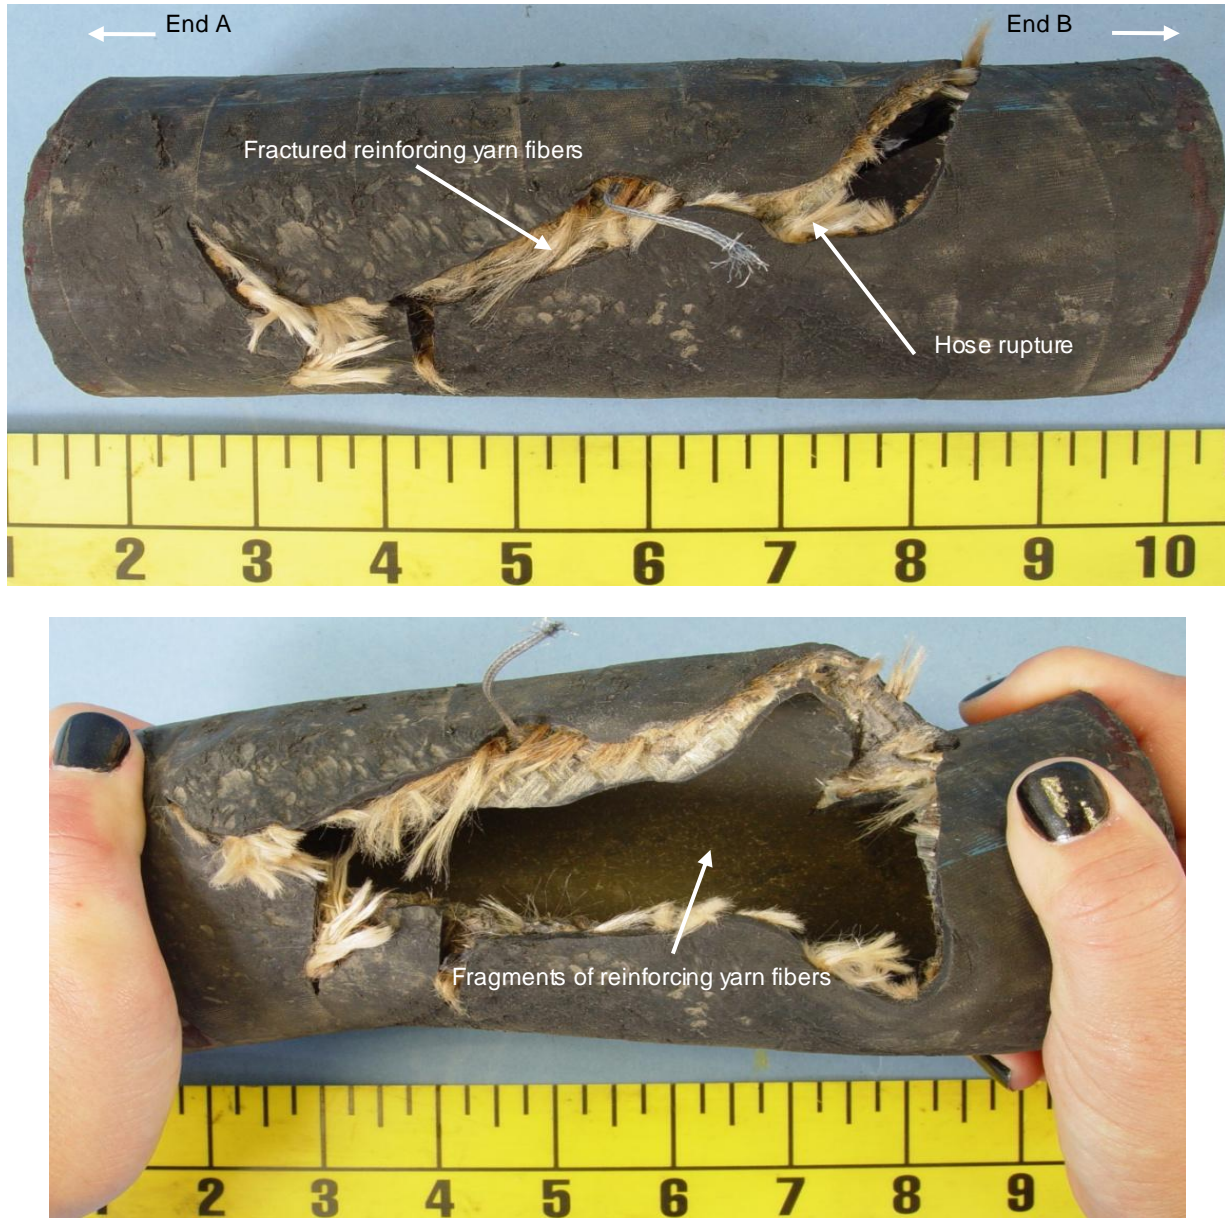
Figure 3. Views of outside (top) and inside (bottom) of ruptured section of accident hose.

The exterior surfaces of the hose assembly contained only superficial abrasions. No gouges, slices, or other defects were noted on the surface of the hose, including the areas adjacent to and abutting the rupture area. The black text on the blue Mylar stripe was abraded in multiple locations so that the stenciling along the length of the hose could not be read; however, several sections of the hose assembly were free of abrasions or stains, and the text could be read. The embossed text on the imprinted line could be read along the length of the hose assembly.

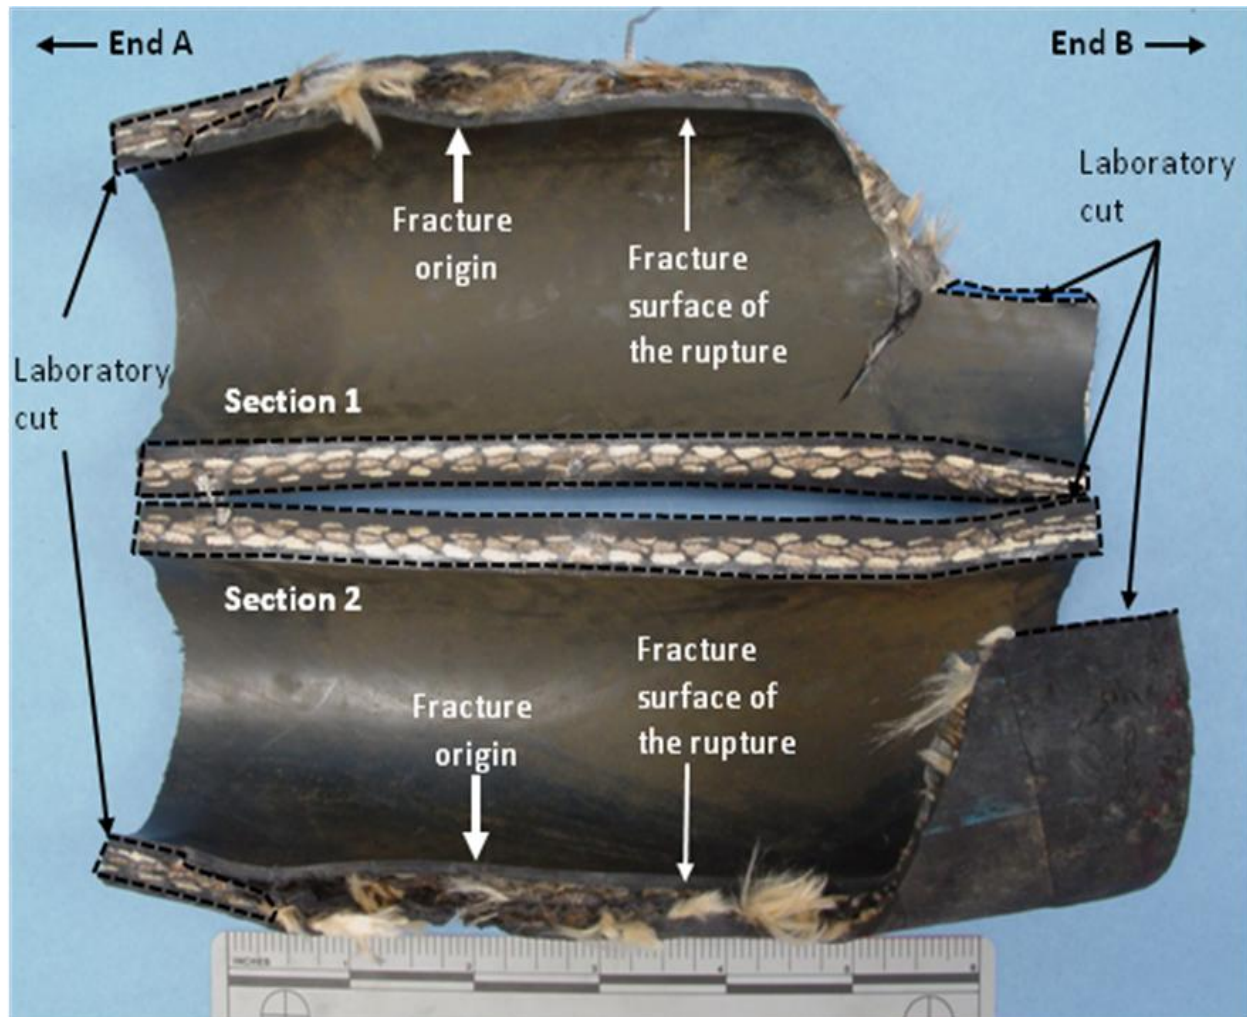
Fractographic¹⁰ evidence indicates that the rupture in the accident hose assembly initiated on the interior wall of the hose and propagated outward. The NTSB's Materials Laboratory identified a definitive fracture origin on the surface of the fracture that was indicative of relatively slow crack growth. (See figure 4.) Several secondary cracks were noted in the interior wall of the hose near the fracture origin; however, the interior surface did not appear to be degraded from anhydrous ammonia exposure.

Figure 4. Section of ruptured accident hose cut to reveal fracture surfaces.

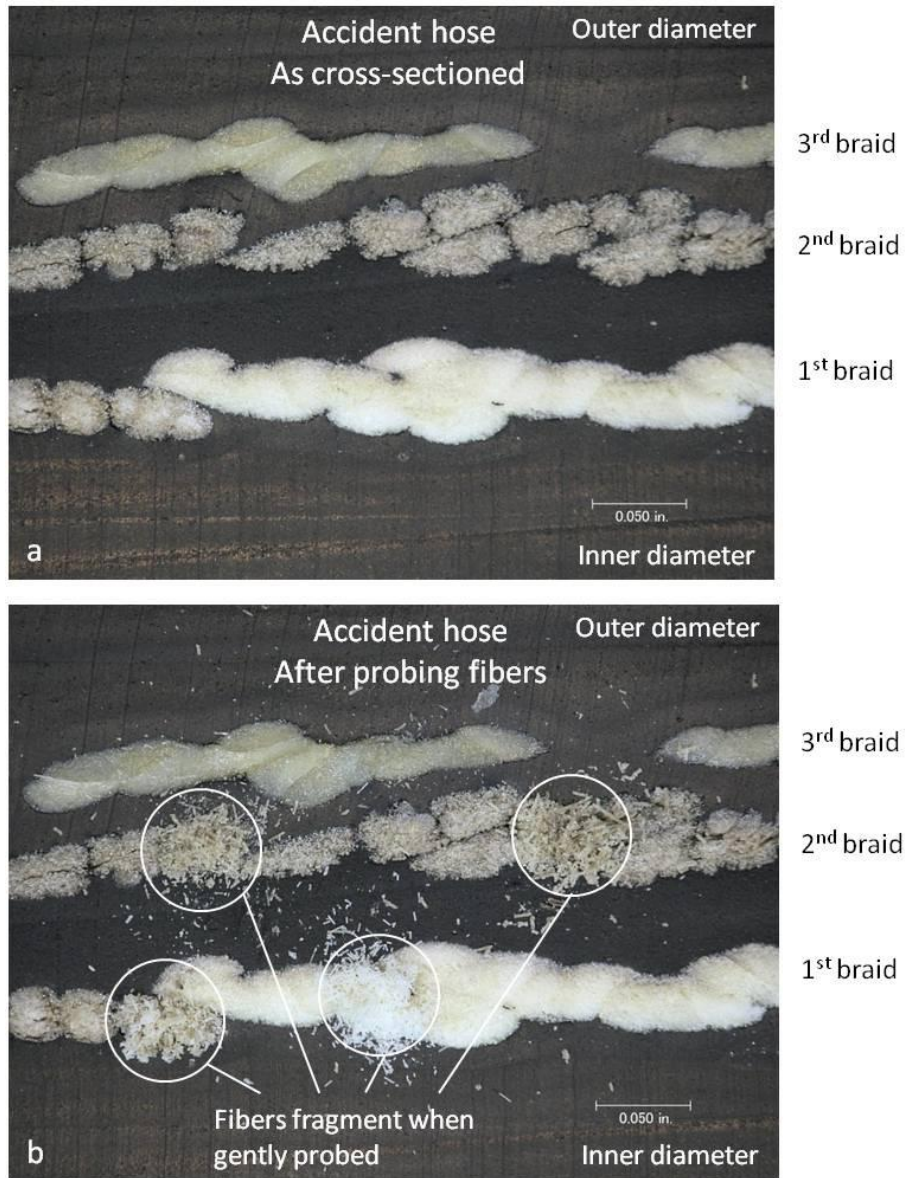
The reinforcing fibers in the two innermost PET braid layers of the hose assembly appeared to be severely damaged on both halves of the fracture surface along the entire length of the ruptured area. In some parts of the ruptured area, the fibers were clumped together and appeared to be encased in salt-like particles. Laboratory analysis of the hose assembly revealed that the fibers in the two innermost PET braid layers were degraded to the point that they were brittle and friable when strained or mechanically flexed. (See figure 5.)

Figure 5. Cross-section of accident hose showing brittleness of fibers in two innermost PET braid layers.

The PET used for the yarn braids is not chemically resistant to anhydrous ammonia or ammonium hydroxide. As documented in several studies,¹¹ exposure to anhydrous ammonia or ammonia-related compounds results in a chemical reaction (ammonolysis) that can cause PET fibers to degrade and lose strength.

Testing completed by both the NTSB's Materials Laboratory and an independent laboratory¹² confirms that the PET fibers in the accident hose had sustained chemical degradation that dramatically reduced the strength of the PET fiber. The NTSB concludes that the accident hose failed because it was not chemically compatible with the anhydrous ammonia in the cargo tank that caused the chemical degradation, the loss of mechanical strength, and the ultimate failure of the cargo hose.

Require cargo tank motor vehicle carriers and transfer facilities to verify (1) that cargo transfer hose assemblies, whether carried on the vehicle or provided by the facility, are chemically compatible with the hazardous material to be transferred and (2) that drivers verify hoses are marked as compatible with the material to be transferred before either loading or unloading operations begin. (H-12-3)
