Air Products and Chemicals, Inc. Tube Trailer
Module Hydrogen Release and Subsequent Fire
Diamond Bar, California
February 11, 2018

NTSB/HZM-19/02
PB2019-101398
Notation 59258
Adopted October 10, 2019

Hazardous Materials Incident Report

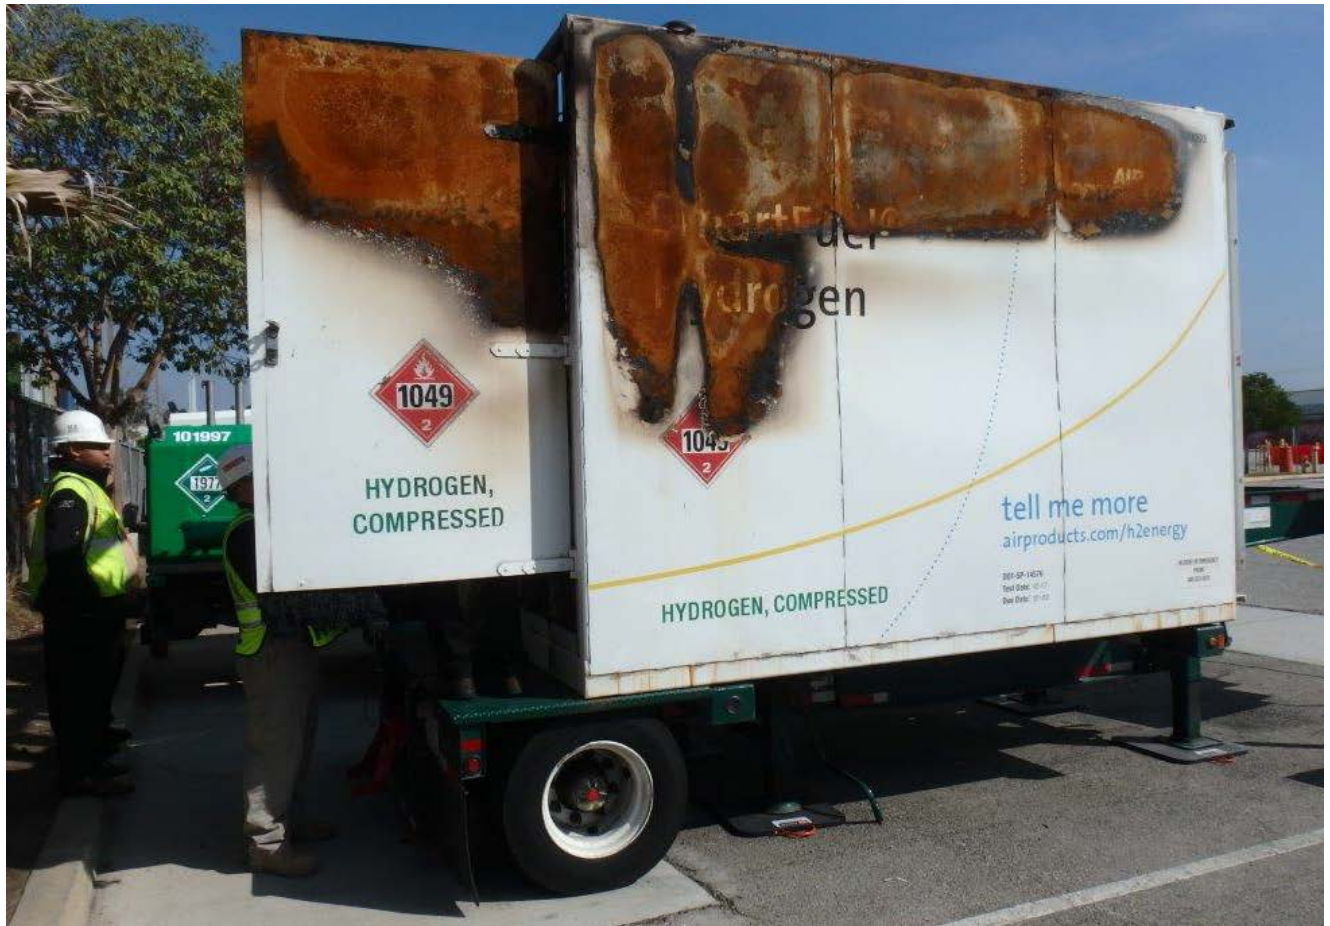
Investigators observed thermal damage on the exterior upper-right rear of the trailer door and upper-right side of the CT-250 module structure. (See figure 5.) This damage ranged from discoloration of the paint to areas where the paint was completely burned off the exterior.

Figure 5. Air Products tube trailer module 430003, exterior right side, March 12, 2018.

The right-rear door handle hasp was bent upward, and the door panel was bowed outward. The frame of the door panel also buckled outward about 1.5 inches. The bow in the right-rear door was centered opposite the position of cylinder No. 14. The trailer frame and appurtenances were not damaged in the incident.

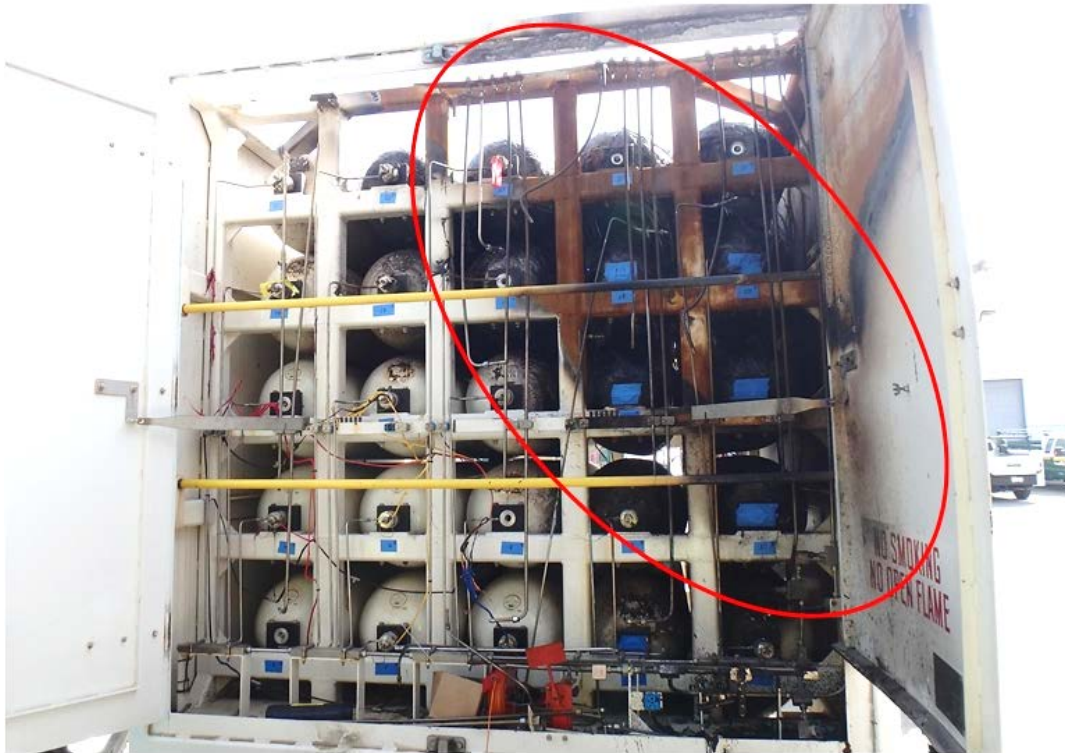
Thermal damage was concentrated in the upper right interior of the tube stack and is summarized in the Table. Investigators observed no cylinder cuts and no abrasions. Damage was limited to the exposure of heat and flame. (See figure 6.)

Figure 6. Module number 430003 rear view with the area of greatest thermal damage circled, March 12, 2018.

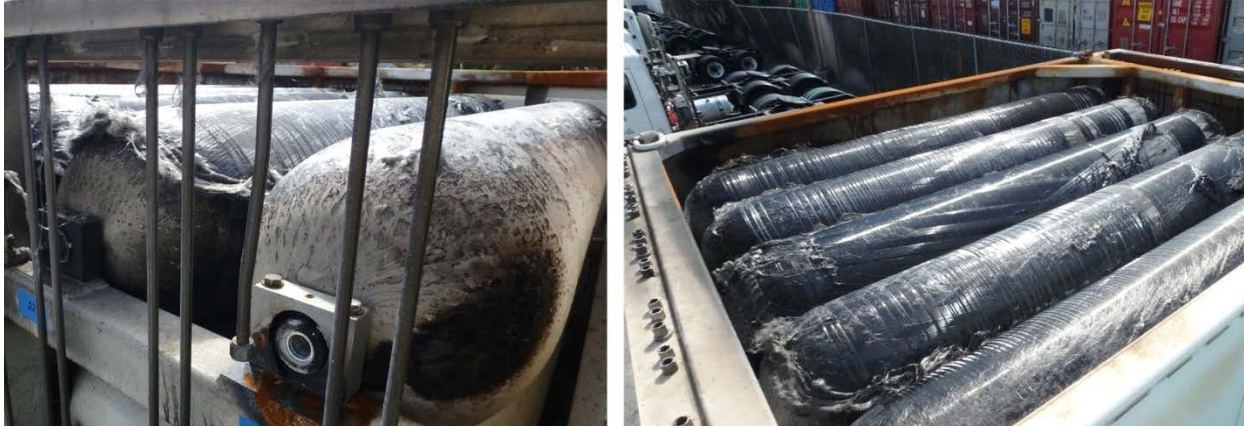
Figure 7. Cylinders 21 through 25 thermal damage with protective fiberglass and epoxy coating burned away, March 14, 2018.

SCI/Worthington technicians noted that the cylinder in position 24 exhibited the most severe fire damage, with its outermost carbon fiber layers that were wrapped in the hoop orientation burned away in three locations. The underlying carbon fiber composite layers wrapped in the helical orientation were exposed. SCI/Worthington burst tested this cylinder, finding that the cylinder wall failed at 24,600 psig, whereas the minimum burst pressure permitted in a DOT-SP 14576 test for a new and undamaged cylinder is 25,500 psig.

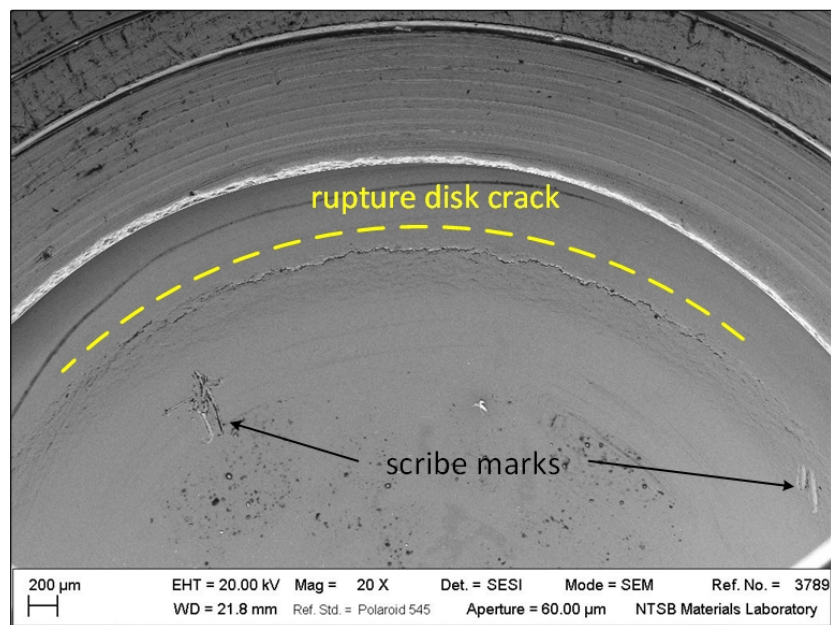
The rupture disk contained in the rear incorrect PRD for cylinder No. 11, which was outside of the area of greatest thermal exposure, had a concave shape with a deflection toward the discharge port. A radial crack had formed on the rupture disk surface and the concavity of the center of the disk suggests the disk was subjected to high pressure during its 6 weeks in service. The cylinder manufacturer specifications call for the cylinders to be equipped with a PRD rated at 10,000 psi. Additionally, the disk should have been fabricated from material other than nickel because the Sherwood type 3132SB technical information states that nickel PRDs and fittings must not be used in hydrogen service. Metallurgical analysis of rupture disks following other PRD failures have shown that hydrogen embrittlement of nickel disks has led to stress cracks and premature failures.²³ Figure 8 shows a magnified view of the fracture area on the surface of the cylinder No. 11 PRD rupture disk, which reveals a rough textured area primarily below the fracture that is circumferentially continuous and indicative of tensile stretching. The cylinder No. 11 rupture disk fracture mode was a ductile overstress fracture, suggesting that it likely would have actuated within a short time given additional use and pressure cycling.²⁴

Figure 8. Magnified view of cylinder No. 11 PRD rupture disk (magnification of 20X). Scribe marks were etched into the disk during the postincident laboratory examination.

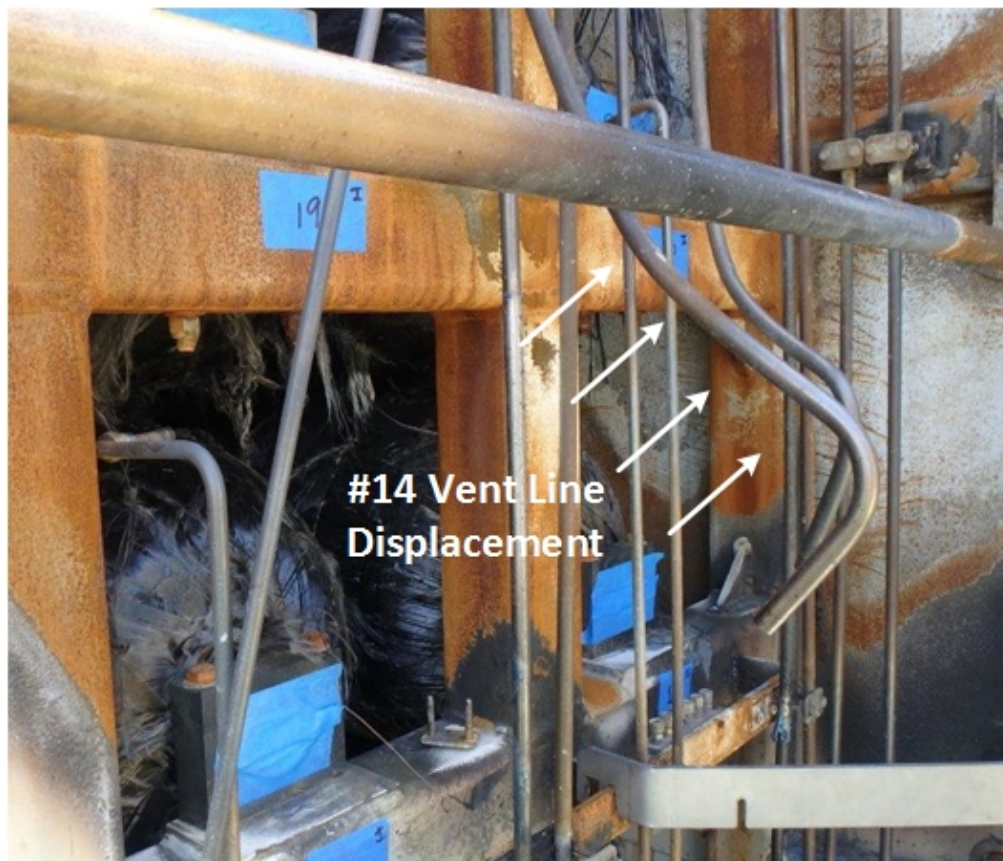
Under the thrust force and pressure of gas flowing from the actuated PRD, the cylinder No. 14 vent line was ejected from the PRD assembly fitting and was bowed outward and partially wrapped around a handrail. (See figure 9.) The separated vent line allowed the escaping high-pressure hydrogen to be directed to the interior of the cabinet rather than upward and outside of the cabinet as intended by the design. The hydrogen could have been ignited by the shock wave from the sudden release and/or impact between the dislodged vent tubing, handhold bar, and the rear door of the trailer.

Figure 9. No. 14 vent line displacement. The vent line was bent outward from the cylinder and against the handhold rail. March 12, 2018.

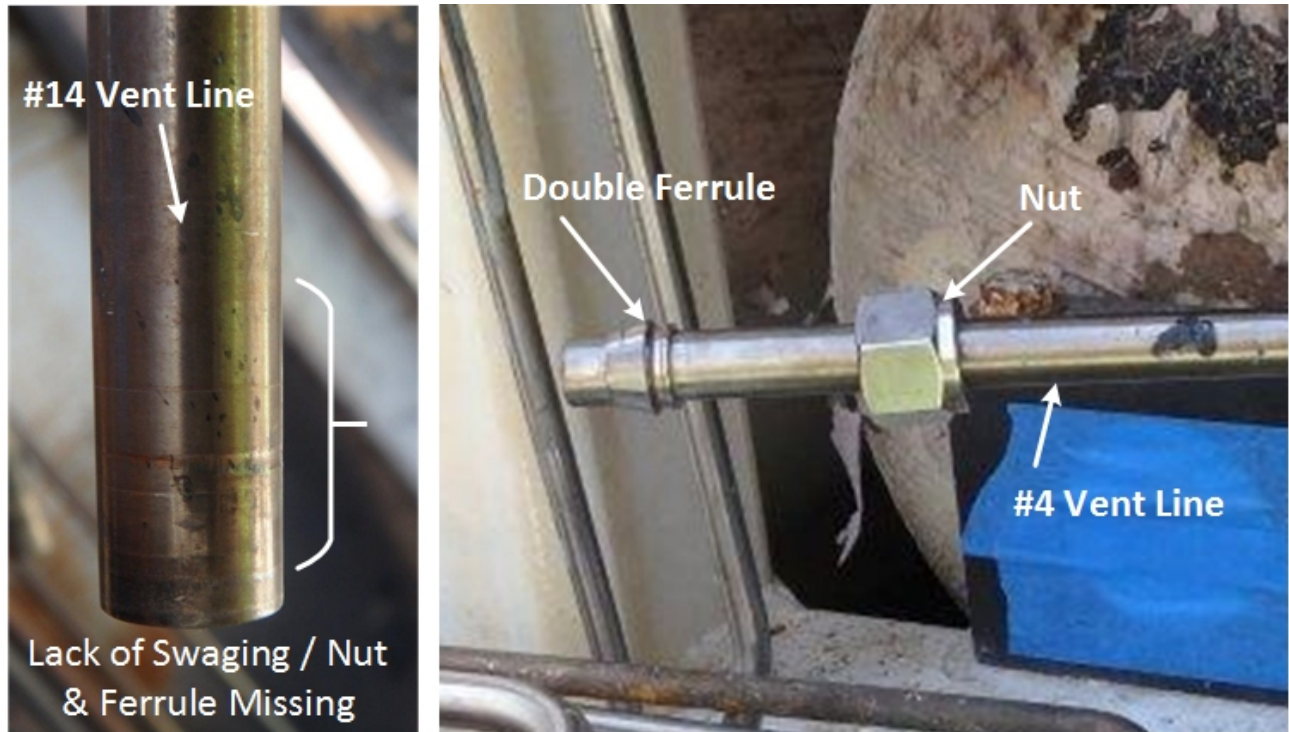
The nut-and-fitting ferrules were missing from the vent line that should have swaged the tubing if the compression fitting had been sufficiently tightened. (See figure 10.) When the vent tubing is initially assembled with the fitting, it is supposed to be checked with a No-Go gap gauge to ensure that the nut has compressed the ferrules, narrowing the tubing diameter enough to lock the ferrules in place. This compression secures the fitting against gas leakage and retains the tubing in place.

Figure 10. Comparison of No. 14 vent line (left) with No. 4 vent line (right). The nut and the ferrule for coupling to the Parker elbow is missing from the No. 14 vent line.

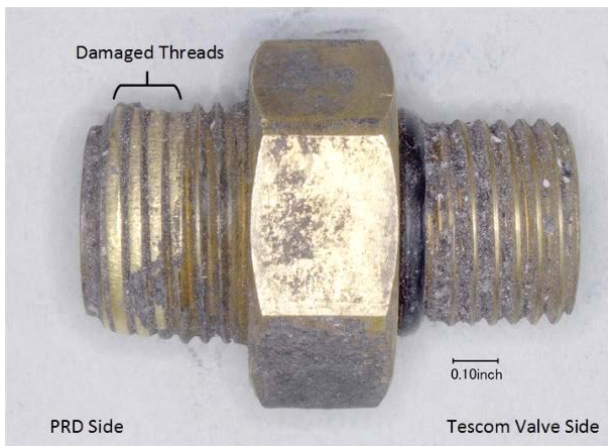
The cylinder No. 14 adaptor fitting remained fastened to the Tescom shutoff valve; however, its downstream "male" threads were damaged, and the corresponding PRD body "female" threads were flattened from forced separation of the two pieces. (See figure 11.)

Figure 11. Cylinder No. 14 PRD adaptor fitting with damaged male threads.

- Air Products has provided FIBA with stainless steel PRD adaptor fittings to replace the brass ones to avoid frequently observed thread damage.

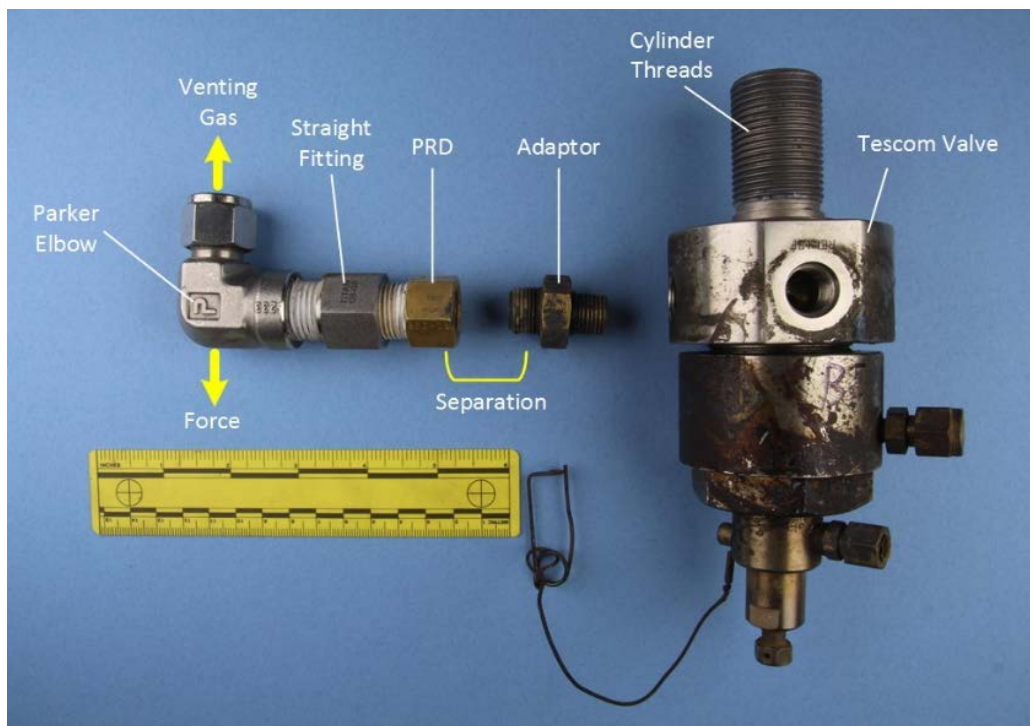
The cylinder No. 14 PRD assembly fitting separation occurred after the vent line was ejected as high-pressure venting gas jetted from the open 90° elbow with downward perpendicular thrust. (See figure 12.)

Figure 12. Cylinder No. 14 PRD assembly, adaptor, and Tescom valve. Hydrogen gas vented from the vent line compression fitting.

The venting gas imparted force against the PRD assembly adaptor attachment point, stripping its brass threads and causing the assembly to drop to the bottom pan of the trailer where it was not directly exposed to the subsequent fire. This was evident from the relatively clean state of the PRD assembly and the lack of indication that the fusible metal had melted. A short soot

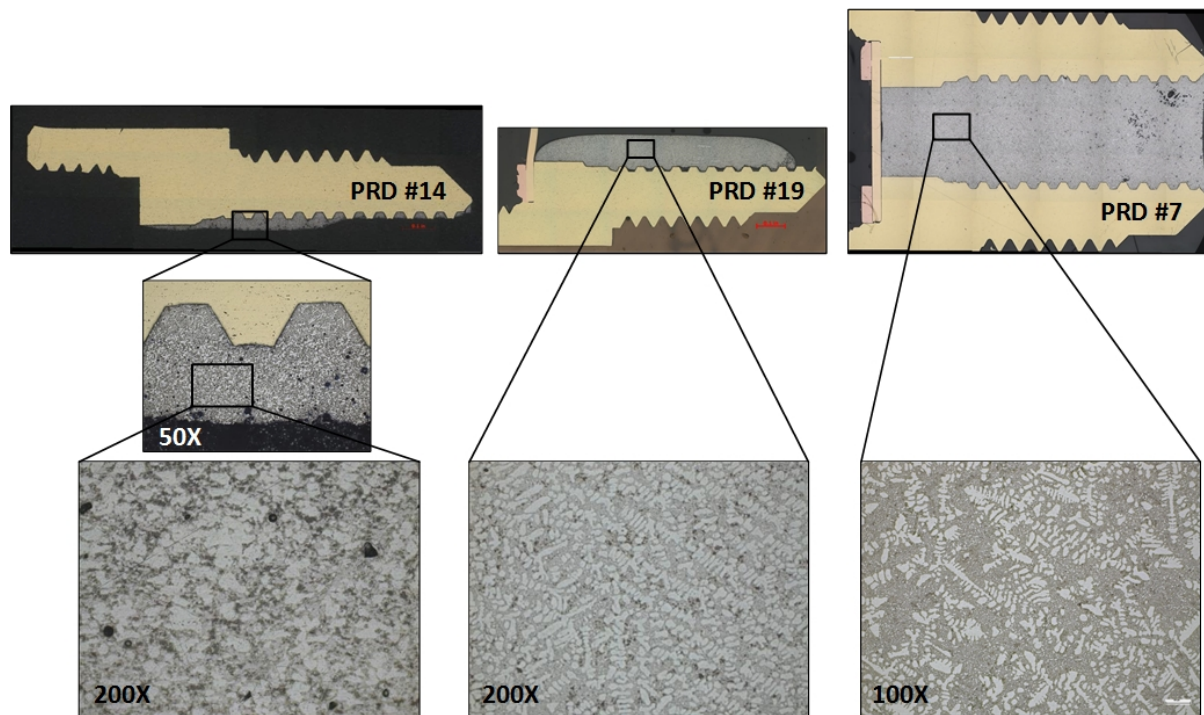
NTSB investigators compared fusible metal residues in the discharge ports of the PRDs from cylinder Nos. 4, 14, and 19 (located directly above cylinder No. 14 in the tube trailer) with the unaffected and intact PRD from cylinder No. 7. Some fragmented fusible metal material and residue was observed adhering to the cylinder No. 14 PRD discharge port interior grooved surfaces. Optical microscope images revealed the fusible metal residue microstructure away from the thread roots in the discharge port of the cylinder No. 14 PRD appeared very different to the melted and resolidified fusible metal residues found in the cylinders Nos. 4 and 19 and the unaffected fusible metal in the cylinder No. 7 PRD. (See figure 13.)

Figure 13. Comparison of fuse metal residues from PRD No. 14 (left), PRD No. 19 (center), and PRD No. 7 (right).

The teardrop and rounded shapes of melted and resolidified fusible metal residue in the cylinder No. 19 PRD that sustained heat exposure during the module fire were also different from the fusible metal residue adhering to the discharge port grooves in the cylinder No. 14 PRD. The shape and microstructure differences of fusible metal residue from the cylinder No. 19 PRD suggests it was heated and flowed from the discharge port, while in cylinder No. 14, the fusible metal appears to have been mechanically expelled from the discharge port under pressure alone. Therefore, the NTSB concludes that although the other cylinder PRDs in the tube trailer module were actuated because of fire exposure, the cylinder No. 14 PRD actuated before the fire began.

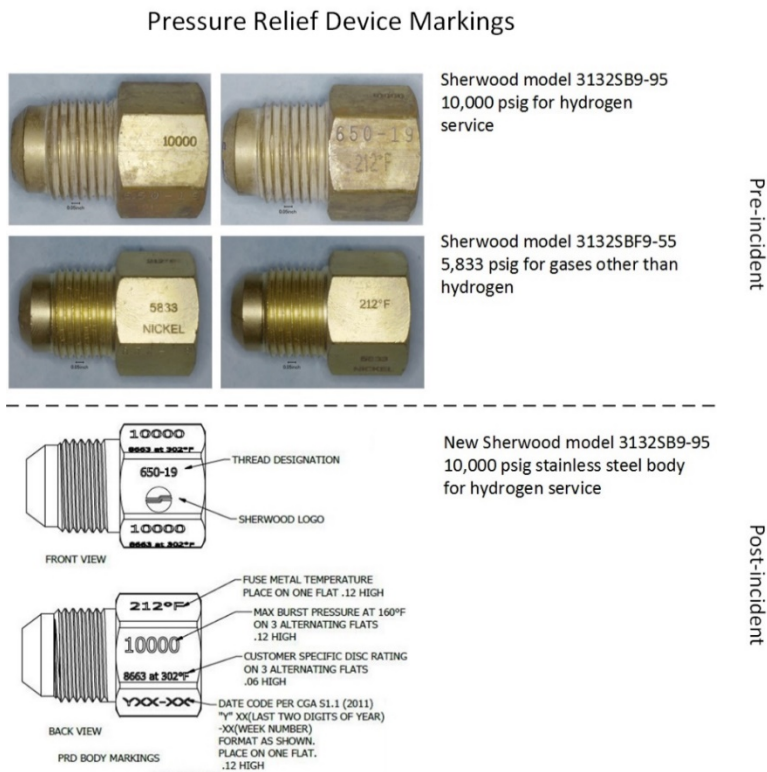
with a small font on one hex would not have been sufficient to alert him of his error. Therefore, the NTSB concludes that the lack of noticeable marking or other visual indicators, unique design features, and unique model numbering to readily identify PRDs intended for different applications, made them easy to confuse and did not avert the requalification technician from installing four wrong PRDs on the incident tube trailer module.

Figure 14. Comparison of old and new PRD markings.

Since this incident, the PRDs manufactured for Air Products now have larger-font pressure ratings engraved on multiple locations such that the number is visible regardless of the PRD body orientation. Further, Air Products has requested future 10,000 psi PRDs to be fabricated from stainless steel, which is silver in color and visually different from the gold-colored brass PRD body used for a 5,833 psi PRD. Air Products successfully subjected the alternative PRD design to bonfire testing as required by the conditions of DOT-SP 14576, and is seeking PHMSA approval to switch to the stainless steel version for greater identification and robustness.²⁹ Figure 14 shows the new PRD design compared to the previous design, including improved markings to eliminate confusion between the PRD models and ensure that the devices are selected for the appropriate service criteria.
