CSX Transportation, Inc. Tank Car Release of UN1987
Denatured Ethanol
Fredericksburg, Virginia
November 2, 2016

NTSB/HZM-20/01
PB2022-100361
Notation 64530
Adopted February 14, 2020

Hazardous Materials Incident Report

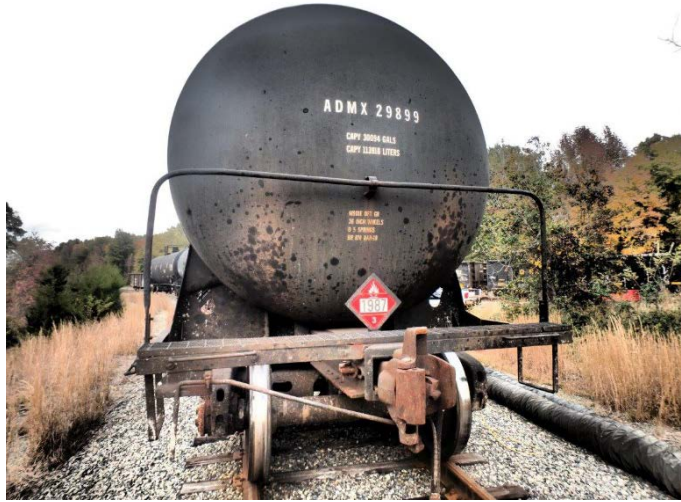
Figure 2. Tank car ADMX 29899 at the incident location.

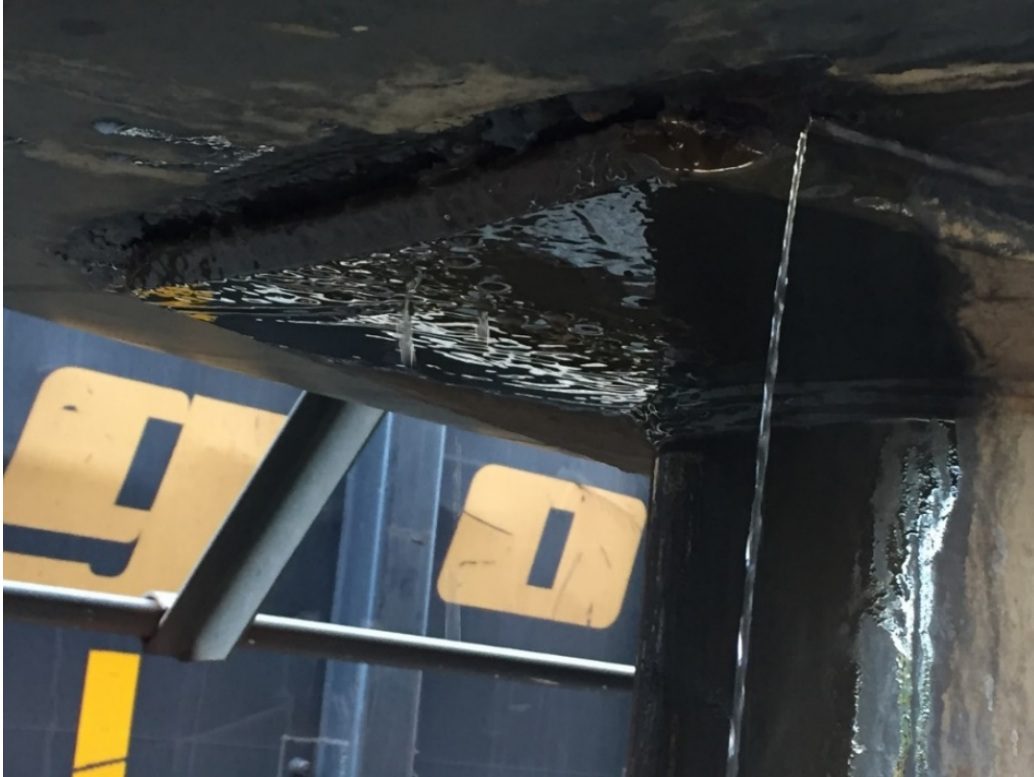
At 3:12 p.m., the Fredericksburg Fire Department dispatched to the incident scene and discovered ethanol leaking at the B-end inboard side of the stub sill cradle pad near the termination of the left side longitudinal cradle pad-to-tank fillet weld.² (See figure 3.) The fire department noted that leaking ethanol was spilling onto ballast on the right of way, but the unseasonably warm weather accelerated its evaporation. By 3:45 p.m., a railroad emergency response contractor arrived on site, collected the leaking ethanol in an open container, and moved the tank car to an adjacent track where the product could be transferred to another tank car. Crews completed the transfer by 3:15 a.m. on November 3.

Figure 3. Ethanol leaking from the cracked tank shell. (Photograph courtesy of CSX.)

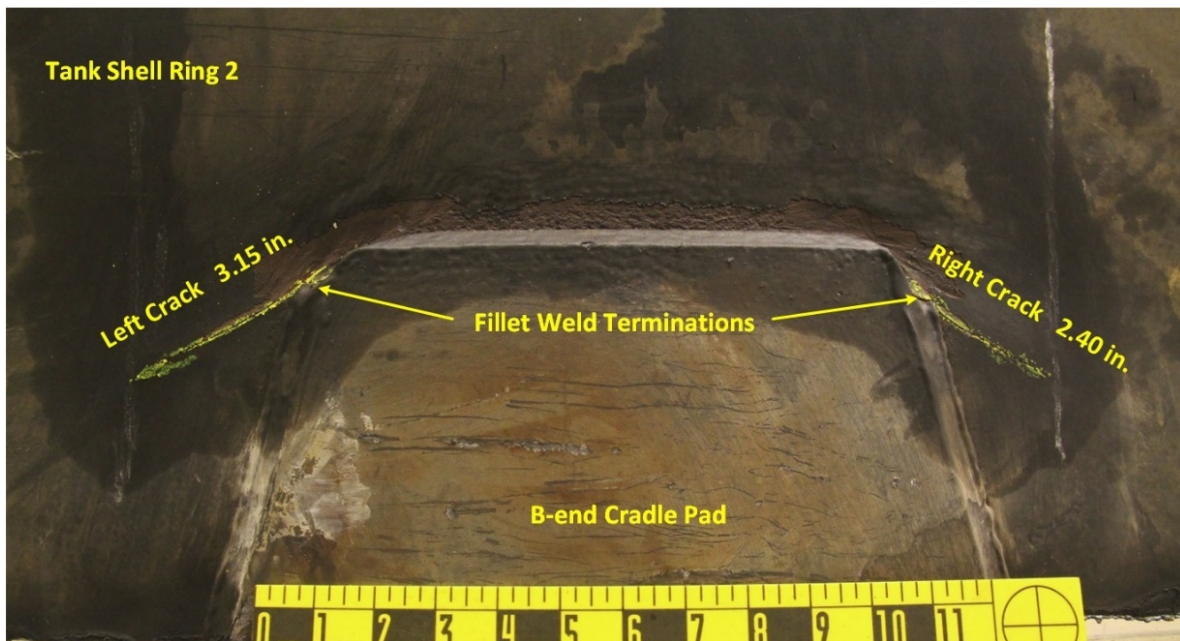
National Transportation Safety Board (NTSB) investigators found two tank shell cracks adjacent to the B-end cradle pad about 45° angles from the end of the inboard cradle pad fillet weld terminations. For the purposes of this report, the cracks were labeled “left” and “right” as shown in figure 6. At the exterior surface of the tank, the left crack was 3.15-inches long and the right crack was 2.40 inches long.

Figure 6. B-end tank car section, including the inboard end of the stub sill cradle pad and two shell cracks. The cracks initiated at the terminations of the longitudinal fillet welds.

Each crack exhibited two primary initiation sites, located at the inboard terminations of the cradle pad fillet welds. The cracks propagated away from the toes of the welds on each side of the cradle pad. Ratchet marks present on both fracture surfaces were consistent with multiple fatigue cracks that coalesced during propagation.¹²

The crack propagation features on both the left and right sides were consistent with a fatigue crack propagating from the outer tank surface, which, after having grown through most of the tank shell cross section, underwent reverse bending, whereby multiple smaller fatigue cracks

initiated on the inner surface and grew outward. The fatigue cracks merged to become shell breaching through-cracks from which the contents of the tank car escaped.

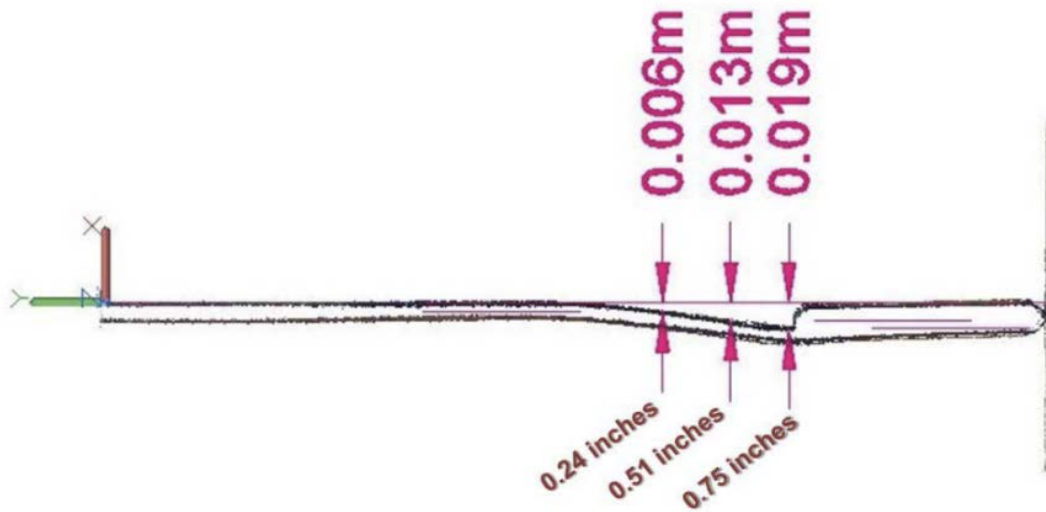
The B-end shell contained an inward buckle inboard of the cradle pad with a maximum depth of 0.75 inches. Figures 7 and 8 show several depth measurements relative to a tank car longitudinal tangent, based on a laser scan of a section from the B-end of the tank car. These figures show the section upside down, with the outer surface of the tank car on the top and the cradle pad on the right.

Figure 7. Plot of NTSB Materials Laboratory laser scan of the tank bottom showing shell buckling depth found at the inboard end of the cradle pad.

The apex of the buckle corresponded with the location of both fatigue cracks. This buckle depth exceeded the maximum allowable depth of 0.5 inches, as published in AAR maintenance advisory MA-0123 (AAR 2010) and AAR *Manual of Standards and Recommended Practices* (MSRP) Section C-III, Appendix R (AAR 2014). The AAR standard requires stub sill tank cars to be home shopped and the owner to be notified when tank shell deformation as large as that found in ADMX 29899 is present.¹³

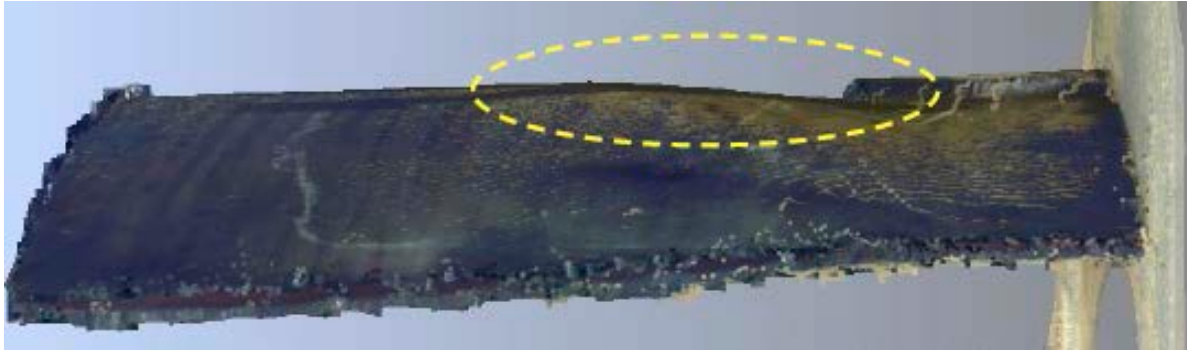
Figure 8. Visual rendering of laser scan data showing tank shell buckling at the inboard end of the cradle pad.

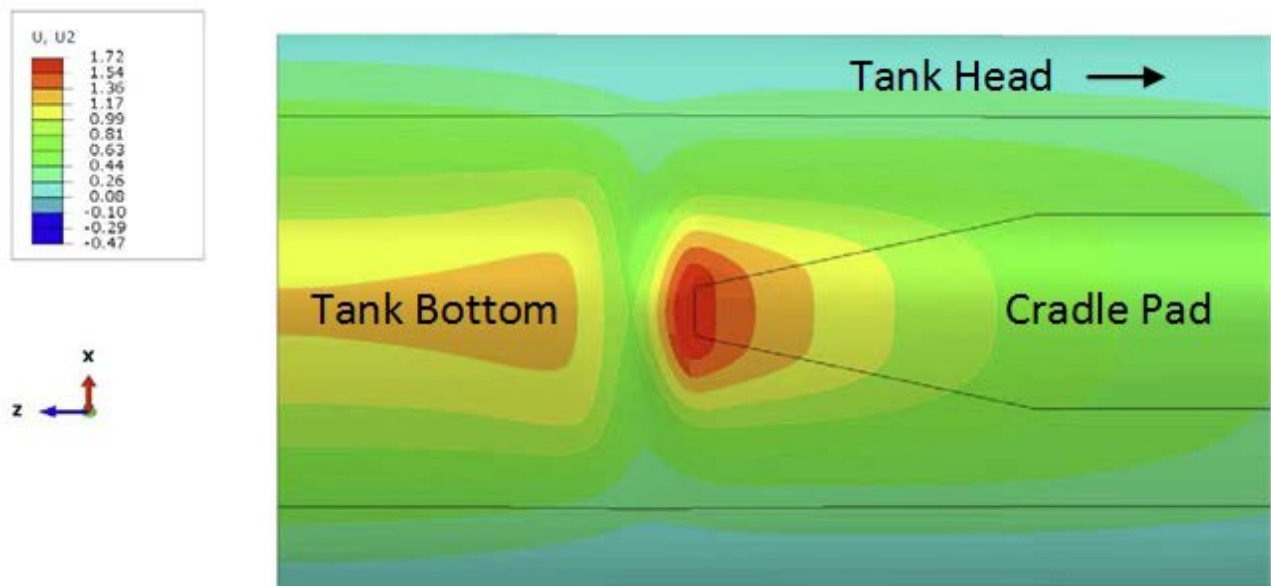
The NTSB modeling showed that the draft gear force needed to create a buckle like that found on the incident tank car was about 3,715 kilopounds (kip). The depth contours of the tank bottom near the buckled region at the inboard end of the cradle pad give similar results to the damage found on the incident tank car. (See figure 9.)¹⁸

Figure 9. Finite element model result showing vertical displacement in inches following a quasi-static draft gear force of 3,715 kips.

The finite element model indicated that a coupler force of 3,715 kips was required to cause the buckle observed in the incident tank car. In the FRA testing, the largest peak forces increased sharply with impact speed, rising from about 500 kips at 7.5 mph to about 1,500 kips at 10 mph (FRA 2019). A linear extrapolation of those data indicates that a force of 3,715 kips would require an impact speed of about 15.5 mph. The largest force measured in the field tests of an instrumented tank car was 1,790 kips, recorded when the instrumented tank car was being coupled into a standing set of cars from a speed of 9 mph (FRA 2016). Although the exact impact conditions cannot be determined, the results from the finite element model compared to the forces measured by the FRA testing show that the impact speed to cause the deformation observed in ADMX 29899 would have exceeded the AAR-recommended hazardous materials tank car coupling speed of 4 mph (AAR 2018). Therefore, the NTSB concludes that the tank shell buckle was likely the result of coupling at a speed higher than the AAR-recommended 4 mph.

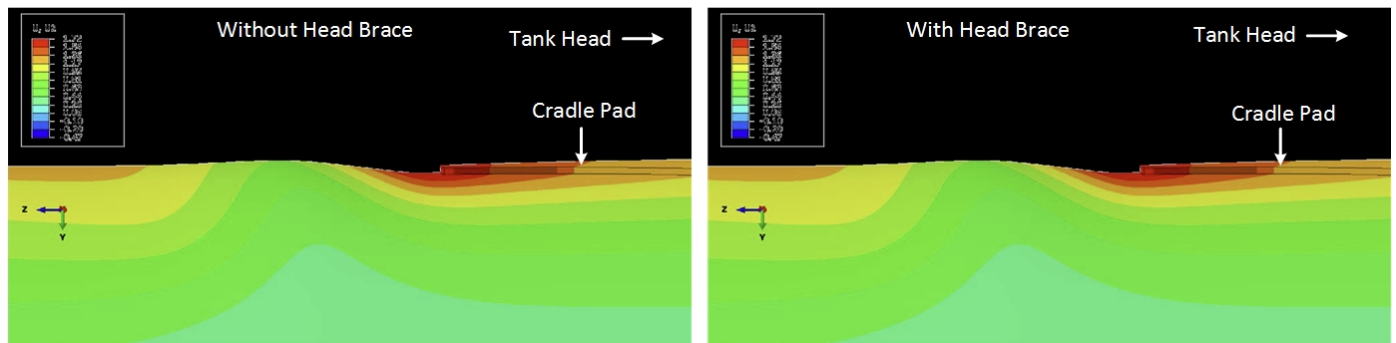
NTSB investigators found that the addition of a head brace, such as the P470 enhancement type, would not have helped to prevent or relieve the formation of a shell buckle inboard of the cradle pad. Figure 10 compares the magnitude of shell buckling modeled on a tank car equipped with and without a head brace, showing nearly identical results. The left image shows the case without a head brace and the right image shows similar output when the tank is equipped with a head brace, such as the P470 enhancement.

Figure 10. Finite element modeling output showing vertical displacement contours (units in inches) of the rotated tank bottom near the buckled region.

To further explain this modeling result, the NTSB simulated an additional case in which the head brace material was artificially made 10 times stiffer. The vertical displacement contours for this case resulted in a buckle of similar size to the original case. Therefore, the NTSB concludes that the decision to not install the P470 head brace enhancement on tank car ADMX 29899 did not affect the formation of a shell buckle in the region where the tank shell cracks occurred.
