# National Transportation Safety Board

## Marine Accident Brief

### Fire aboard Vehicle Carrier *Courage*

<b>Accident no.</b>	DCA15RM024
<b>Vessel name</b>	<i>Courage</i>
<b>Accident type</b>	Fire
<b>Location</b>	North Sea in the approaches to the English Channel, about 57 miles* east-northeast of Harwich, United Kingdom, 52°04.8' N, 002°48.0' E
<b>Date</b>	June 2, 2015
<b>Time</b>	2215 British summer time (coordinated universal time + 1)
<b>Injuries</b>	None
<b>Damage</b>	\$10 million in vessel damage, \$90 million in cargo loss
<b>Environmental damage</b>	None
<b>Weather</b>	Visibility unrestricted at night, winds 34–40 knots, seas 24 feet
<b>Waterway information</b>	The English Channel and its approaches from the east and west are some of the busiest waterways in the world, providing access to Europe's largest ports; there was significant vessel traffic on the night of the accident.

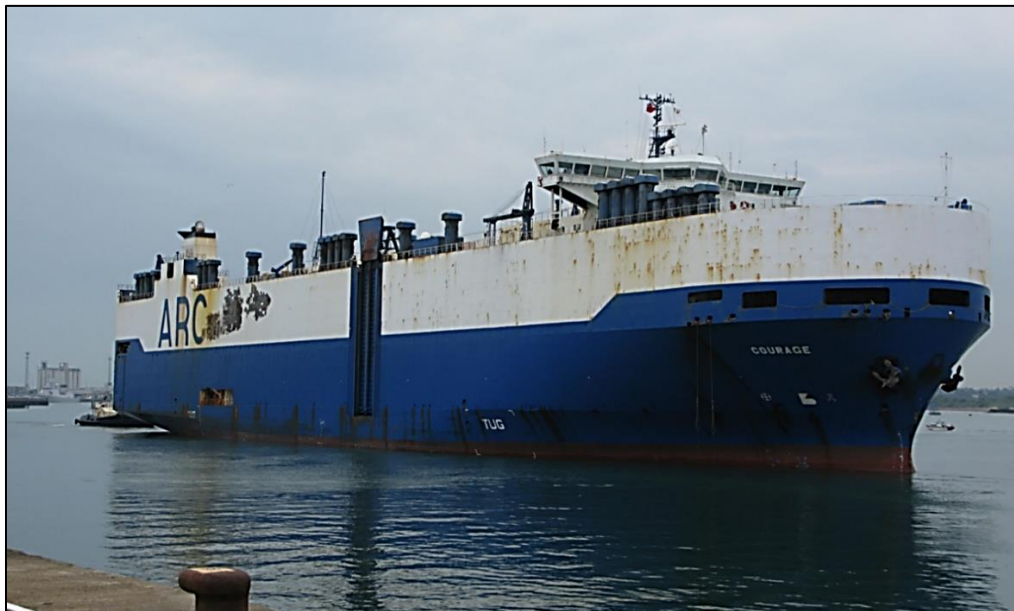
***Courage* just after the accident, with scorch marks on the starboard aft side as a result of the fire. (Photo by US Coast Guard)**

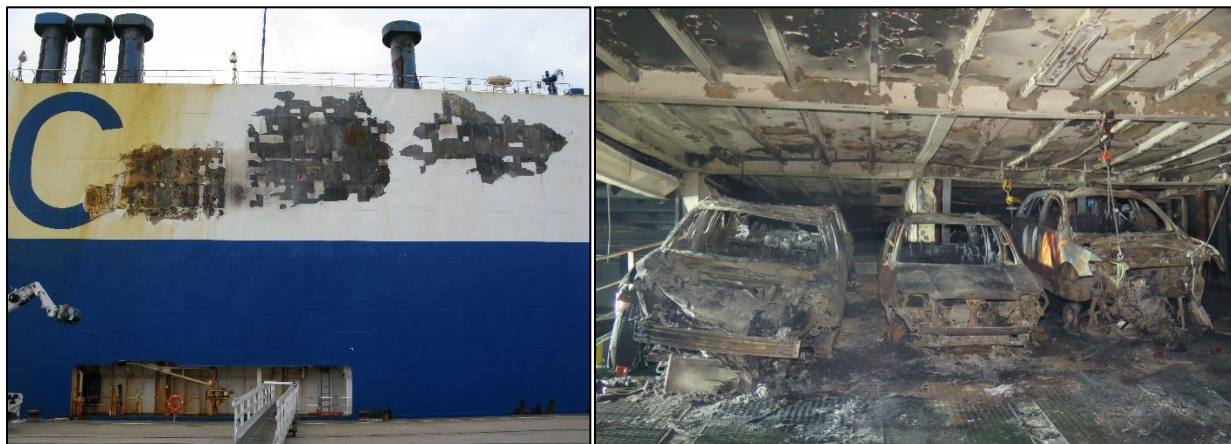
Fire investigators hired by the vessel owner and working with the US Coast Guard examined the affected spaces and identified the likely origin to be a ramp on the starboard side, aft, from Deck 8 to Deck 10 (the moveable Deck 9 was almost completely pressed up to the bottom of Deck 10). Vehicles on this ramp were completely destroyed by fire, and there was substantial damage to the ramps from Deck 10 to Deck 11 and from Deck 11 to Deck 12 that were immediately above this area.

Left photo shows exterior damage to *Courage* starboard side in the vicinity of the fire. Right photo shows damaged ramp and destroyed vehicles near the origin of the fire. (Photos by Coast Guard)

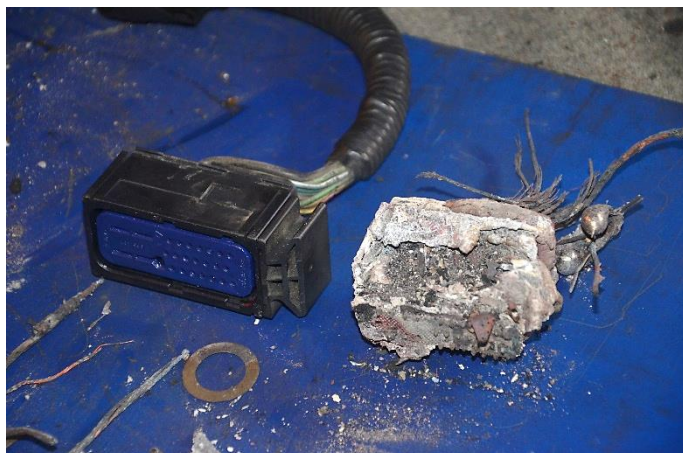
ABS module from 2002 Ford Escape, where the fire likely started on board *Courage*, pictured next to a sample undamaged module. (Photo courtesy of Minton, Treharne & Davies Ltd.)

Fire investigators recovered the ABS module for the Ford Escape along with other evidence from the vehicles on the ramp where the fire was believed to have started. A joint forensic examination of this evidence was conducted in Bremerhaven in January 2016. Visual examination of the module was inconclusive and additional tests were planned.

In March 2017, the ABS module was examined using CT scans during testing conducted at Southampton University in the UK. CT scan images

provided to NTSB fire investigators clearly showed that the two end connectors (a positive and a negative) of the ABS module had significant localized arcing damage, while other wiring in the module was relatively undamaged. The amount of localized arcing damage was consistent with electrical arcing/shorting in this area and not external exposure to a fire. Thus, fire investigators concluded that the ABS module was the likely source of the fire.

The National Transportation Safety Board determines that the probable cause of the fire on the vehicle carrier *Courage* was electrical arcing in the automatic braking system (ABS) module of a vehicle carried on board.
