National Transportation Safety Board

Marine Accident Brief

Fire aboard Cargo Ship *Chipolbrok Moon*

Accident type	Fire/Explosion	No. DCA18FM025
Vessel name	<i>Chipolbrok Moon</i>	
Location	Industrial Terminal West, Greens Bayou, Port of Houston, Texas 29°44.94'N; 95°10.07'W	
Date	May 23, 2018	
Time	0010 central daylight time (coordinated universal time – 5 hours)	
Injuries	None	
Property damage	\$12 million est.	
Environmental damage	None	
Weather	Partly cloudy, light east winds, air temperature 73°F	
Waterway information	Greens Bayou is located at about mile 43 on the north side of the Houston Ship Channel, which extends from Galveston across Galveston Bay to the city of Houston.

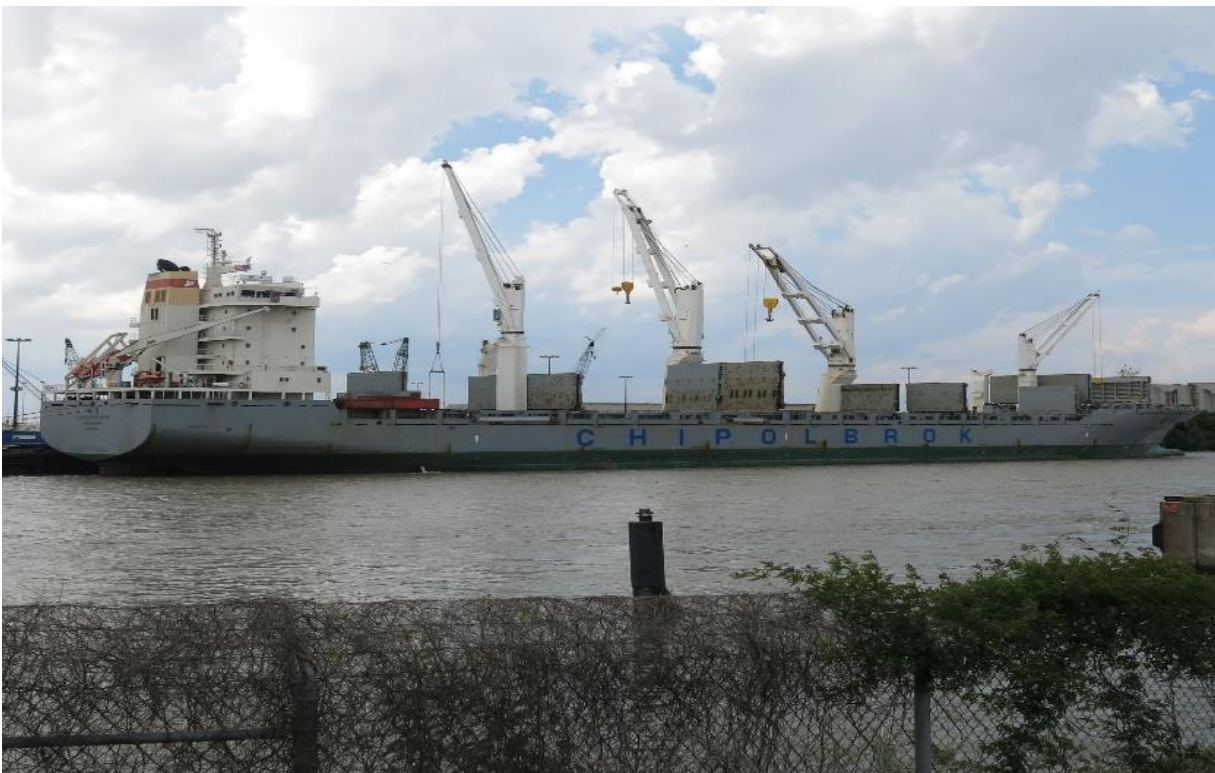
Cargo vessel *Chipolbrok Moon* docked in Houston after the accident.
