# National Transportation Safety Board

## Marine Accident Brief

### Barge Breakaway and Contact with the Emsworth Locks and Dams

<b>Accident type</b>	Contact	No. DCA18PM011
<b>Vessel names</b>	<i>Dashields, Emsworth, and 27 barges</i>	
<b>Location</b>	Ohio River, mile 6.2, <sup>1</sup> Emsworth, Pennsylvania 40° 30.18' N, 080° 5.35' W	
<b>Date</b>	January 13, 2018	
<b>Time</b>	0630 eastern standard time (coordinated universal time – 5 hours)	
<b>Injuries</b>	None	
<b>Property damage</b>	\$12.5 million, including salvage, repairs, and lost vessels	
<b>Environmental damage</b>	Unknown amount of coal and cement released into the Ohio River	
<b>Weather</b>	Overcast with light snow, visibility 2 miles, winds 14 mph from the north, air temperature 15°F, water temperature 32°F	
<b>Waterway information</b>	The Ohio River extends 980 miles from the confluence of the Monongahela and Allegheny rivers at Pittsburgh, Pennsylvania, to Cairo, Illinois, where it flows into the Mississippi River. On the day of the accident, the river gage height at the Emsworth Dam Lower Pool was 27.04 feet, about 4 feet above flood watch activation. The current was estimated at 5–8 mph.

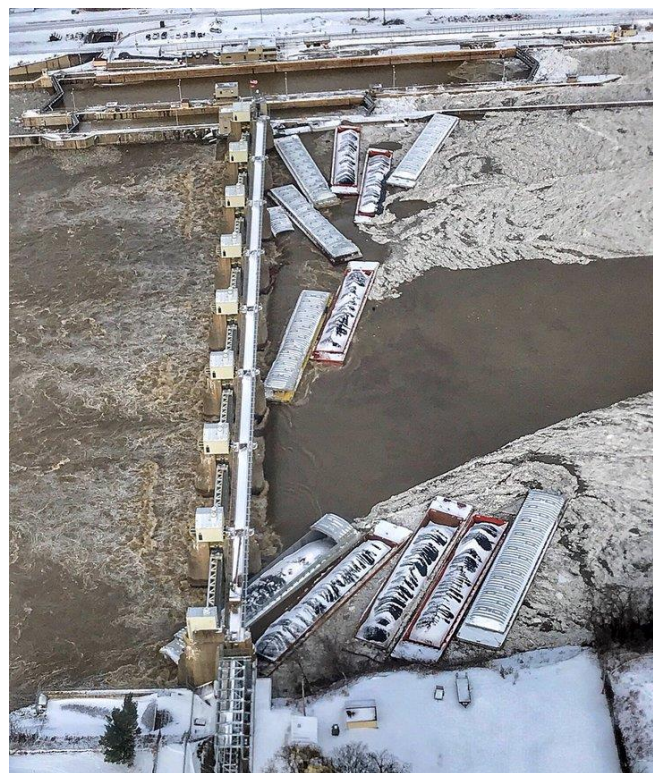
**Aerial photo of Emsworth Locks and Dam with breakaway barges (Photo by US Coast Guard)**

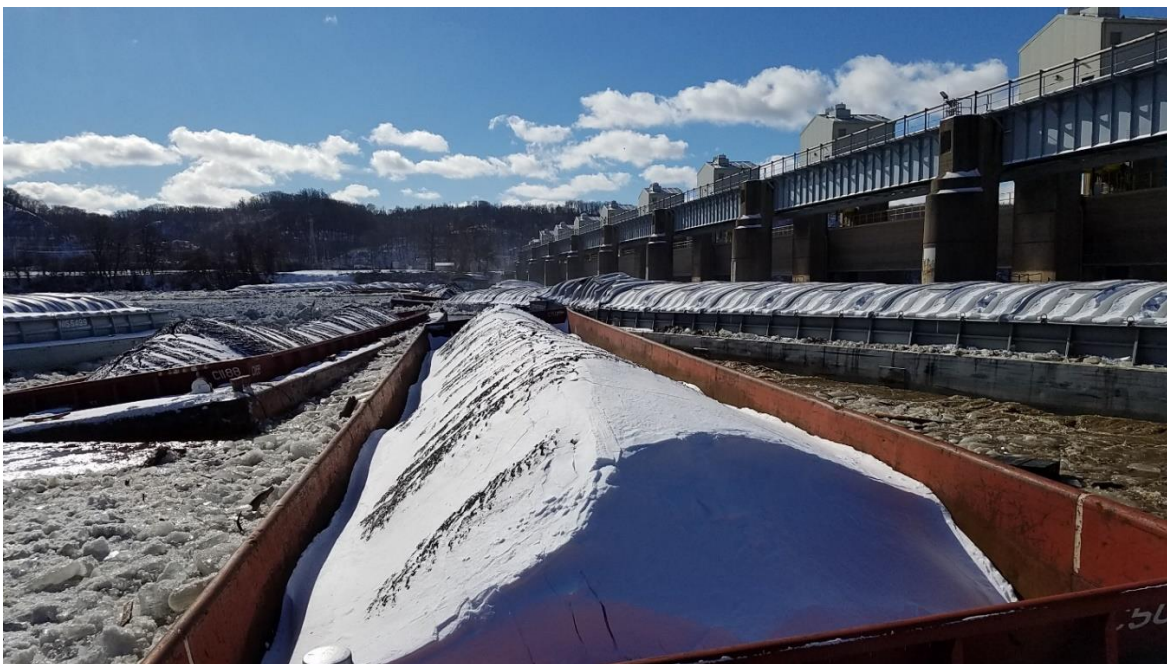
The 25 remaining barges drifted down the Ohio River, and, at 0712, the first of the barges struck the dam located north of Neville Island. Seven barges passed through the dam's open lift gates, two barges sank above the dam, and the rest of the barges lodged in various locations along the dam structure, riverbank, and the area surrounding the dam. One barge floated down the back channel on the south side of Neville Island, hit the dam, and then sank above the dam.

Hopper barges after striking the main channel dam. (Photo by Coast Guard)

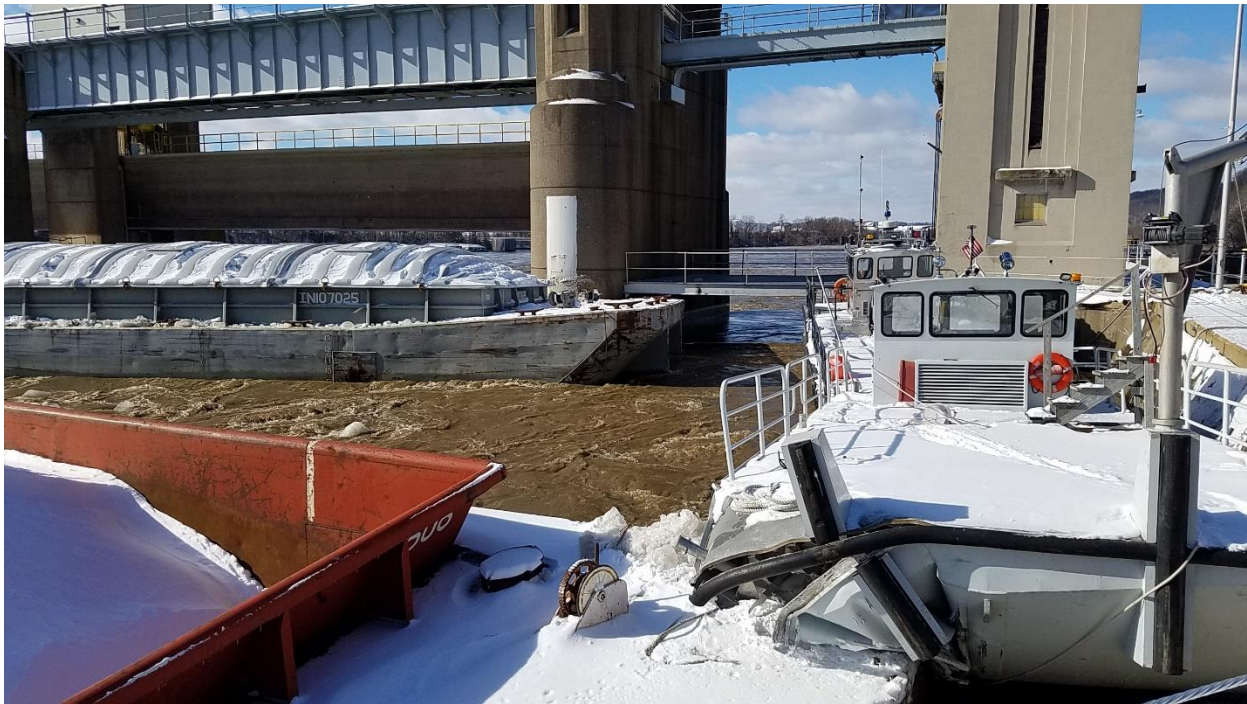
The accident resulted in the constructive total loss of both Corps of Engineers vessels, valued at \$690,404 combined. Seven barges were also lost, and all but one of the remaining barges required repairs. Damage to the barges, including lost cargo, totaled \$7.10 million. Salvage and other additional costs totaled \$3.99 million. According to the Corps of Engineers, the accident did not cause structural damage to the Emsworth Dams.

**Stern of barge C508 after colliding with Corps of Engineers workboats *Emsworth* (foreground) and *Dashields* (background). (Photo by Coast Guard)**

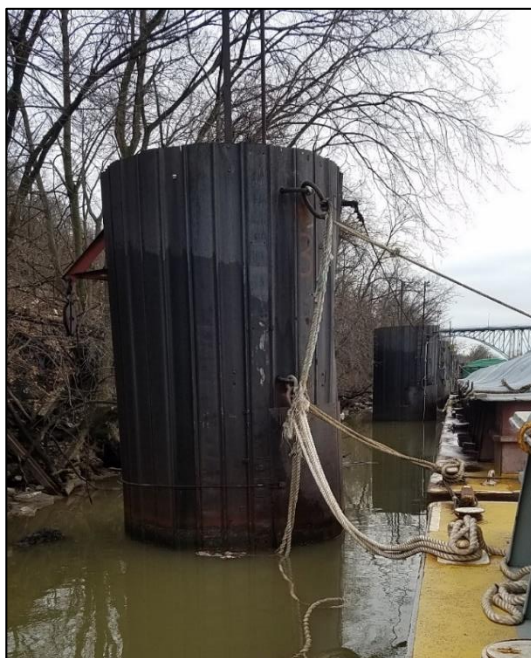
**Mooring cell at the Jacks Run fleeting area. (Photo by Coast Guard)**

fleeting, the shifting in and out, and the maintenance of the facility. I rarely go to the facility. I haven't been there for months.” The captains of the *James Garrett* and the *Cori Weiland* were asked if the crews had a process for inspecting the D-rings that were mounted to the mooring cells. They stated that they looked to see if there was visual damage, but no formal inspections were done by the operators. One of the captains then stated that, “there are cells down there that we don't use because of the conditions of the cell. We know to stay away from them.”

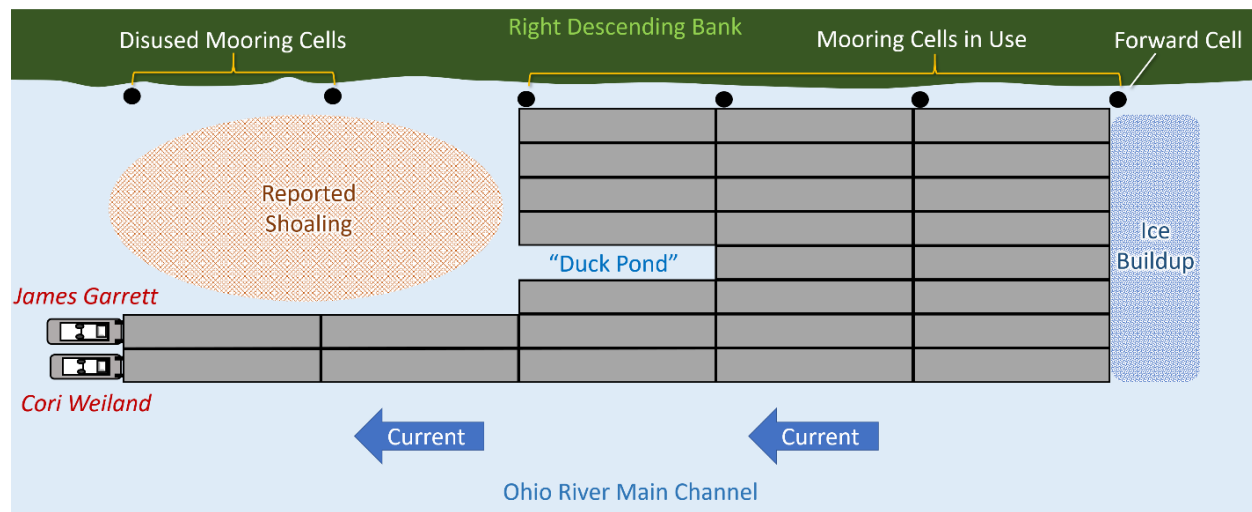
The barges moored at the Jacks Run fleeting area on the day of the accident were aligned in five rows, with the first two rows consisting of eight barges moored together side-by-side. The third row contained seven barges, with four barges on the shore side and three barges on the river side, with a gap, sometimes called a “duck pond,” in between the two groups of barges. The last two rows each had two barges moored behind the two riverside barges of the preceding row. The flotilla of barges was moored along the riverbank to four of the steel-pile mooring cells. The remaining mooring cells were unused due to the poor condition of the cells and because of the shoaling in the vicinity of the cells.

**Barge mooring arrangement at Jacks Run fleeting area prior to the breakaway. (Barges, towing vessels, and mooring cells drawn approximately to scale; other elements not to scale)**

The captains of the *Cori Weiland* and the *James Garrett* told investigators that they had tried to close the duck pond in the third row of the flotilla but were prevented from doing so by ice

that had built up between the barges and in the duck pond area. Furthermore, they could not narrow the fleet due to the shoaling from Jack's Run Creek. The captains stated that they were familiar with the fleeing guide; however, the guide included only general procedures for highwater conditions.

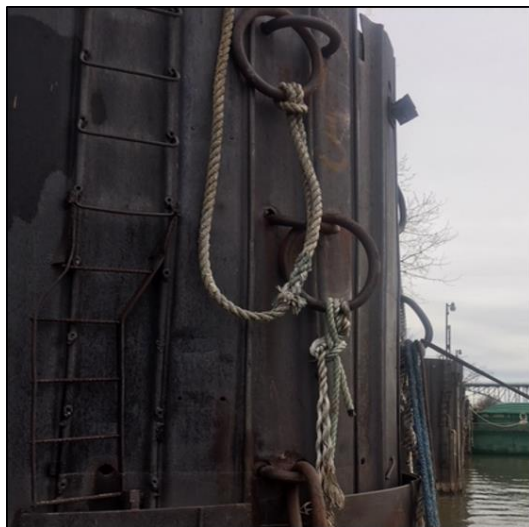
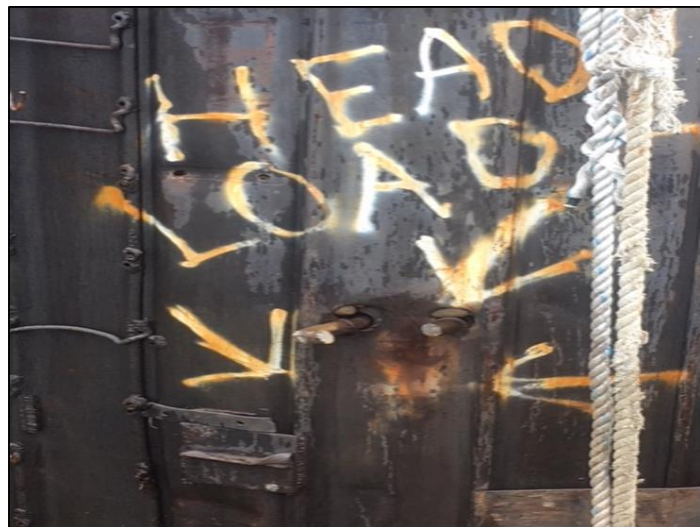
During a postaccident examination of the fleeting area, investigators found that a steel ring on the upstream mooring piling that had held the headlines for the barge flotilla had broken away from the piling at its anchor point. A steel mooring ring on the third piling downstream from the head piling had deformed into an oblong shape. Lengths of parted and frayed steel cables and lines were still attached to several of the mooring points.

**At left, a piling with mooring rings as designed. At right, the forward piling with a broken mooring ring anchor point and missing ring.**

Just prior to the breakaway of the barges, the Ohio River was swelled by heavy rain causing the current to increase significantly over a short period of time. The rising water and increasing current, along with floating ice that had been building up at the head of the barge flotilla, significantly strained the barge moorings. When the barges broke free, the captain of the towing vessel *Cori Weiland* reported seeing sparks in the vicinity of the forward mooring cell. After the accident, investigators found that the mooring ring on the cell was missing, and the mooring ring anchor point was broken. A mooring ring on another cell was significantly misshapen. Broken mooring lines and cables were also found attached to the mooring cells. The NTSB concludes that the breakaway of the barges at Jacks Run fleeting area occurred when the force of the river current acting on the extensive ice buildup at the front of the barge flotilla exceeded the capacity of the fleeting area's mooring cell fittings and the barge mooring wires.

2. Poor maintenance of the mooring cells and shoaling in the fleeting area prevented the towing vessel crews from establishing a suitable mooring arrangement for the barge fleet, which resulted in a failure of the moorings during highwater and ice conditions.

Develop a regulated navigation area for the Pittsburgh region that would ensure the integrity of fleeting areas and include detailed requirements for barge moorings during highwater and ice conditions. (M-19-7)

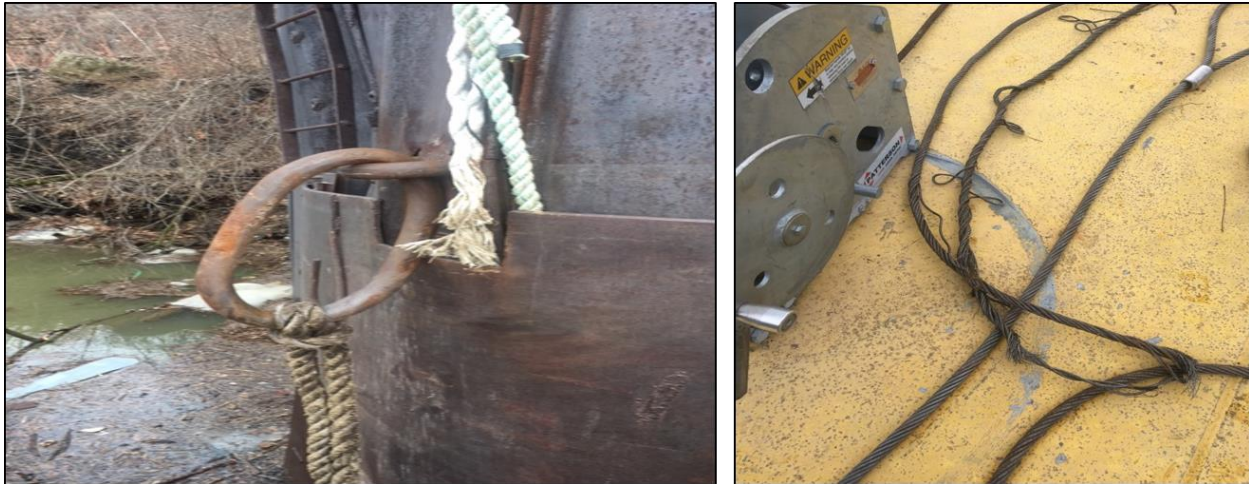
**At left, a deformed anchor ring on third piling back from the forward piling. At right, parted and frayed mooring wires from the lead shore-side barge during the accident.**

1. The breakaway of the barges at Jacks Run fleeting area occurred when the force of the river current acting on the extensive ice buildup at the front of the barge flotilla exceeded the capacity of the fleeting area's mooring cell fittings and the barge mooring wires.
