National Transportation Safety Board

Marine Accident Brief

Contact of Towing Vessel *Edna T. Gattle* and Tow with Union Pacific Railway Bridge

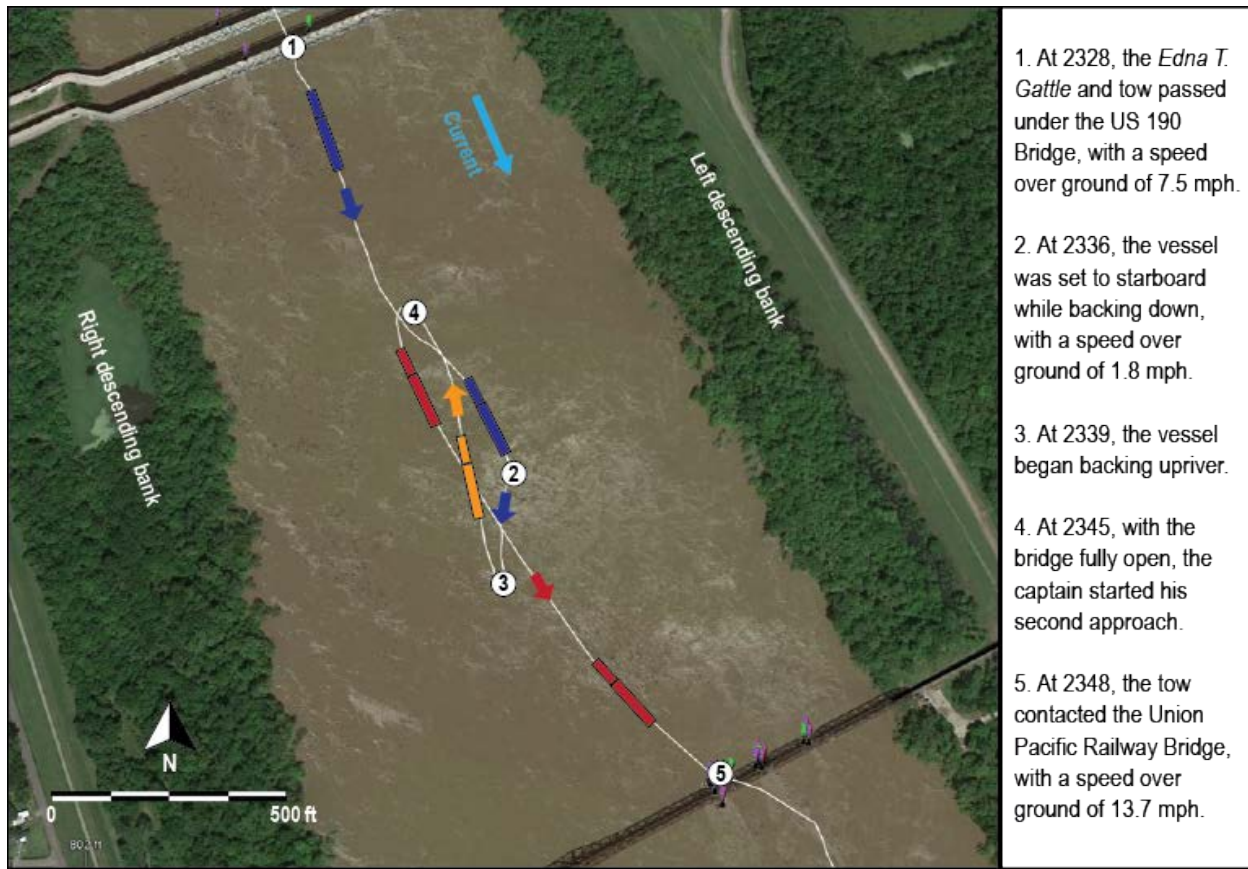
The *Edna T. Gattle's* approach to the Union Pacific Railway Bridge. The track is shown as a white line. (Data source: US Coast Guard Navigation Center; background source: Google Earth Pro)

At 2337, the bridge opened, and the captain was given permission to proceed. As he continued backing down, the captain attempted to move to port (toward the left descending bank) using flanking rudders but stated that he was unsuccessful because of the current.³ The vessel began moving astern about 2339, and the captain continued to back up the river (against the current). By the time the captain began his second approach, the vessel and tow were about 150 feet to starboard (closer to the right descending bank) of the vessel's original approach and were not lined up on the opening of the swing bridge, so the captain made an approach on the bridge at a much steeper angle, beginning at 2345.

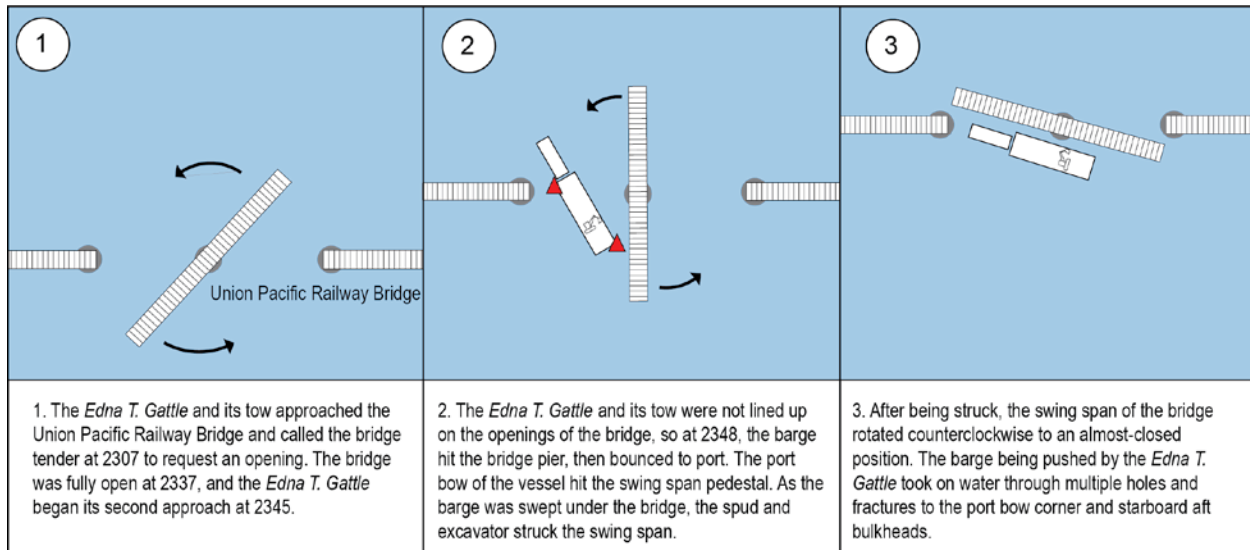
At 2348, the starboard quarter of the barge hit the bridge pier, then bounced to port. The port bow of the *Edna T. Gattle* hit the swing span pedestal. As the barge was swept under the bridge, the spud and excavator struck the swing span. The tow, propelled by current, forward

momentum, and a large eddy on the downriver side of the pedestal, forced the bridge to move in a counterclockwise motion, almost back to its closed position.

Depiction of the *Edna T. Gattle* and tow as the vessel approached and struck the Union Pacific Railway Bridge, forcing the bridge to swing counterclockwise to an almost-closed position.

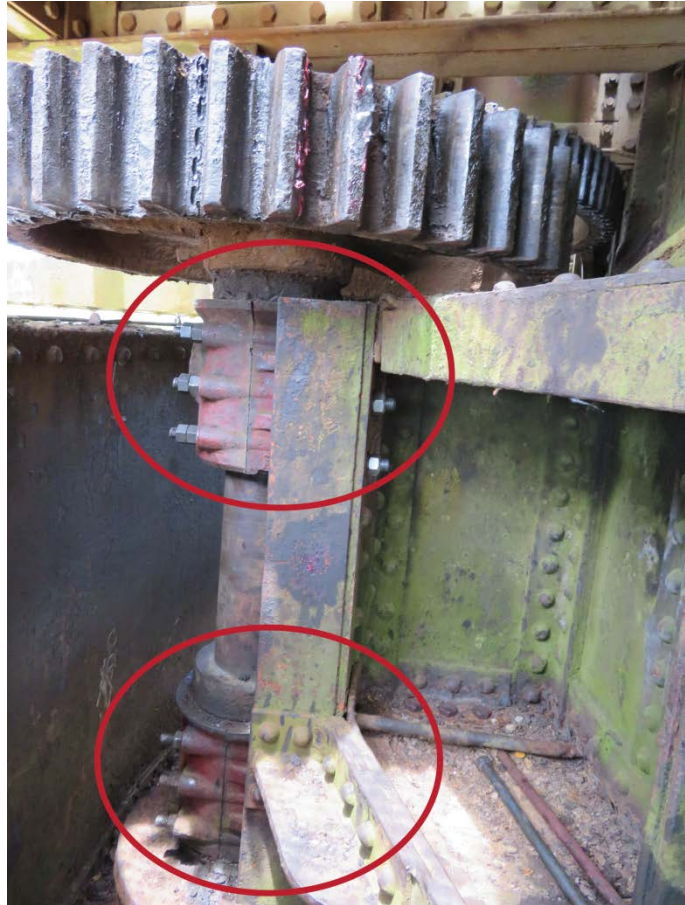
When the barge hit the bridge pier, bolts on the western gear were sheared off, and the eastern gear was displaced. A locking mechanism was also damaged, preventing the bridge from closing. Trains were diverted north to Alexandria, Louisiana. Temporary bridge repairs were completed by April 27, allowing trains to pass at a reduced speed.

A repaired gear within the pedestal. The new bolts are shown in the red circles.
