National Transportation Safety Board

Marine Accident Brief

Collision between *Cooperative Spirit* Tow and *RC Creppel* Tow

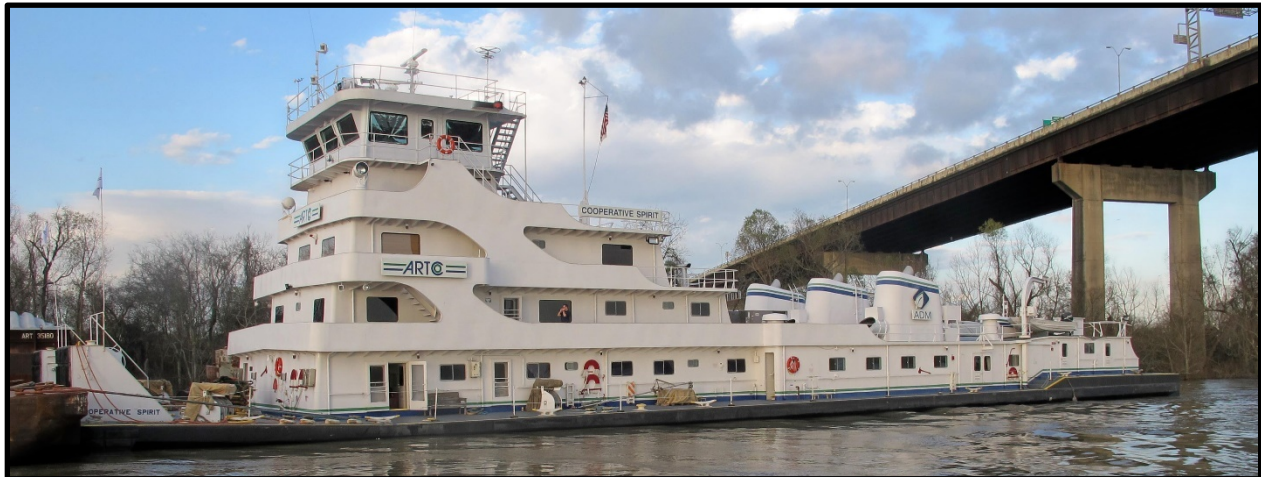
Cooperative Spirit moored after the accident.

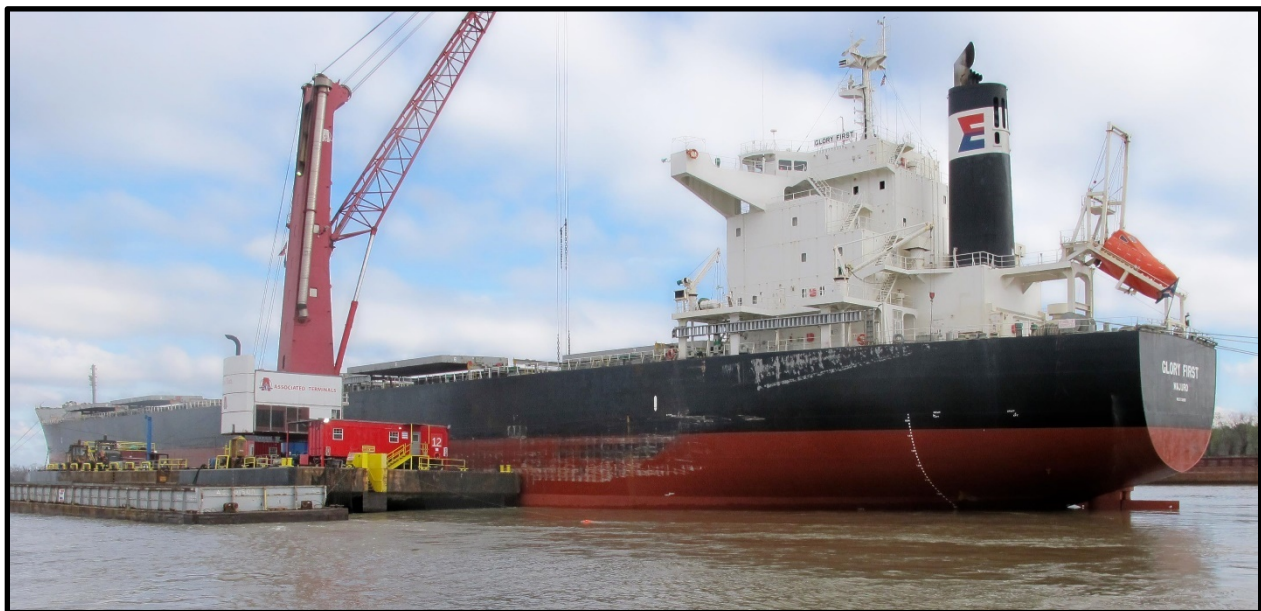
Glory First anchored after the accident.

The *Glory First* sustained external hull damages on its portside outer shell plating with indentations and a set-in (a deformation of steel plate[s]) located near the bow (cargo hold no. 1) and farther aft around cargo hold no. 7.

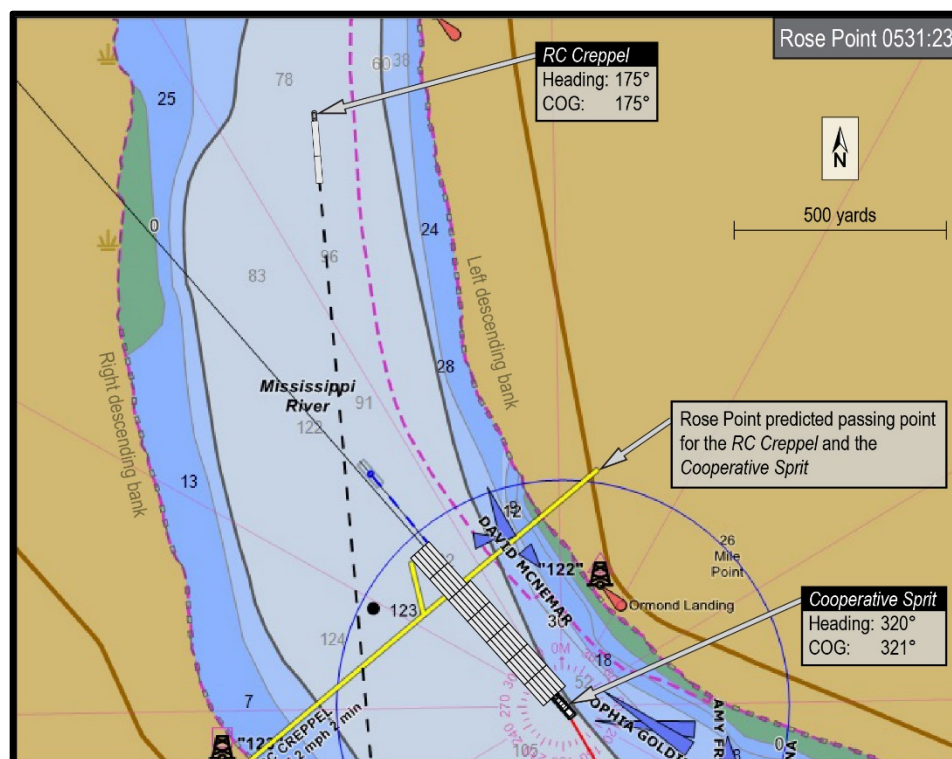
At 0531:23, even as the pilot used right rudder angles of 15-20° to round the point, the *Cooperative Spirit*'s course over ground began to move to port toward the right descending bank at a speed of 4.6 mph, away from its course of 320°. At that time, the *Cooperative Spirit*'s lead barges were about 810 yards (about 0.5 miles) from the *RC Creppel*'s lead barge. The rate-of-turn indicator continued to show a rate of turn to port.

Screenshot of *Cooperative Spirit* Rose Point at 0531:23 when the vessel's course and heading began to swing toward the right descending bank (with *Cooperative Spirit* tow and *RC Creppel* tow icons added to show overall tow dimensions to approximate scale). (Source: ARTCO, annotated by NTSB)

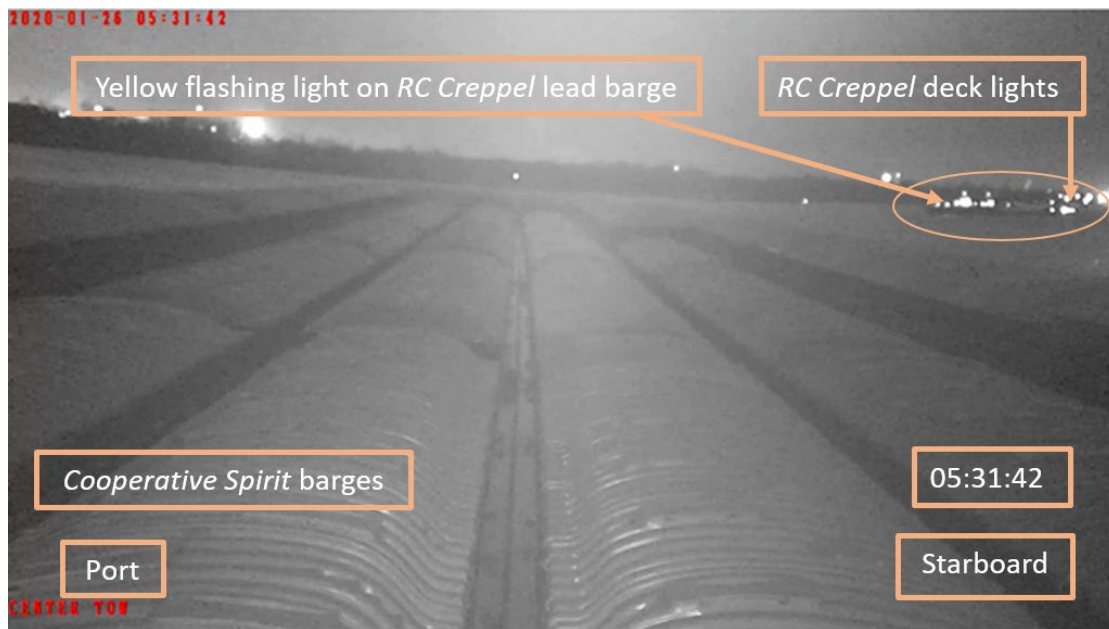
Screenshot from *Cooperative Spirit* center camera looking northwest at 0531:42. Image shows the *RC Creppel* navigation and deck lights against lighting in the background from vessels in the vicinity of Hahnville Landing. (Source: ARTCO annotated by NTSB)

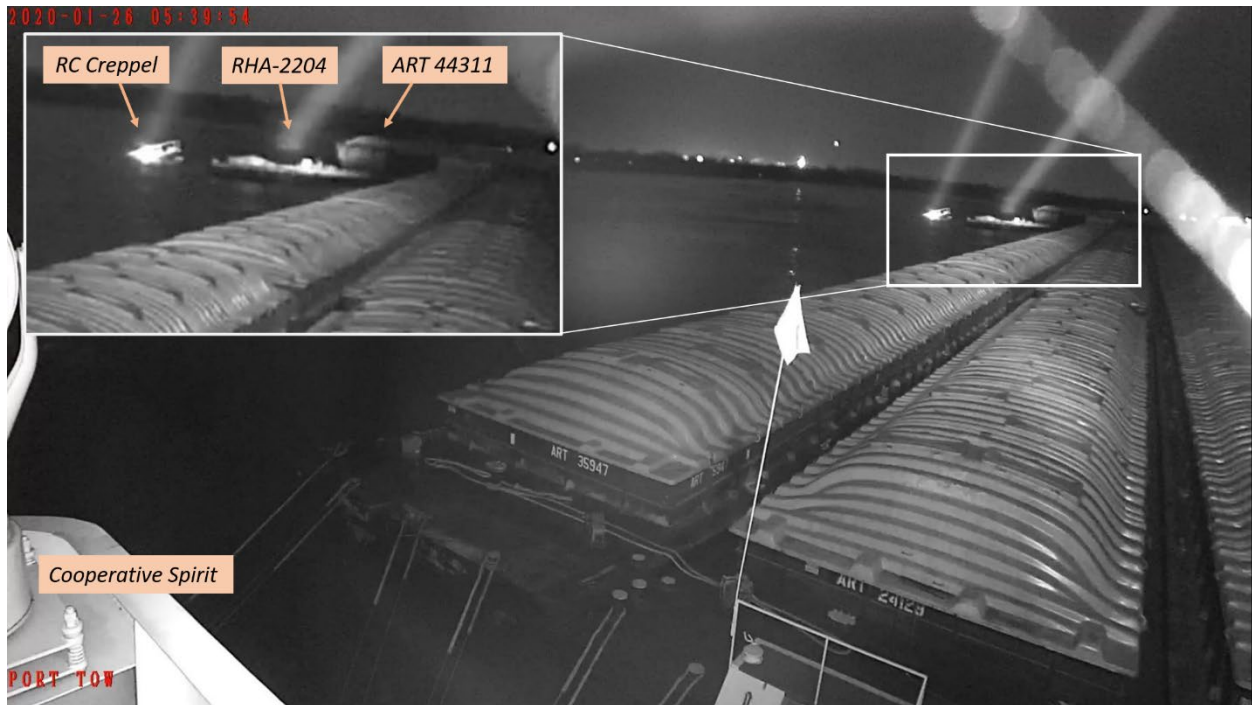
Cooperative Spirit port camera screenshot of the mostly submerged *RC Creppel* and barge *ART 44311* on top of barge *RHA-2204* at 0539:54. (Source: ARTCO, annotated by NTSB)

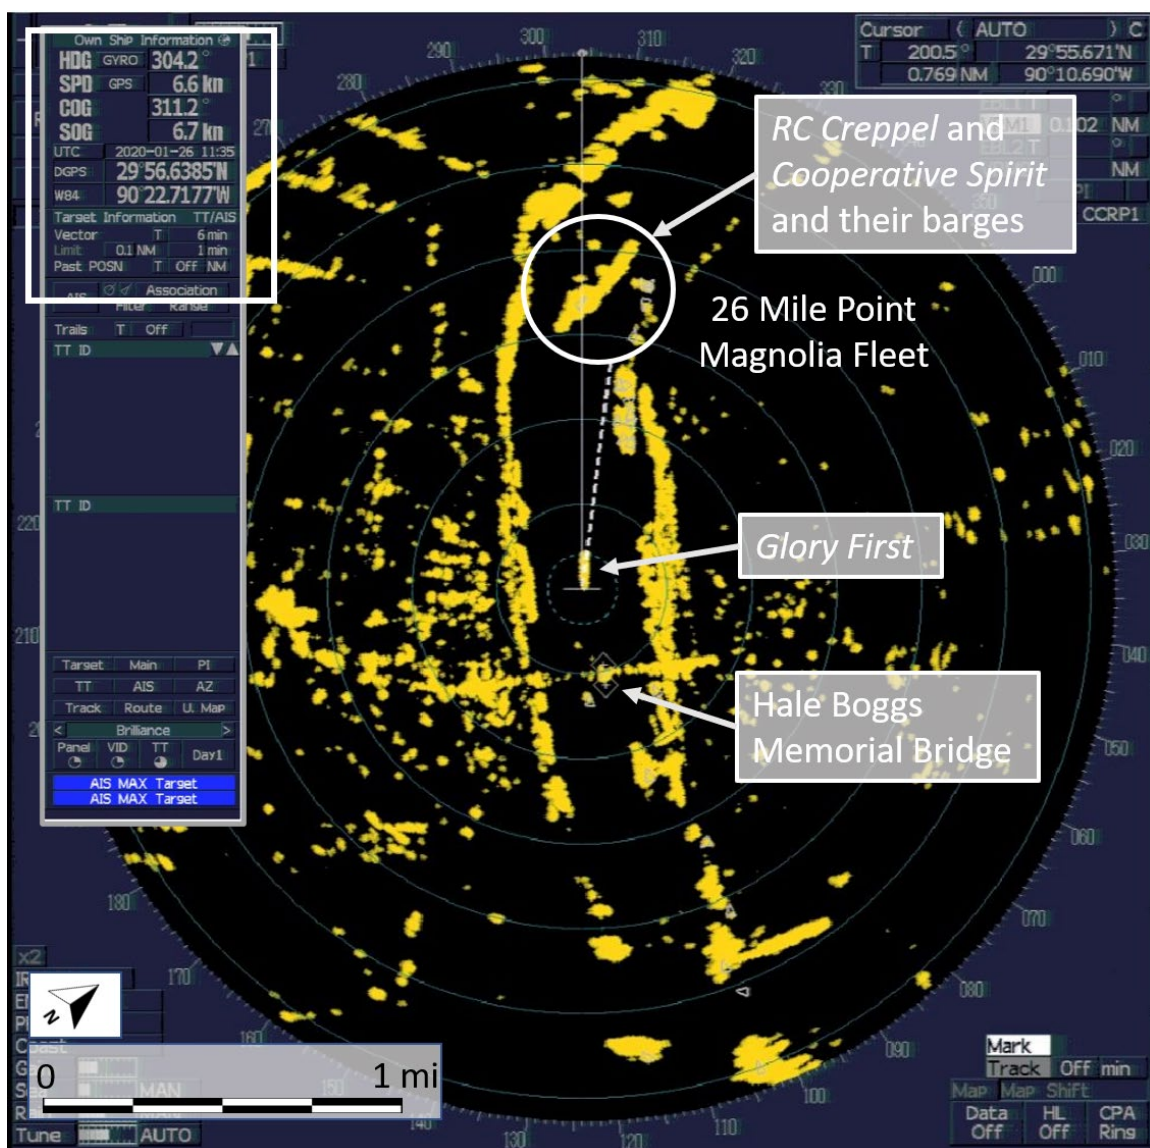
The *Glory First*'s radar showed the *RC Creppel*, *Cooperative Spirit*, and their barges as one entity about a 45° angle within the bend, blocking the river with the ends equidistant from the riverbanks. The NOBRA pilot stated that his first thought was to stop the *Glory First*, but he decided not to because the vessel would lose steerage as it slowed, and there was a potential for collision with the many boats and hazardous cargo barges in the Magnolia fleeting area below and along the left bank at 26 Mile Point. He stated that he considered maneuvering the *Glory First* into the mud along the left descending bank but did not because he assessed that there was not enough room. He reported back to the *Cooperative Spirit* pilot that he was going to slow down as much as he could. At 0537, the *Glory First* was 1,000 yards (about 0.6 miles) from the breakaway barges and traveling at 6.3 knots (7.2 mph). The radar showed that the distance from the *RC Creppel* and *Cooperative Spirit* tows to the right descending bank was decreasing, and by 0538:31, there was no space between the tows and the right descending bank.

Glory First radar at 0537:07, when the pilot called the *Cooperative Spirit*. (Source: *Glory First*, annotated by NTSB)
