Collision between Liquefied Gas Carrier
Genesis River and *Voyager* Tow
Houston Ship Channel, Upper Galveston Bay, Texas
May 10, 2019

Marine Accident Report

NTSB/MAR-21/01
PB2021-100912

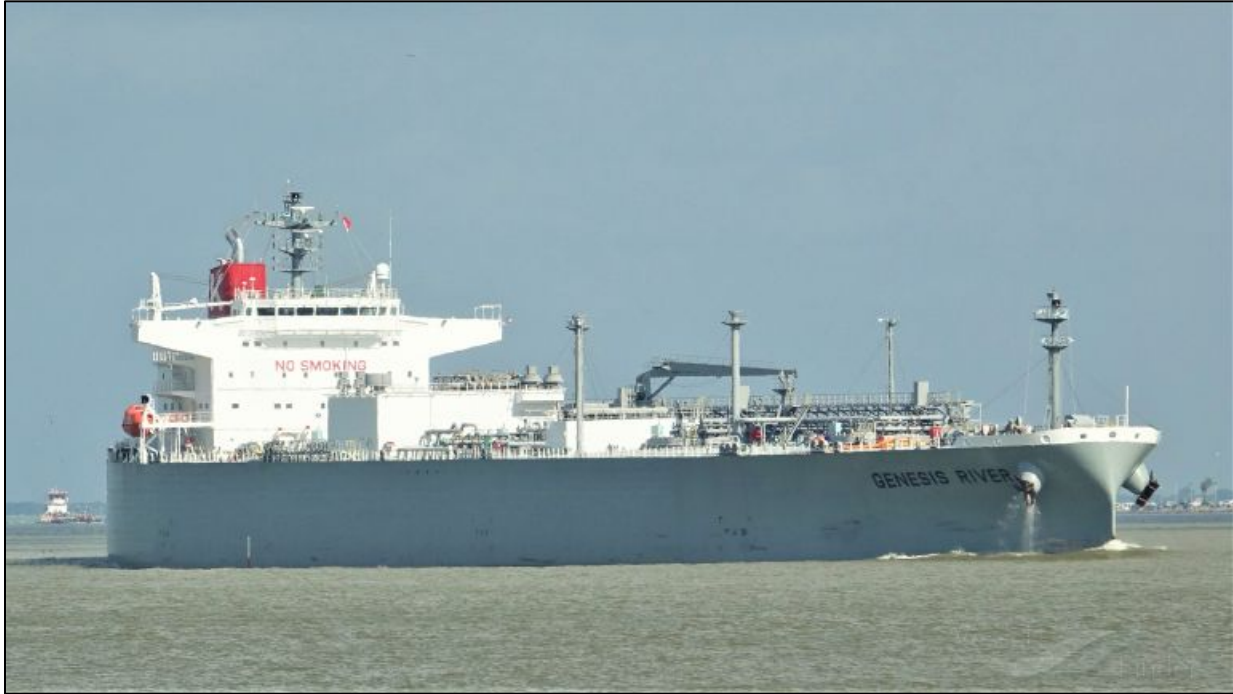
Figure 1. *Genesis River* under way in Bolivar Roads near Galveston, Texas, two weeks after the accident. (Source: William J. Leach, Jr., VesselFinder.com)

The Coast Guard study also notes that trim by the bow decreases path stability, and the study found that the *Genesis River* may have trimmed as much as 7.4 feet by the bow. Note the photograph of the *Genesis River* in [figure 1](#), which was taken as the vessel was outbound in the Houston Ship Channel with the same cargo load after it was released by the Coast Guard following the accident. The image shows the vessel down by the head as it transits the channel. Squat and trim vary by the square of the ship's speed, and thus small changes in speed can have significant

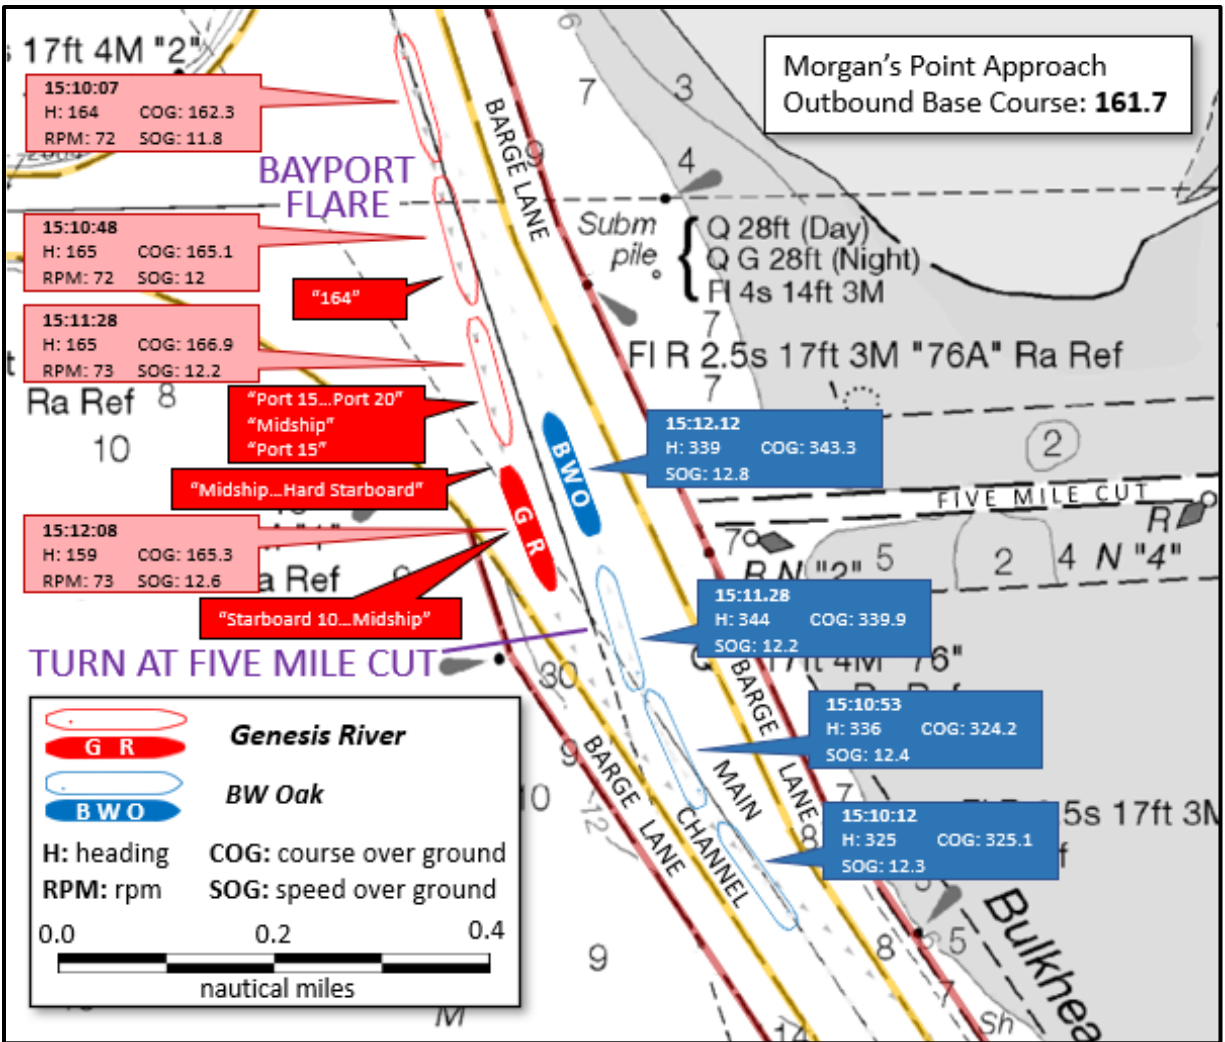
Figure 5. Pilot 2 helm orders as *Genesis River* and *BW Oak* passed in Bayport Flare. Positions based on automatic identification system (AIS) reporting data from each ship. (Background source: NOAA chart 11327)

At 1511:32, when the bows of the *Genesis River* and *BW Oak* were about 0.11 miles apart, Pilot 2 on the *Genesis River* ordered port 15 degrees rudder and then, shortly thereafter, port 20 degrees rudder. Four seconds later, he ordered the rudder to midship. The ship's heading was 164 degrees when he issued the midship order.

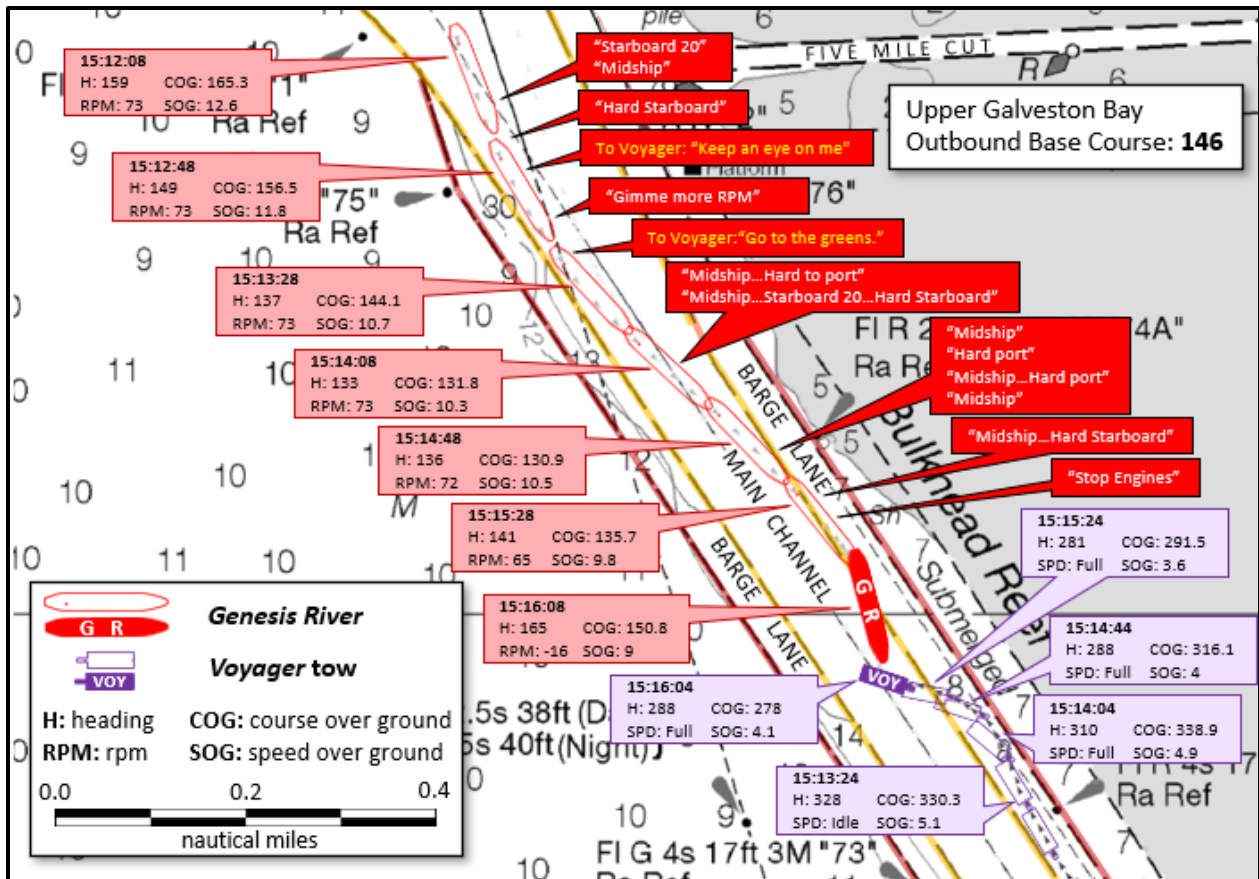
The Collision. At 1512:25, as the ship's heading continued shifting to port and passed 155 degrees, Pilot 2 ordered starboard 20 degrees rudder to stop the swing of the ship. The rudder moved to 20 degrees starboard until the pilot ordered the rudder back to midship at 1512:32 (see figure 6). Five seconds later, as the ship's heading passed 151 degrees, Pilot 2 ordered hard starboard rudder. The rudder moved to starboard, reaching 35 degrees at 1512:45, with the ship's heading passing 149 degrees.

Figure 6. Pilot 2 orders and communications before the collision. (Background source: NOAA chart 11327)

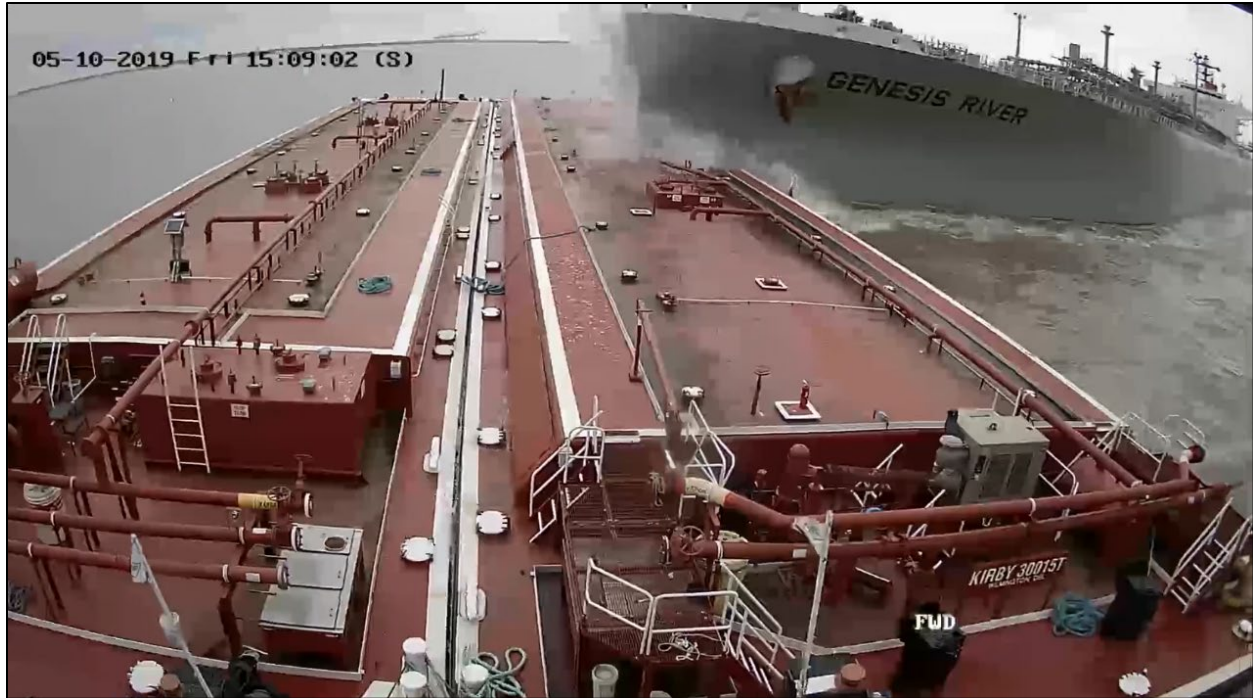
At 1516:09, the *Genesis River*’s bow struck barge *30015T* midship on the starboard side (see [figure 8](#)), penetrating through the double hull and breaching the no. 2 starboard cargo tank. The gas carrier’s bow continued through the barge’s hull into the no. 2 port cargo tank. The force of the collision capsized barge *MMI3041*, the tow’s port barge, although no tanks were breached. When the *Genesis River* impacted the *30015T*, the port face and long wires securing the barges to the *Voyager* parted. As the barges were pushed sideways by the *Genesis River*, the *Voyager* pivoted on the starboard face wire until the towing vessel’s starboard side contacted the stern of the *30015T*. As the *Voyager* continued to be pulled, it heeled significantly to starboard until the last face and long wires gave way, allowing the relief captain to regain control of the vessel. The loose end of the parted starboard long wire, which had fallen into the water, then fouled the *Voyager*’s starboard propeller, stalling the engine.

Figure 8. Screen capture from wheelhouse video on board the *Voyager* at the moment that the *Genesis River* struck barge 30015T. (Source: Kirby Inland Marine, LP)

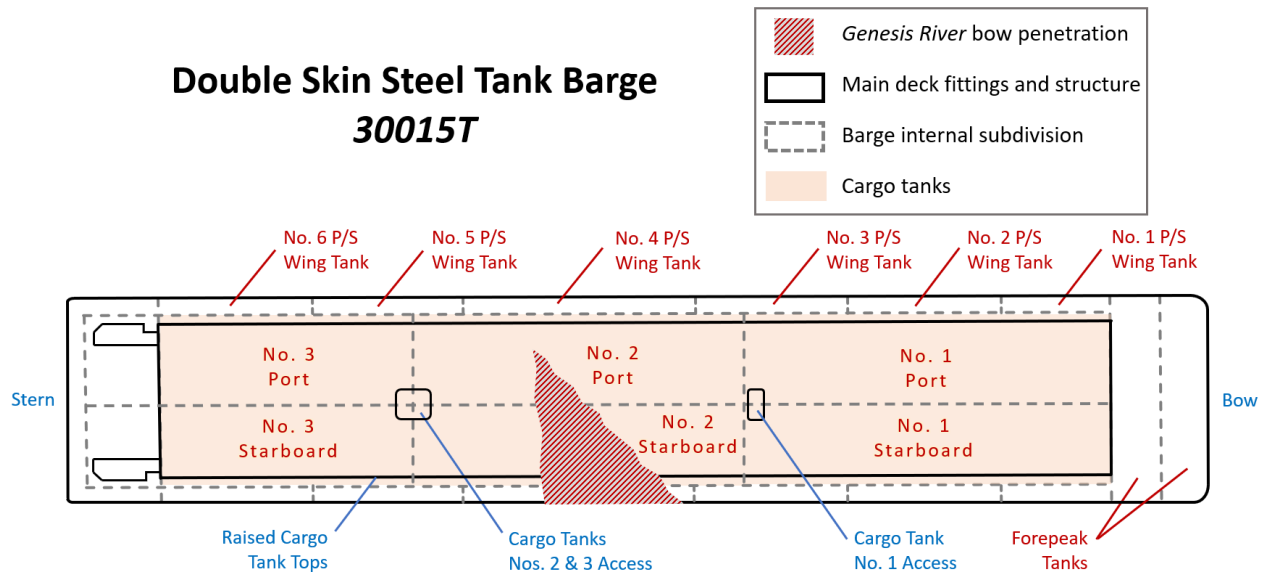
Figure 11. Barge 30015T simplified plan with area of major damage.

Accident Damage. Barge 30015T sustained a 23-foot-by-30-foot triangular-shaped gash in the starboard side, as well as bent or broken plating, framing, and piping throughout the vessel (see figure 12). The void space surrounding the cargo tanks on the 30015T was at the point of impact. Although double-hull requirements are intended to prevent the majority of spills from grounding or lesser impacts, the high-energy collision with the much larger *Genesis River* (displacing nearly 70,000 long tons at the time of the accident), which struck the 30015T hull with its narrow, SEA Arrow bow at over 10 knots, exceeded the protection afforded by the barge’s double hull.

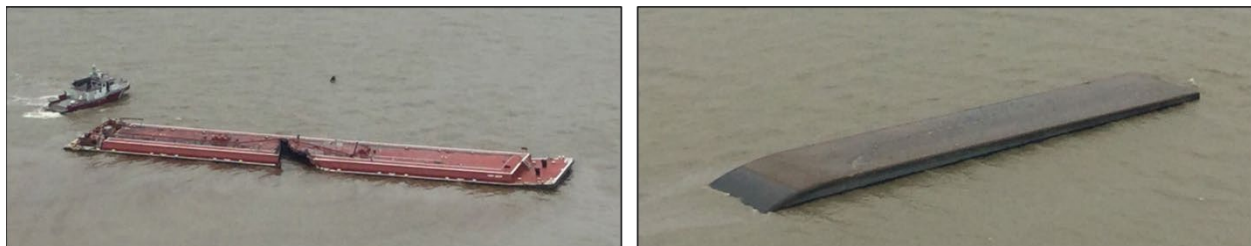
Barge *MMI3041* sustained inset or buckled plating along the wing tanks on both sides of the vessel. Additionally, several holes were made in the hull during salvage operations. Both barges were later determined to be constructive total losses and scrapped, with a combined insured value of \$2,789,643.

Figure 12. Barges 30015T (left) and MMI3041 (right) postaccident.

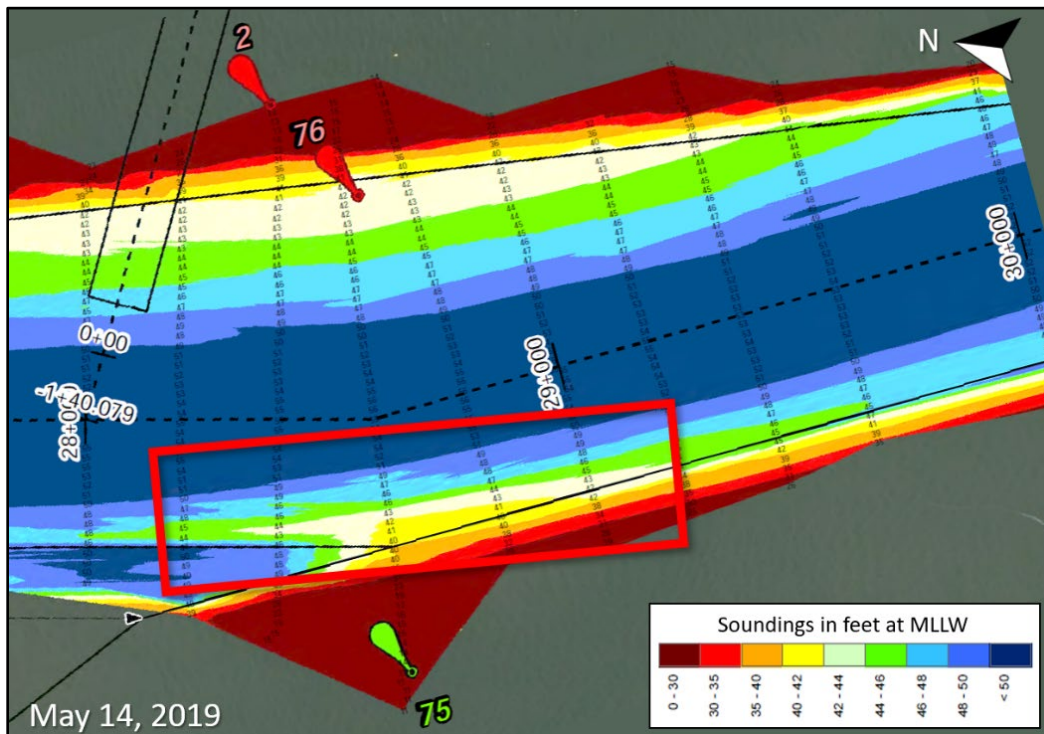
Figure 14. May 2019 sounding survey data in feet at MLLW for the Houston Ship Channel at the turn at Five Mile Cut. The red box shows the area on the western side of the channel where shoaling occurred in the 4 months since the January survey. (Source: USACE)

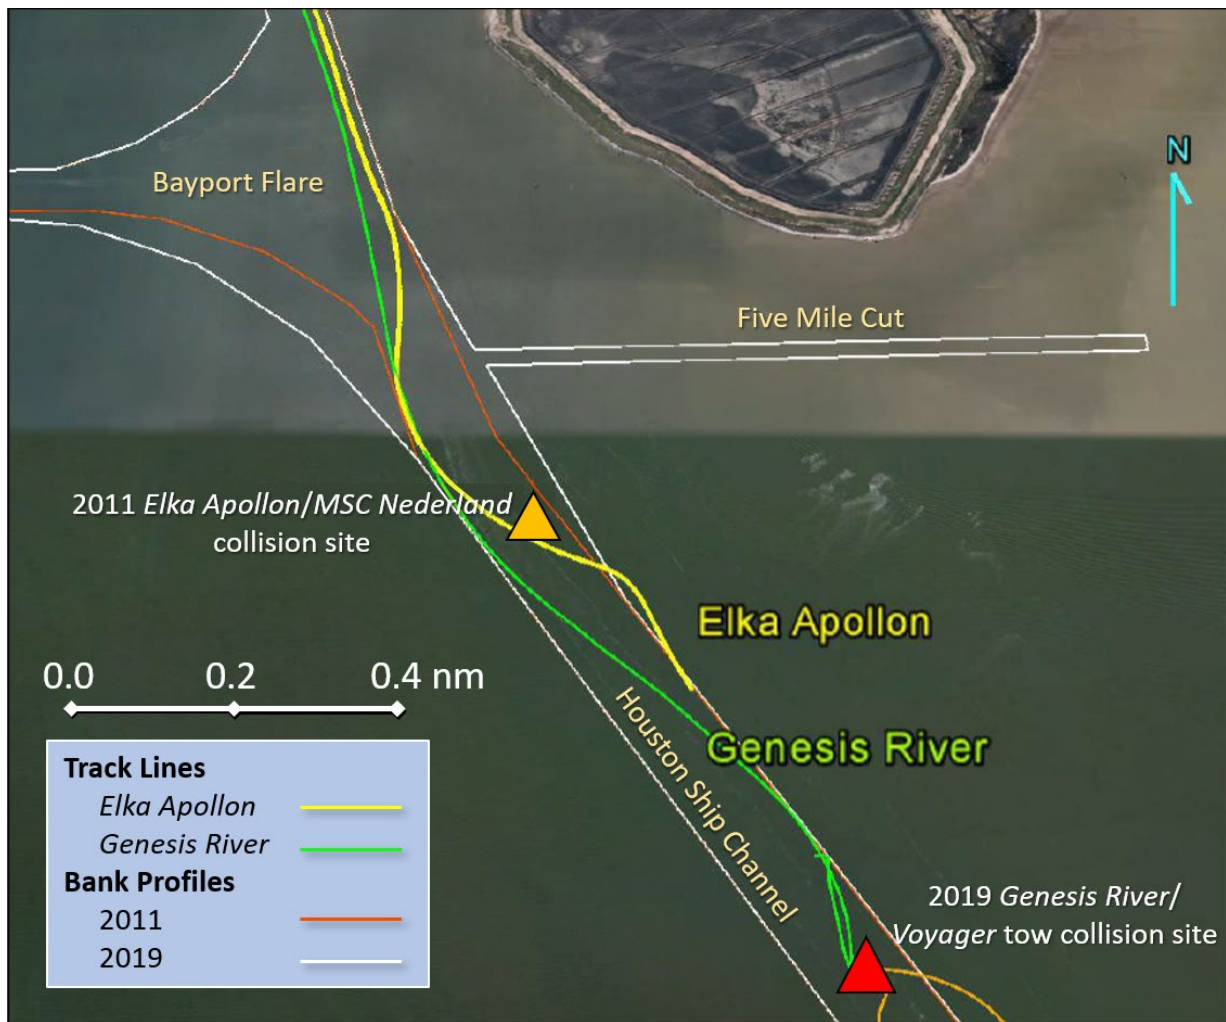
between the outbound 799-foot-long tanker *Elka Apollon* and the inbound 778-foot-long containership *MSC Nederland* occurred in nearly the same location, as shown in figure 18. (Note that the 2011 accident occurred before the Bayport Flare and the eastern side of the turn at Five Mile Cut were widened.) The NTSB determined that the probable cause of the *Elka Apollon*/*MSC Nederland* collision was the failure of the pilot conning the *Elka Apollon* to appropriately respond to changes in bank effect forces as the vessel transited the Bayport Flare, which, like the *Genesis River* 8 years later, caused the *Elka Apollon* to sheer across the channel and collide with an oncoming vessel. Contributing to the accident were the narrow waterway, bank effects at the Bayport Flare, and traffic density—nearly the same factors as in the *Genesis River*/*Voyager* tow accident.

Figure 18. Tracks of the *Elka Apollon* (2011) and *Genesis River* (2019) during accident voyages. Note the changes in the channel bank profile between the two accidents, as indicated by orange and white lines.
