Issued January 13, 2022

MIR-22/01

## Contact of *Robert Cenac* Tow with CSX Railway Rigolets Bridge

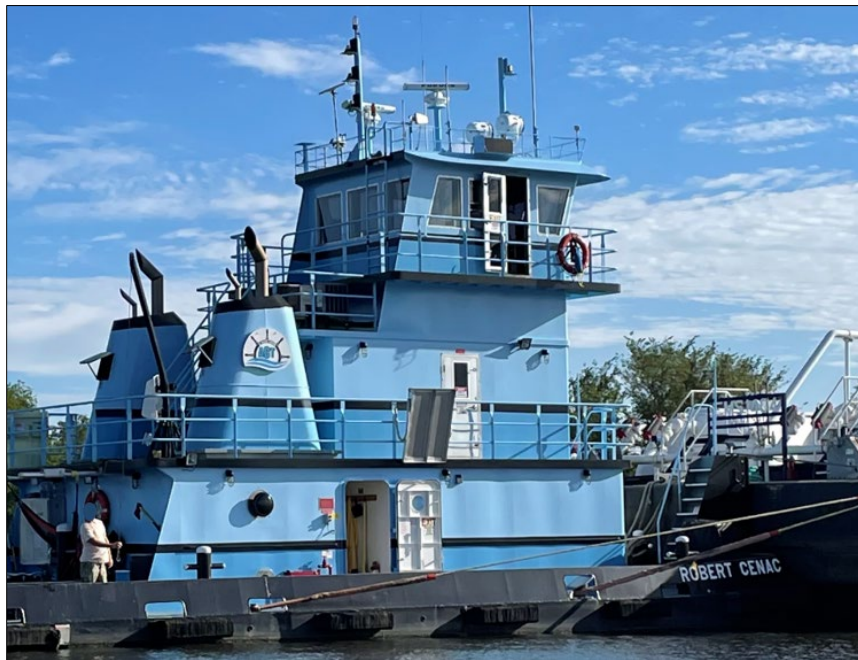
**Figure 1.** *Robert Cenac* after the accident. (Source: anonymous)

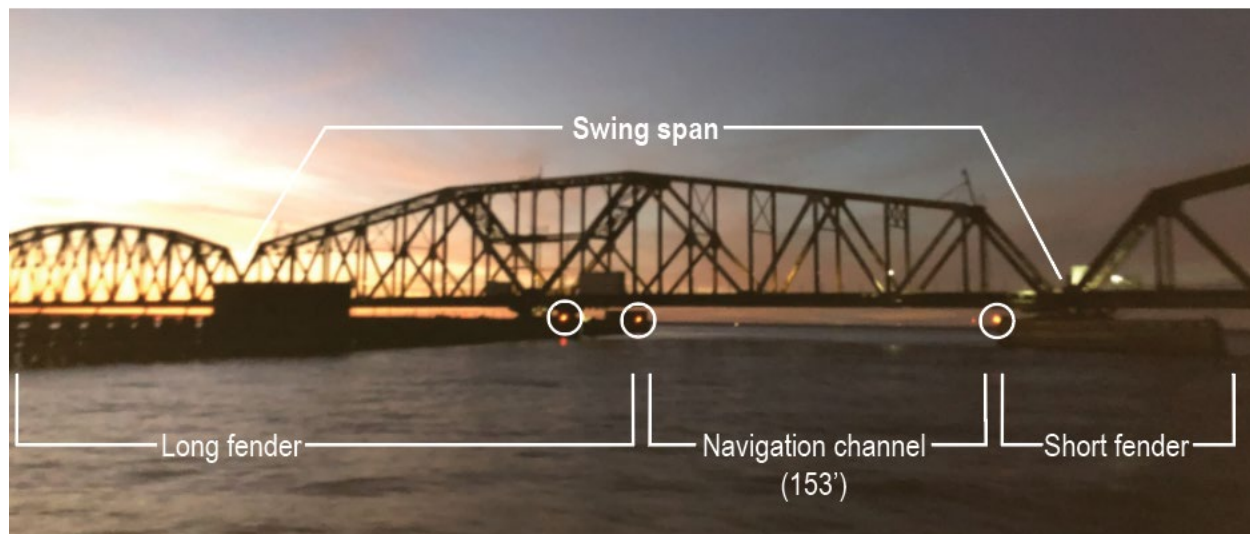
**Figure 3.** January 29, 2021, postaccident photo of the Rigolets Bridge (in the closed position), as it would have been approached from the south, heading north. Red navigation lights on the long and short fenders are circled. Note there are no navigation lights at the top of and each end of the swing span, and there are no red navigation lights at either end of the short or long fenders, nor anywhere on the south side of the bridge on the short or long fenders. (Source: Bullard Marine Solutions, annotated by NTSB)

The *Robert Cenac* captain described seeing only two lights on the long fender and one on the short fender as the tow approached the channel to pass through the bridge, where there should have been three on each. Postaccident video and pictures of the Rigolets Bridge confirmed the captain's observations: there were no lights marking the south end of the short fender and long fender. The swing span was not fitted with alternate green and red navigation lights marking each end and the top center of the bridge span. No correspondence was found from the Coast Guard exempting the Rigolets Bridge from the requirements of 33 *CFR* 118.70.

Postaccident, CSX installed additional white flood-type lighting to illuminate the bridge and the channel. The pilot of the *Robert Cenac* told investigators that, during later transits through the bridge, the additional lighting made it easier to identify the opening. As of this report's issue date, the swing span of the Rigolets Bridge remains without navigation lighting as required by regulation.

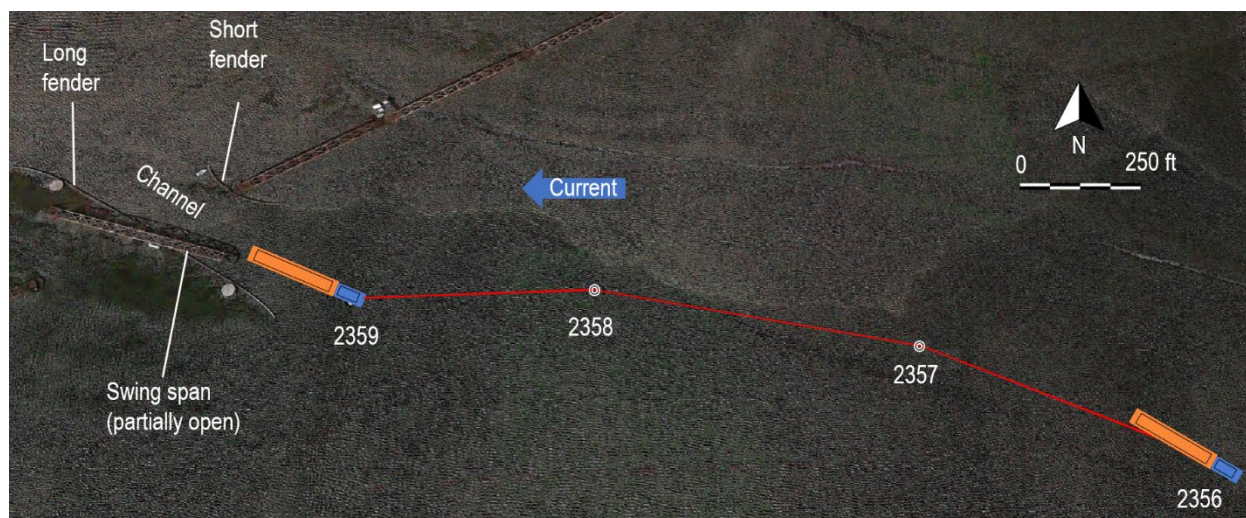
At 2358, the tow was at a speed of 7.1 mph; less than a minute later, the speed of the tow began to rapidly decrease. About 2359, the coaming on the forward port side of the barge struck the overhanging south (when open) end of the swing span. The bridge operator told investigators that, while his hand was on the lever opening the bridge, he saw on the closed-circuit television camera the *Robert Cenac* tow “shooting the gap... a couple of seconds” before the barge hit the span.

**Figure 4.** Trackline of the *Robert Cenac*, based on automatic identification system course over ground data and the approximate position of the tow upon its contact with the Rigolets Bridge. Bridge position in the photo is about three-quarters of the way open. Tow headings are estimated. (Background source: Google Earth)

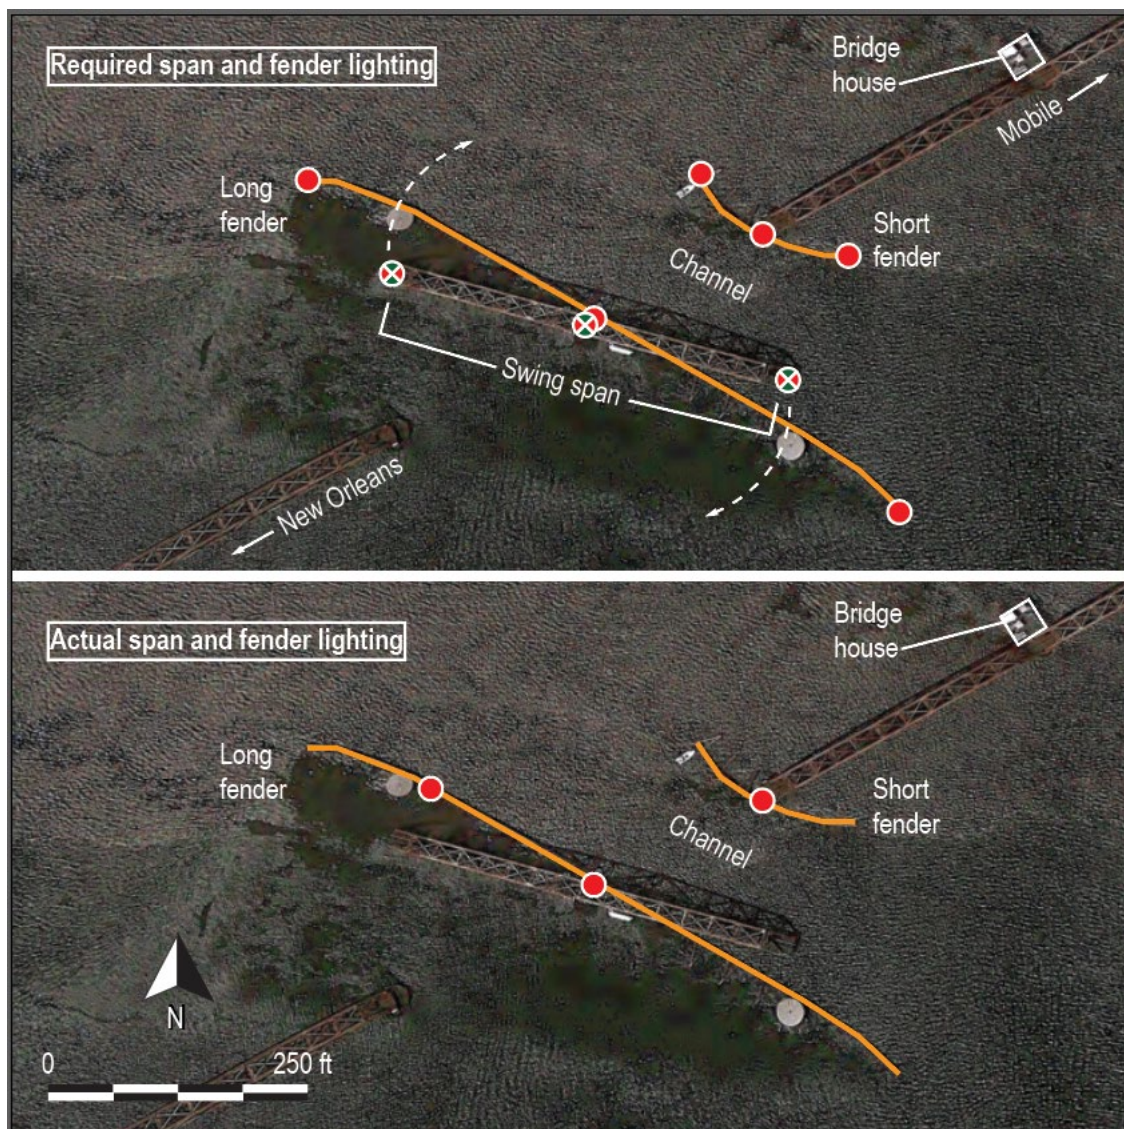
**Figure 6.** August 2015 images of the Rigolets Bridge channel and fendering with the swing span about three-quarters of the way open. (Background source: Google Earth)

The last CSX bridge inspection report for the Rigolets Bridge was completed about 3 weeks before the accident, on December 7, 2020, and documented one missing solar navigation light on the long fender; there was no further documentation regarding its repair or replacement status. Additionally, damage was documented on the short fender on the upstream (north) side due to a recent vessel contact, and the long fender was missing about 12 boards on the downstream (south) side of the dolphin due to a recent storm.

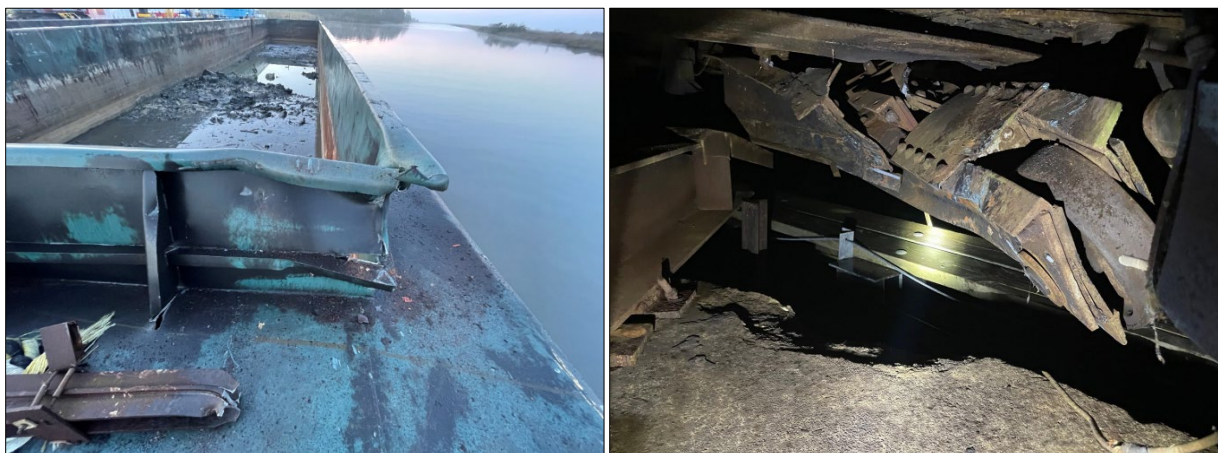
The damage to the forward port side of the barge *SH 238* consisted of indentations and cracks to the portside forward bow and portside forward hopper coaming, which cost an estimated \$5,000 to repair. The captain told investigators the *Robert Cenac* never struck any part of the span or fendering, and there was no damage to the towing vessel.

**Figure 7.** Left: Portside forward of barge *SH 238* looking aft showing damage to the hopper coaming. In the lower left, debris (wedge arm) from the bridge is visible. (Source: *Robert Cenac* crewmember) Right: Southeast corner of the swing span (in the open position) showing damage to the balance wheel and support beam. (Source: Coast Guard).

The Rigolets Bridge sustained damage costing about \$1.1 million. A third-party postaccident survey report stated that the *Robert Cenac* tow initially struck the south end of the bridge's opened swing span, veered off the swing span, and then collided with the north side of the bridge's short fender, causing damage to the north side of the short fender and the south side of the long fender. The survey also reported that "the tug's stern likely contacted the bridge's south side/long fender in way of the center pivot pier" and that damage to the fenders "appeared to be newly sustained."

Another postaccident survey report documented that the south end (in the open position) floor beam of the swing span/bridge "was directly impacted approximately four feet from the inside edge of the west truss." There was damage to the swing span structure and components, the assembly used to open and close the swing span, and electrical and cabling components. Evidence markings were found on the north main pinion, indicating the span was struck "near the bridge fully open position." After repairs were made, the Rigolets Bridge was restored to regular service on March 2, 2021.
