MIR-22/04

## Collision between Offshore Supply Vessel *Cheramie Bo-Truc No. 33* and US Coast Guard Cutter *Harry Claiborne*

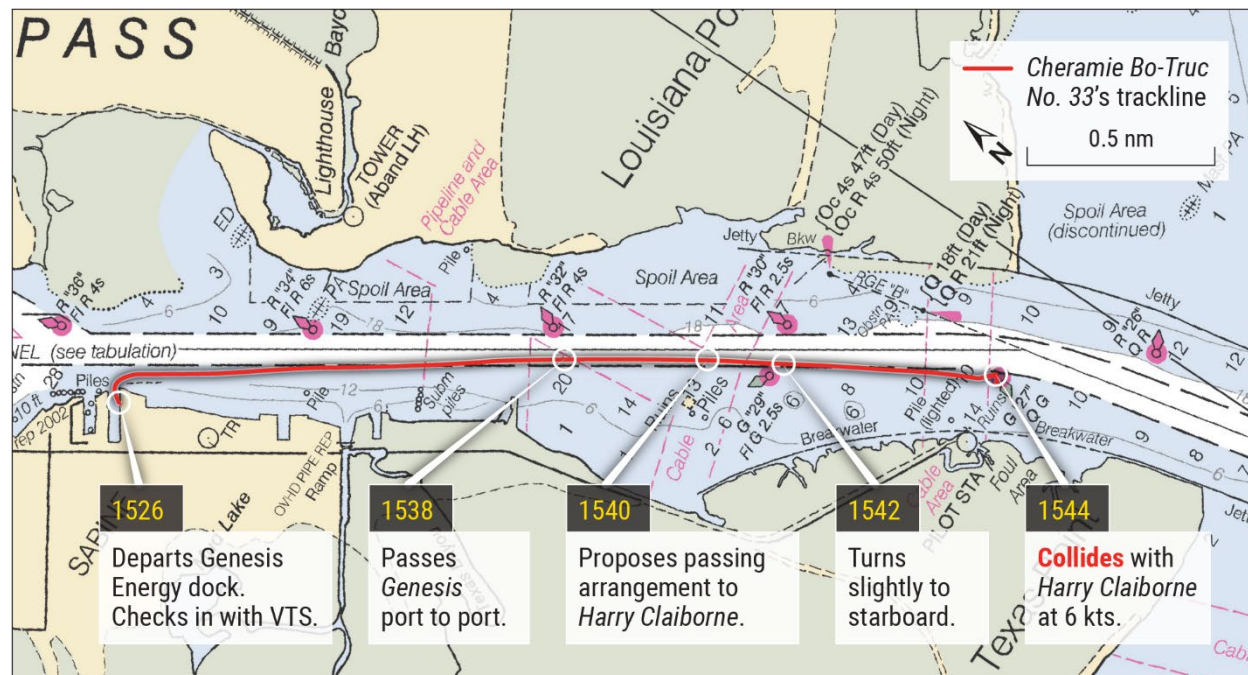
At 1542, after passing green buoy no. 29, the *Cheremie Bo-Truc No. 33* made a slight course change to starboard (see figure 3). Up to that point, the offshore supply vessel had been traveling about 13.1 knots. The captain reported that as the vessel approached the *Harry Claiborne*, the reading on the *Cheremie Bo-Truc No. 33*'s depth sounder quickly dropped, prompting the captain to abort his attempt to pass starboard of the cutter to avoid running aground. Realizing the imminent danger of collision, the captain then reversed the vessel's engines and used the bow thruster and rudder to turn to port to try to avoid hitting the cutter.

**Figure 3.** Sabine Pass chart showing the path of the *Cheremie Bo-Truc No. 33* (in red) from the Genesis Energy dock to the collision site. (Source: National Oceanic and Atmospheric Administration [NOAA] chart 11342, annotated by NTSB)

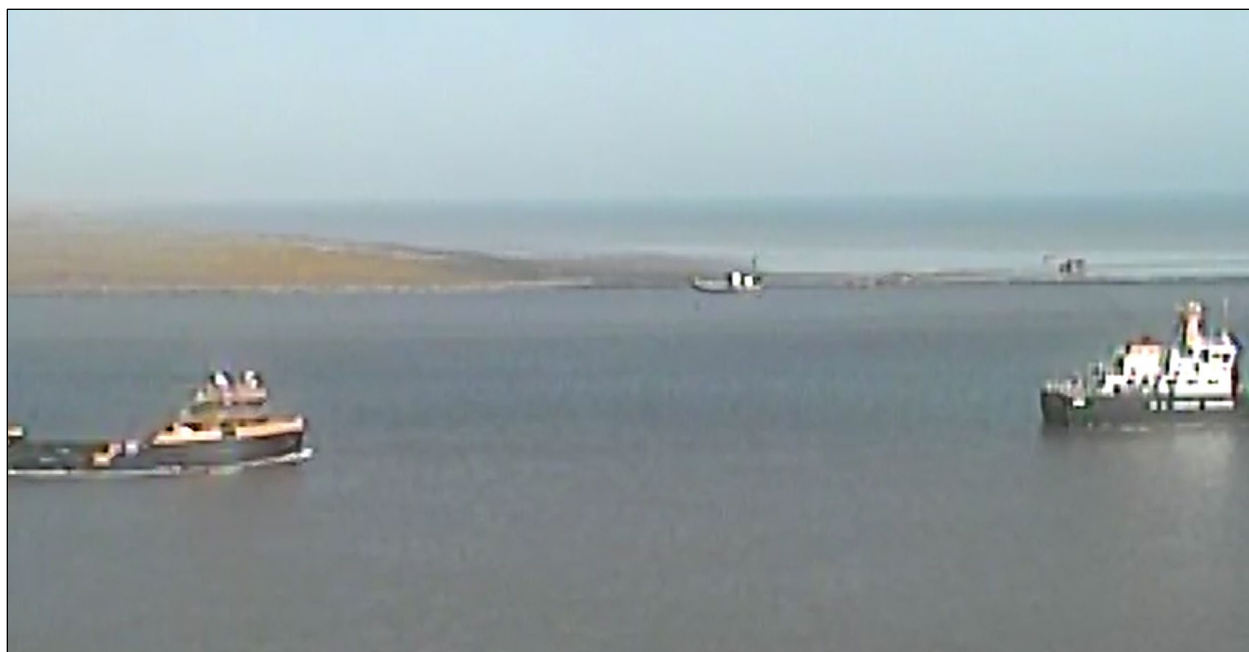
At 1543, the VTS watchstander, who was monitoring the waterway using AIS and the traffic service's camera, was looking for the tug *Rachel*, which at the time was traveling inbound in the Sabine Pass jetty channel. Noticing the close-quarters situation developing between the cutter and the offshore supply vessel, he zoomed in on the video to investigate (see figure 4). The camera captured the offshore supply vessel's swing to port and the subsequent collision.

**Figure 4.** Screen capture from VTS camera footage at 1543, a minute before the collision.  
(Source: Coast Guard)

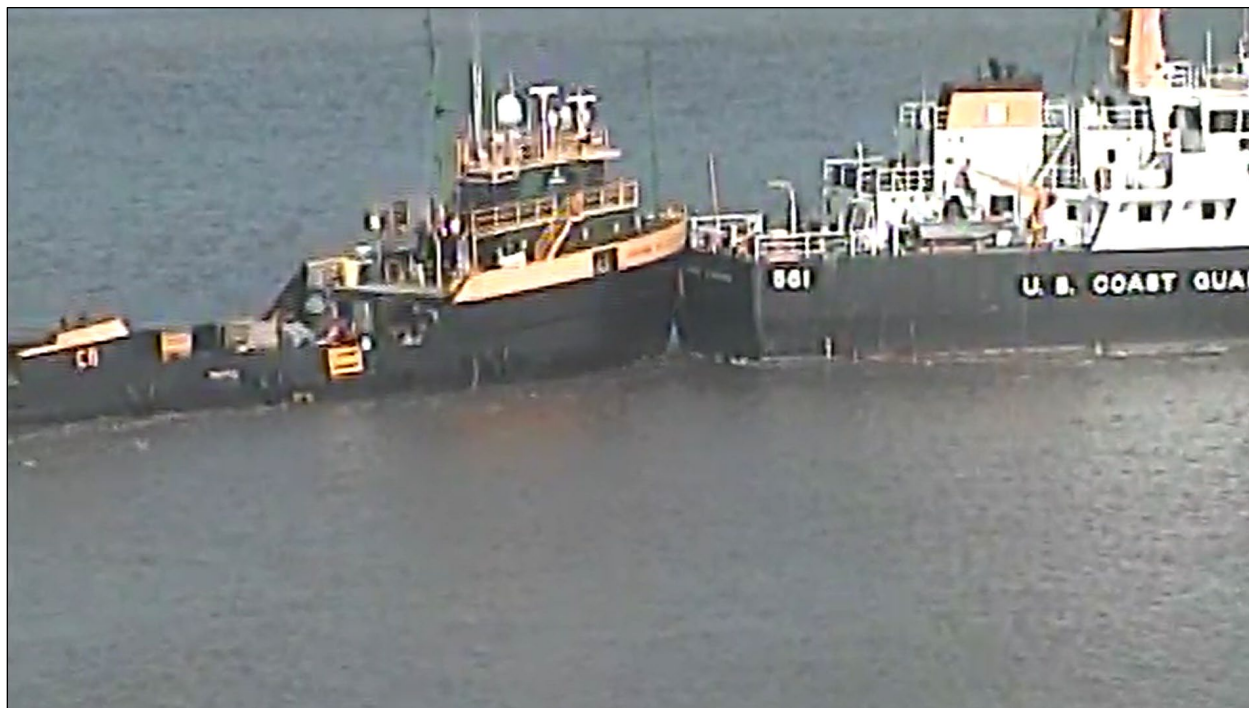
At 1544, while traveling at 6 knots, the *Cheramie Bo-Truc No. 33* collided with the *Harry Claiborne*, its bow striking the cutter's transom on the port side (see figure 5). The impact slightly displaced the cutter, which was within 10 yards of buoy no. 27's assigned position on the edge of the dredged channel. Two crewmembers aboard the *Harry Claiborne* sustained minor injuries. To avoid being swept out into the channel if they lost propulsion, the cutter crew secured the buoy chain with a hook and dropped the ship's anchor. With the cutter's DP system active, the thrusters moved the vessel back to its programmed position and heading.

**Figure 5.** Screen capture from VTS camera footage at 1544, the time of the collision. (Source: Coast Guard)

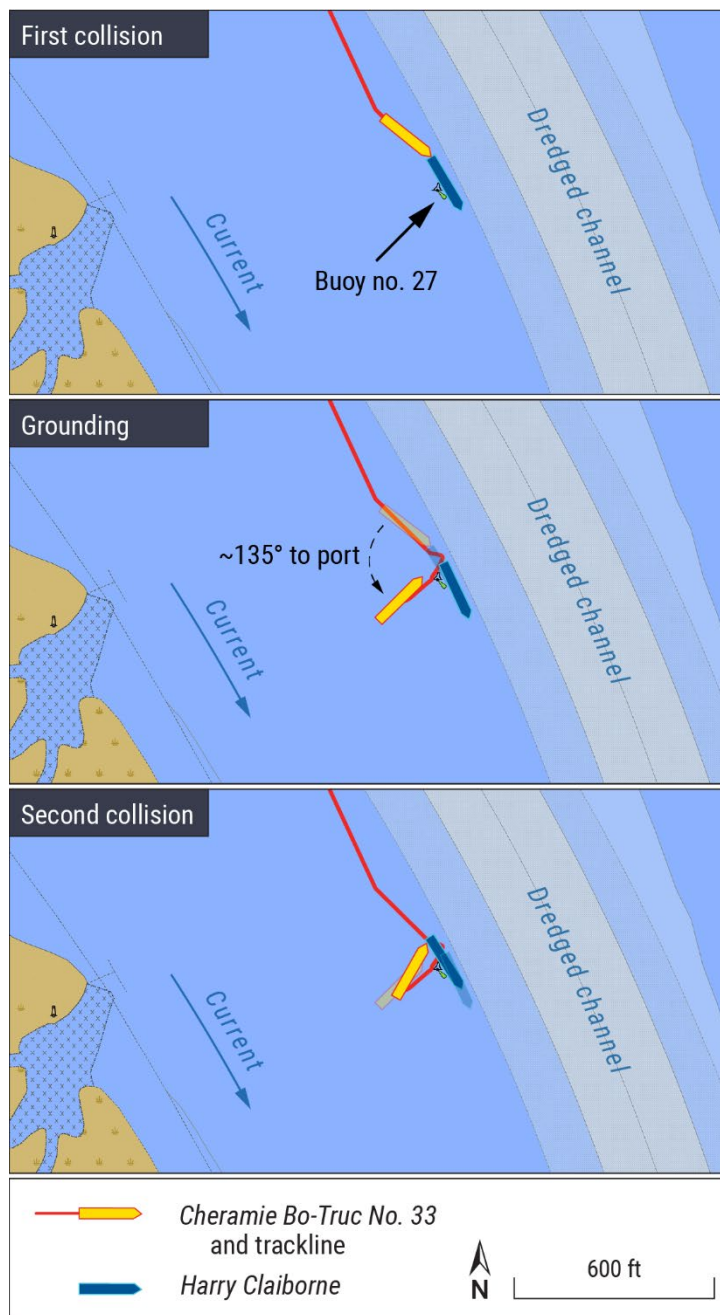
After the offshore supply vessel struck the cutter's stern, momentum rotated the *Cheramie Bo-Truc No. 33* to port about 135° and carried it down the *Harry Claiborne's* starboard side into the mud, until the offshore supply vessel came to rest on a northeast heading. VTS captured radio conversations between the cutter and offshore supply vessel as they exchanged injury and damage reports. AIS data showed the offshore supply vessel was aground about 130 feet west-southwest of buoy no. 27. Figure 6 provides a diagram illustrating the sequence of these events—the grounding and second collision—following the initial collision.

**Figure 6.** Illustration of the positions of the offshore supply vessel (yellow) and the cutter (blue) with estimated headings relative to buoy no. 27 during the first collision, grounding, and second collision. (Background source: NOAA Electronic Navigational Charts, annotated by NTSB)

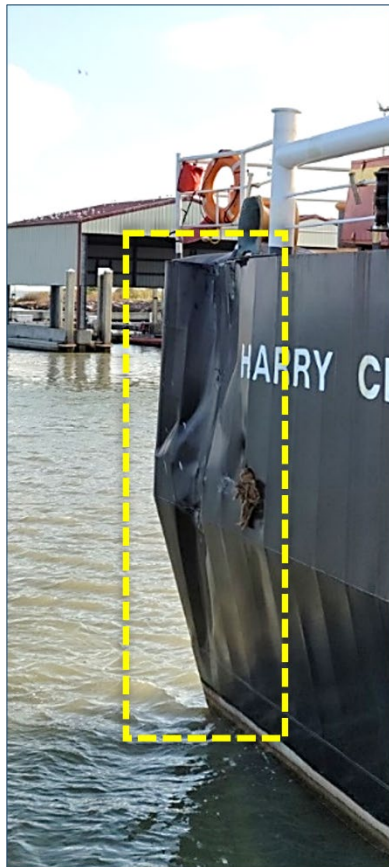
The *Cheramie Bo-Truc No. 33* sustained a fractured bulwark on the starboard bow. The *Harry Claiborne* sustained damage on the port side to its shell plating, vertical framing, fantail, and Z-drive (see figure 7). From the second collision, the cutter sustained additional damage on its starboard quarter above the waterline.

**Figure 7.** Damage to the *Harry Claiborne's* port transom.

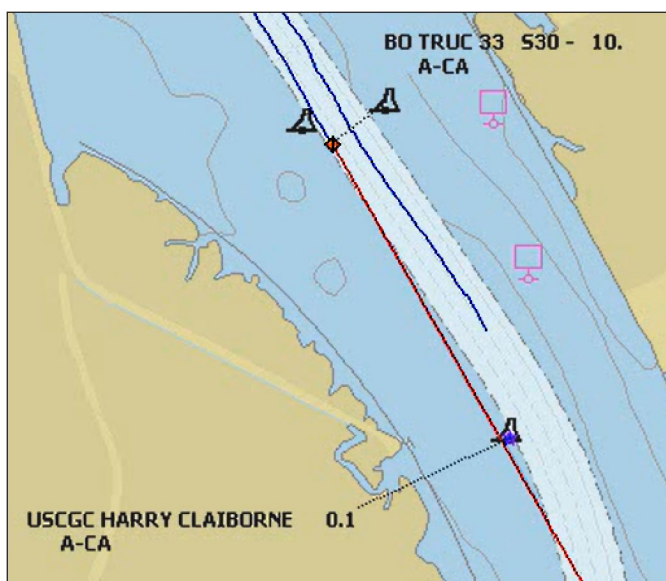
**Figure 8.** Screen capture from VTS PAWSS at 1540, after the *Cheremie Bo-Truc No. 33* (blue line, left) passed buoy no. 29. The vessel's 12-minute true motion vector is shown in red. The blue line at the right represents the path of an inbound vessel. (Source: Coast Guard)

Port Arthur did not warn the VTS watchstander of vessels leaving the channel, nor did anyone report to VTS there was post-hurricane shoaling in the area. Figure 8 provides a screen capture from the traffic service's PAWSS software when the *Cheramie Bo-Truc No. 33*, just after passing buoy no. 29, was heading toward shallow water, based on its 12-minute true motion vector.

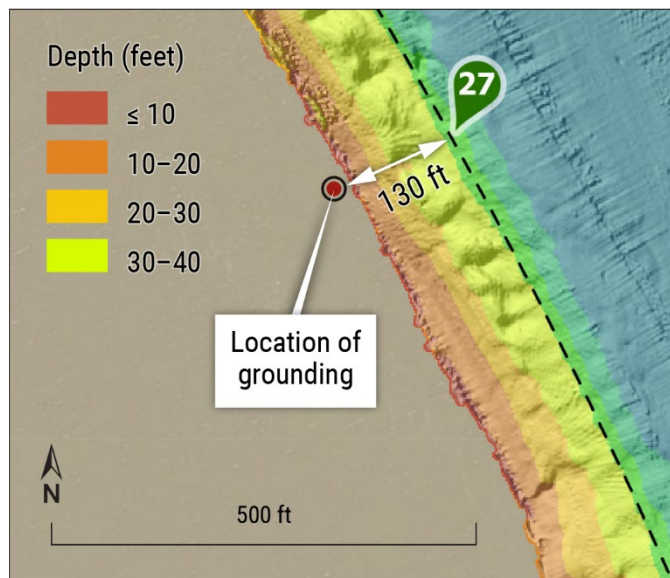
**Figure 9.** Image from Army Corps of Engineers postcasualty bathymetry survey showing water depths around sites of the collision site near buoy no. 27 and the grounding site about 130 feet (40 meters) west of the buoy (annotated by NTSB).

A postcasualty bathymetry survey by the US Army Corps of Engineers showed depths greater than 20 feet within 70 feet of the buoy and depths of 10 feet within 130 feet west of the buoy's assigned position, where the *Cheramie Bo-Truc No. 33* grounded (see figure 9).
