Issued March 21, 2022

MIR-22/09

Contact of *Ava Claire* Tow with Leland Bowman Lock Gate

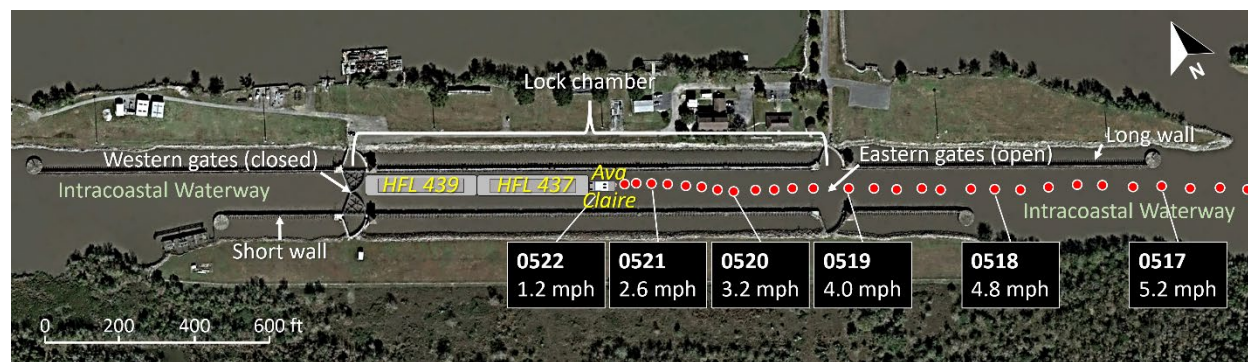
Figure 3. Automatic identification system (AIS) track of the *Ava Claire*, as indicated by the red dots, with a scaled representation of the tow added. The AIS antenna was located on the towing vessel, about 615 feet aft of the bow of barge *HFL 439*. (Background source: Google Earth)

According to the captain, when the head of the tow was about 600 feet from the western gates, he moved the engine throttles to slow astern. Based on automatic identification system (AIS) data, the tow’s speed at the time was 3.7 mph and decreasing.

The deckhand stated that radio communications improved when the head of the tow was about 250 feet from the western gates. At this time, the captain was able to hear the deckhand’s distance calls. AIS data shows that the vessel’s speed was 3 mph. The captain said that when the tow was about 200 feet from the gates, he put the engines at full astern. The tow continued to slow but did not fully stop before the starboard bow of the *HFL 439* struck gate no. 3 on the northwest side of the lock at 0522. The tow’s speed when it contacted the gate was 1.2 mph.

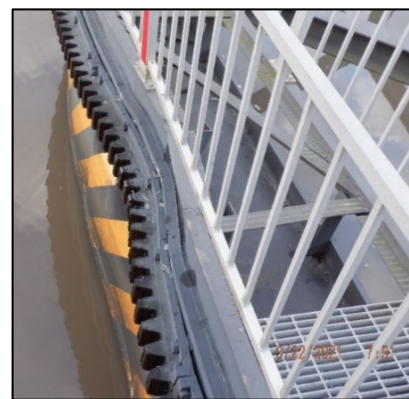
Steel plating, internal framing, and sections of the rack on lock gate no. 3 were bent 12 inches inward where the barge struck the gate. The gate structure was also knocked out of alignment, preventing it from being

Figure 5. Damaged steel plating and rack on gate.

fully opened. At the time of this report, damage below the waterline had not been assessed, nor the gate repaired.
